US ECOLOGY (USE) REMEDIAL INVESTIGATION STATUS

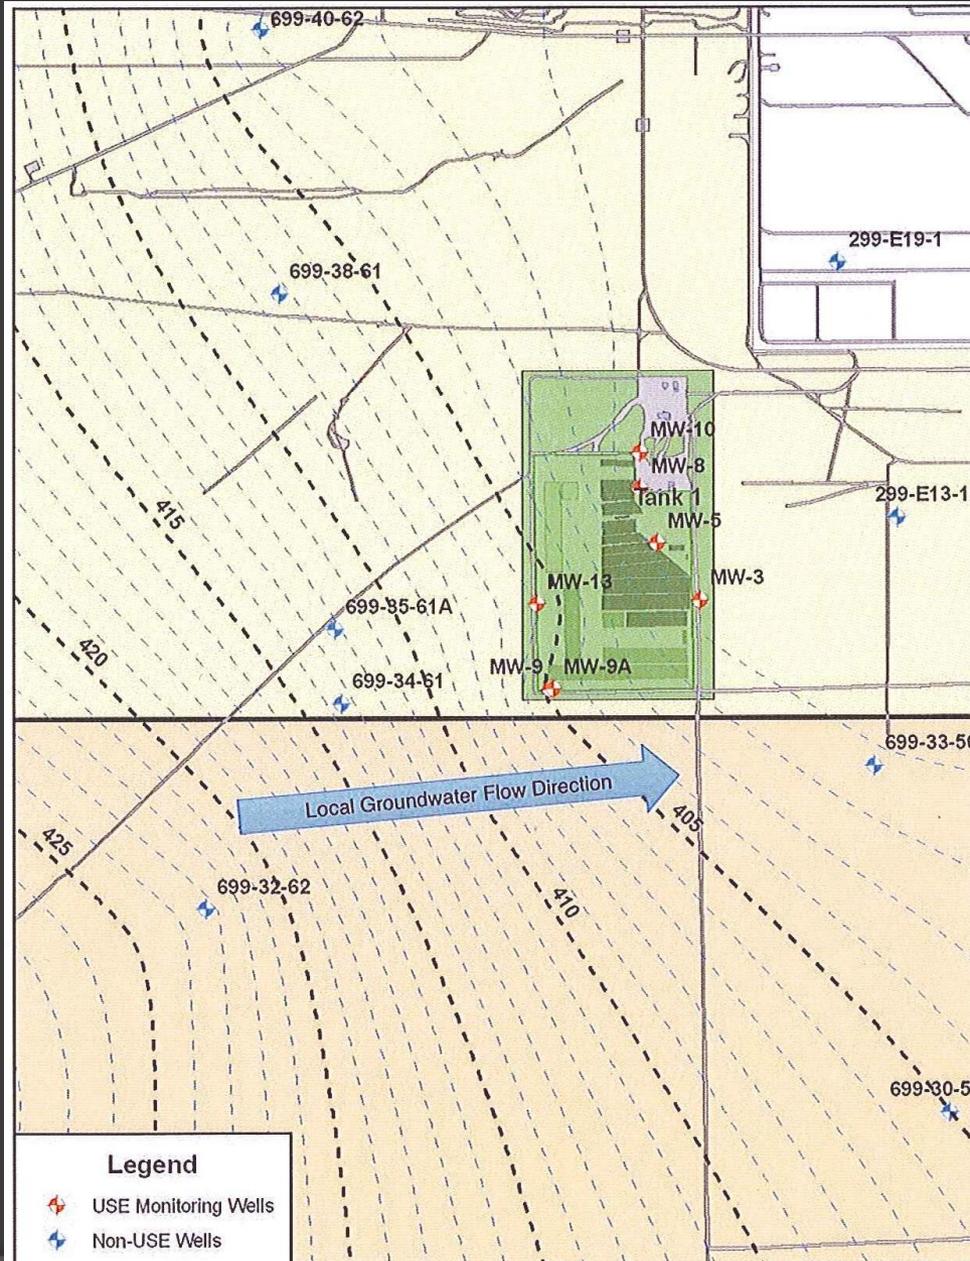
Figure 34 Corrected Site Waterlevels From Both USE and Non-USE Wells

- Review groundwater levels from 1993-2008
- Average decrease in slope of water level of 0.1 m/y (.32 ft/yr.)
- Groundwater flow in Central Plateau is affected by the presence of buried flood channel
- Hydraulic gradient is estimated to be 10^{-5}
- Reference PNNL-16346

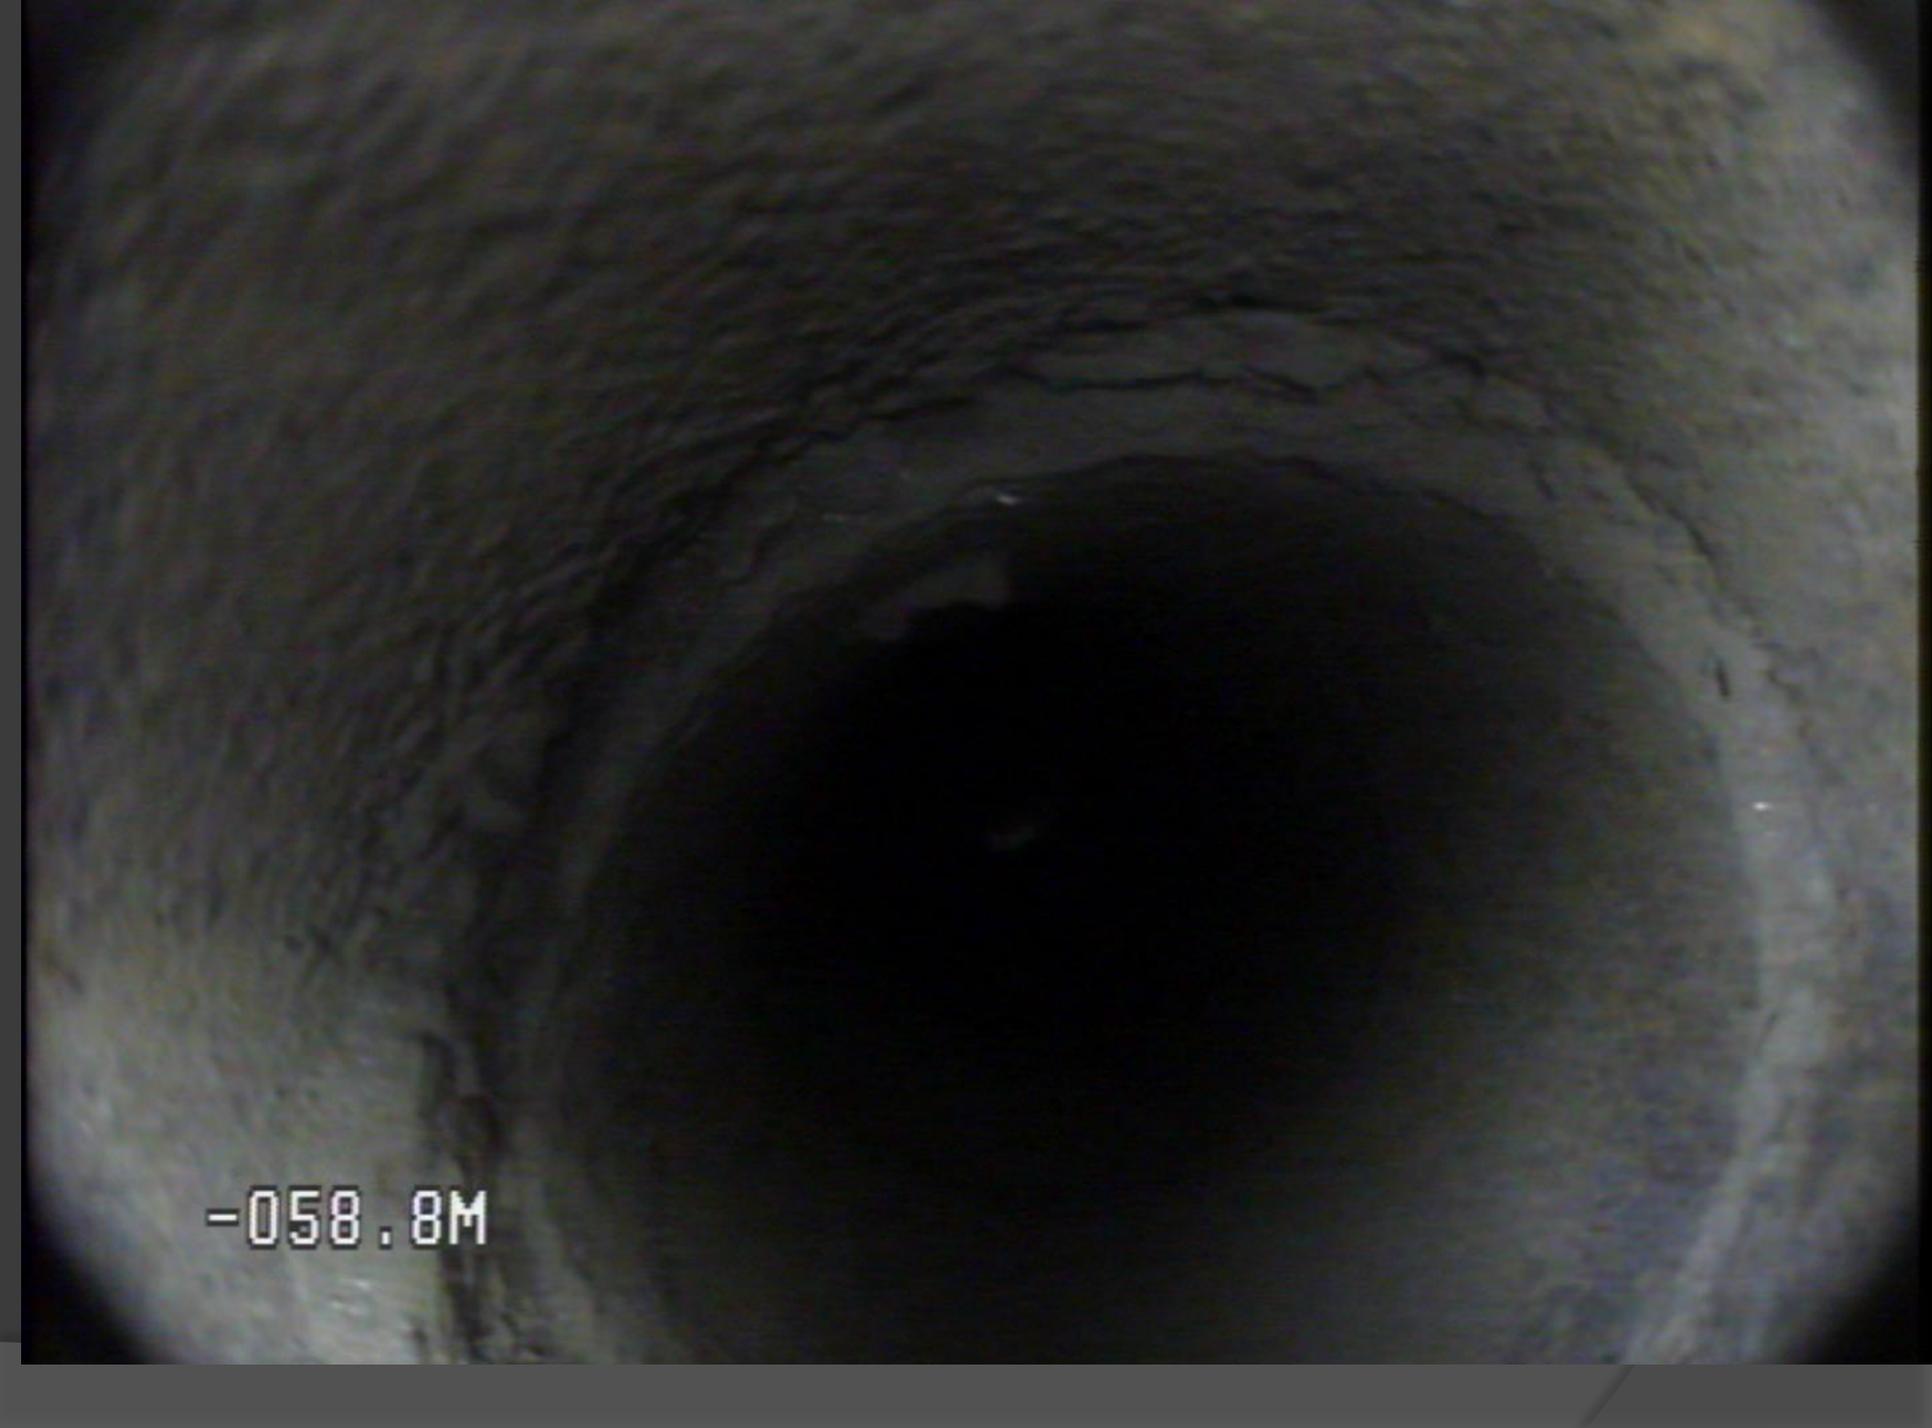
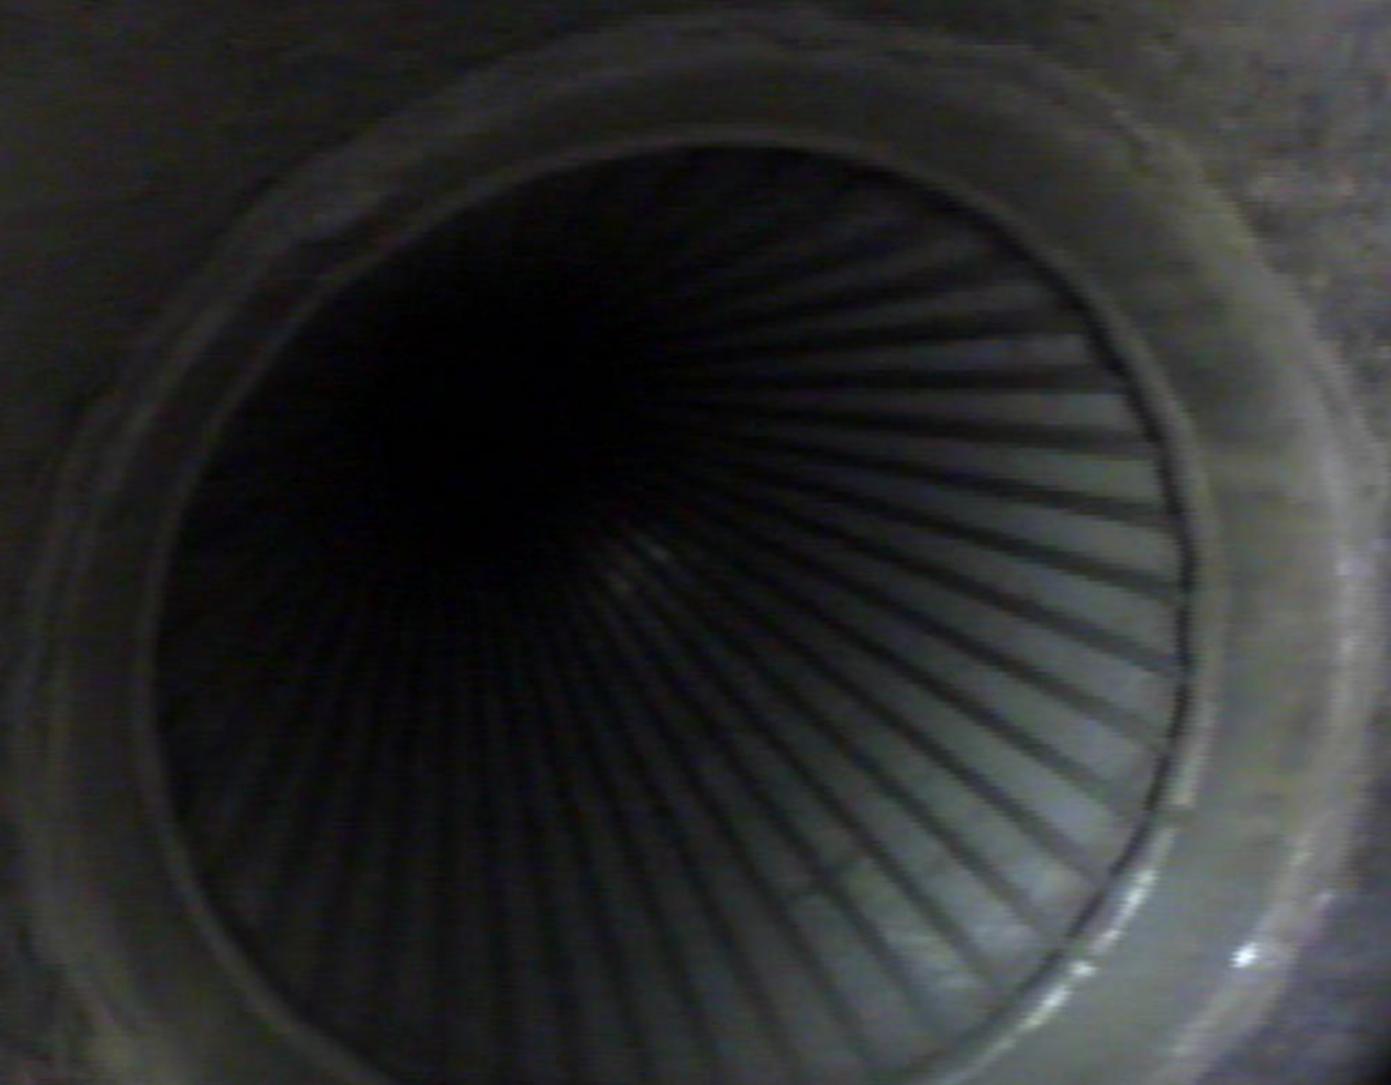
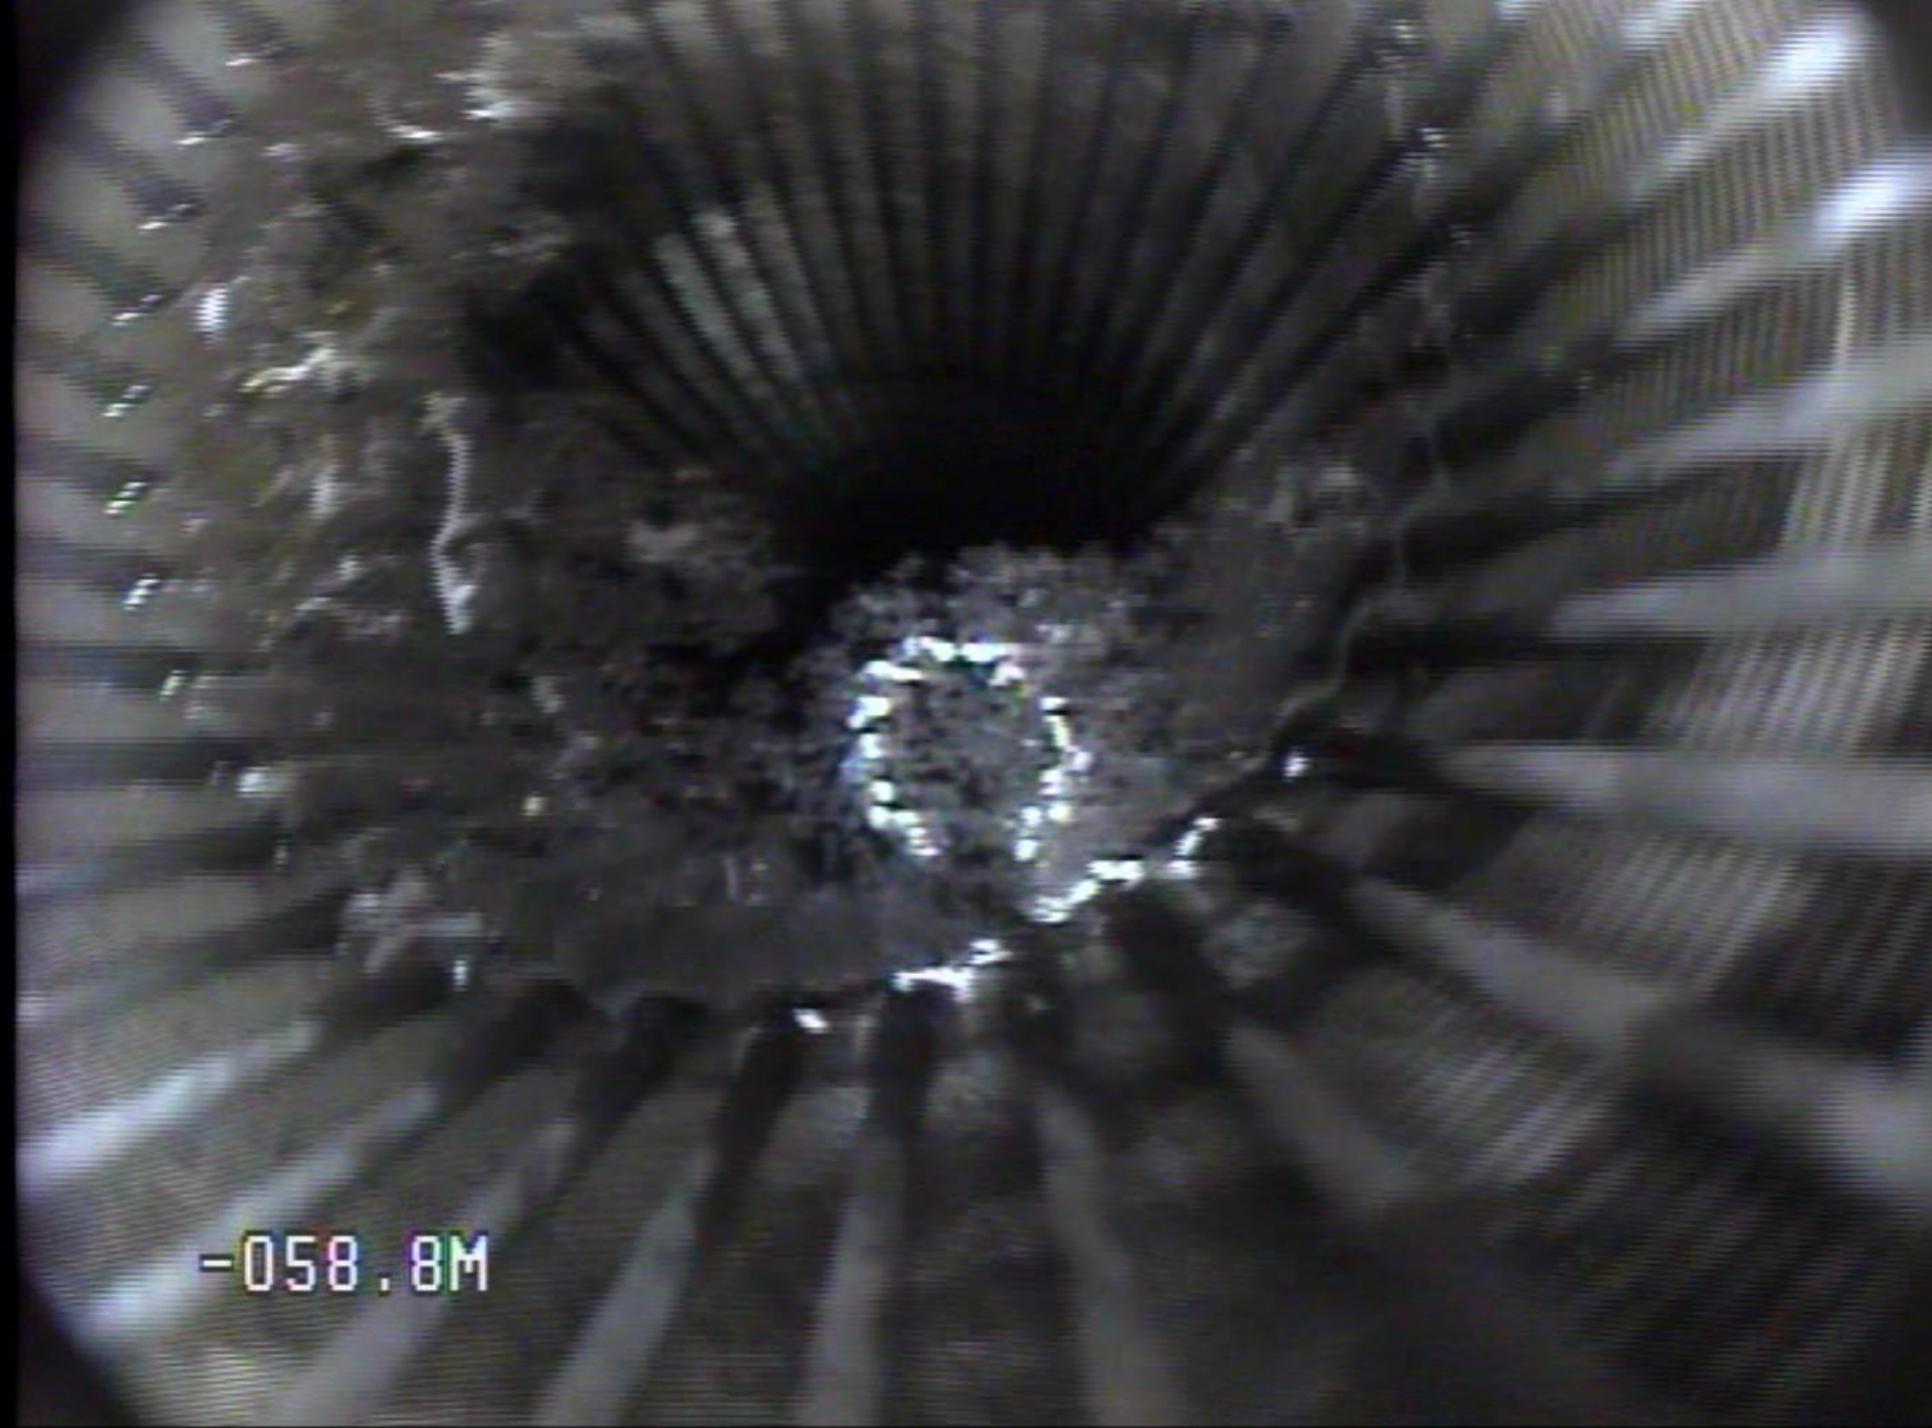
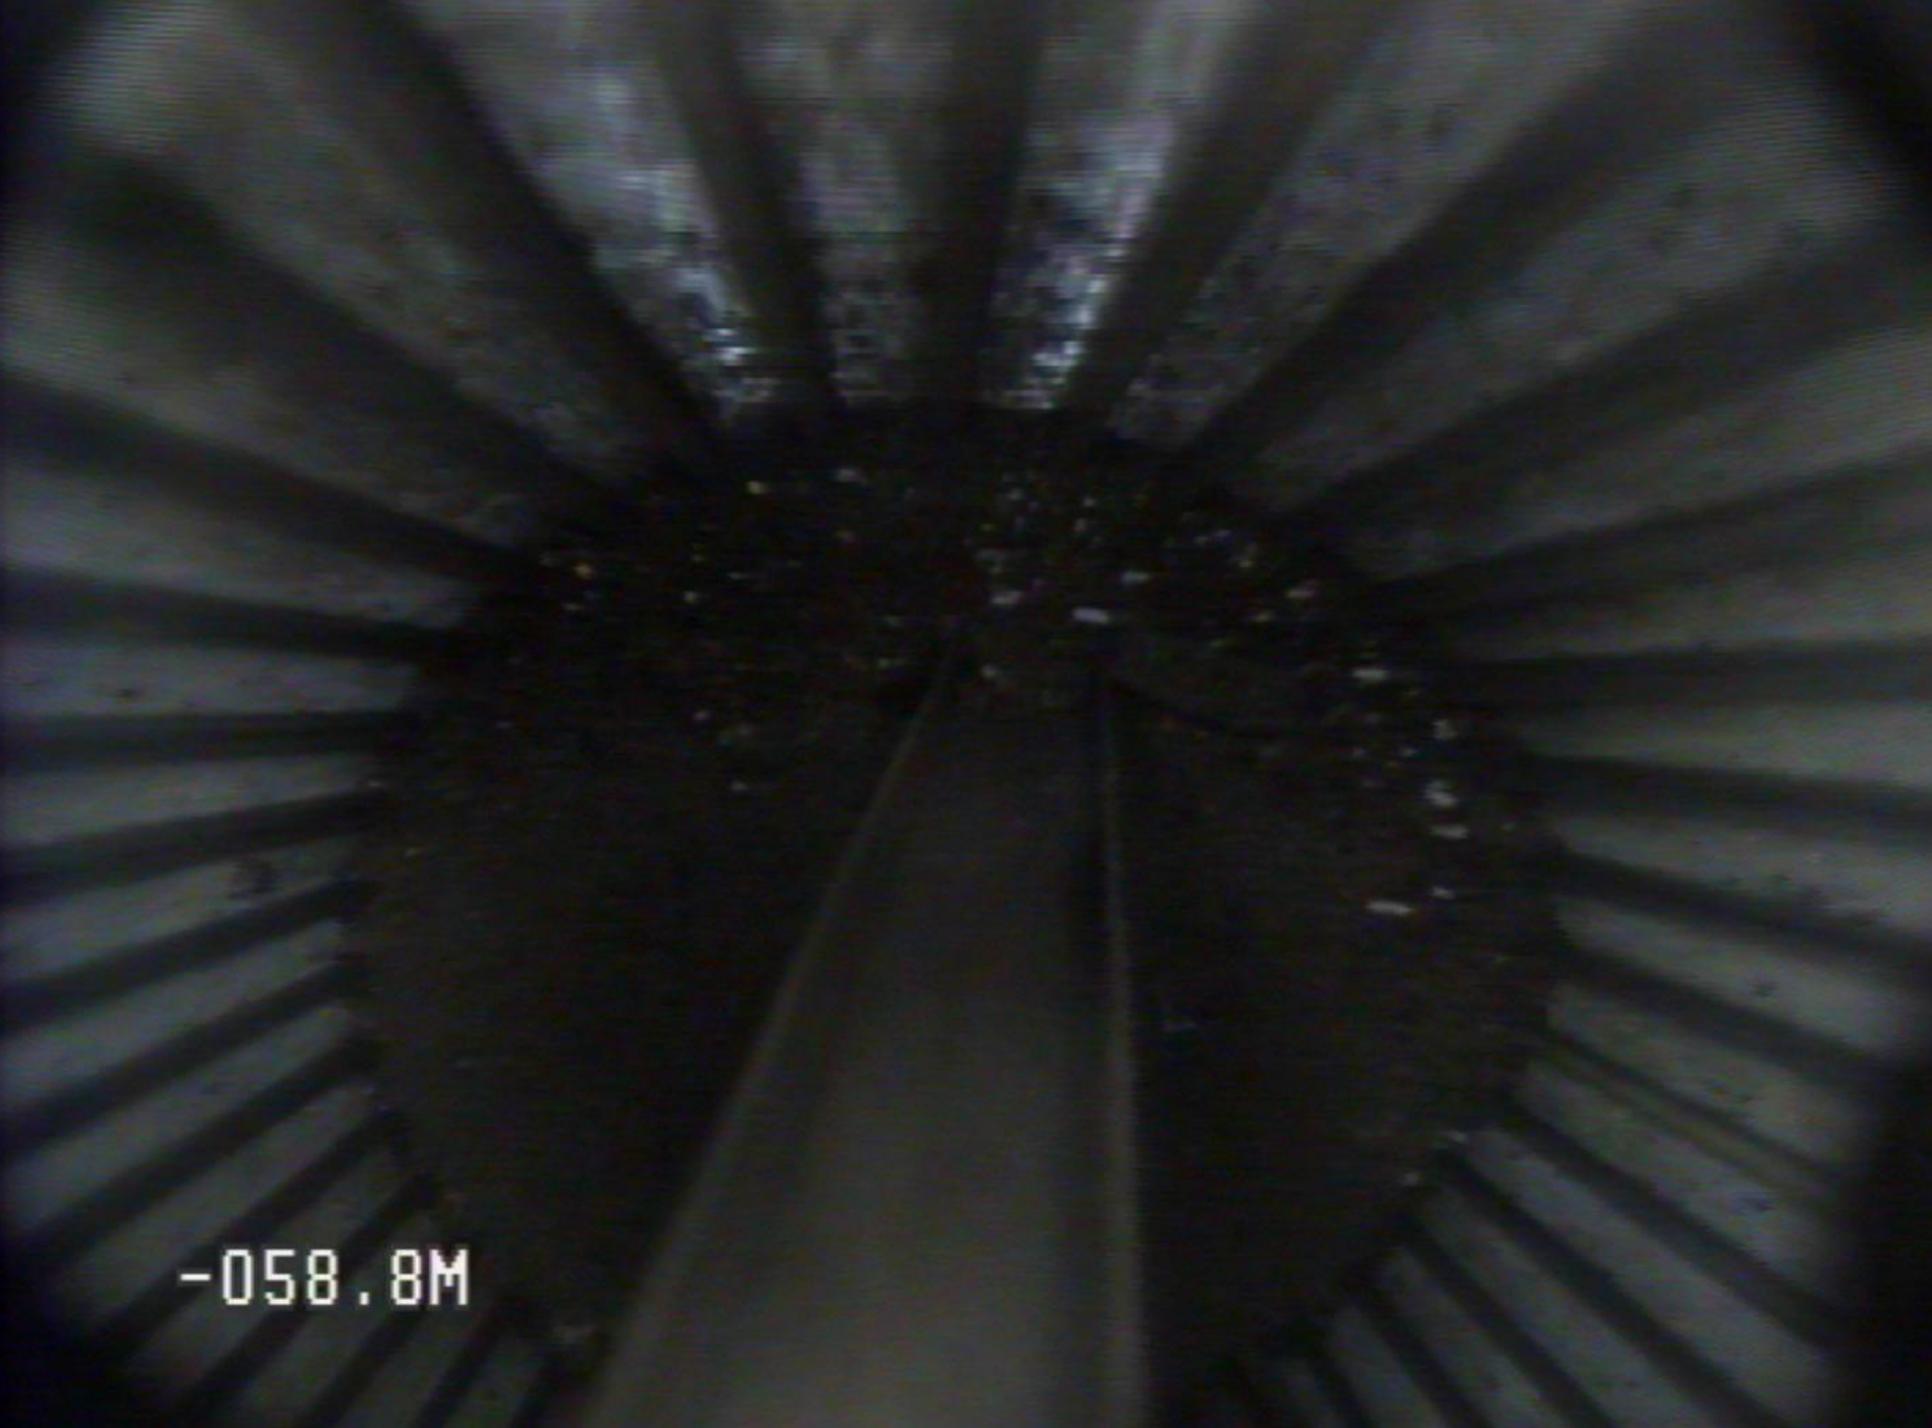
Monitoring Well 10 Borehole Camera Images

- Document and inspect the integrity of internal surfaces for each of the 7 monitoring well casings
- Dedicated groundwater monitoring pumps removed
- MW 3, 5, 13 no conditions to report
- MW 8, 9, 9A, 10 various O&M
