Re: Ecology Assessment Report for Field Monitoring Activities of the waste material near Riser 83 of the 241-AY-102 Double Shell Tank (DST)

## ASSESSMENT REPORT

### Field Monitoring Activities

Project: 241-AY-102 Field Monitoring, Riser 83 Video

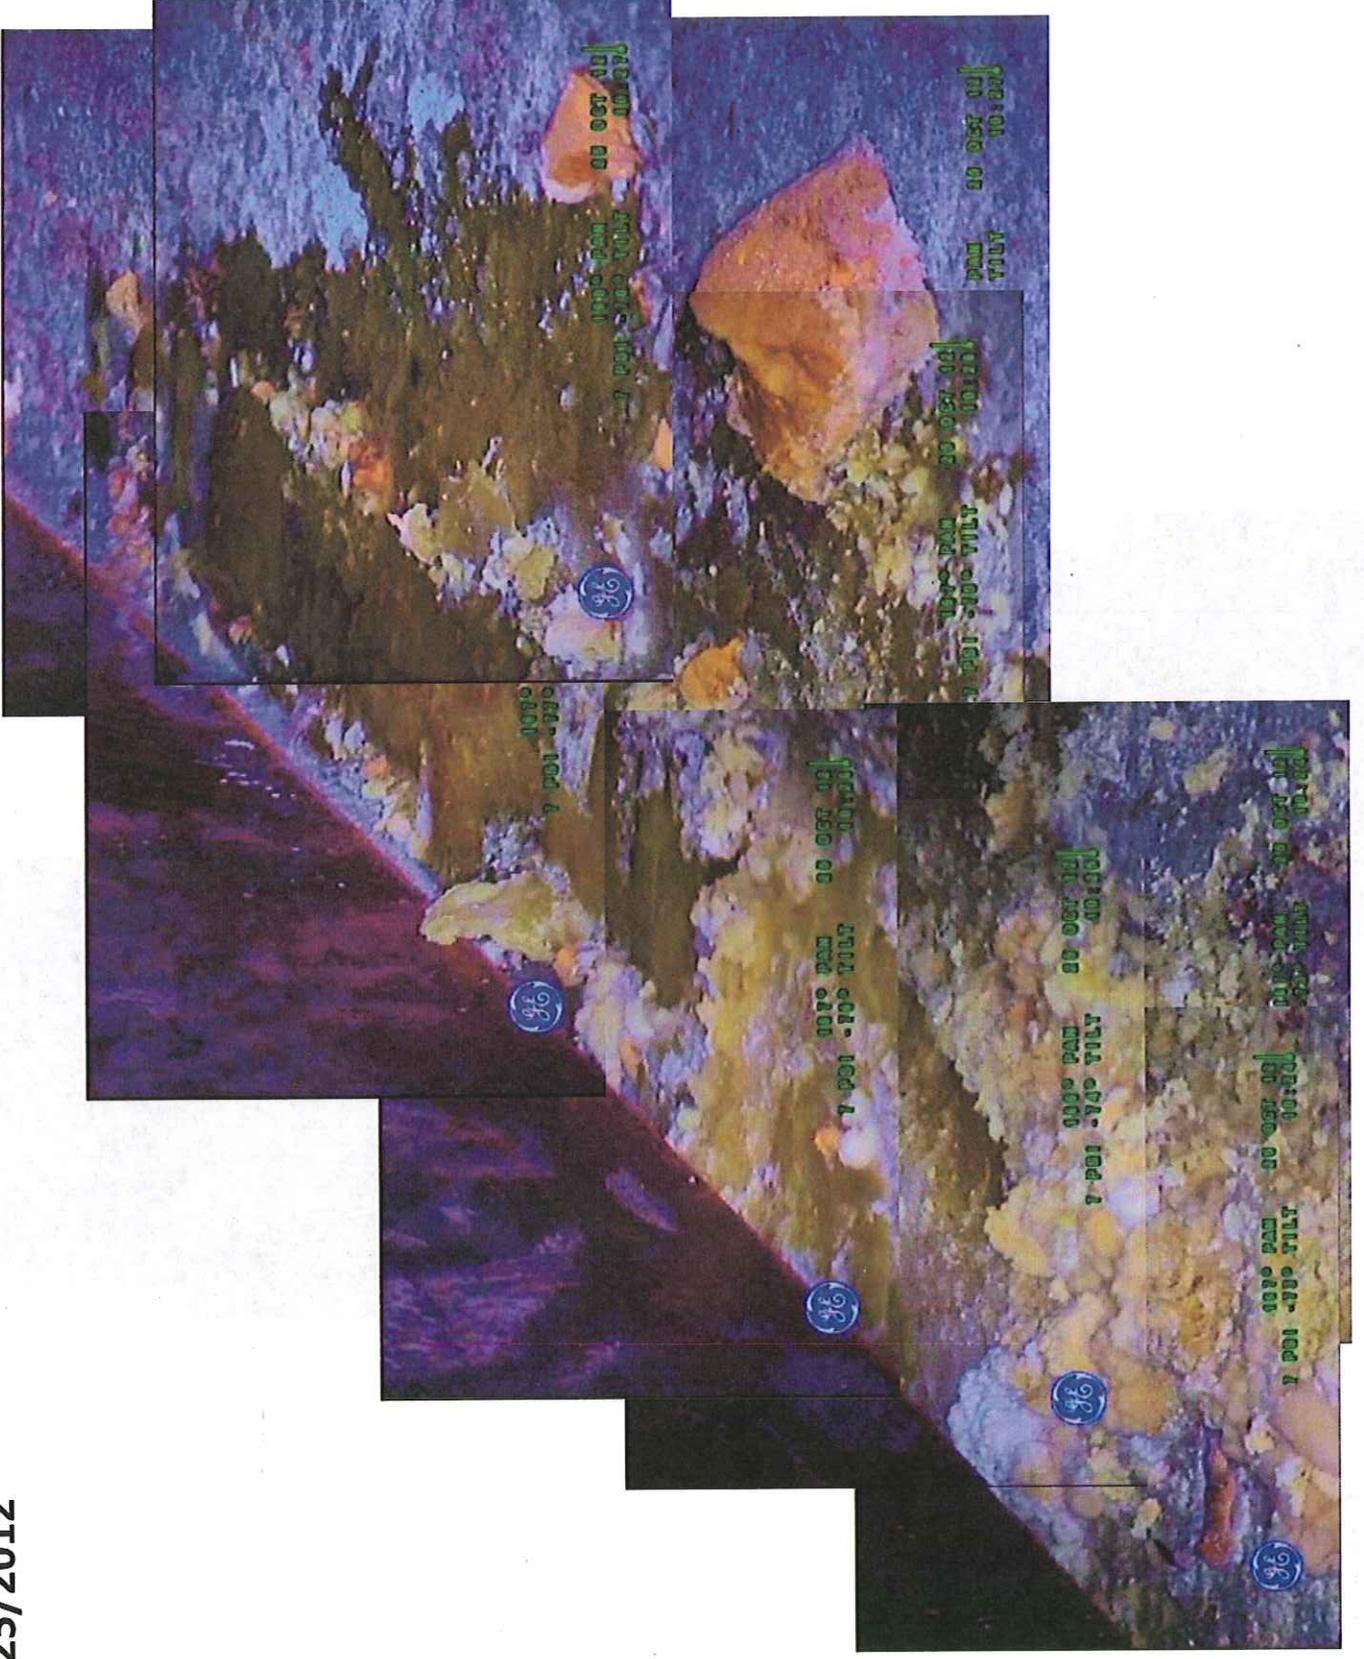
10/25/2012

- All witnessing the inspection noted that the color of the waste appeared to be changing. The dark green was changing to a lighter green in some locations. The lighter green was becoming a dark yellow. The darker yellow was changing to a lighter yellow. The lighter yellow was turning to a white color along the waste perimeter. This indicates that the waste material may be drying, most likely due to the ventilation.

- The camera viewed the waste in respect to the different in-annular space "landmarks" including the black dot or rock, two white pebbles and ventilation slots. It was noted by all witnessing the video that the size of the area of the waste material did not appear to have grown as compared to the amount of waste material viewed during the visual inspection conducted on 10/18/12.

- It was estimated that the area extent of the waste material in this riser location was approximately 6 inches by 22 inches when first discovered. It is approximated that the area extent of the waste material in this riser location is now approximately 8 inches by 36 inches in the rounded portion and approximately 48 inches in total length.

- All witnessing the video noted that the quantity and potential cascade of waste through a ventilation slot had either shrunk in size or receded. It looked more like the photos from visual inspections taken on 10/1/12 than those collected during the 10/18/12 effort.

- Ecology noted that there did not appear to be any visual damage indicators such as staining, cracking, pitting, etc. of the 6 inch wide carbon steel refractory ring, annulus floor, primary tank liner, or the refractory/concrete material where the waste was in direct contact with the tank structures. ORP noted that preliminary analytical results of the waste material indicated the presence of corrosion prohibiting constituents such as nitrite and hydroxides. ORP is actively seeking chemistry control/stabilization of the waste material present within the annulus.
