Professional Engineer's Statement
Everett Smelter Cleanup
March 17, 2003

Washington Department of Ecology Everett Smelter Site 2002 Cleanup

Details of Cleanup Activities

Address: 222 Bridgeway
 Everett, WA 98201

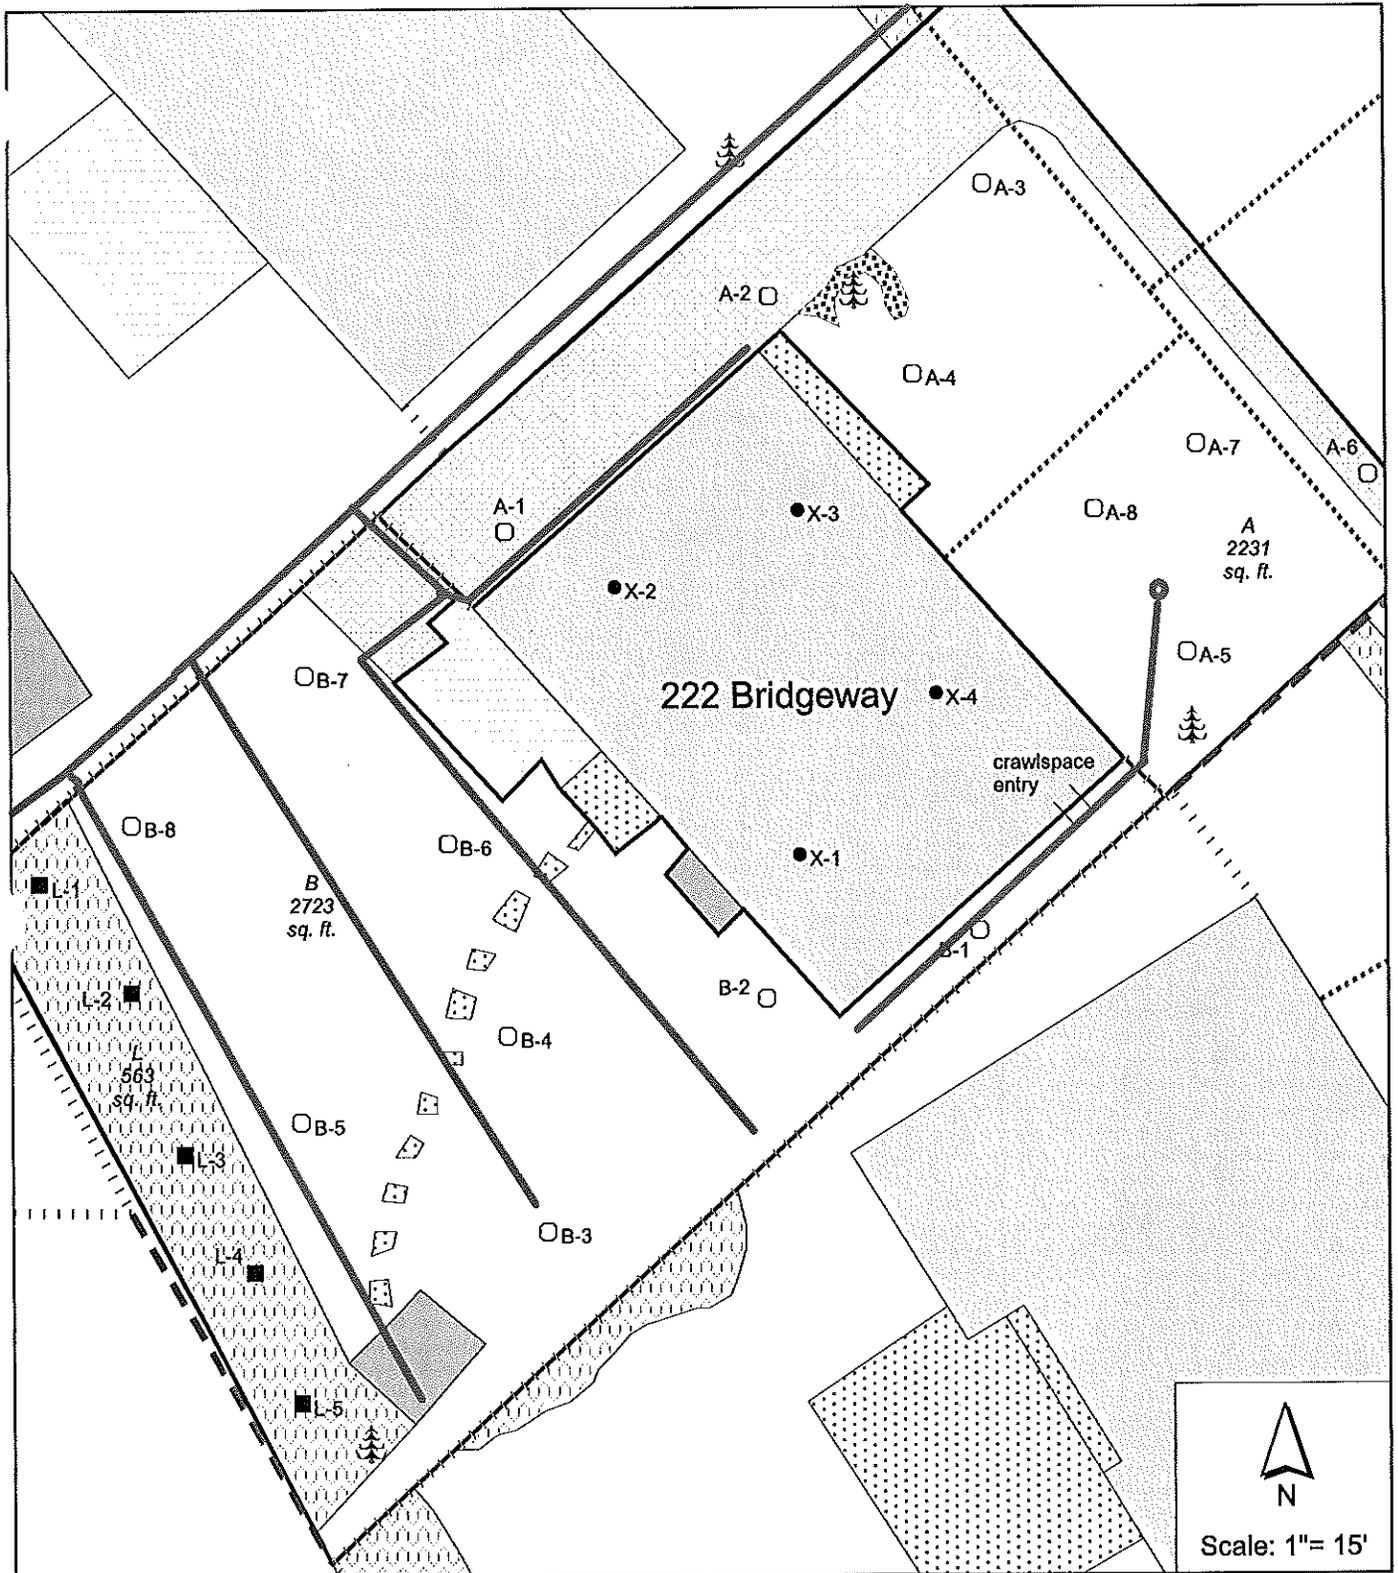
222 Bridgeway (Home 52)

For the purposes of sampling to determine the depth to which excavation would be required, this property was divided into two Decision Units, A and B, as shown on the attached map. The following is a summary of the work done to remediate the property within each of the decision units.
