**Professional Engineer's Statement
Everett Smelter Cleanup
March 17, 2003**

Washington Department of Ecology Everett Smelter Site 2002 Cleanup

Details of Cleanup Activities

Address: 108 Skyline Drive
 Everett, WA 98201

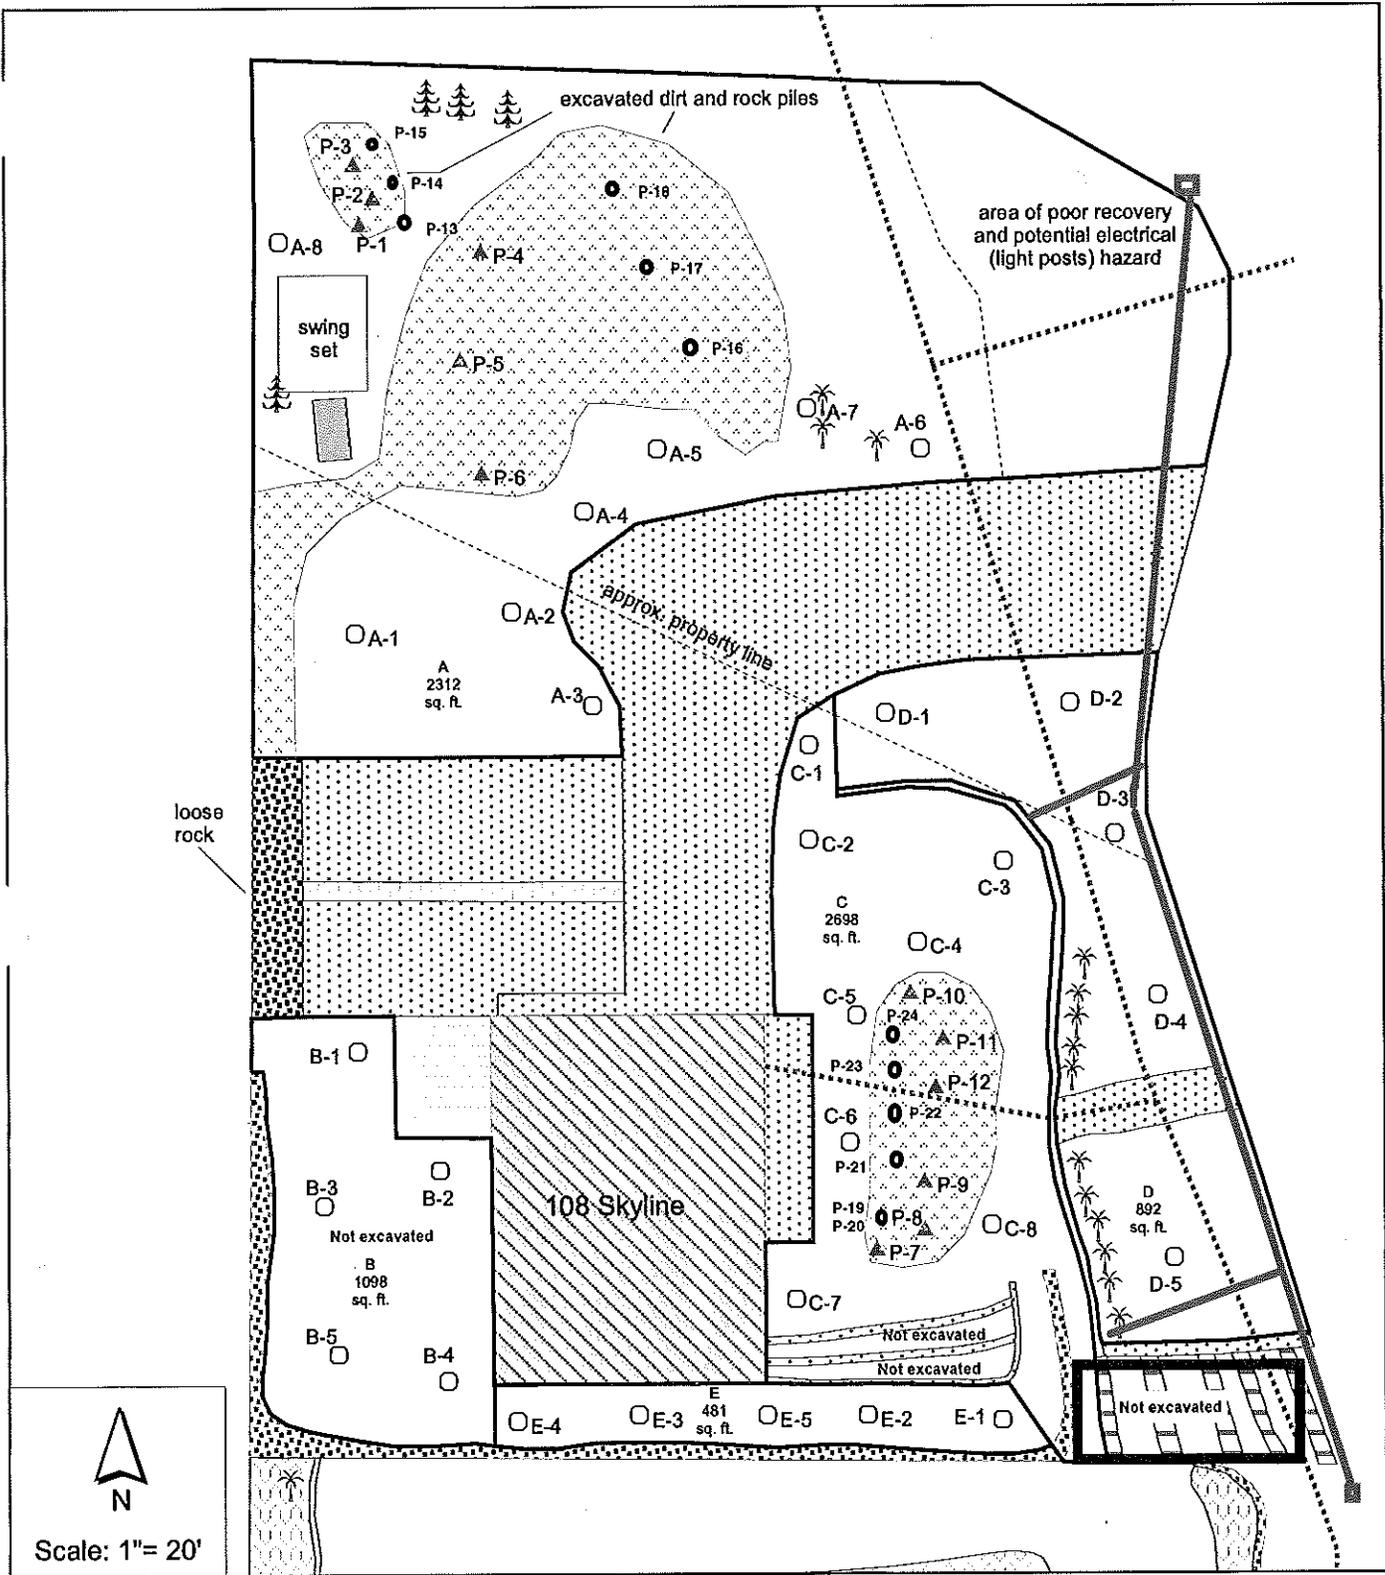
108 Skyline (Home 40)

For the purposes of sampling to determine the depth to which excavation would be required, this property was divided into five Decision Units, A, B, C, D and E, as shown on the attached map. The following is a summary of the work done to remediate the property within each of the decision units.
