Professional Engineer's Statement
Everett Smelter Cleanup
March 17, 2003

Washington Department of Ecology Everett Smelter Site 2002 Cleanup

Details of Cleanup Activities

Address: 203 Skyline Drive
Everett, WA 98201

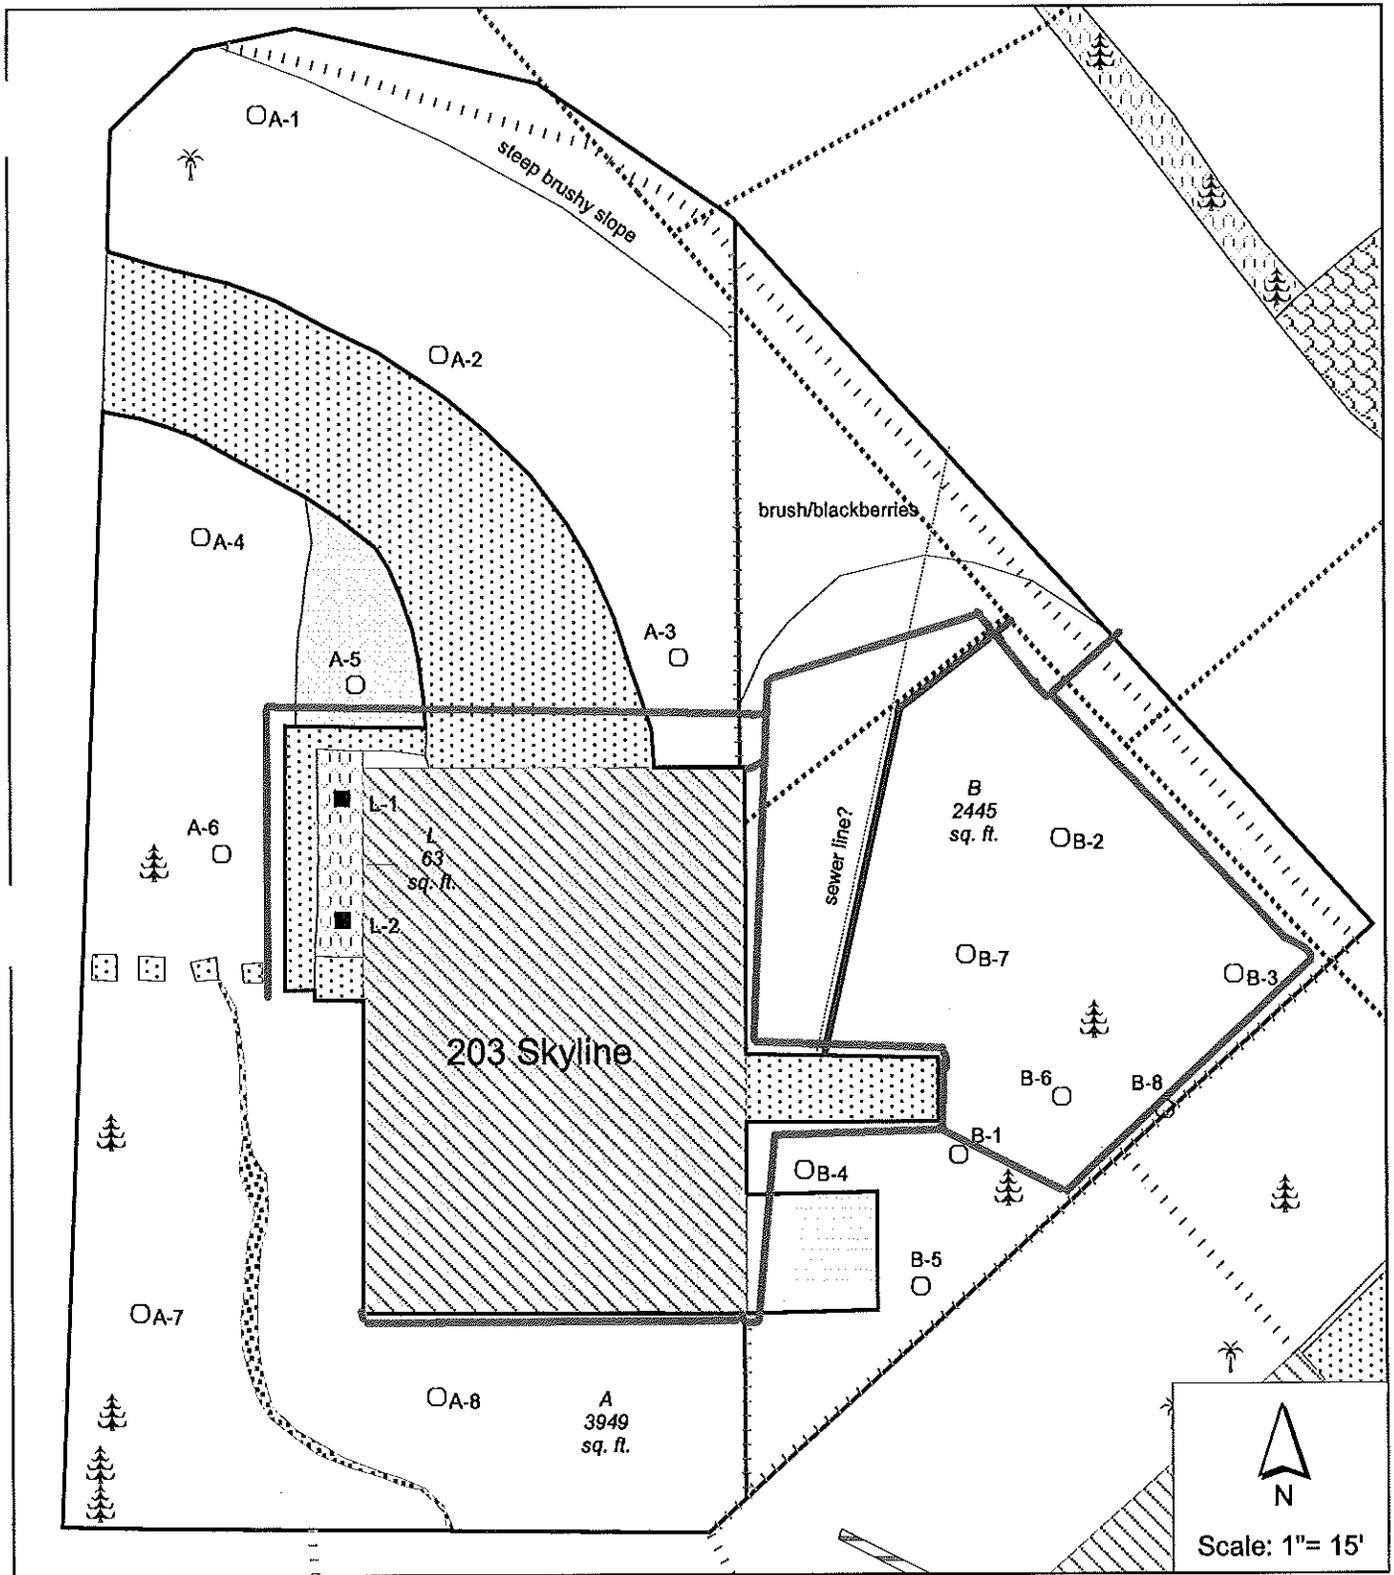
203 Skyline (Home 41)

For the purposes of sampling to determine the depth to which excavation would be required, this property was divided into two Decision Units, A and B, as shown on the attached map. The following is a summary of the work done to remediate the property within each of the decision units.
