Professional Engineer's Statement
Everett Smelter Cleanup
March 17, 2003

Washington Department of Ecology
Everett Smelter Site
2002 Cleanup

Details of Cleanup Activities

Address: 209 Skyline Drive
 Everett, WA 98201

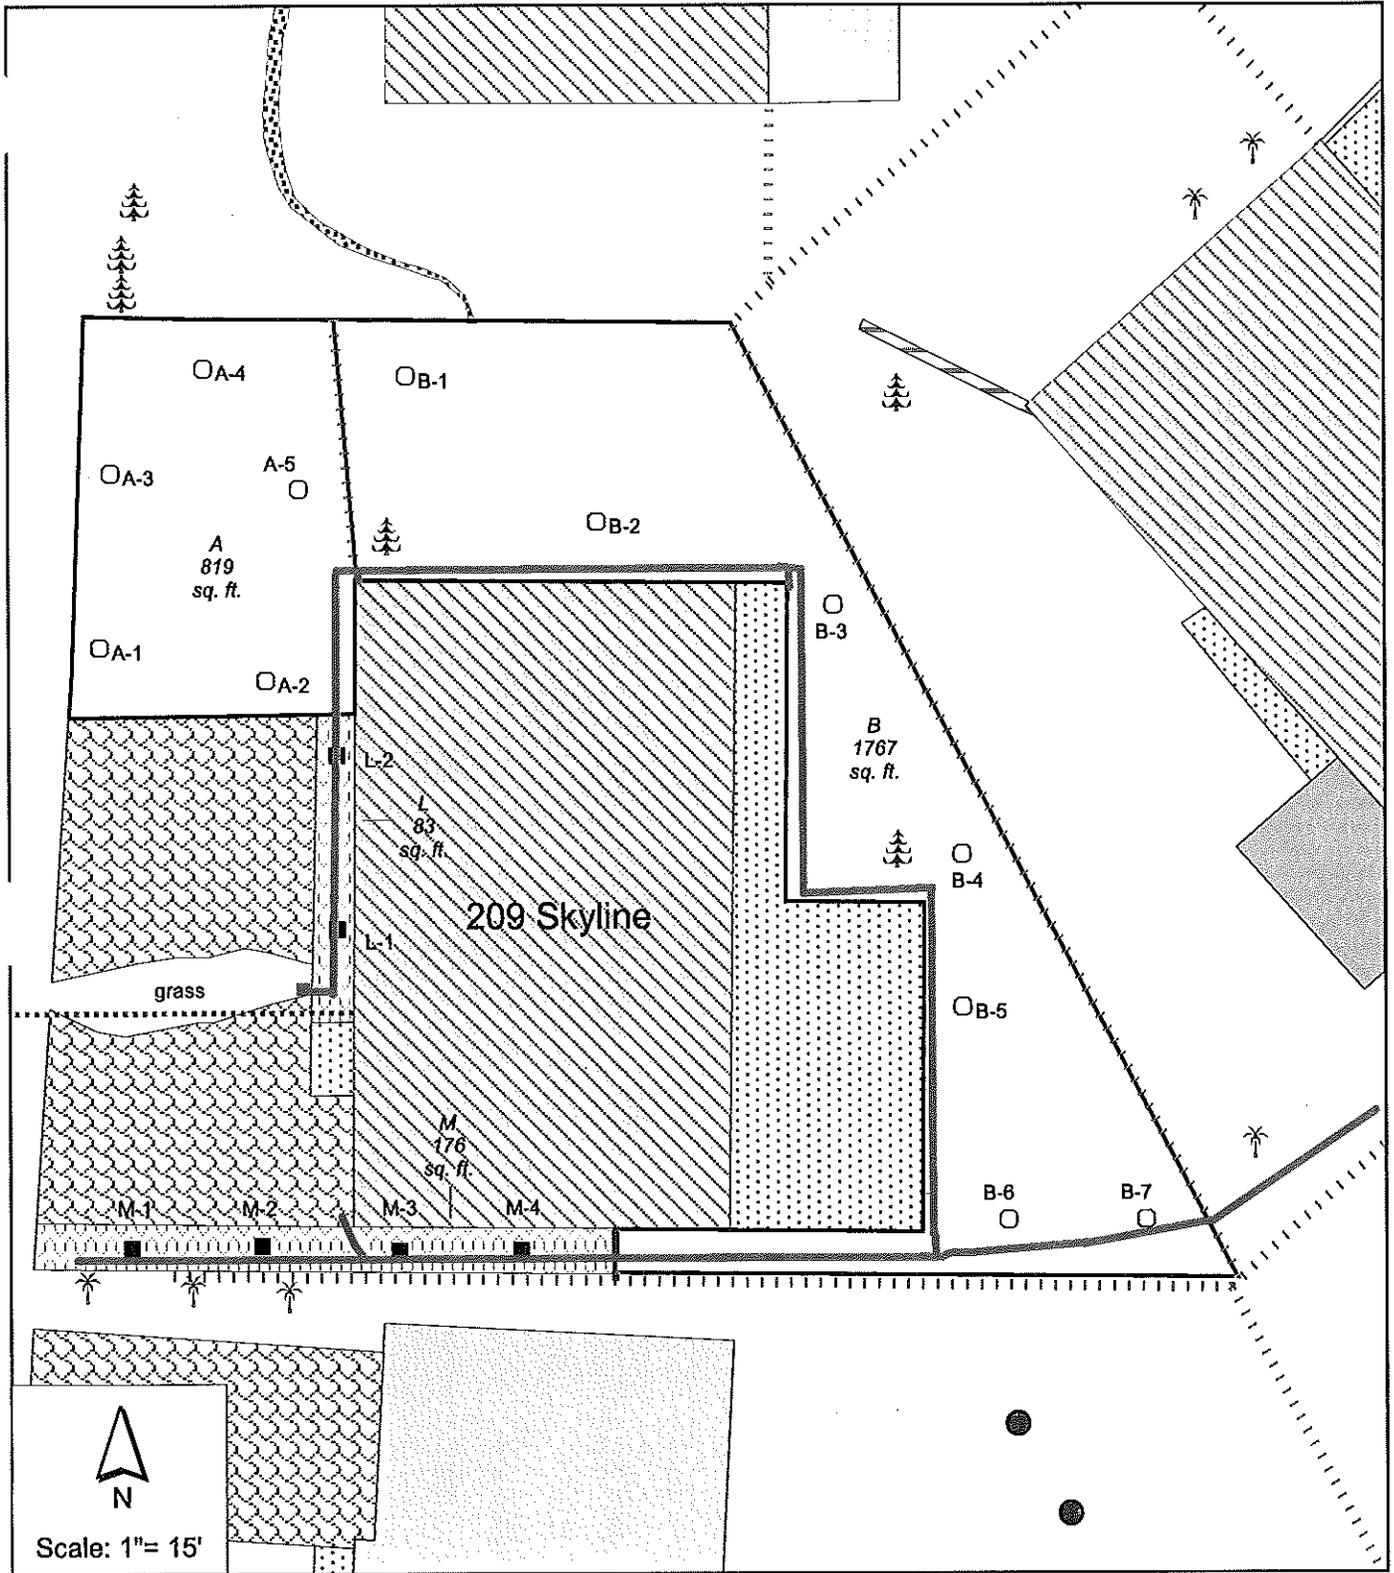
209 Skyline (Home 42)

For the purposes of sampling to determine the depth to which excavation would be required, this property was divided into two Decision Units, A and B, as shown on the attached map. The following is a summary of the work done to remediate the property within each of the decision units.
