**Professional Engineer's Statement
Everett Smelter Cleanup
June 16, 2008**

Washington Department of Ecology Everett Smelter Site 2007 Cleanup

Details of Cleanup Activities for 201 Bridgeway

Property Owner	James & Kathleen Pankiewicz
Address:	201 Bridgeway Everett, WA 98201
Snohomish County State of Washington	
Tax Parcel No.	# 005203-000-050-00

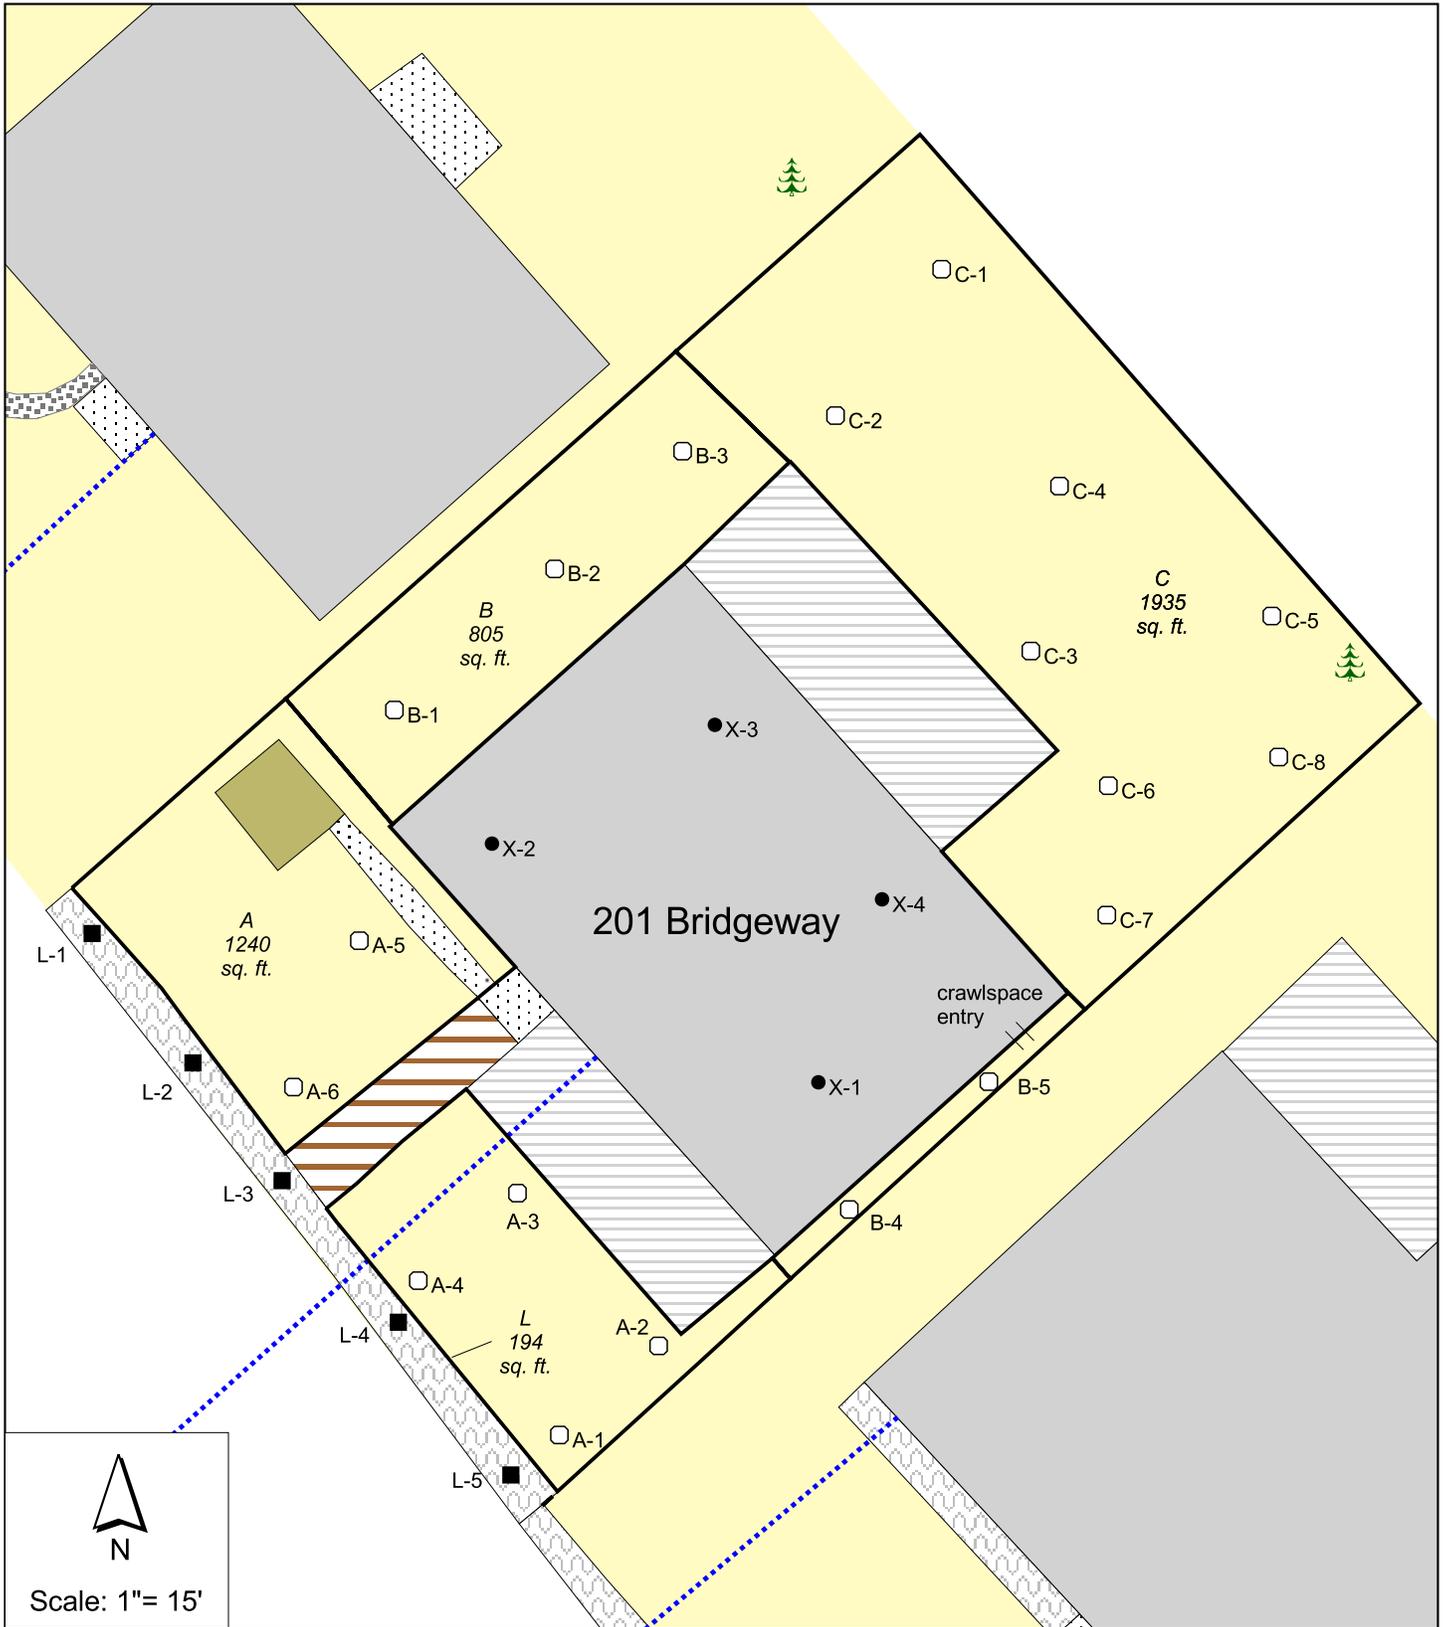
201 Bridgeway (Home 45)

The purpose of sampling was to determine the required depth of excavation for this property. The property was divided into three *Decision Units* A, B, and C, as shown on the attached map in Attachment A. A *rotating laser level* was used to measure the depth of the excavated soil in each decision unit.

The street-level parking area (located at landscape samples L-1 to L-5 in the map) was excavated to a depth of 24 inches. The *wooden railroad ties* were replaced with block walls and augmented with *geogrid* and retaining wall drainage. Originally, the timber steps were in the middle of the yard directly lined up with the front door. Per homeowner request, the original timber steps were placed at the northern end of the new block wall.

At the request of the tenants and with homeowner approval, the wooden shed formerly in the front yard (near the western corner of the house) was moved to the backyard. It's close to the northeast corner of the house in Decision Unit B (see attachment A). A *crushed rock* pad and pathway was prepared in this area.
