**Professional Engineer's Statement  
Everett Smelter Cleanup  
June 16, 2008**

# Washington Department of Ecology Everett Smelter Site 2007 Cleanup

## Details of Cleanup Activities for 229 Bridgeway

# 229 Bridgeway (Home 56)

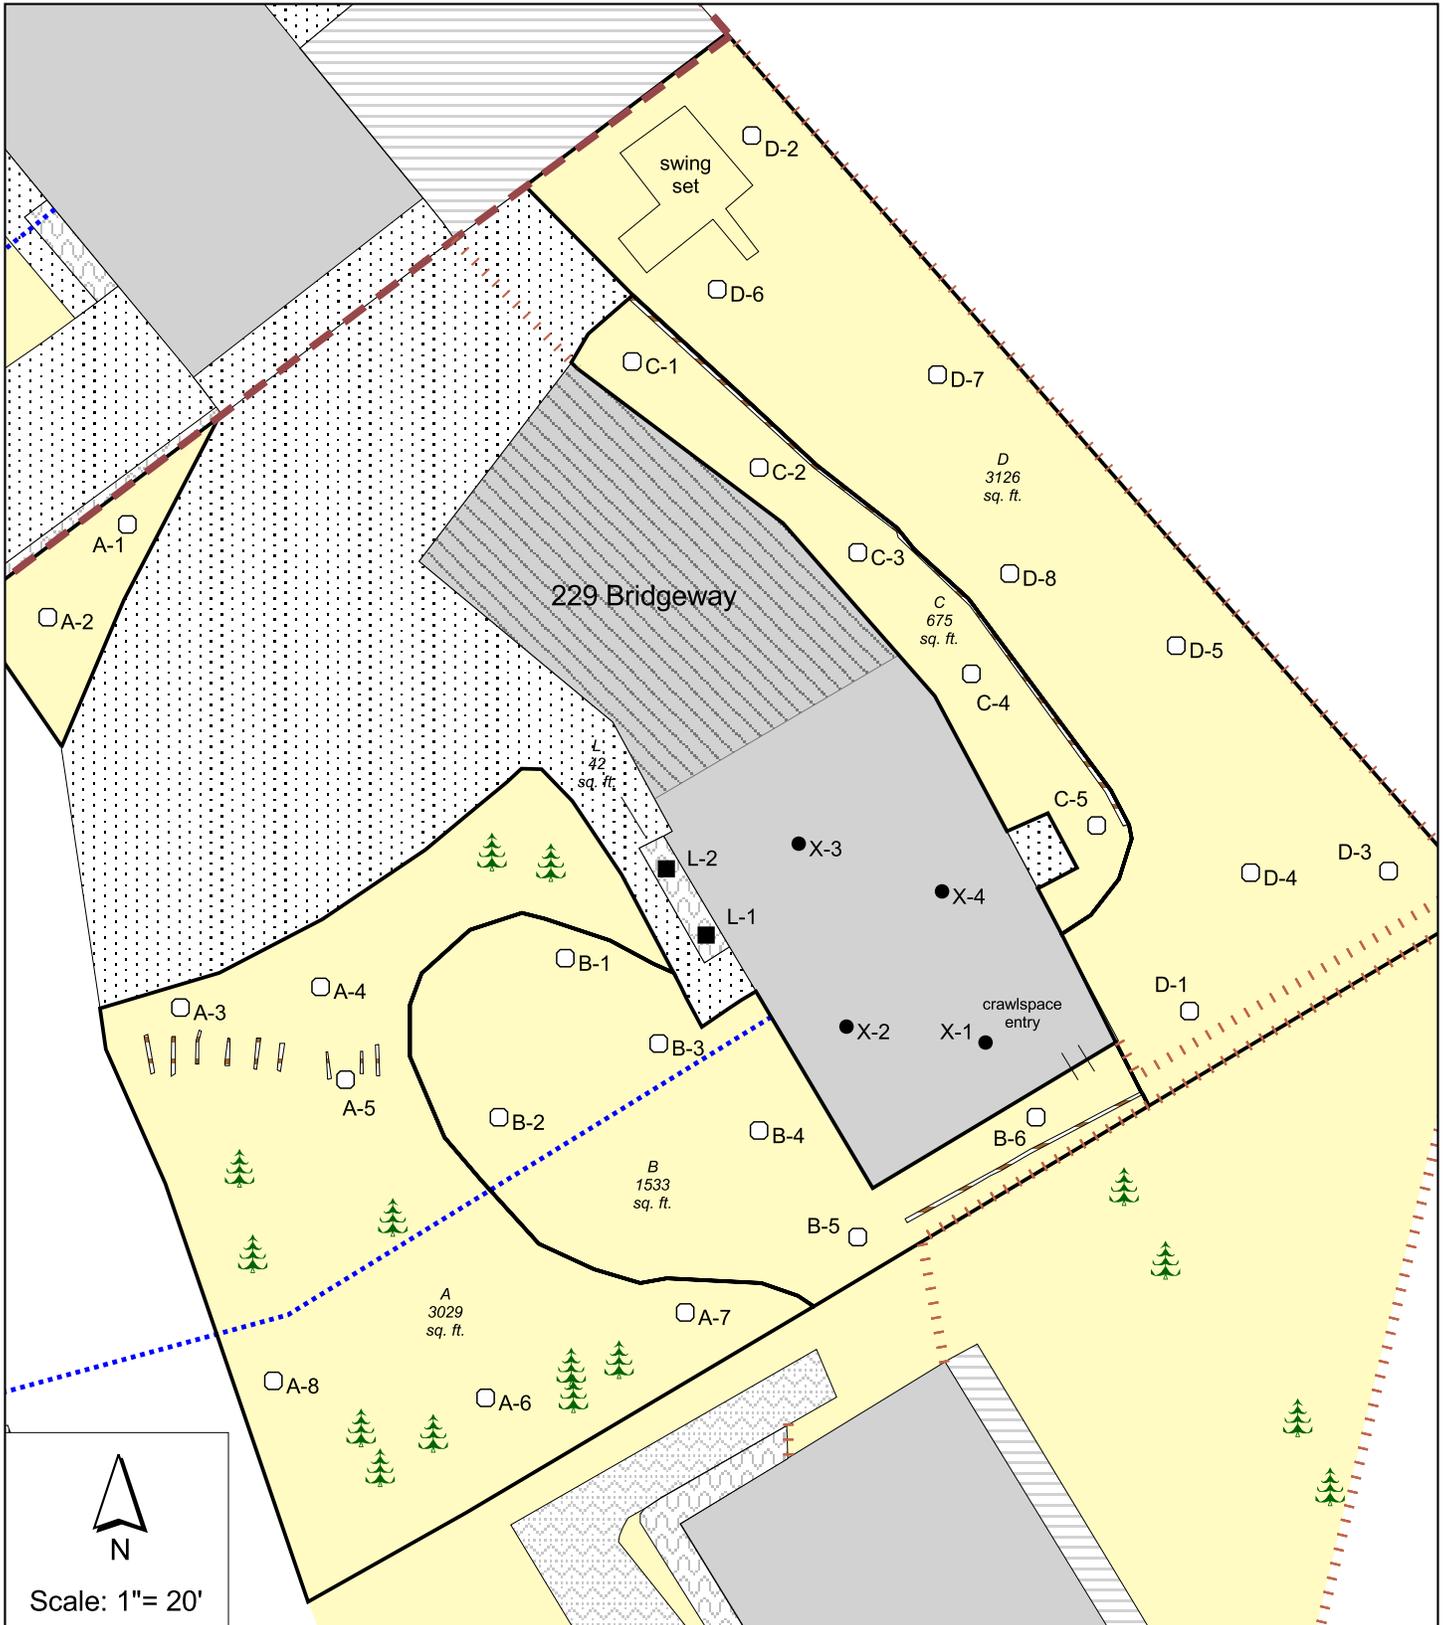
The purpose of sampling was to determine the required depth of excavation for this property. The property was divided into four *Decision Units* A, B, C, and D, as shown on the site map in Attachment A. Attachment B graphically shows the sample results. An explanation of the graphs is in Attachment C. A *rotating laser level* was used to measure the depth of the excavated soil in each decision unit.
