**Professional Engineer's Statement
Everett Smelter Cleanup, 2000-2001**

Washington Department of Ecology Everett Smelter Site 2000 - 2001 Cleanup

Details of Cleanup Activities

Address: 212 Skyline Drive
 Everett, WA 98201

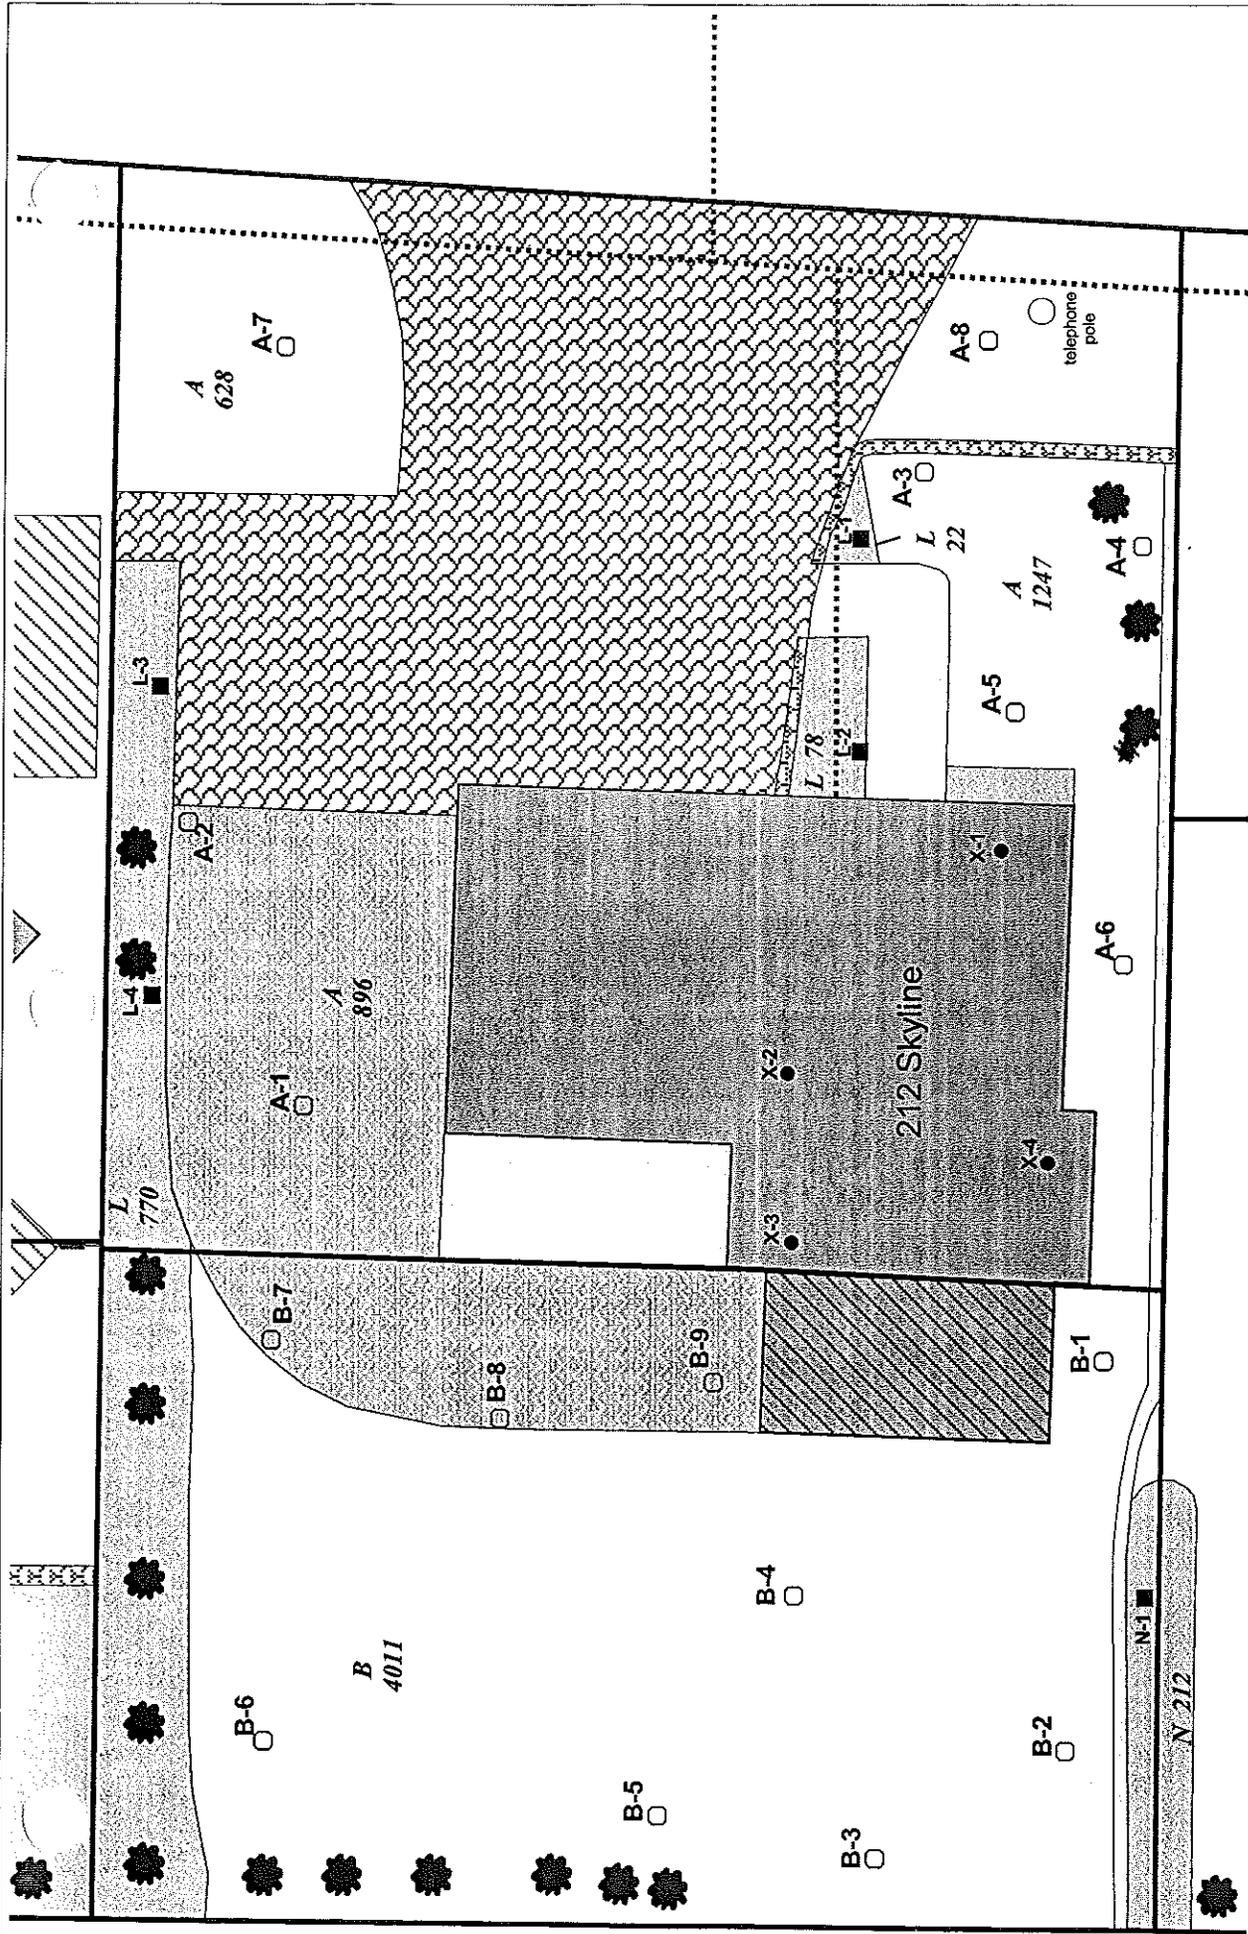
212 Skyline (Home 036)

This property was divided by Ecology into three Decision Units, A and B, as shown on the attached map, for purposes of pre-cleanup sampling and decision-making regarding the depth to which excavation was required. The following is a summary of the work done in the remediation of the property within each of the decision units.
