Washington Department of Ecology

Everett Smelter Site

Summer 1999 Cleanup

Details of Cleanup Activities

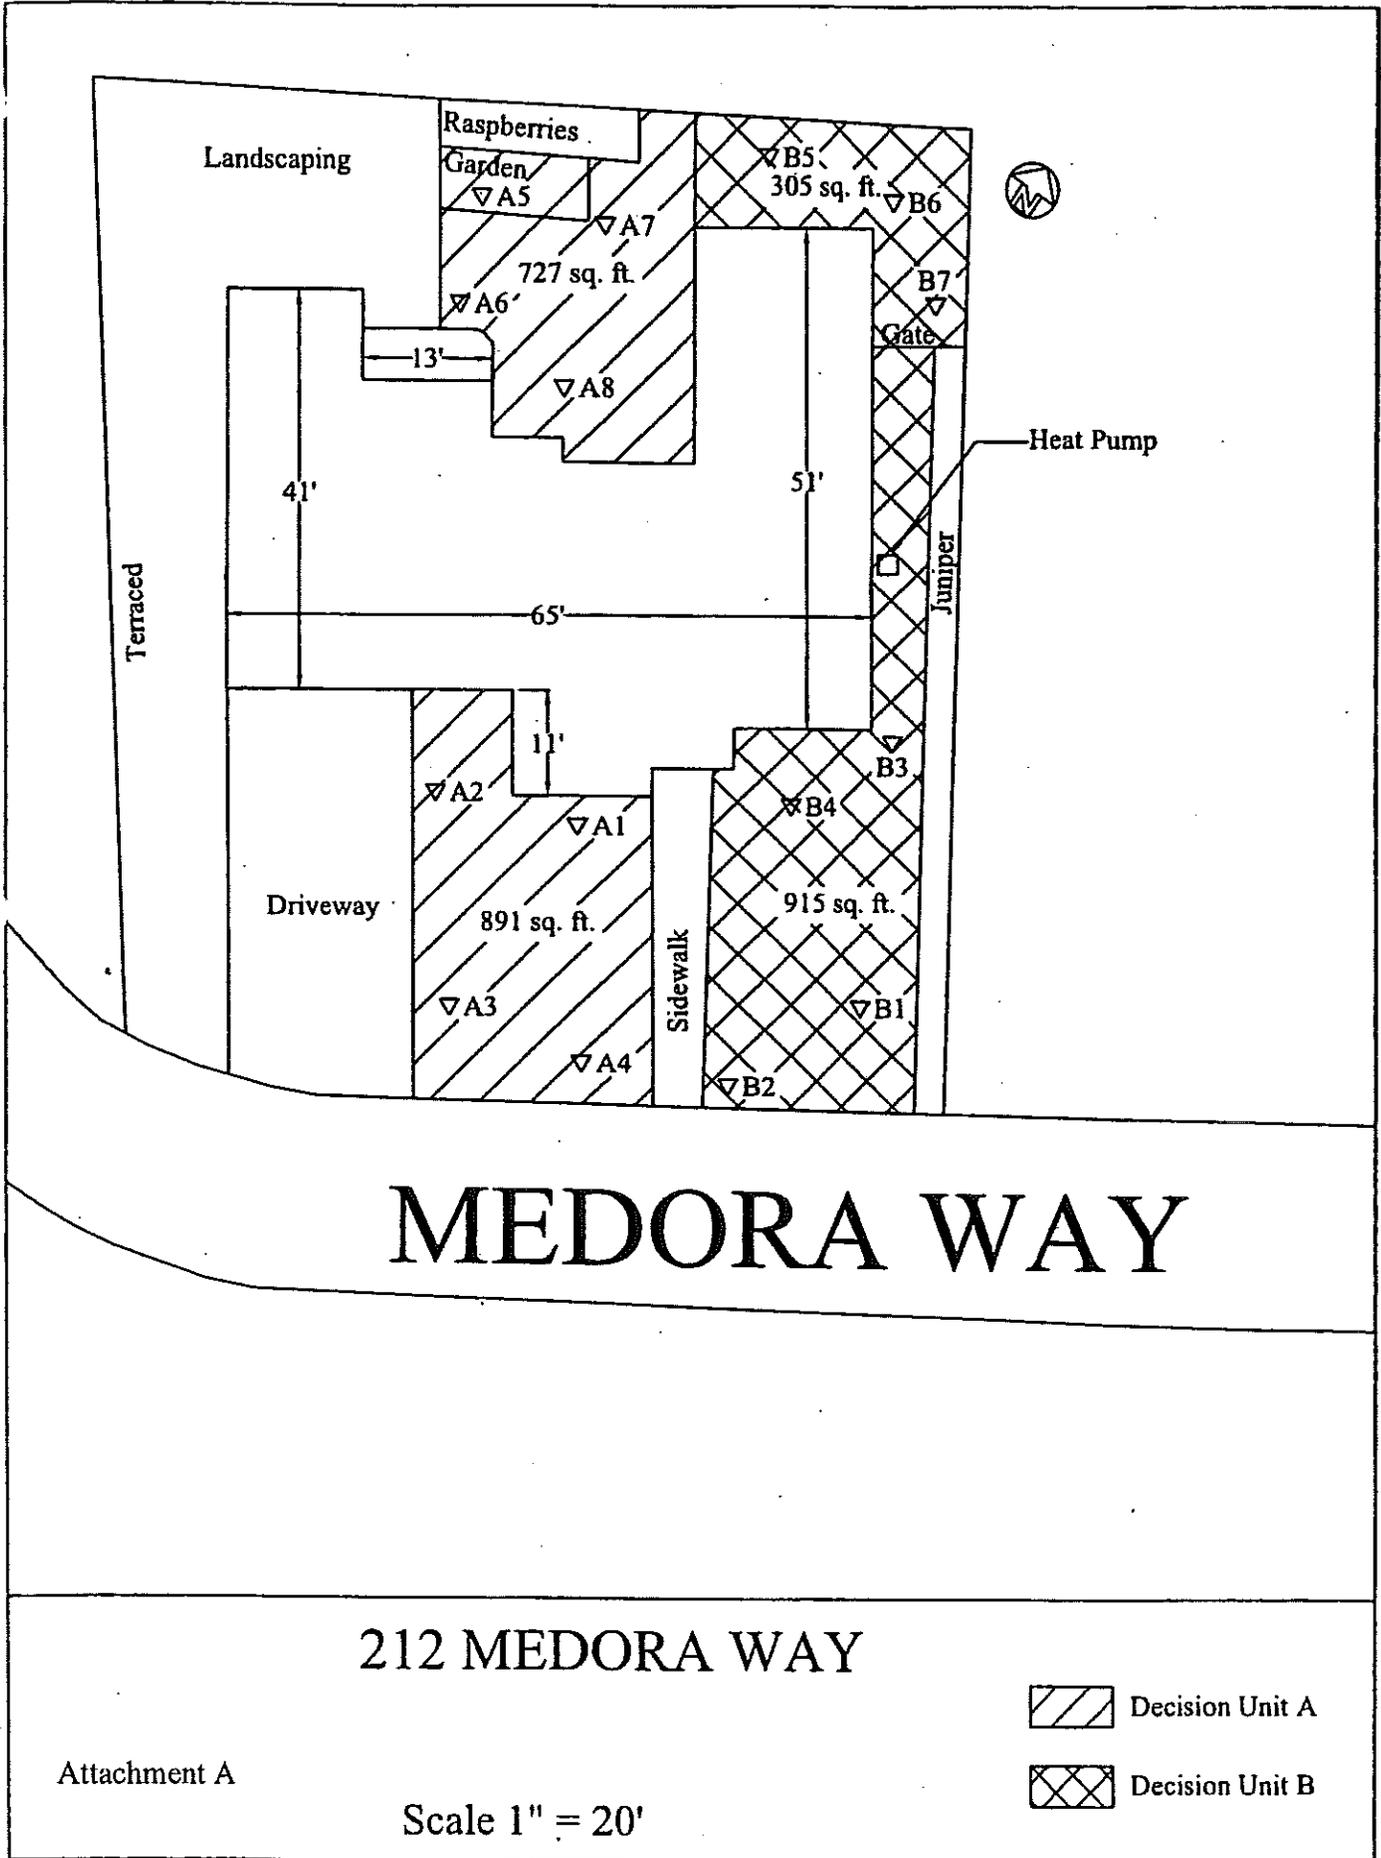
Attachment A

This property was divided by Ecology into two Decision Units, A and B, as shown on the attached map, for purposes of pre-cleanup sampling and decision-making regarding the depth to which excavation was required. The following is a summary of the work done in the remediation of the property within each of the decision units.
