**Professional Engineer's Statement  
Everett Smelter Cleanup, 2000-2001**

**Washington Department of Ecology**  
**Everett Smelter Site**  
**2000 - 2001 Cleanup**

**Details of Cleanup Activities**

Address:              221 Skyline Drive  
                             Everett, WA 98201

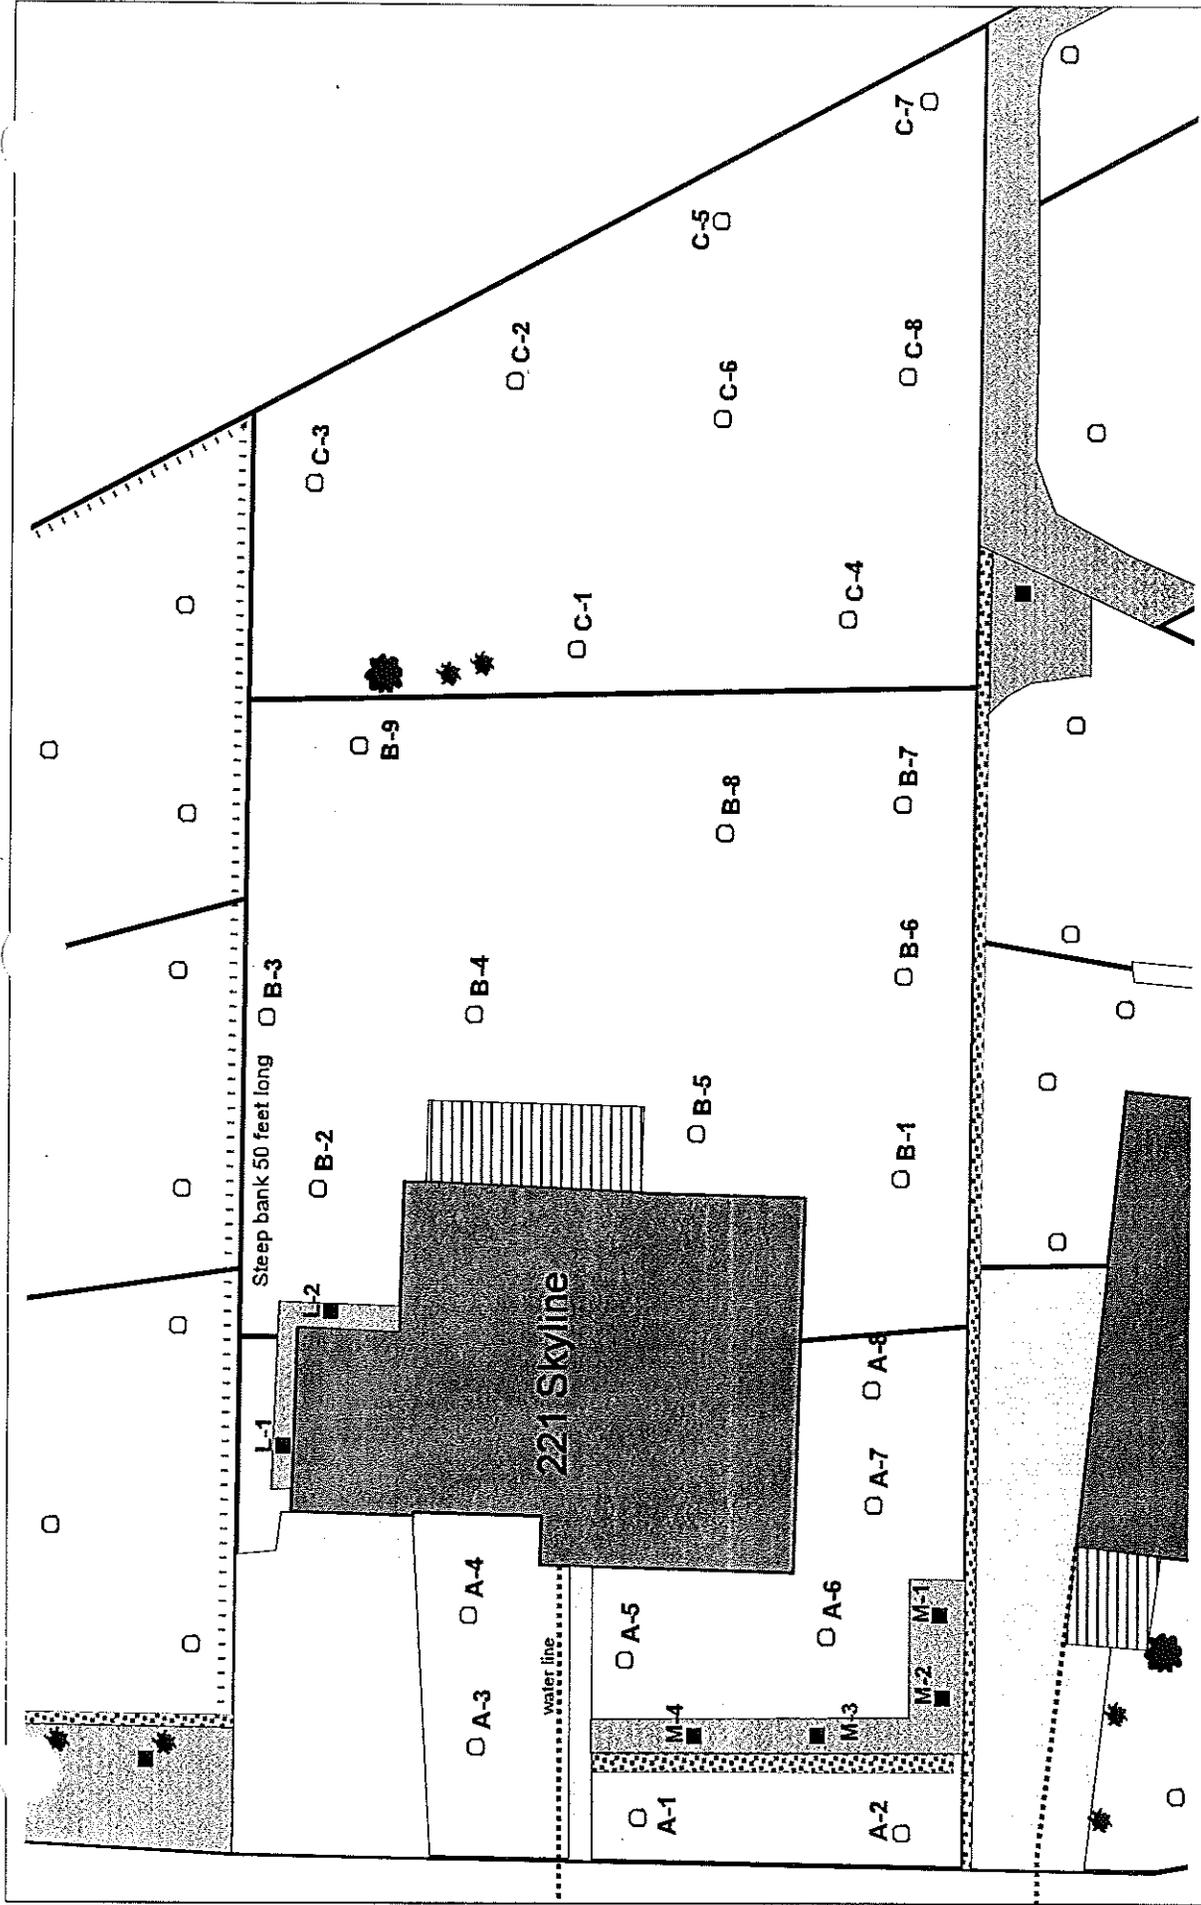
**221 Skyline**  
 Everett Smelter Homesite Cleanup  
 Source: Snohomish Health District

This property was divided by Ecology into three Decision Units, A, B and C, as shown on the attached map, for purposes of pre-cleanup sampling and decision-making regarding the depth to which excavation was required. The following is a summary of the work done in the remediation of the property within each of the decision units.
