**Professional Engineer's Statement
Everett Smelter Cleanup, 2000-2001**

Washington Department of Ecology Everett Smelter Site 2000 - 2001 Cleanup

Details of Cleanup Activities

Address: 235 Bridgeway
 Everett, WA 98201

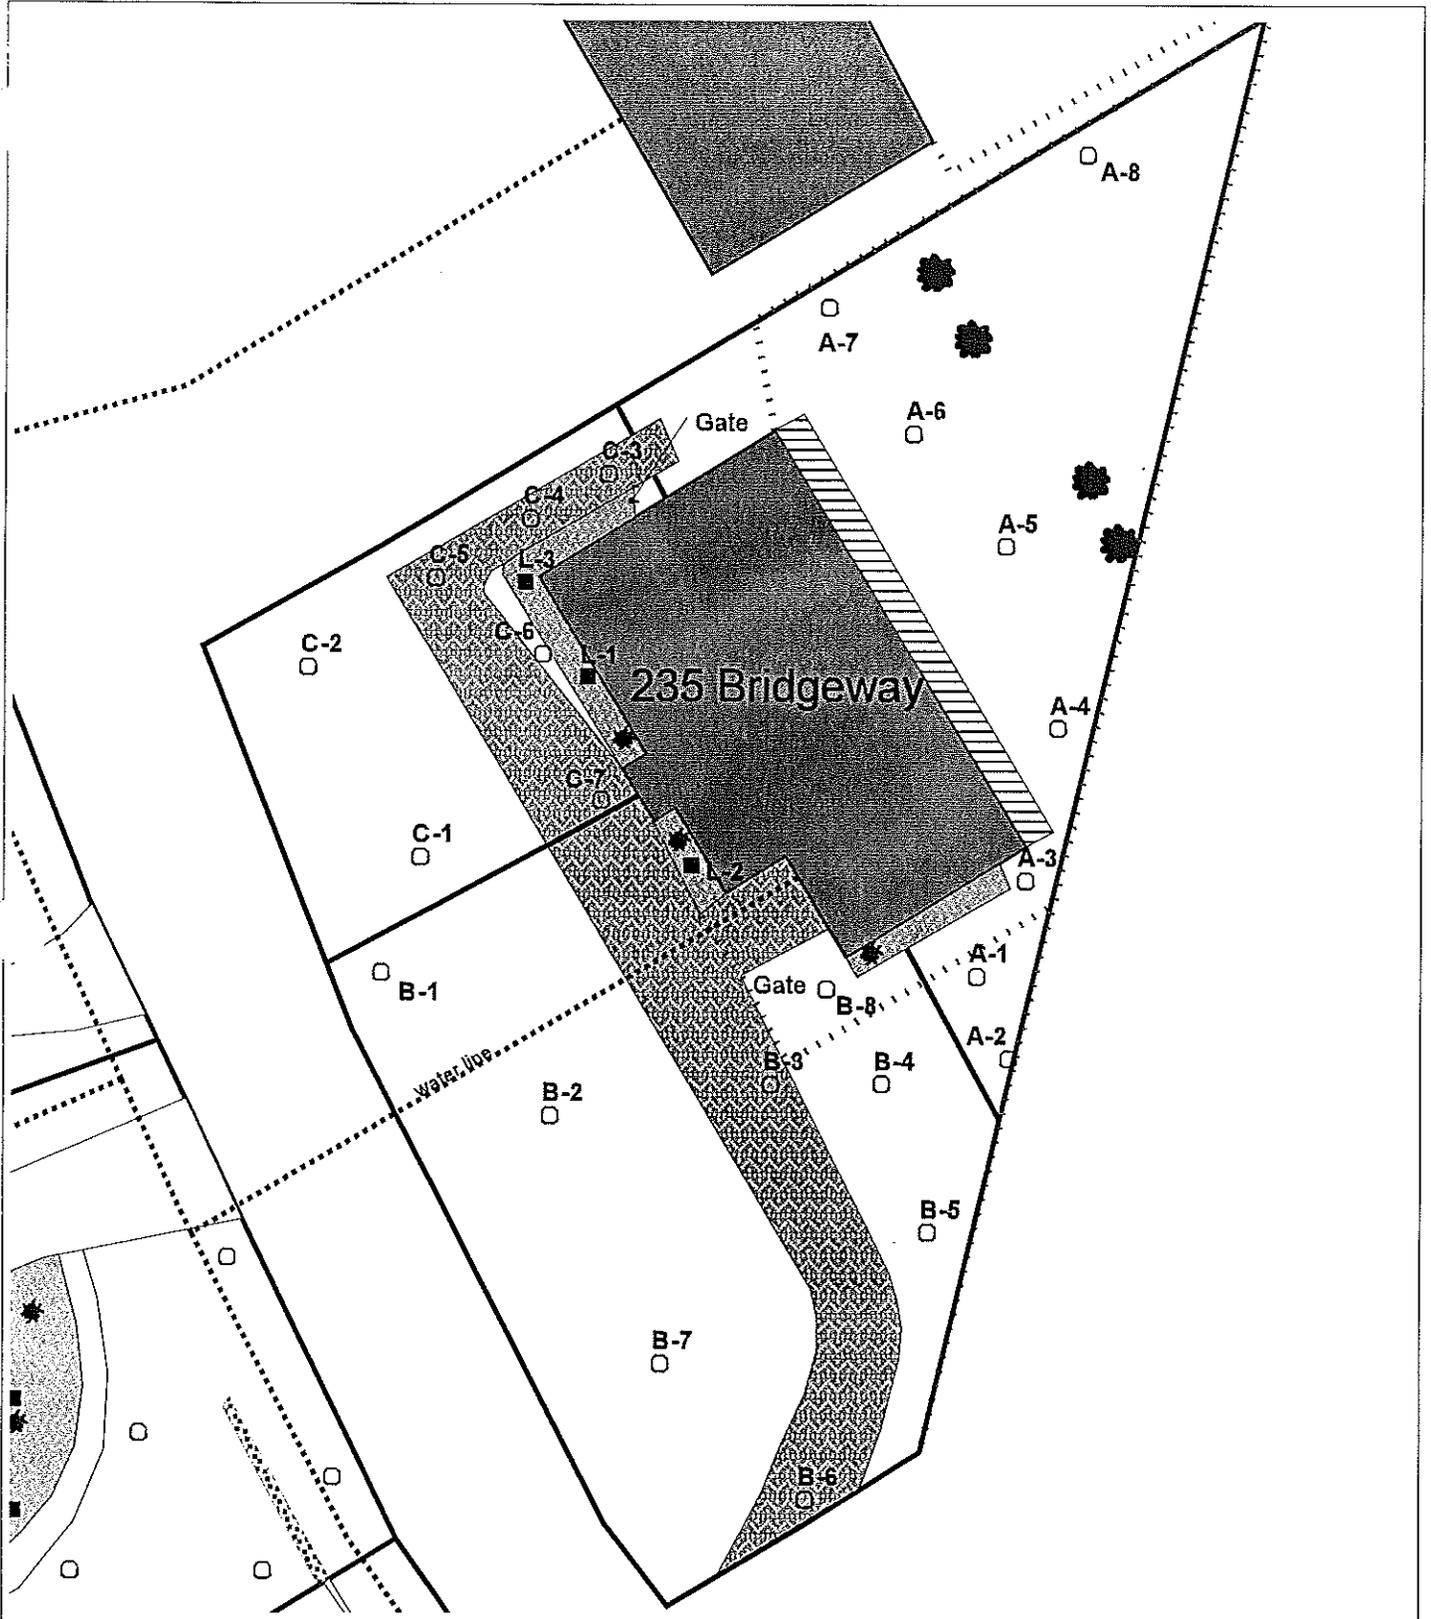
235 Bridgeway

This property was divided by Ecology into three Decision Units, A, B and C, as shown on the attached map, for purposes of pre-cleanup sampling and decision-making regarding the depth to which excavation was required. The following is a summary of the work done in the remediation of the property within each of the decision units.
