**Professional Engineer's Statement
Everett Smelter Cleanup, 2000-2001**

Washington Department of Ecology
Everett Smelter Site
2000-2001 Cleanup

Property Owner: Ronnie and Christine Thomas

Address: 240 Bridgeway
 Everett, WA 98201

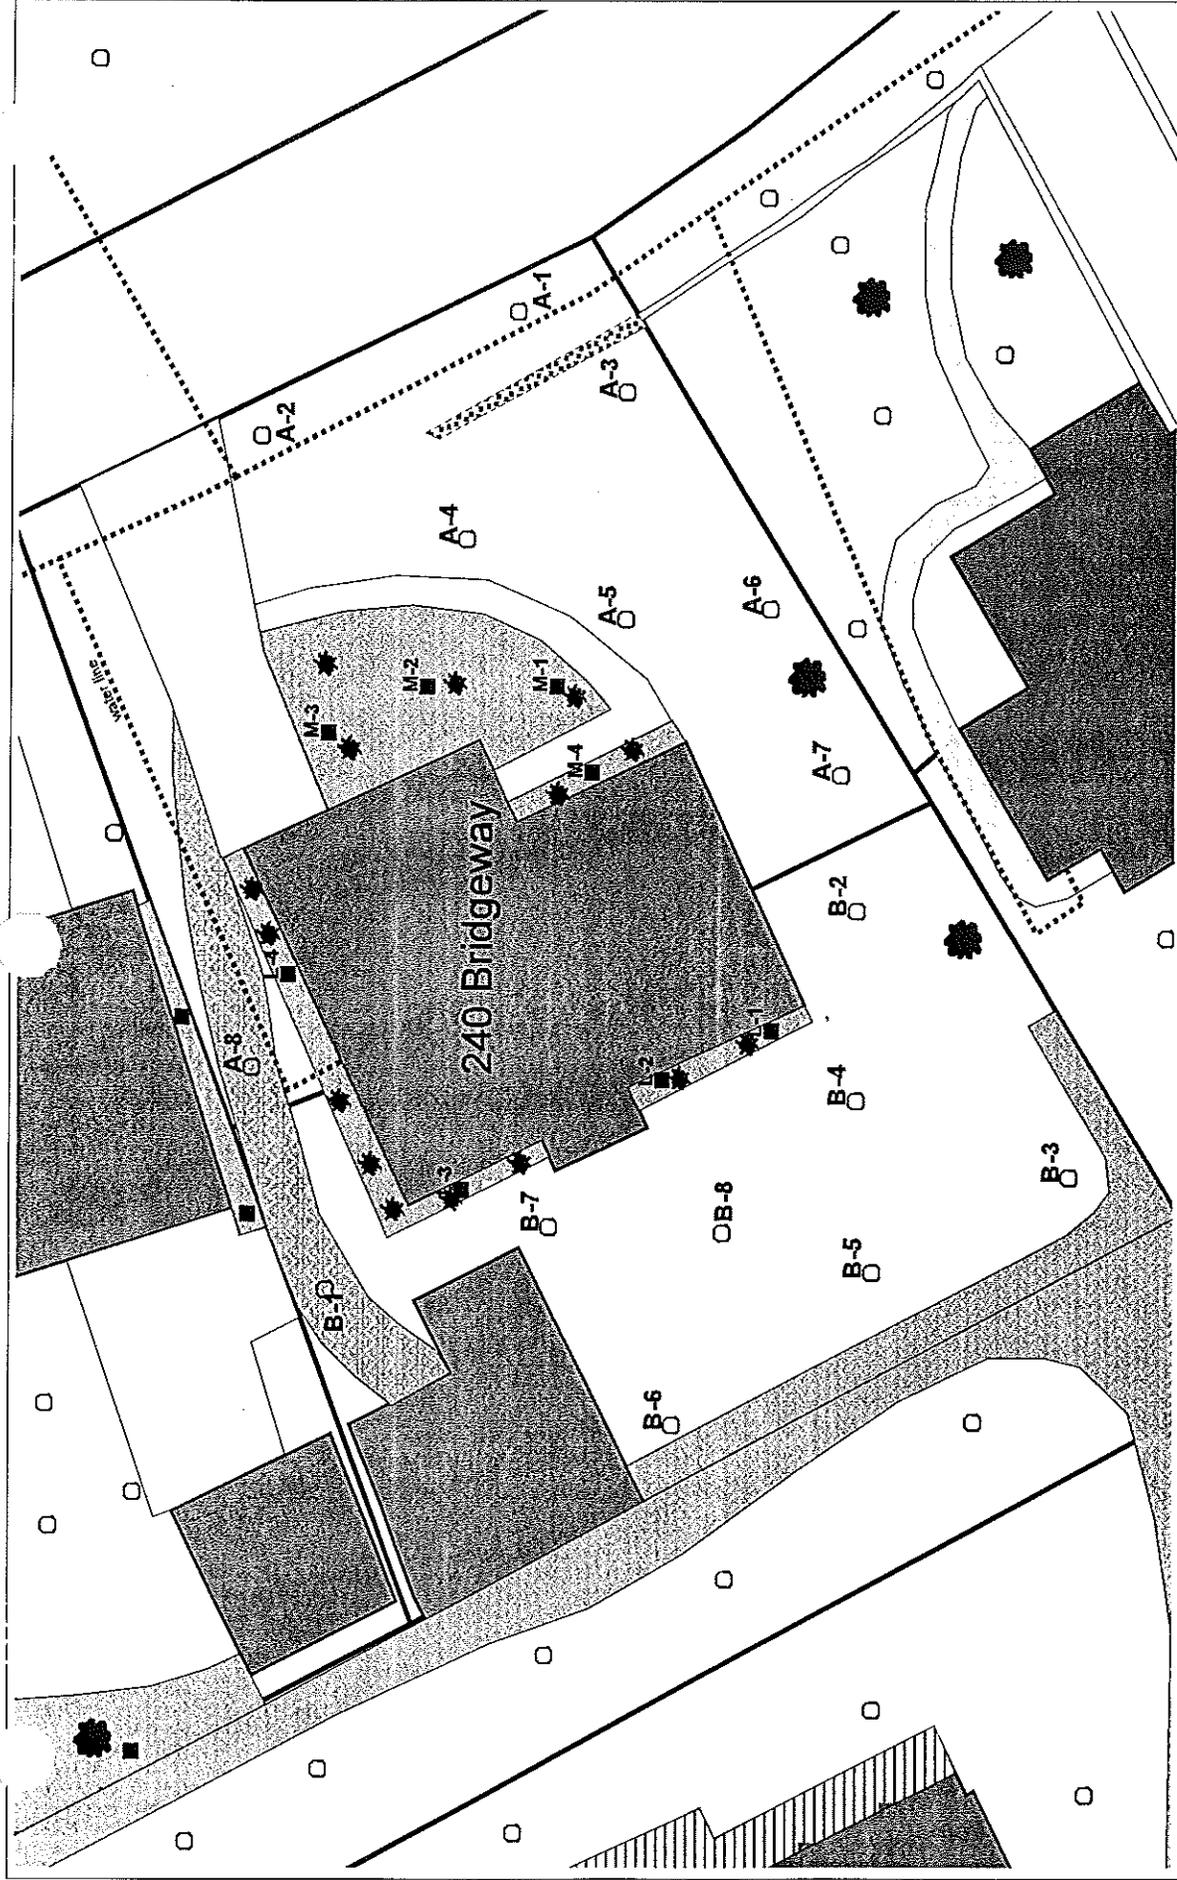
240 Bridgeway

This property was divided by Ecology into two Decision Units, A and B, as shown on the attached map, for purposes of pre-cleanup sampling and decision-making regarding the depth to which excavation was required. The following is a summary of the work done in the remediation of the property within each of the decision units.
