**Professional Engineer's Statement
Everett Smelter Cleanup, 2000-2001**

Washington Department of Ecology
Everett Smelter Site
2000-2001 Cleanup

Details of Cleanup Activities

Property Owner: Martha Watkins

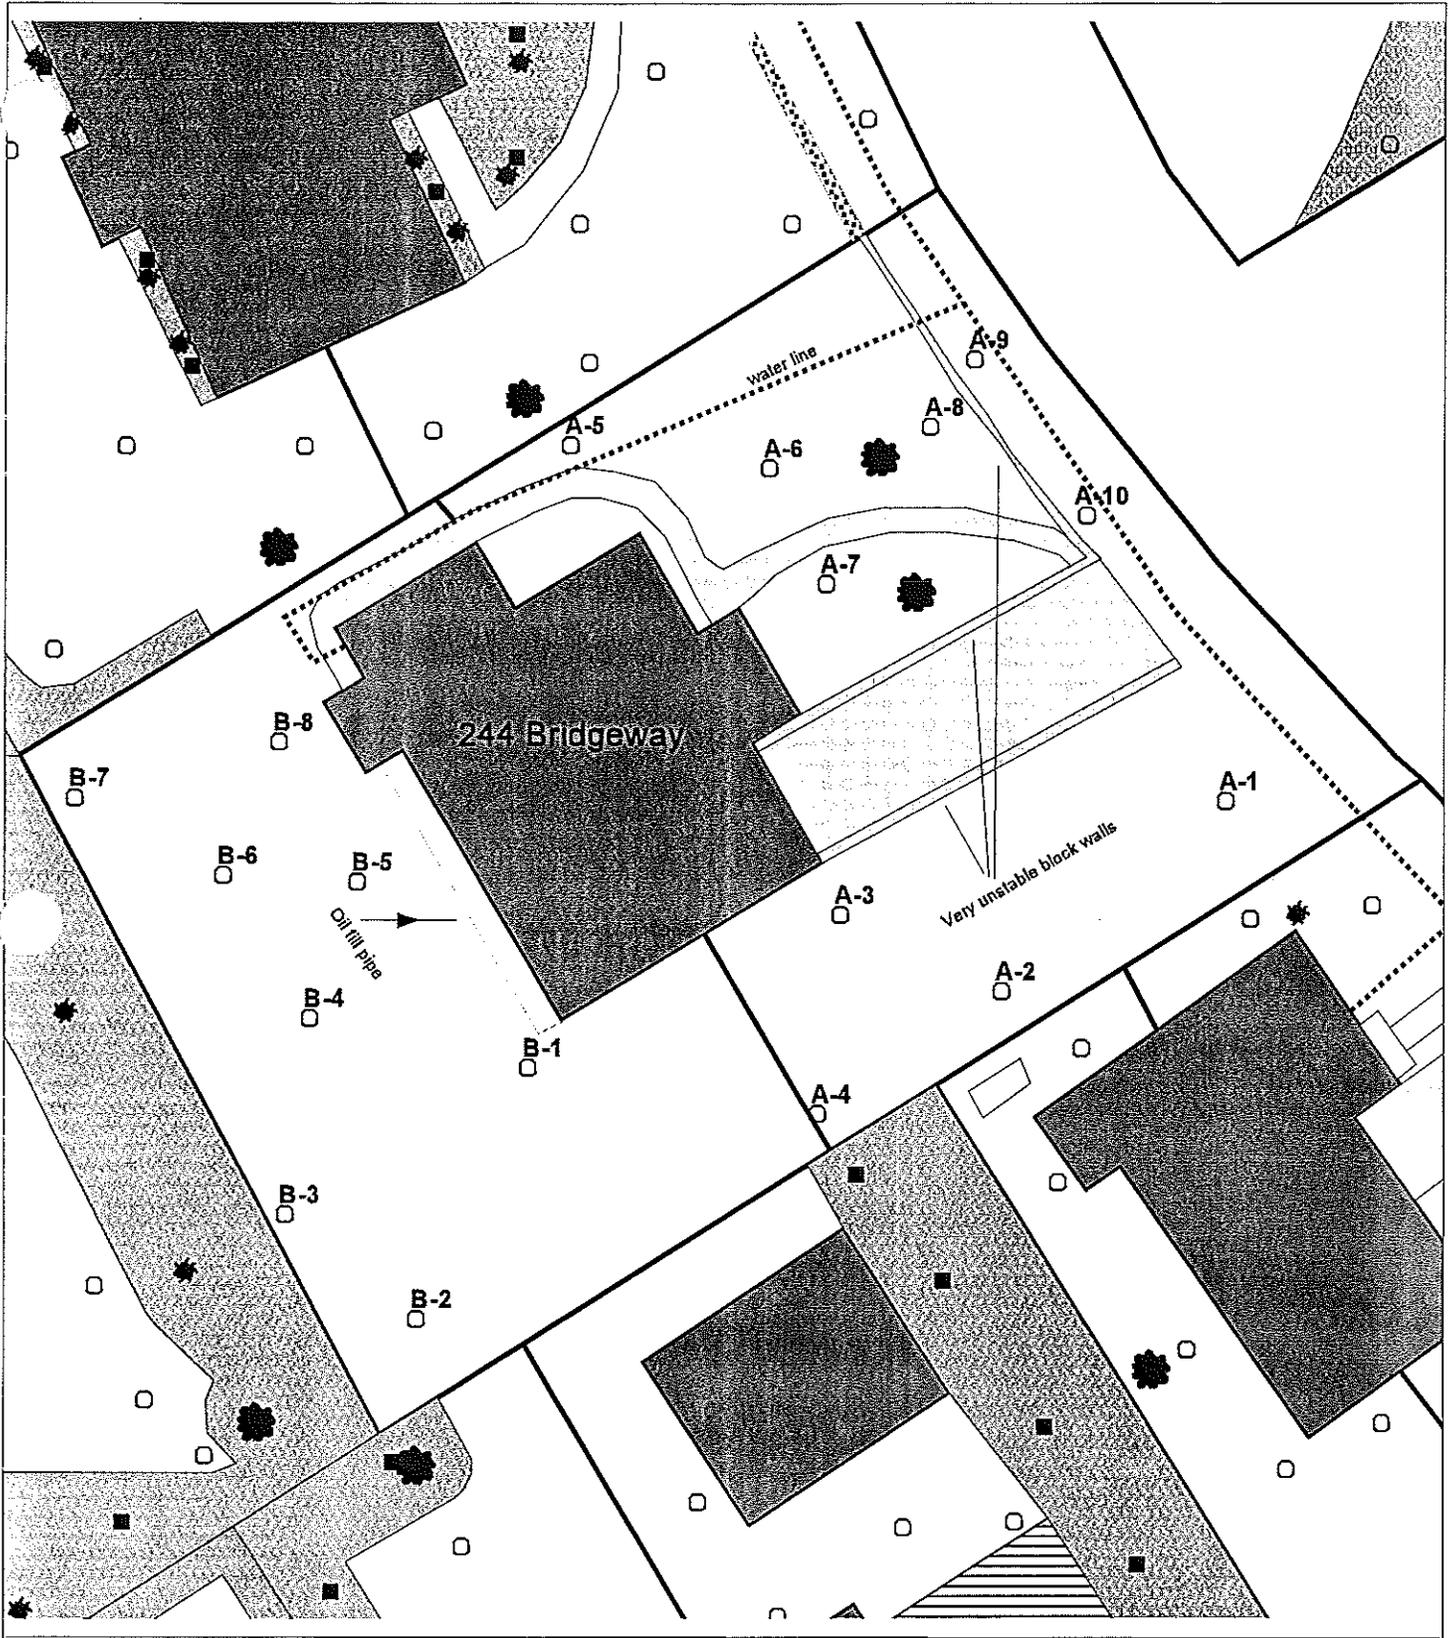
244 Bridgeway

This property was divided by Ecology into two Decision Units, A and B, as shown on the attached map, for purposes of pre-cleanup sampling and decision-making regarding the depth to which excavation was required. The following is a summary of the work done in the remediation of the property within each of the decision units.

Results of pre-cleanup sampling indicated 30 inches of soil were to be excavated from within this decision unit. Attachment B shows that below 30 inches, results of composite sample analyses are below the remediation level of 150 parts per million (ppm). However, because the soil below 30 inches contains arsenic levels above the cleanup level of 20 ppm, a geofabric marker was placed.

Results of pre-cleanup sampling indicated 12 inches of soil were to be excavated from within this decision unit. Attachment B shows that below 12 inches, results of composite sample analyses are below the remediation levels of 60 and 150 ppm and discrete analyses were below the remediation level of 150 ppm. However, because the soil below 12 inches contains arsenic levels above the cleanup level of 20 ppm, a geofabric marker was placed.

Field measurements by the Ecology on-site coordinator confirmed that soil was removed to a depth of 30 inches. Except for the rhododendron near the front door, all plants and soils were excavated. Within the dripline of the rhododendron, the existing topsoil was removed to the top of the root ball. During excavation, two large trees, the walkway from the driveway to the front door and the front steps were removed. The excavation

Field measurements by the Ecology on-site coordinator confirmed that soil was removed to a depth of 12 inches. The excavation was sloped approximately 1:1 away from the foundation of the existing home and walkway to protect the integrity of the structures. In order to facilitate excavation, the clothesline poles were removed. Upon the completion of excavation, the poles were replaced. An old septic tank was uncovered and subsequently backfilled with sand. French drains were installed along the west property line and along the west side of the house. These were connected to a plastic drain pipe placed along the south side of the house and connected to the drainage for the block wall on the south side of the driveway. The downspouts for the gutters on the south side of the house were also connected to this pipe. After placing a geofabric marker, the decision unit was filled with clean backfill material and topsoil, as described in the *Specifications for Everett Residential Soil Remediation*, and then covered with sod.
