# Property Review

## **American Avionics** 7023 Perimeter Road S. Seattle, WA 98108

Toxics Cleanup Program  
Northwest Regional Office  
Washington State Department of Ecology  
Bellevue, Washington

December 2006

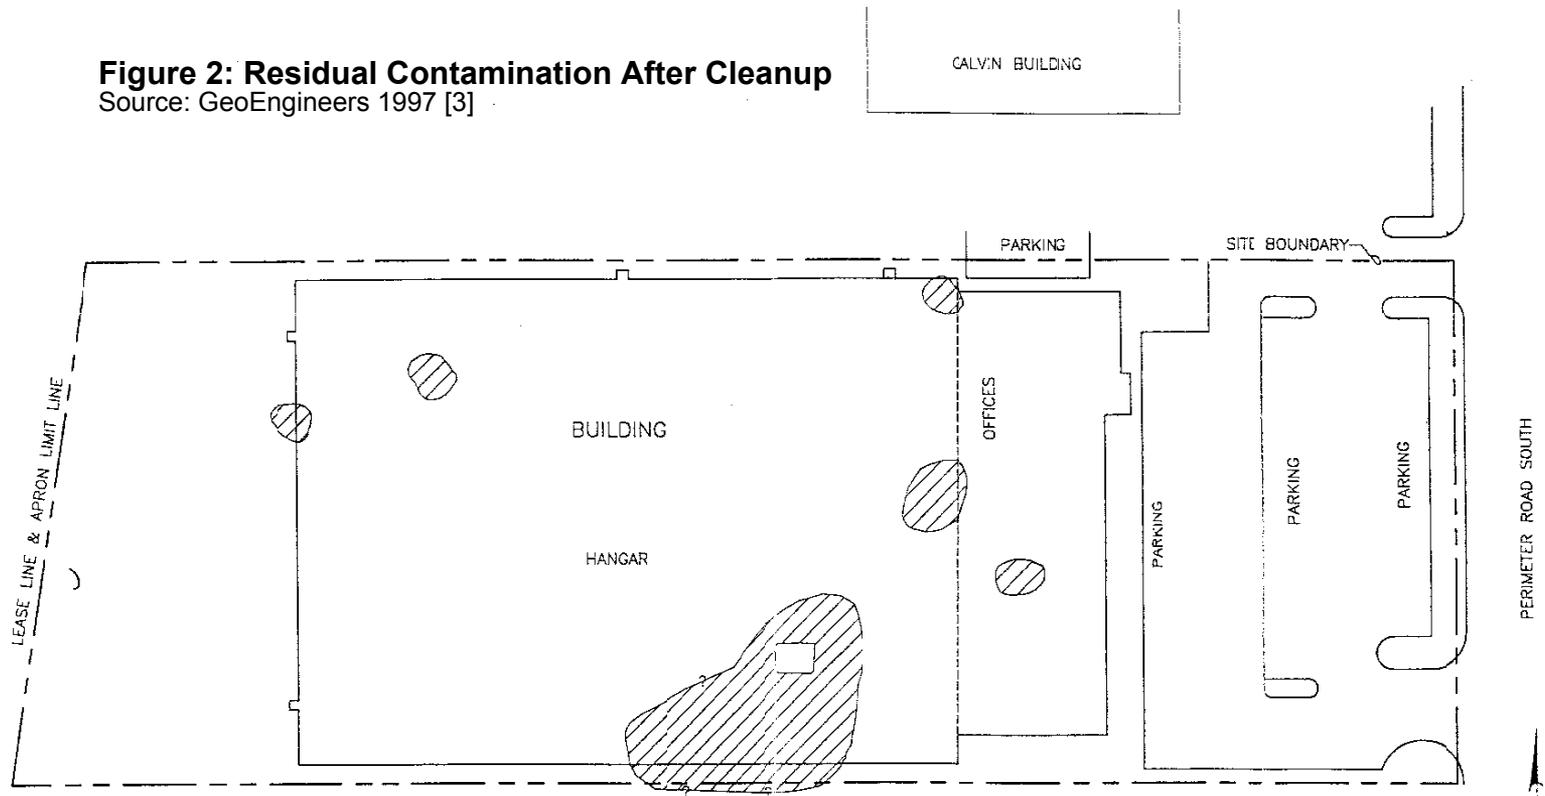
**Figure 2: Residual Contamination After Cleanup**  
 Source: GeoEngineers 1997 [3]

Representative samples were collected from the bottom of the excavations and analyzed for TPH and BTEX. Selected samples were analyzed for HVOCs and metals. TPH concentrations above MTCA Method A cleanup levels were detected in several locations which are now in the interior portion of the building and are covered by the concrete floor slab and building roof [1]. These residual hydrocarbons were located beneath the hangar and office structure, with small portions located beneath the runway tarmac and pavement, at depths from near the surface to at least 6.2 feet below the ground surface (Figure 2). Residual petroleum hydrocarbon concentrations ranged from 6 to 4,810 mg/kg TPH-G, 10.5 to 4,880 mg/kg TPH-D, and 25 to 485 mg/kg TPH-O [9]. The reported results did not generally match the analytical standards for TPH-G and TPH-D, indicating that the petroleum hydrocarbons were a different fuel type. KCIA's consultant suggested that the fuel product may be highly weathered jet fuel [9].

AREAS OF RESIDUAL HYDROCARBONS
