STATE OF WASHINGTON
DEPARTMENT OF ECOLOGY

MEMORANDUM

SUBJECT: Failure Assessment of French Slough Impoundment; SN07-0651

This memorandum summarizes opinions and judgments of the DSO as to the cause of the April 2010 failure of the 30-million gallon Waste Storage Pond operated by the Bartelheimers near Snohomish, Washington.

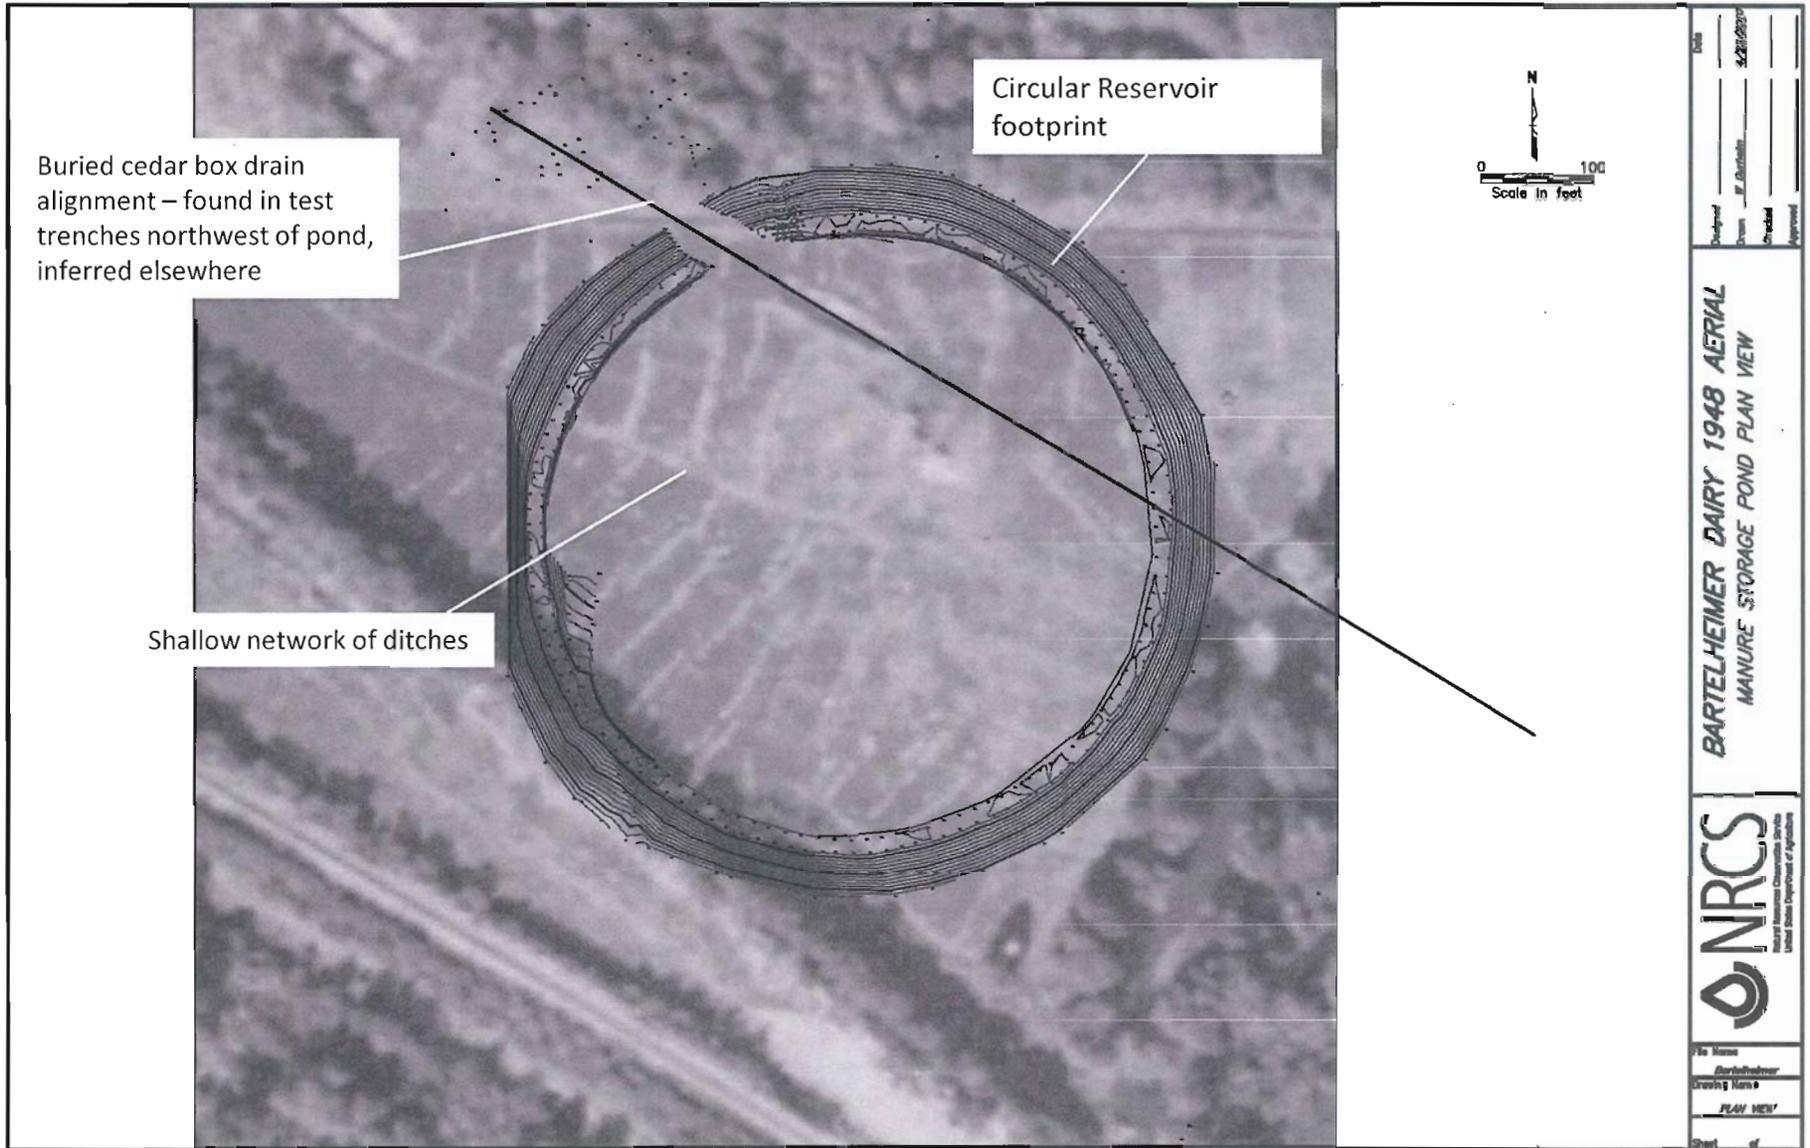
Cedar Field Drain Alignment
Figure 1

Cedar Field Drain – The cedar field drain was installed decades before the impoundment was contemplated. The drain served to improve drainage and thereby aid in farming the field. The DSO understands that Figure 1, based on a 1947 aerial photo of the field, documents the presence of the cedar drain before 1947. Note the alignment of the cedar drain is inferred from isolated lineal features that reportedly were sinkholes that developed along sections of the drain line. There are anecdotal reports that the cedar drain sections where sinkholes occurred were replaced with concrete pipe lengths around the late 1940s. Interviews with the Bartelheimers disclosed that additional sections of the cedar drain were replaced in the 1980s. ADS pipe was

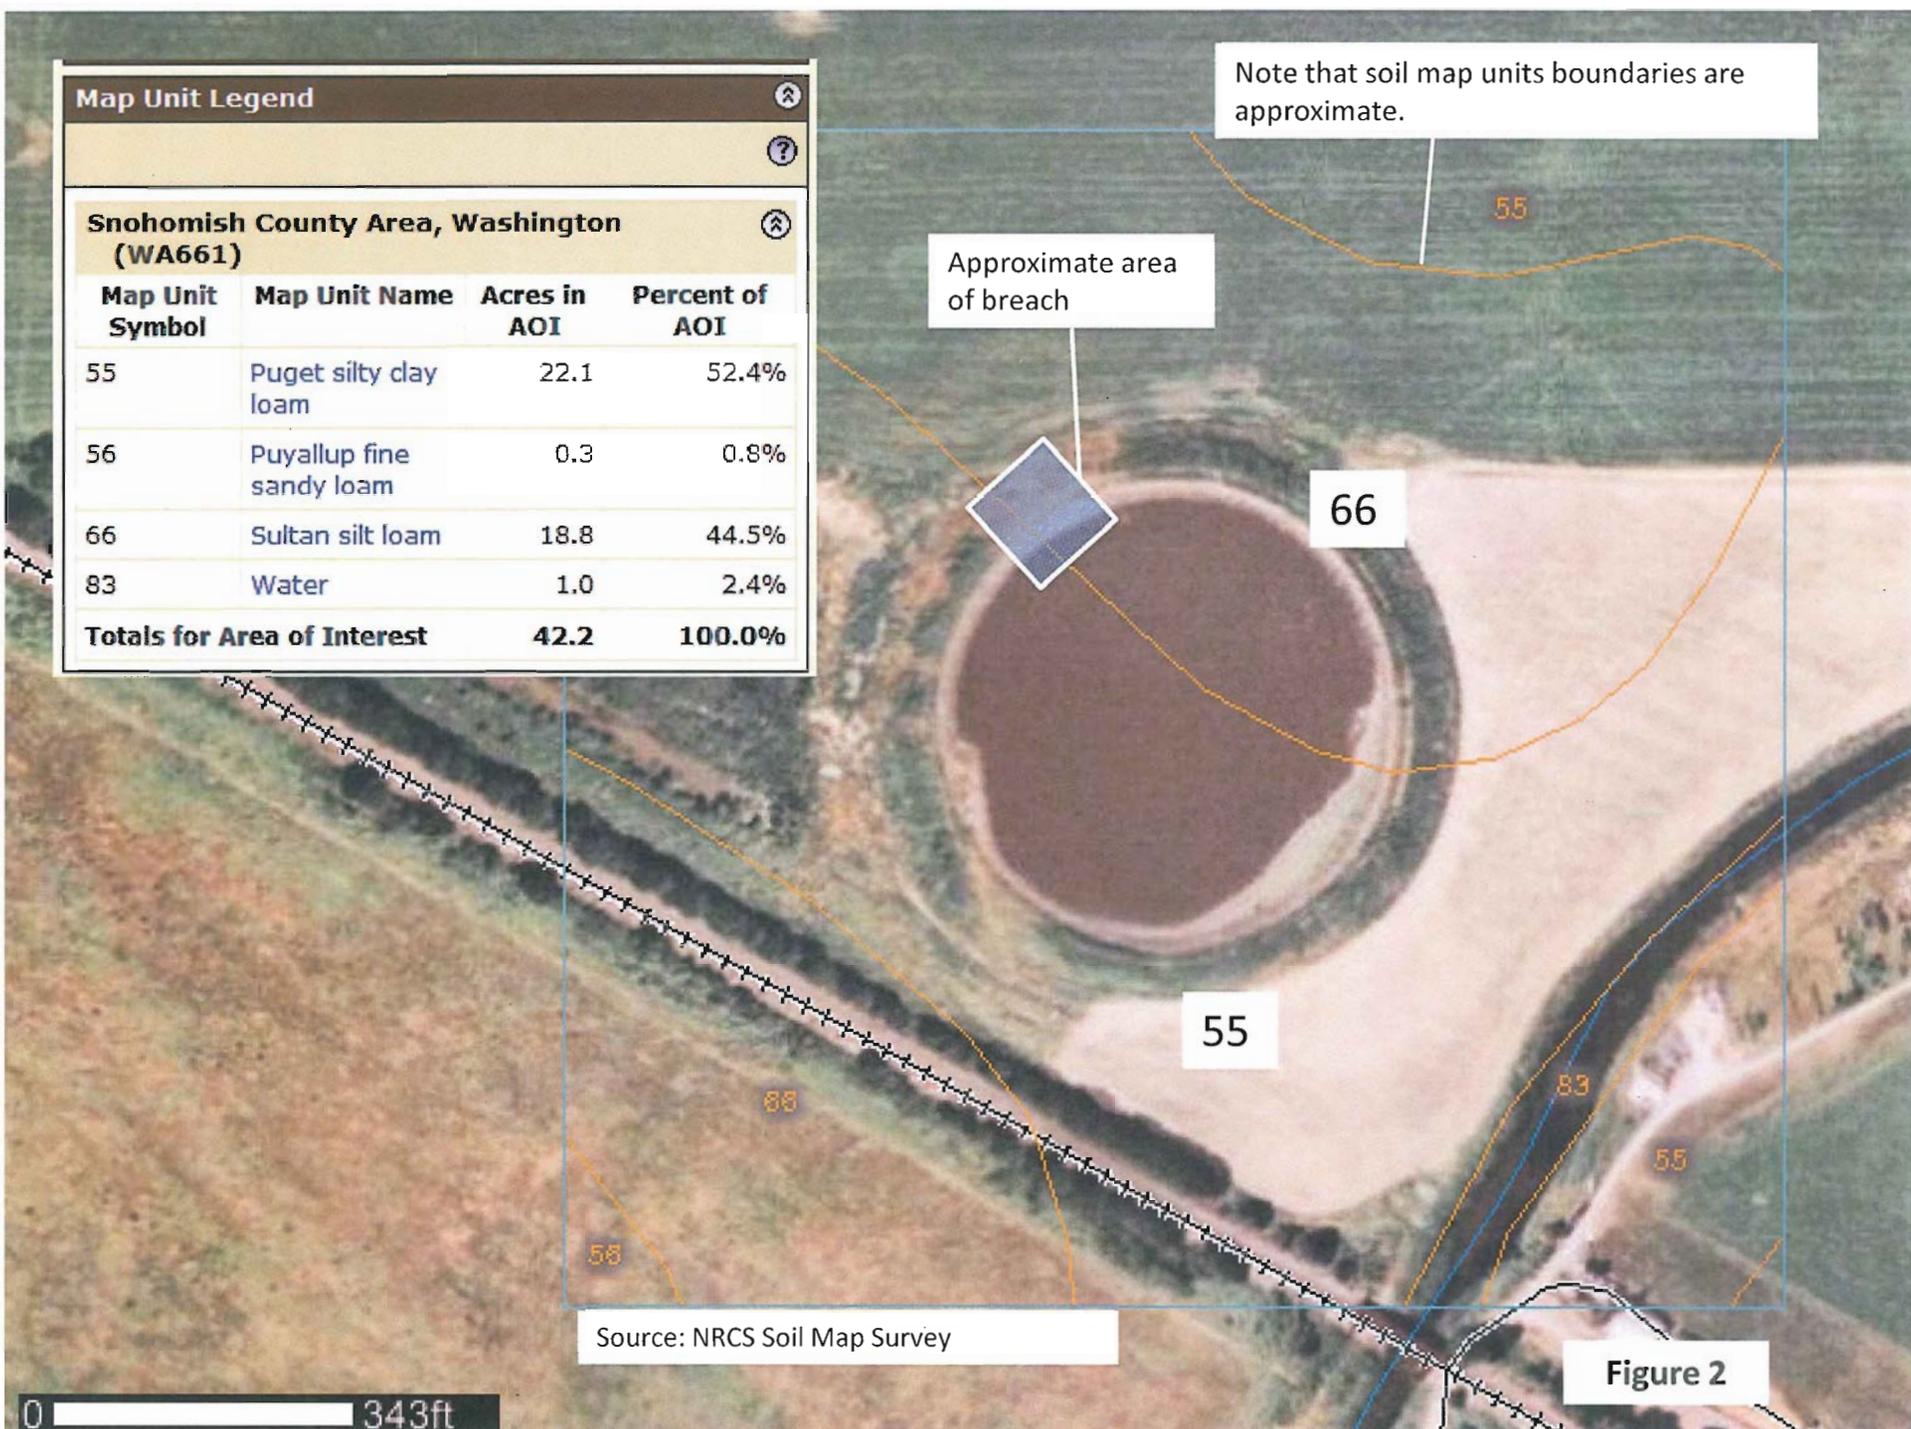
Figure 2

The site is an alluvial plain that extends northwest from French Slough and northeast of the Burlington Northern Santa Fe Railway embankment. In the vicinity of the pond 7 to 8 feet of fine grained soils mantle the site. Fine to medium silty sand underlies the fine grained mantle. The NRCS soil maps identify two principal soil units comprising the fine grained soil mantle in

the pond area: Puget Silty Clay Loam and Sultan Silt Loam. (See Figure 2.) Table 1 lists properties of these soil units cited on the NRCS Soil Survey website³.

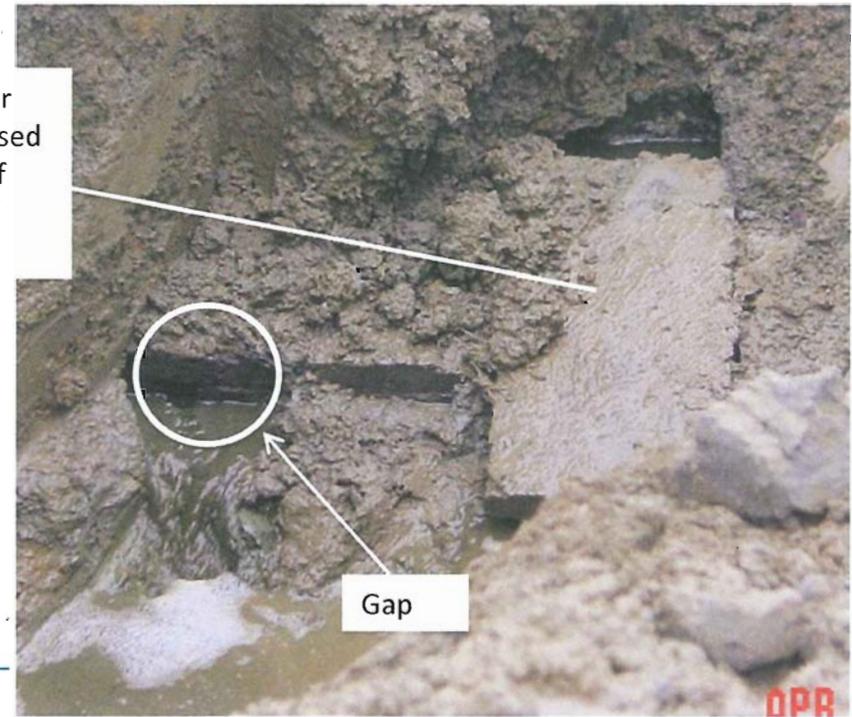
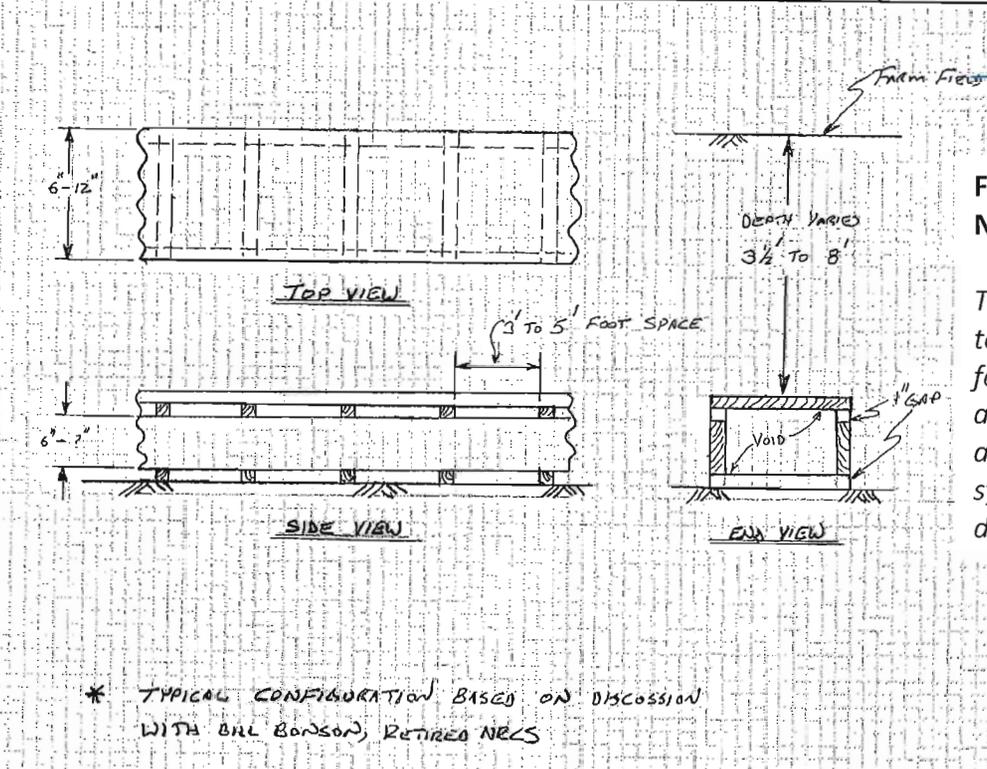
Figure 3 shows a conceptual view of typical design practice for field drains in the 1930s and 40s provided to the DSO by the NRCS. The photo insert in the corner of Figure 3 shows a short exposure of the cedar drain in one of the April 21st test pits dug to investigate the failure. There are notable differences between the conceptual view of such field drains and what was done at the Bartelheimer site. Those differences include elimination of the 1” wide gap between both the lid and sideboards and the sideboards and earthen floor of the drain section. Presumably, such gaps were provided to allow seepage to enter the drain from the top and bottom. At the Bartelheimer site the drain relied principally on seepage entering the unlined floor of the drain via lengthy sections where the bottom of the drain rested on relatively pervious silty sand. Narrow gaps between the individual boards forming the lid and between successive planks of the drain sidewalls provided some limited additional inlet capacity for seepage to enter the drain directly out of the fine grained soil mantle.

French Slough system used 11 1/2" by 1 7/8" (actual dimension) cedar planks to construct the drain. The DSO understands that nails were used for the wall-to-lid connection from NRCS reports. However, DSO staff saw no nails projecting out of the limited sample of the population of boards ejected to the surface in the failure.

The depth of these types of structure varies ranging from 3.5 feet to 8 feet. The depth is dependent on the distance the drained farm field is to the outlet. Fields that are drained are low and wet and constructing the drain sometimes required passing through areas that are not low. In order to maintain a free draining system and to maintain a positive drainage grade the excavation depth through dry areas was typically greater.

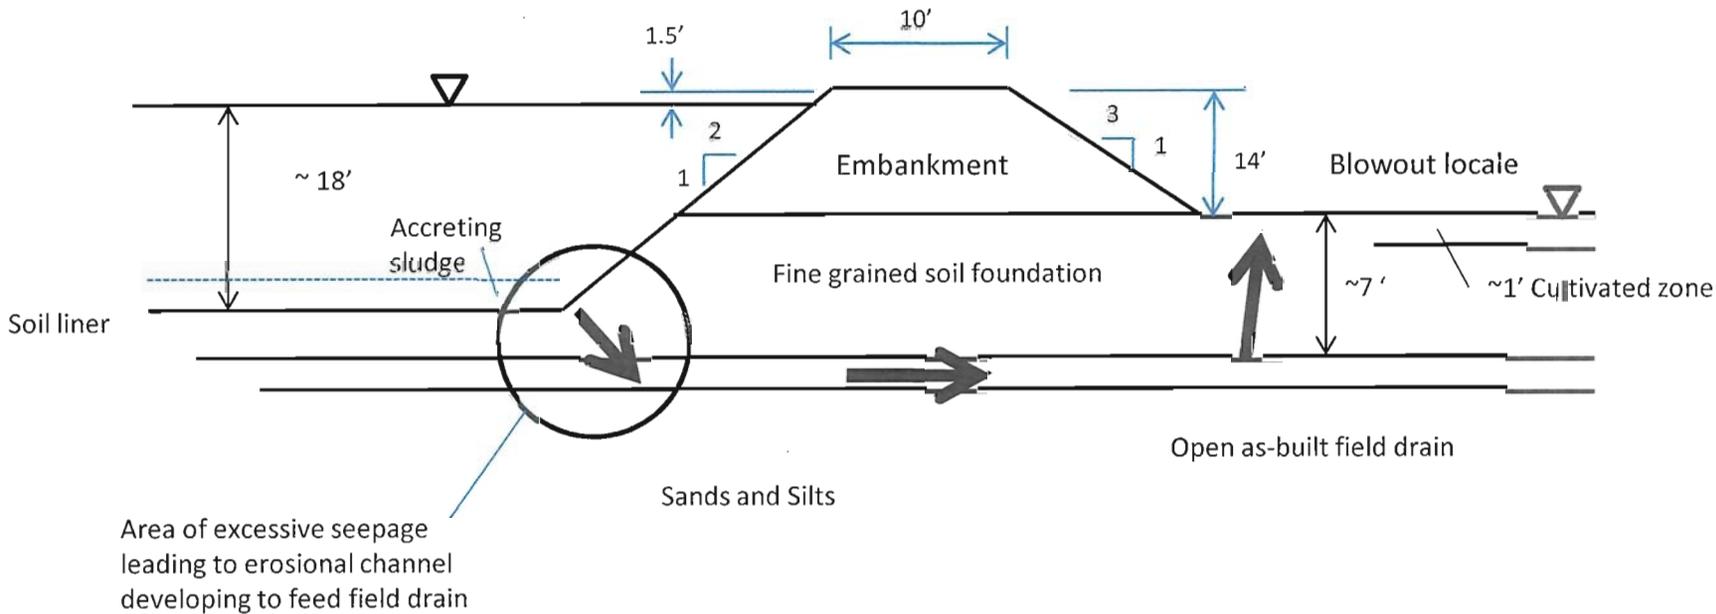
Figure 4

A seepage induced failure requires two things: 1) a continuous pathway for seeping fluid to escape the pond and 2) a flow quantity down that pathway sufficient to wash away soils faster than the pathway can heal⁷ itself. In this case there are three separate reaches to this continuous pathway: the short reach between the pond bottom and the field drain, the field drain beneath the embankment, and the upward pathway through the soil layer to reach the ground surface. (See Figure 4.)

Upward Exit through the Soil Mantle at the Outside Embankment Toe – The DSO believes that fluid pressures in the interior of the cedar drain immediately prior to the failure were driven by the fluid level in the pond. Maximum fluid pressures in the drain would have equaled the difference in elevation between the fluid surface in the pond and the field drain multiplied by the unit weight of the fluid - roughly that of water. The DSO calculated that with the fluid in the pond at or above the normal high pool level, the pressure acting in the cedar drain below the outside dike toe would have been sufficient to force open a pathway to the ground surface. The DSO believes that pathway could have been opened by hydraulic fracturing of the soil column. Hydraulic fracturing is a technique employed by, among others, the oil industry to boost yields from oil bearing strata. The fluid pressure in a sealed off section of the vertical well is increased to the point it opens fractures in the rock. Those fractures allow increased oil flow from the surrounding formation to the collection well. In the French Slough case, rotate the concept 90 degrees. The horizontal cedar field drain is the analog for the vertical boring. The pond fluid pressure in the cedar drain is equivalent to the drill rig pressurizing the encapsulating soil. The resulting cracking of the surrounding formation would have opened an exit pathway up through the fine grained soil mantle to the ground surface.

It is the DSO's opinion that hydraulic fracturing of the mantle would occur when the fluid pressure at the base of the soil column exceeded the lateral confining stress in the soil. The lateral confining stress acting in the soil was estimated as the sum of a frictional component and a cohesion component of the strength of the soil. The component due to friction was approximated by multiplying the wet unit weight of the soil column times the at-rest lateral earth pressure coefficient. The component due to cohesion was estimated using published relationships that relate cohesion to a soil's Atterberg Limits.

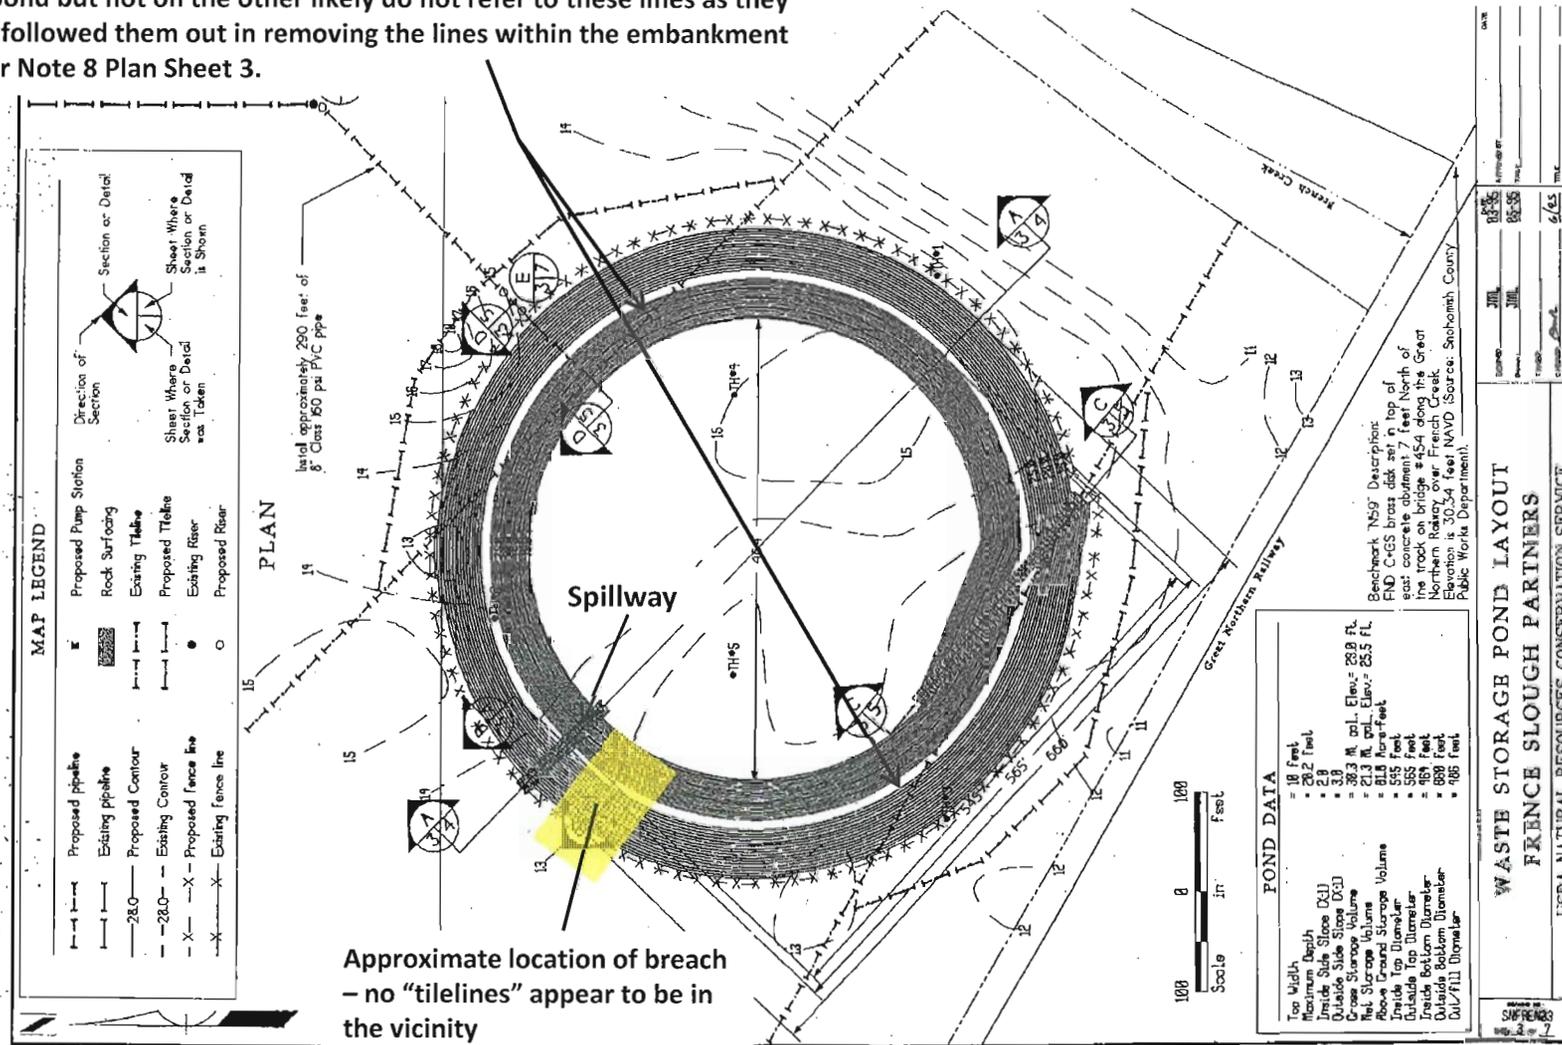
Figure A1

The plans call for removal and rerouting of the "tilelines" around the impoundment. The comments LaVassar heard about finding the drains on one side of the pond but not on the other likely do not refer to these lines as they would have followed them out in removing the lines within the embankment footprint per Note 8 Plan Sheet 3.

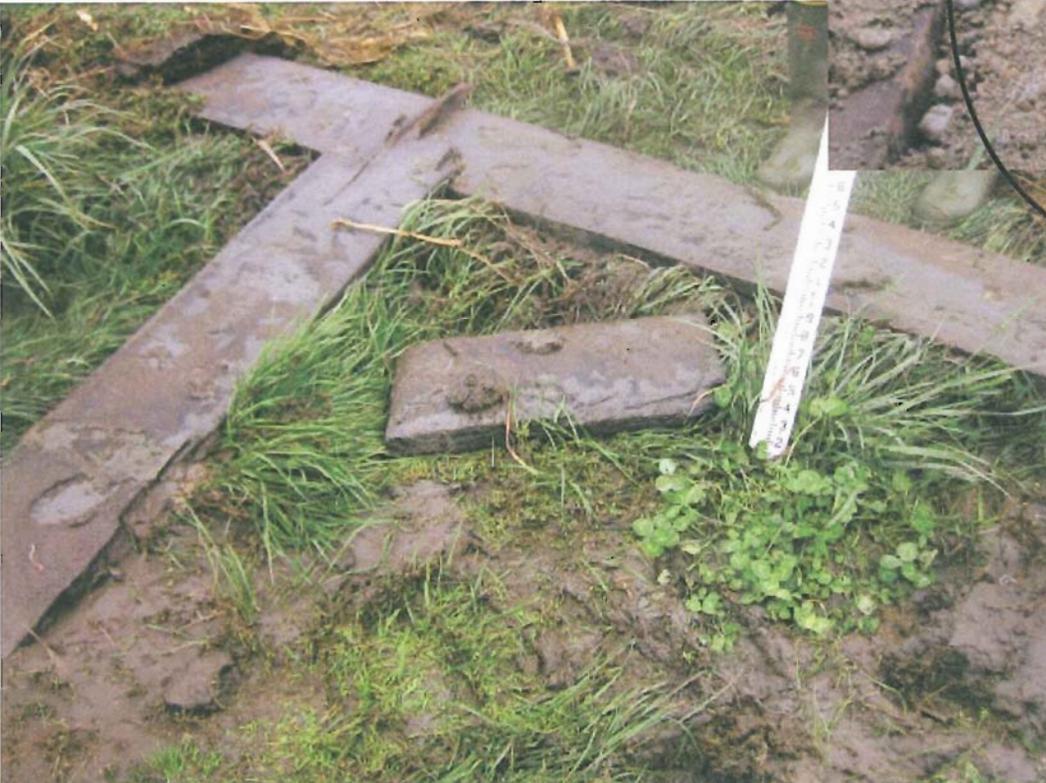
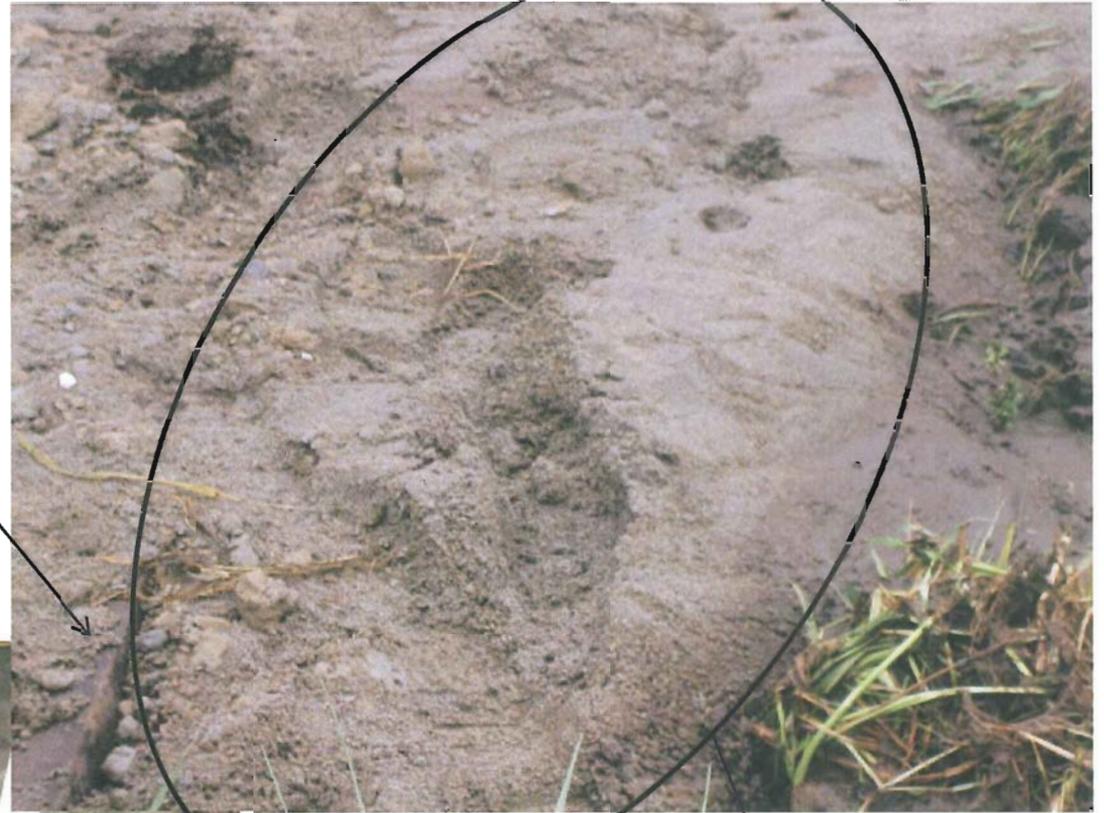
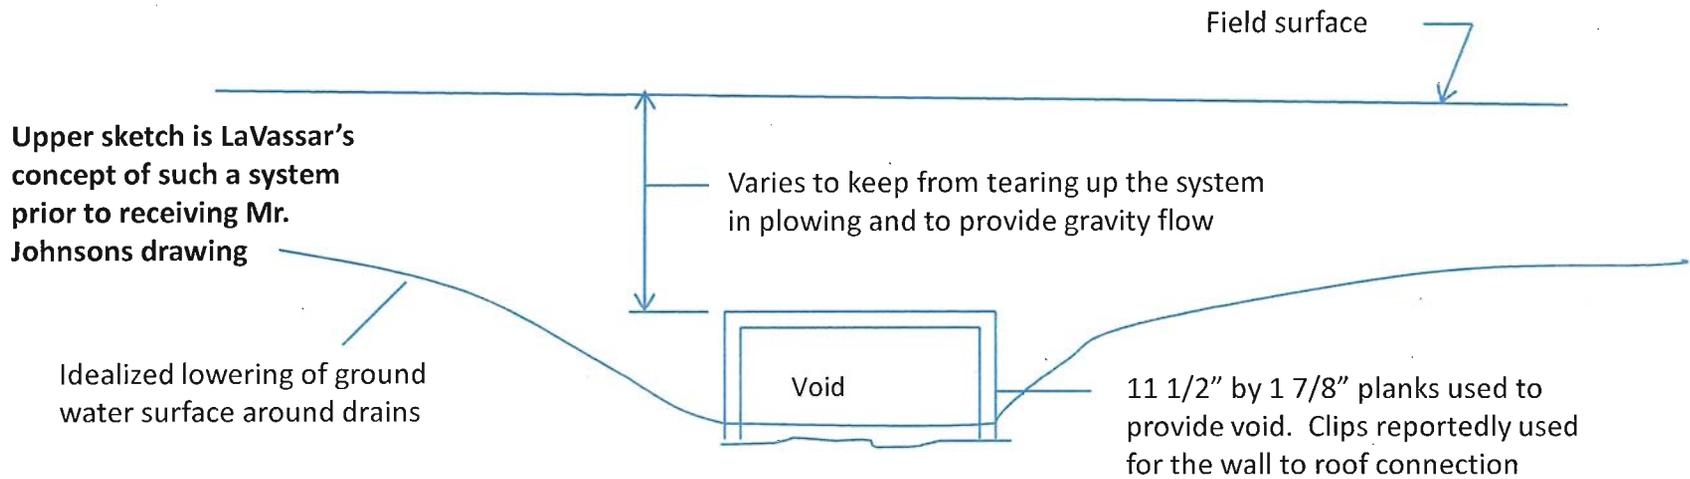
Figure A2

The debris field limits covered a wide area. The debris field surface was littered with pieces (we observed at least 15) of dimensioned lumber 11½" deep by 1⁷/₈" thick, Figure A2. The lengths of lumber fell into two classes, those some 2 feet in length and those 10 to 20 feet in length. The roughly 2 ft. lengths of wood seemed to be spread over the greatest distances. The thickness of the dimensioned lumber suggests the wood was milled decades ago. Yet, the wood was typically judged to be in a sound condition even though wet. This suggests the lumber comes from a depth below the seasonal fluctuations in the ground water surface. Constant submergence can dramatically decrease the rate at which wood deteriorates.

Presumed remnants of buried drain

Exposed lumber
presumably
from drain

Deposits of fine uniform sand and
exposures of fine to coarse rounded
gravels adjacent to the buried lumber

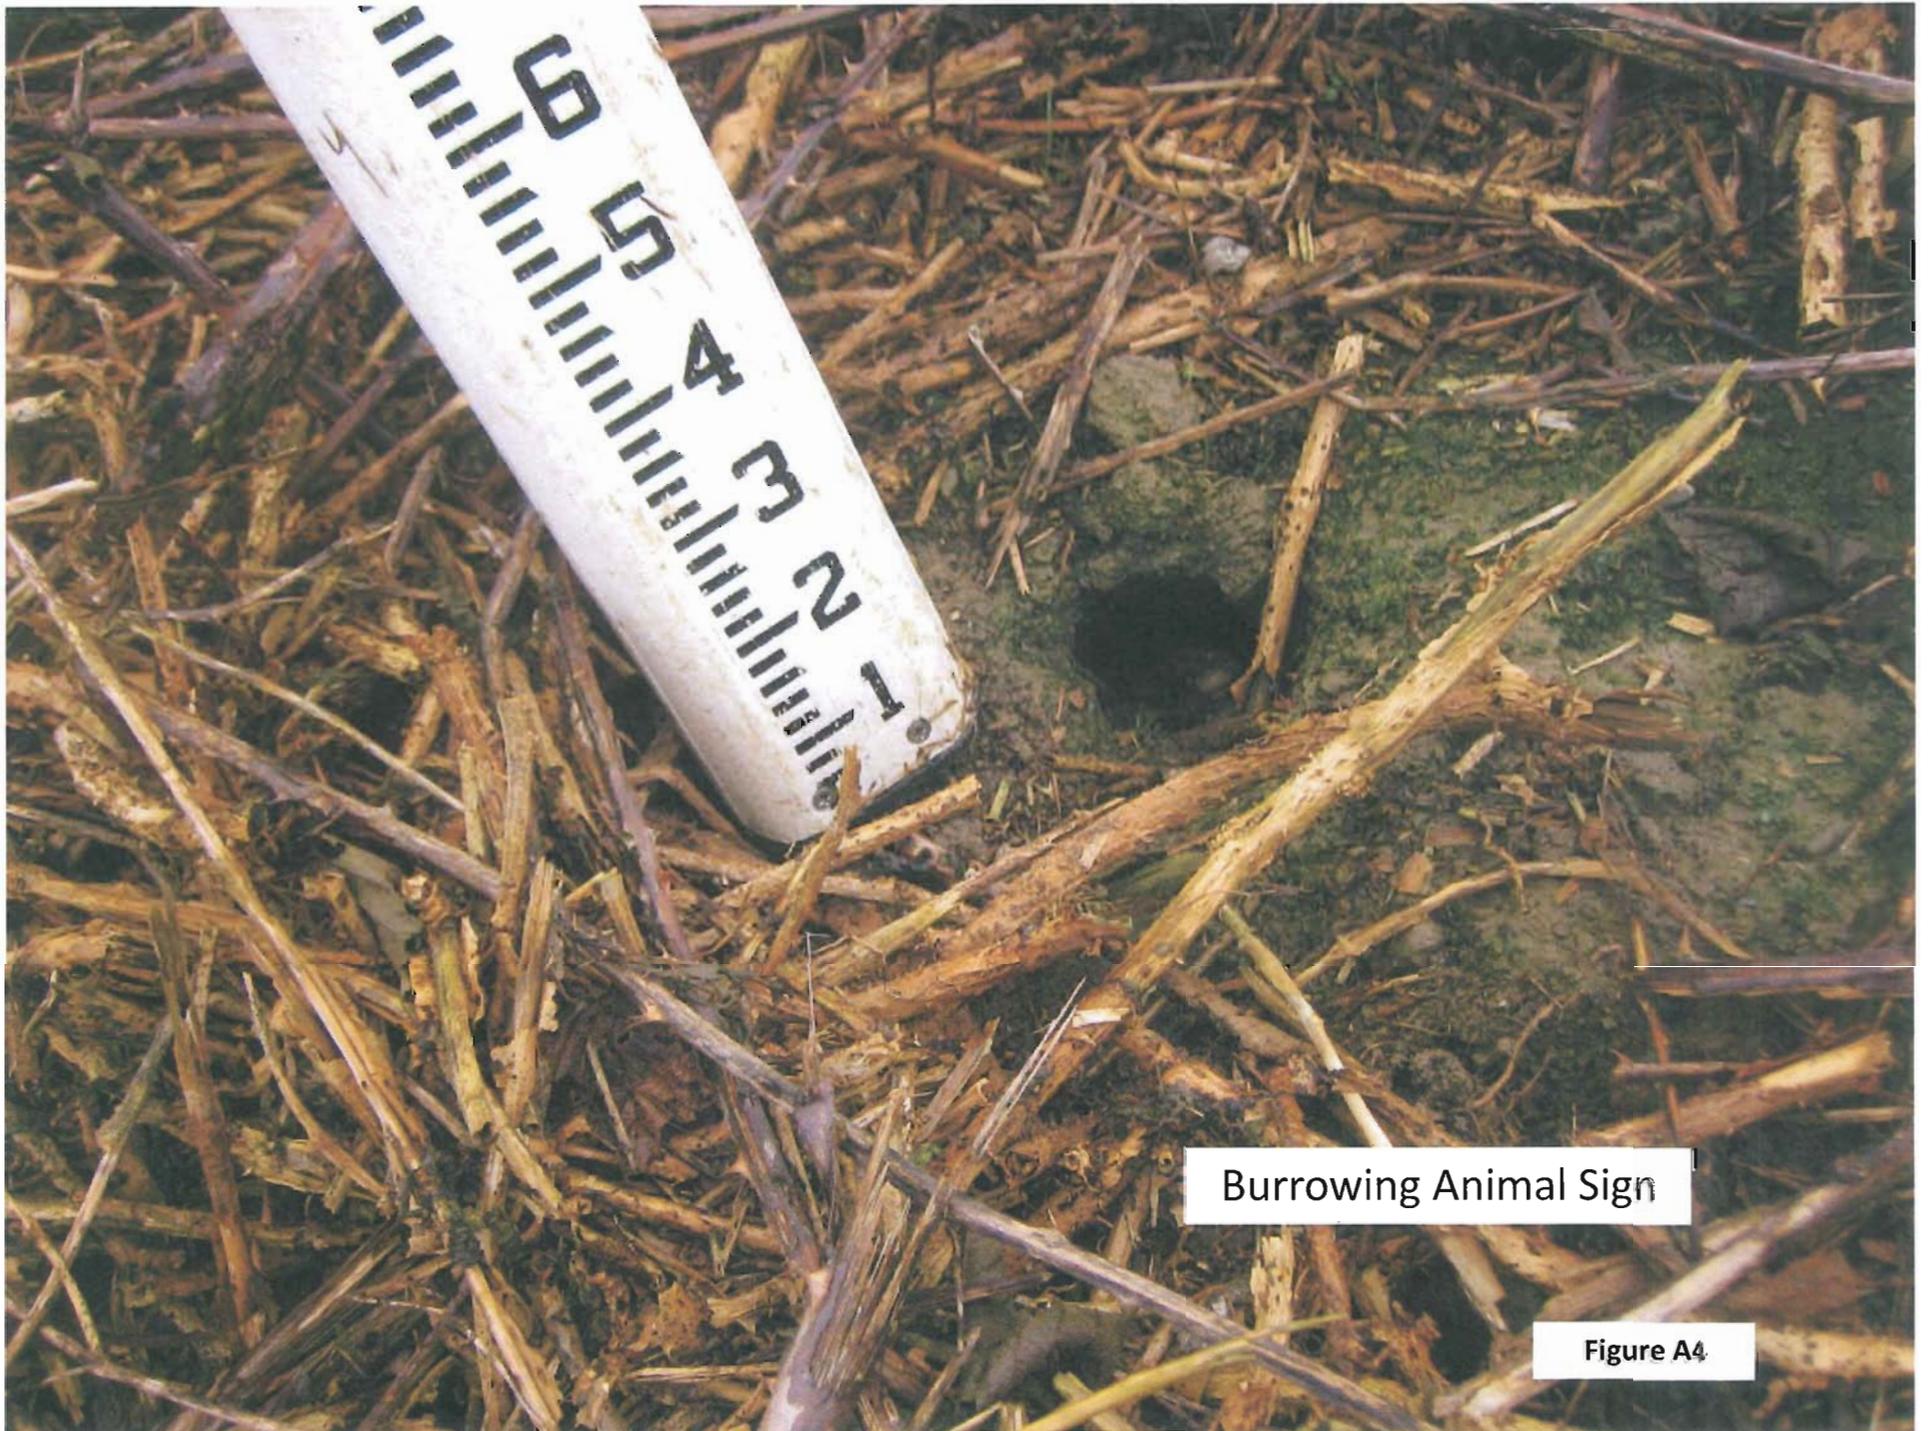
Figure A4

At the embankment we observed local areas on the downstream face and crest where burrowing animals have been active, see Figure A4. The mouths of the larger observed animal runs were on the order of 0.2 foot in diameter. Extensive reaches of the crest and portions of the downstream face showed evidence of having supported a dense growth of blackberries. The vines appeared to have been cut down and chopped up in the recent past and left where they fell.

Burrowing Animal Sign

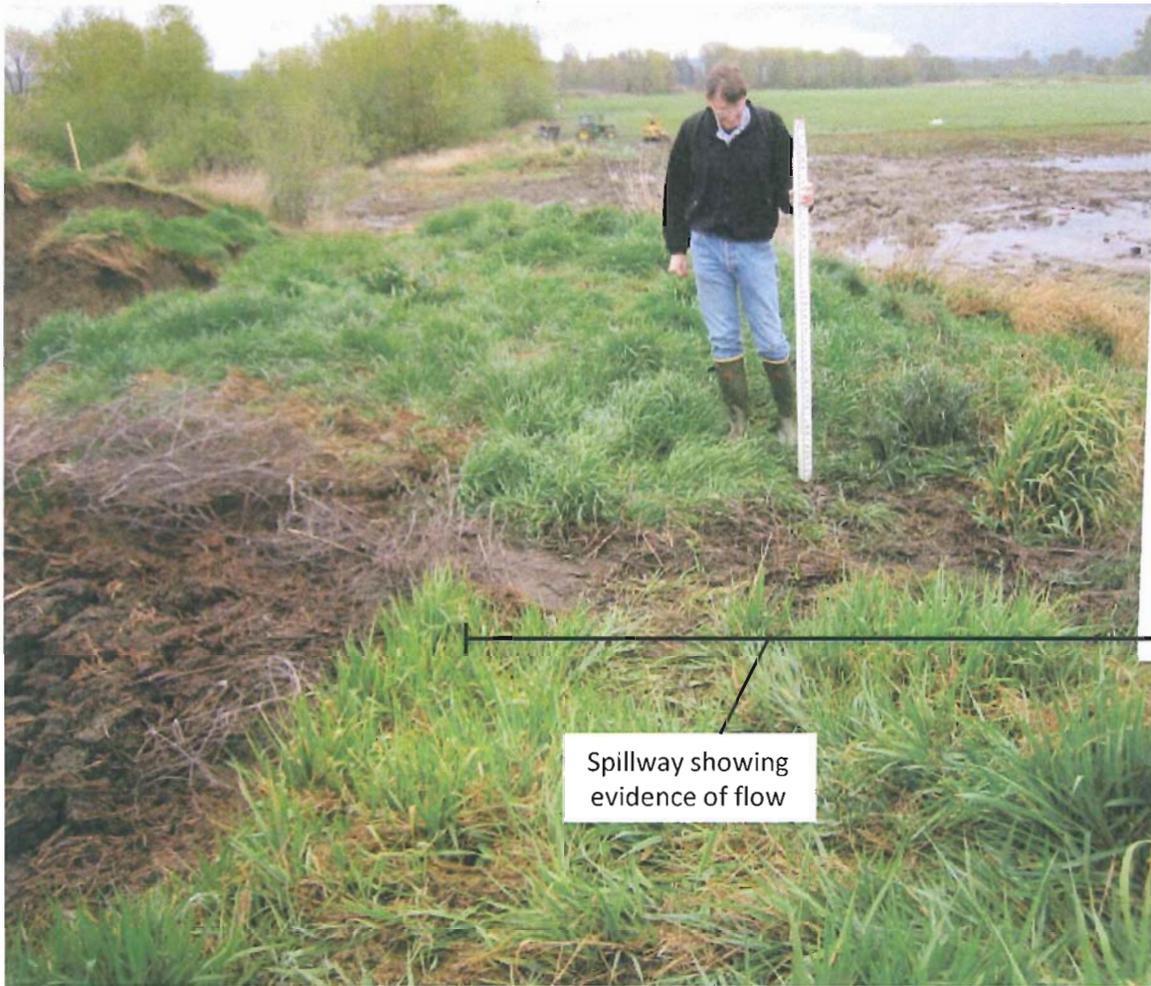
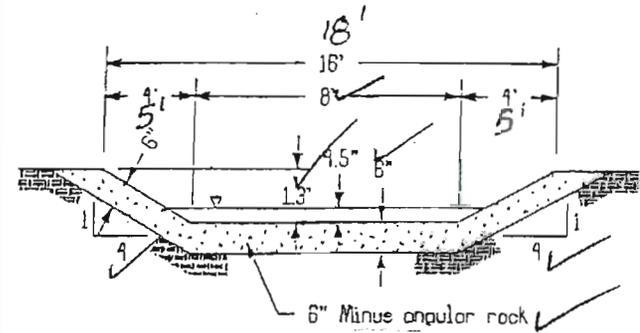
Figure A5

The DSO's April 13th site visit to the failed pond noted visual evidence that flow had exited the emergency spillway and that wind driven waves had broken onto the dam crest locally. In the latter case the resulting sheet flow crossed the 10 foot wide crest and ran down the exterior slope. The sheet flow left a number of meandering shallow depressions across the crest. The depressions were at most an inch or so deep. The import of the foregoing is that the waste level had risen to within a foot of the dike crest. The normal maximum operating pool and emergency spillway levels on the as-built plans are cited as 3.5 feet and 1.3 feet, respectively. The DSO is unaware of information as to how long and how recently the reservoir was operated at this level.

Spillway showing evidence of flow

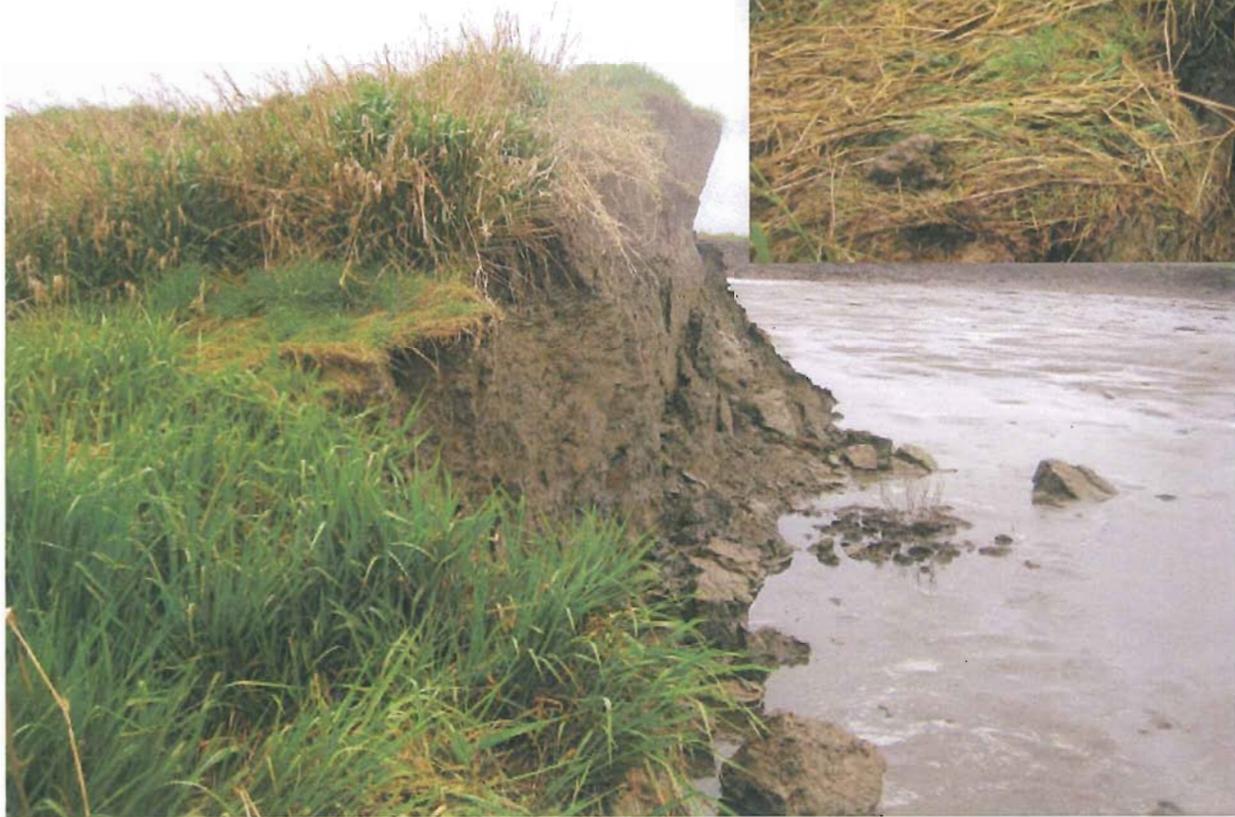
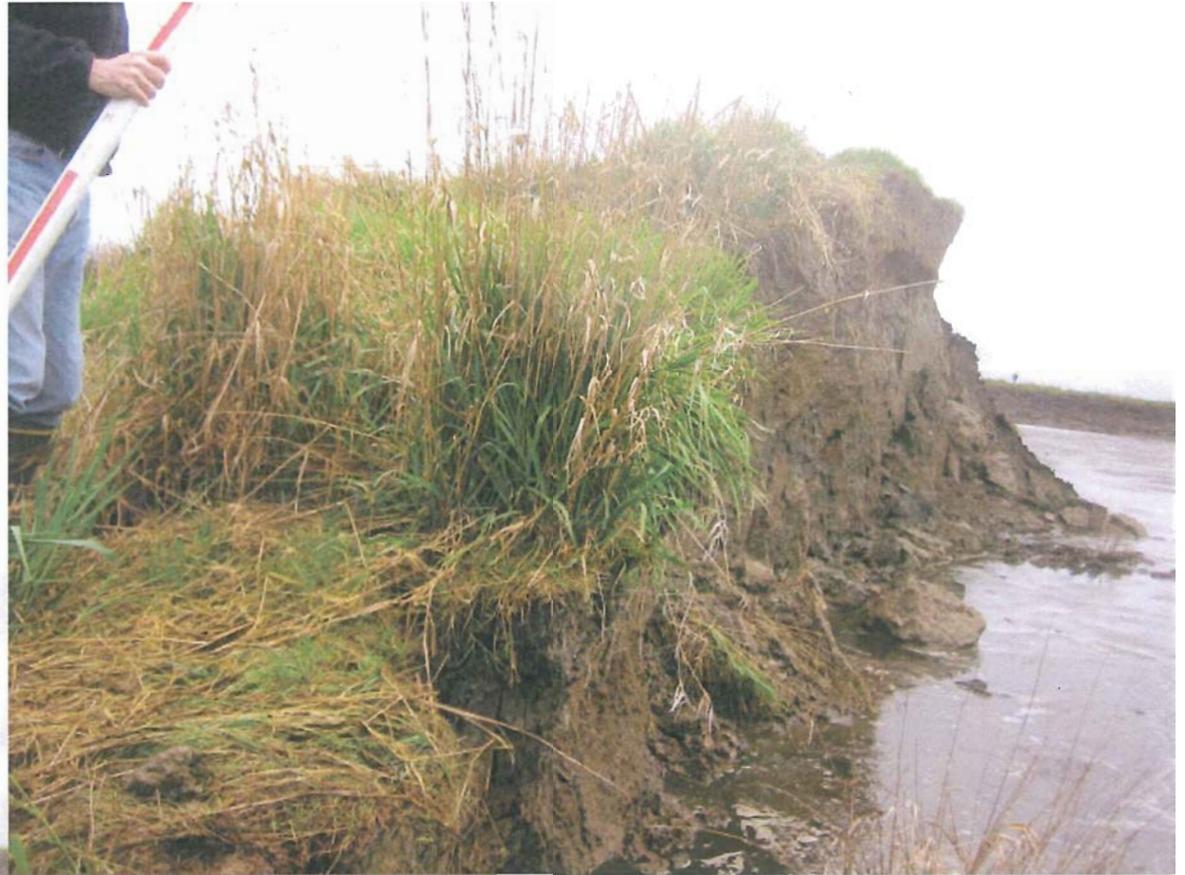
Figure A7

Right Breach Sidewall

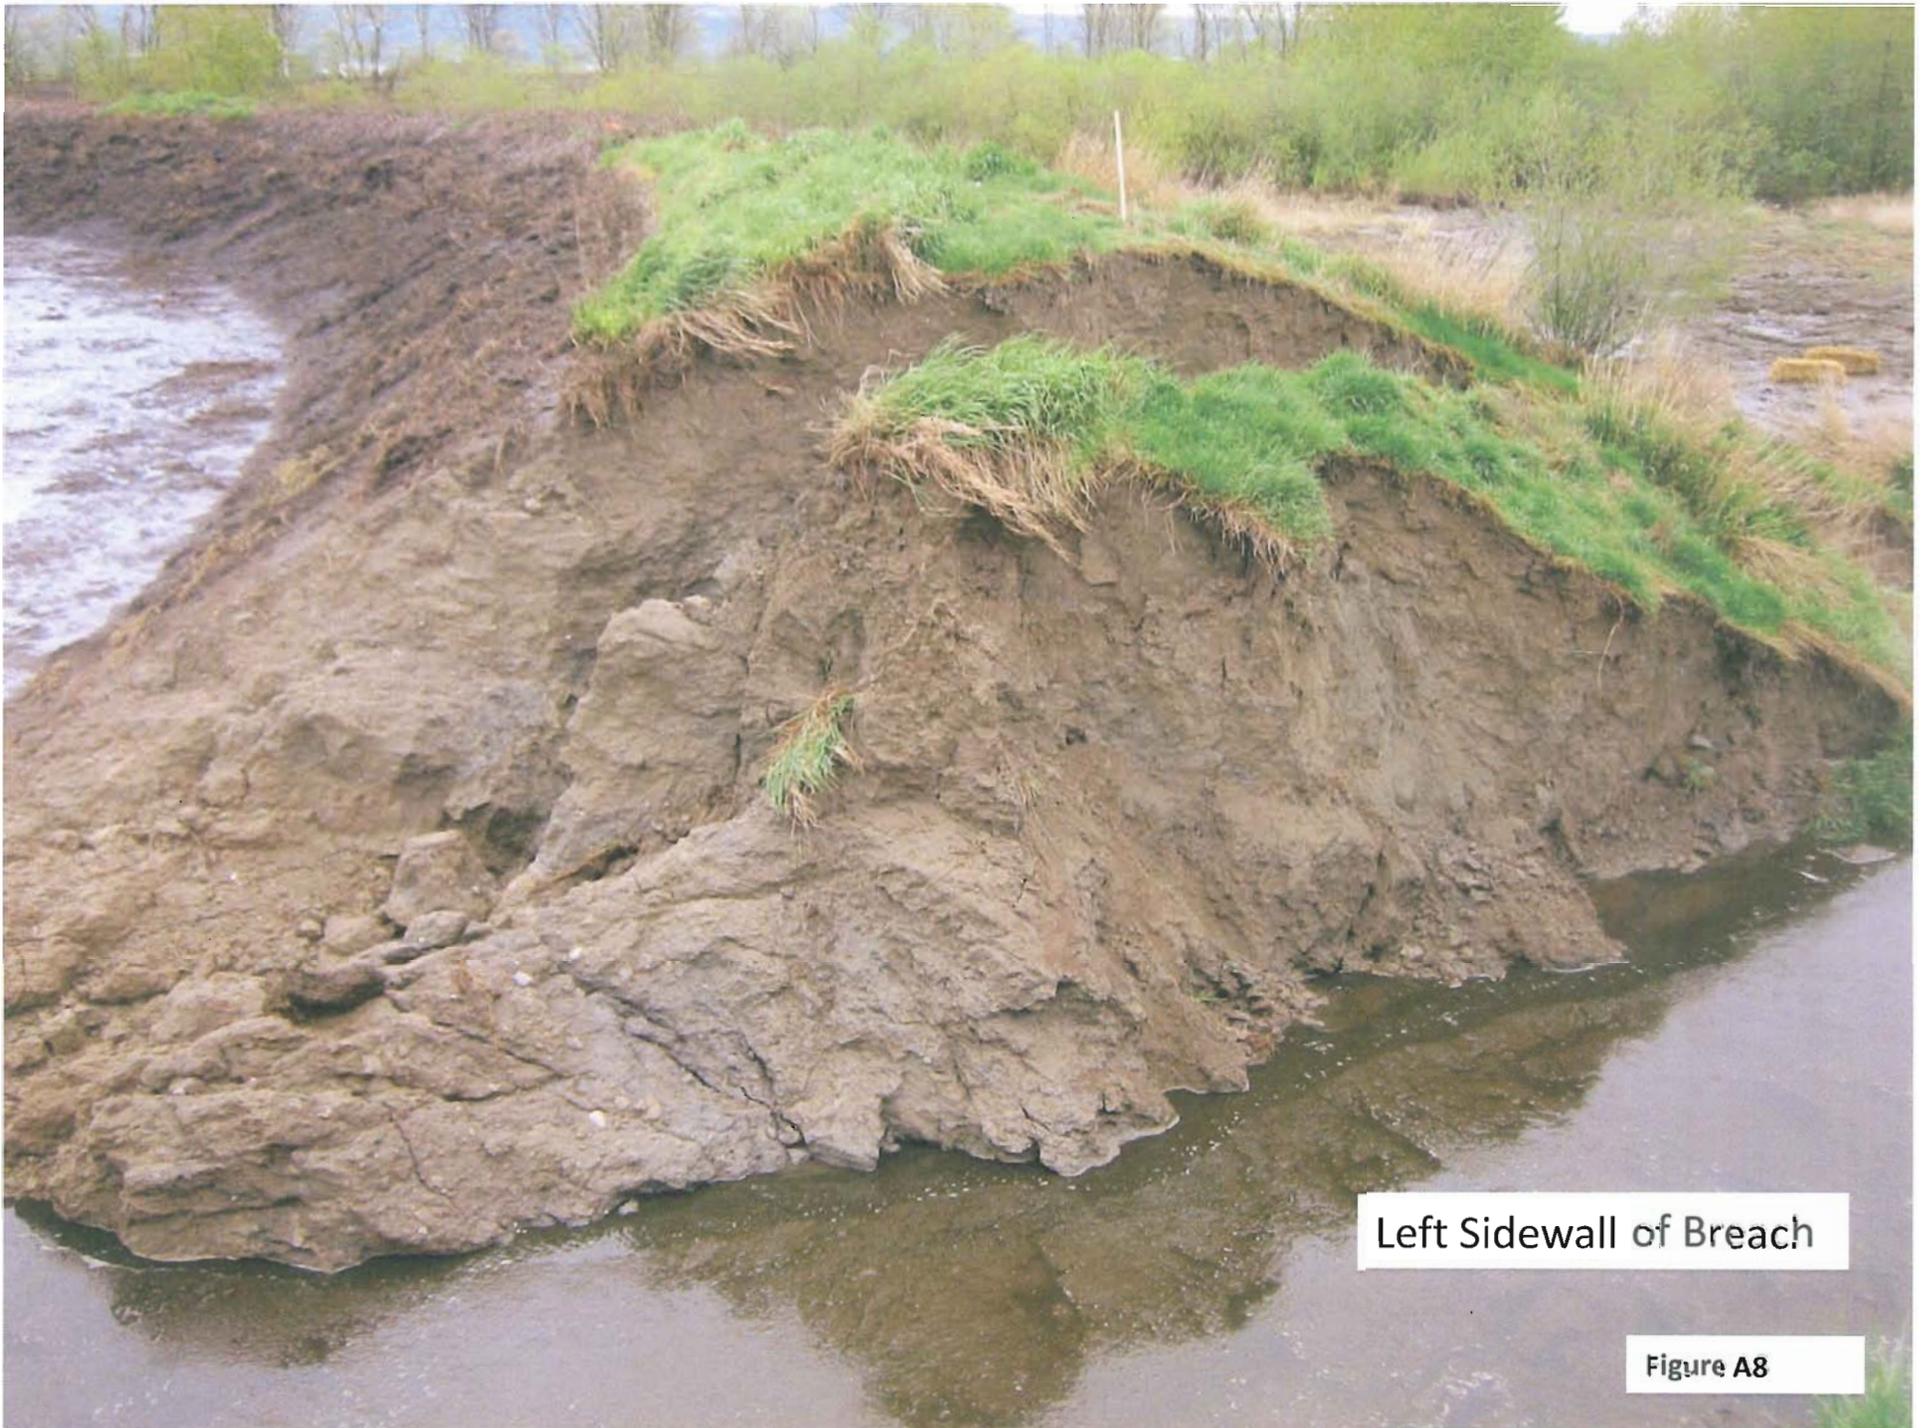
Figure A8

On the left side of the breach Figure A8, the original breach wall had likely been near vertical. However, at some point there was a secondary failure of a roughly 10 ft. thick slab of the cross-section into the breach. That secondary slab failure appeared to have occurred with the base dropping and moving towards the right side into a scour hole that likely developed during the course of the dam breach flood. We were able to get closer to the backside of the secondary block failure and as a consequence we were able to discern what appear to be lift contacts more definitively. The secondary failure block exhibited near vertical cracks likely induced in the process of moving and coming to rest.

Left Sidewall of Breach
