Professional Engineer's Statement
Everett Smelter Cleanup
March 17, 2003

Washington Department of Ecology Everett Smelter Site 2002 Cleanup

Details of Cleanup Activities

Address: 212 Bridgeway
 Everett, WA 98201

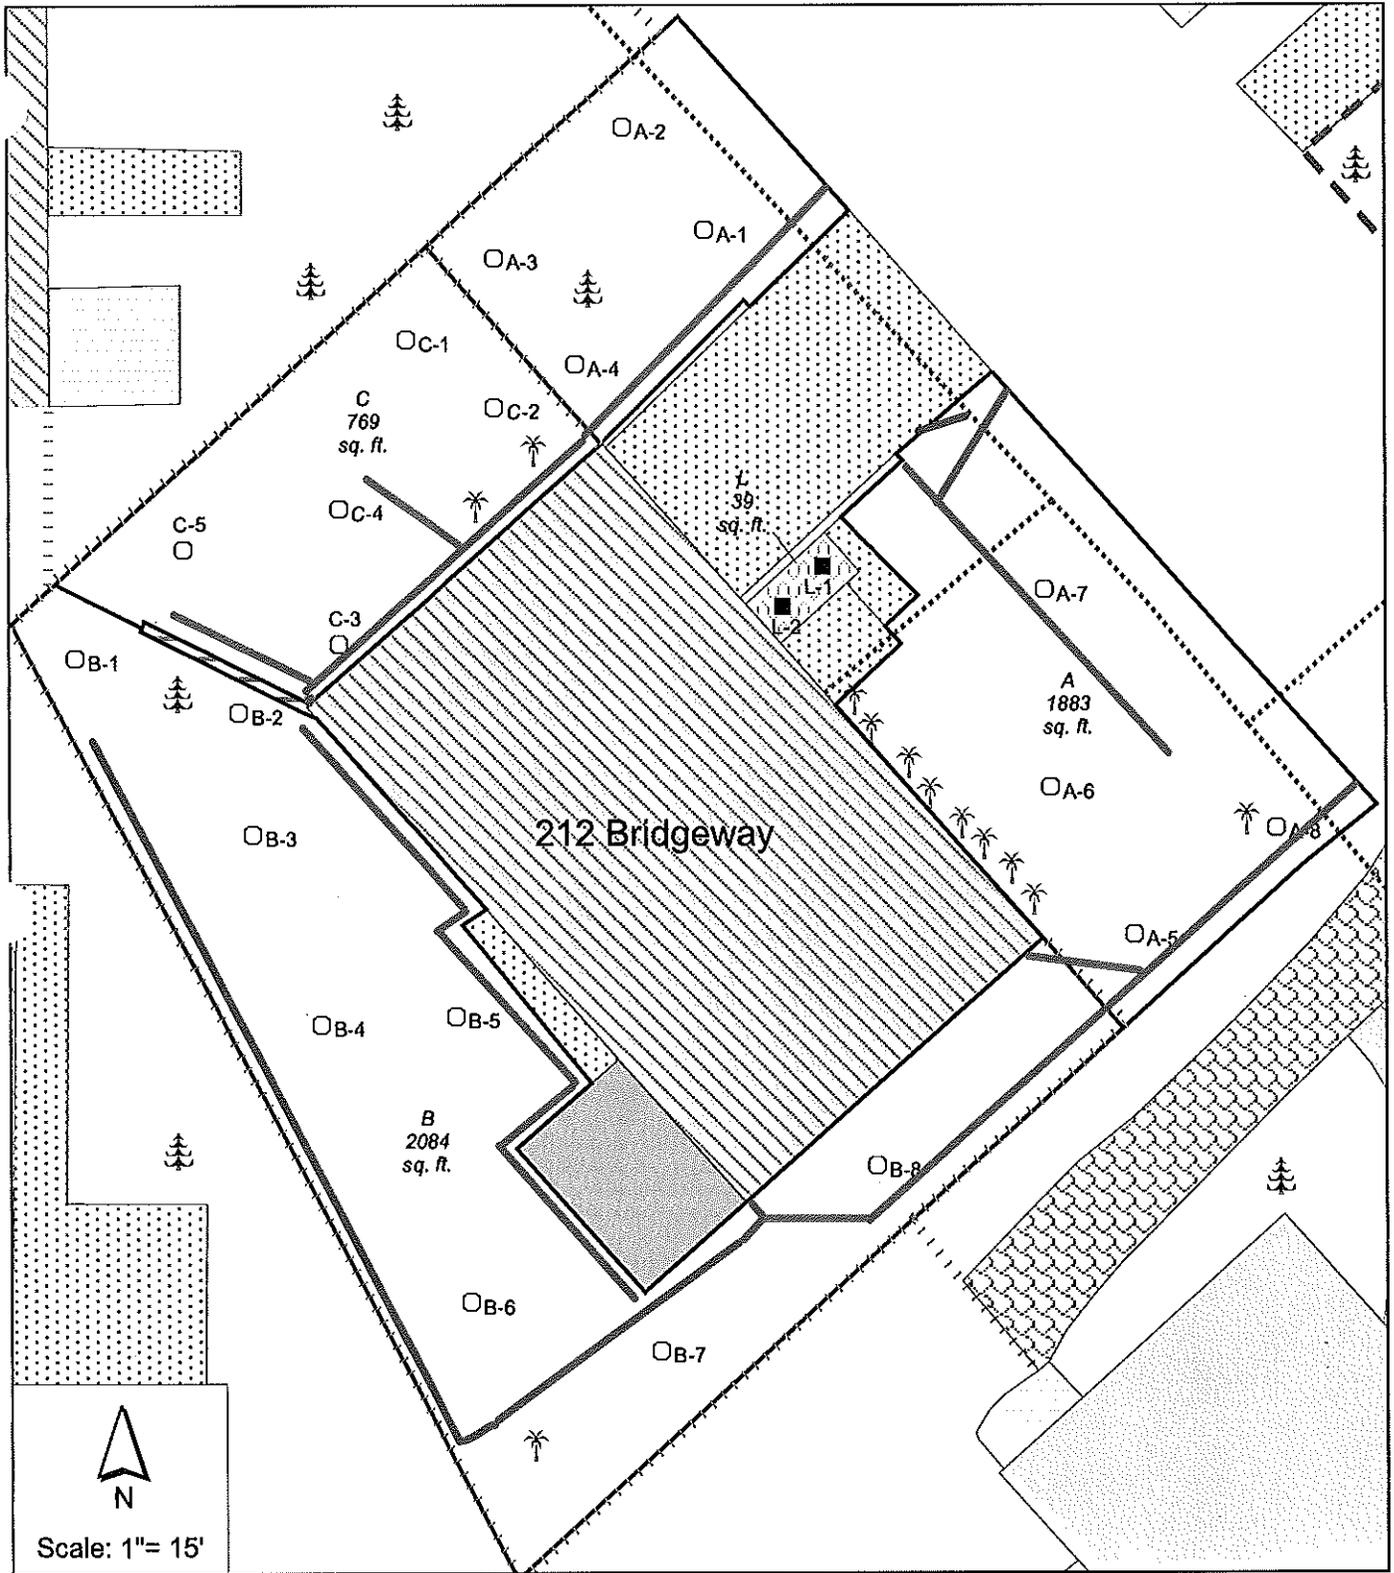
212 Bridgeway (Home 49)
 Everett Smelter Homesite Cleanup
 Source: Snohomish Health District

For the purposes of sampling to determine the depth to which excavation would be required, this property was divided into three Decision Units, A, B and C, as shown on the attached map. The following is a summary of the work done to remediate the property within each of the decision units.
