**Professional Engineer's Statement
Everett Smelter Cleanup, 2000-2001**

Washington Department of Ecology Everett Smelter Site 2000-2001 Cleanup

Details of Cleanup Activities

Address: 236 Bridgeway
Everett, WA 98201

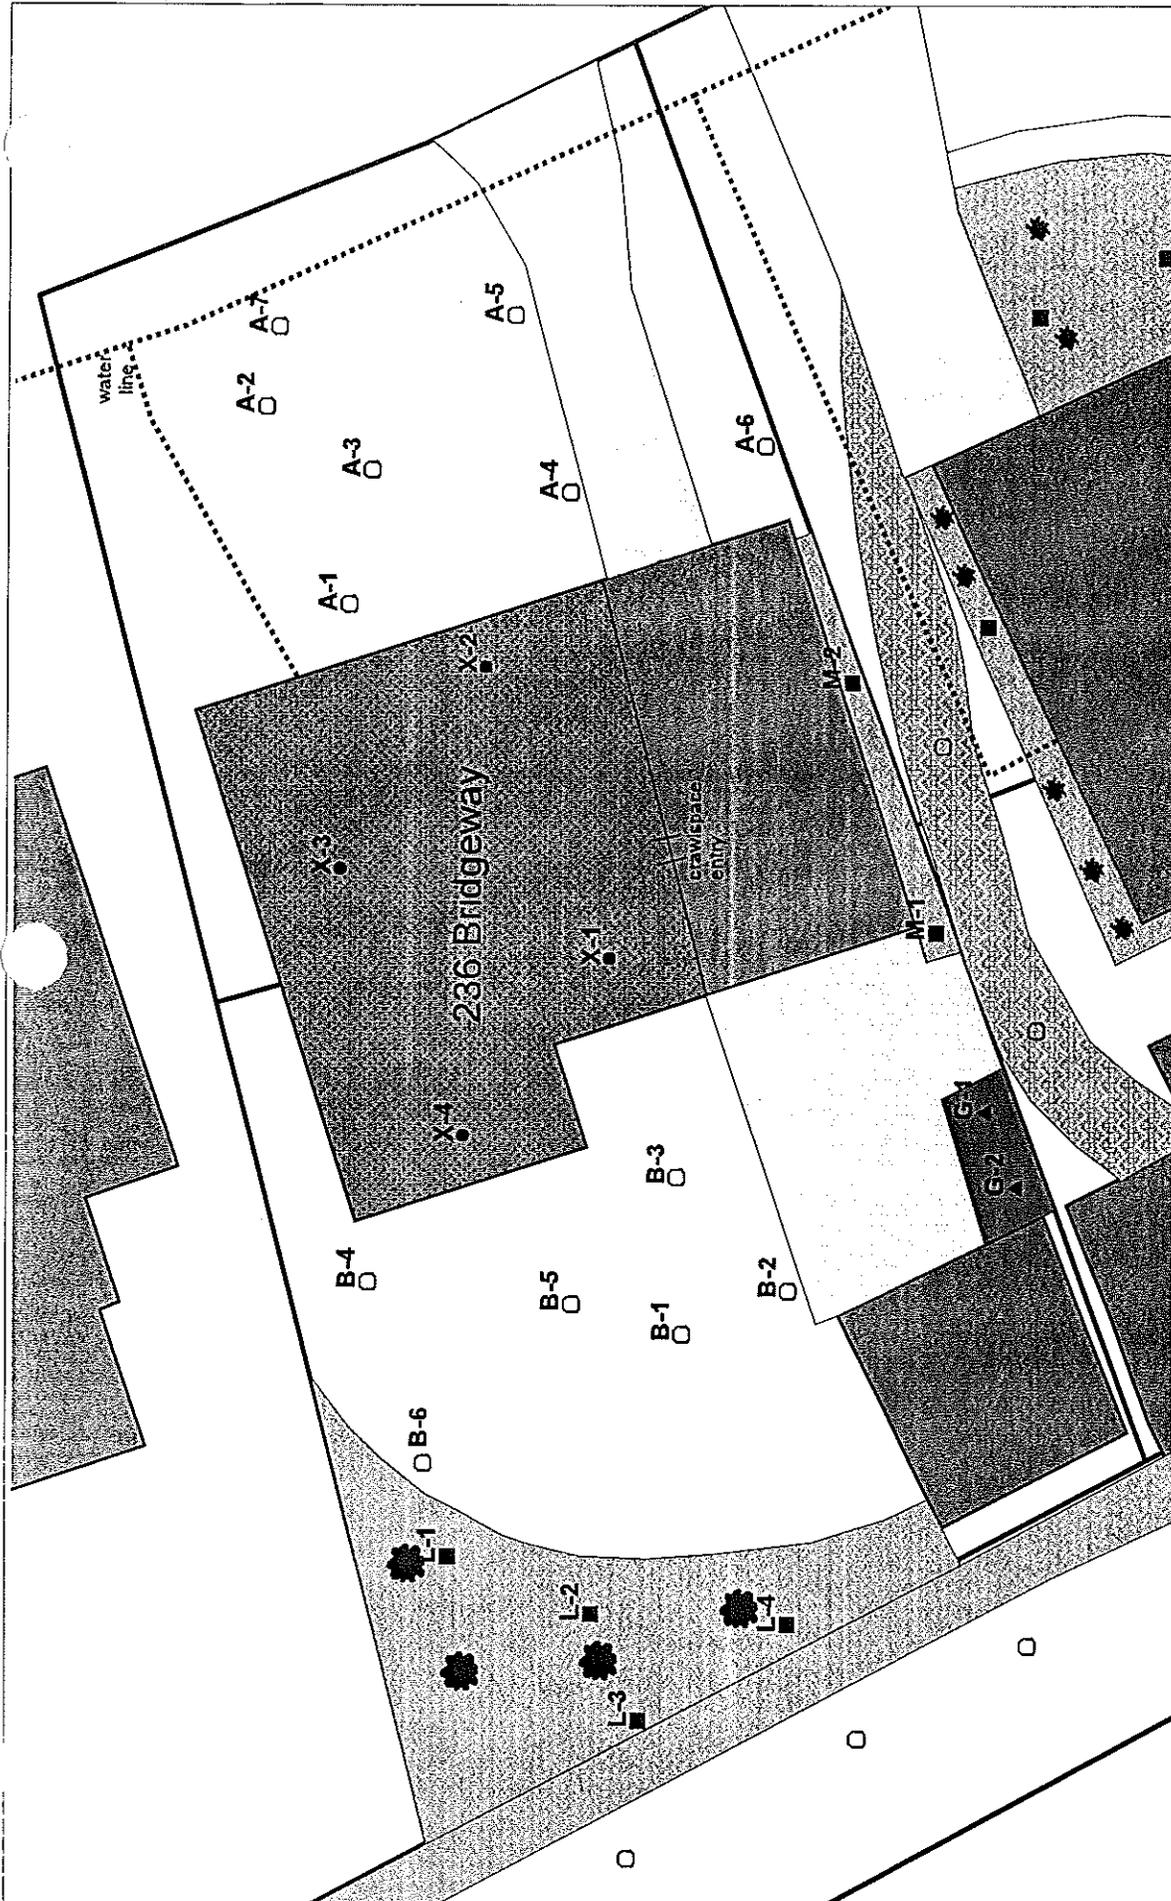
236 Bridgeway

This property was divided by Ecology into two Decision Units, A and B, as shown on the attached map, for purposes of pre-cleanup sampling and decision-making regarding the depth to which excavation was required. The following is a summary of the work done in the remediation of the property within each of the decision units.
