**Professional Engineer's Statement
Everett Smelter Cleanup, 2000-2001**

Washington Department of Ecology Everett Smelter Site 2000-2001 Cleanup

Details of Cleanup Activities

Address:
2830 Medora Way
Everett, WA 98201

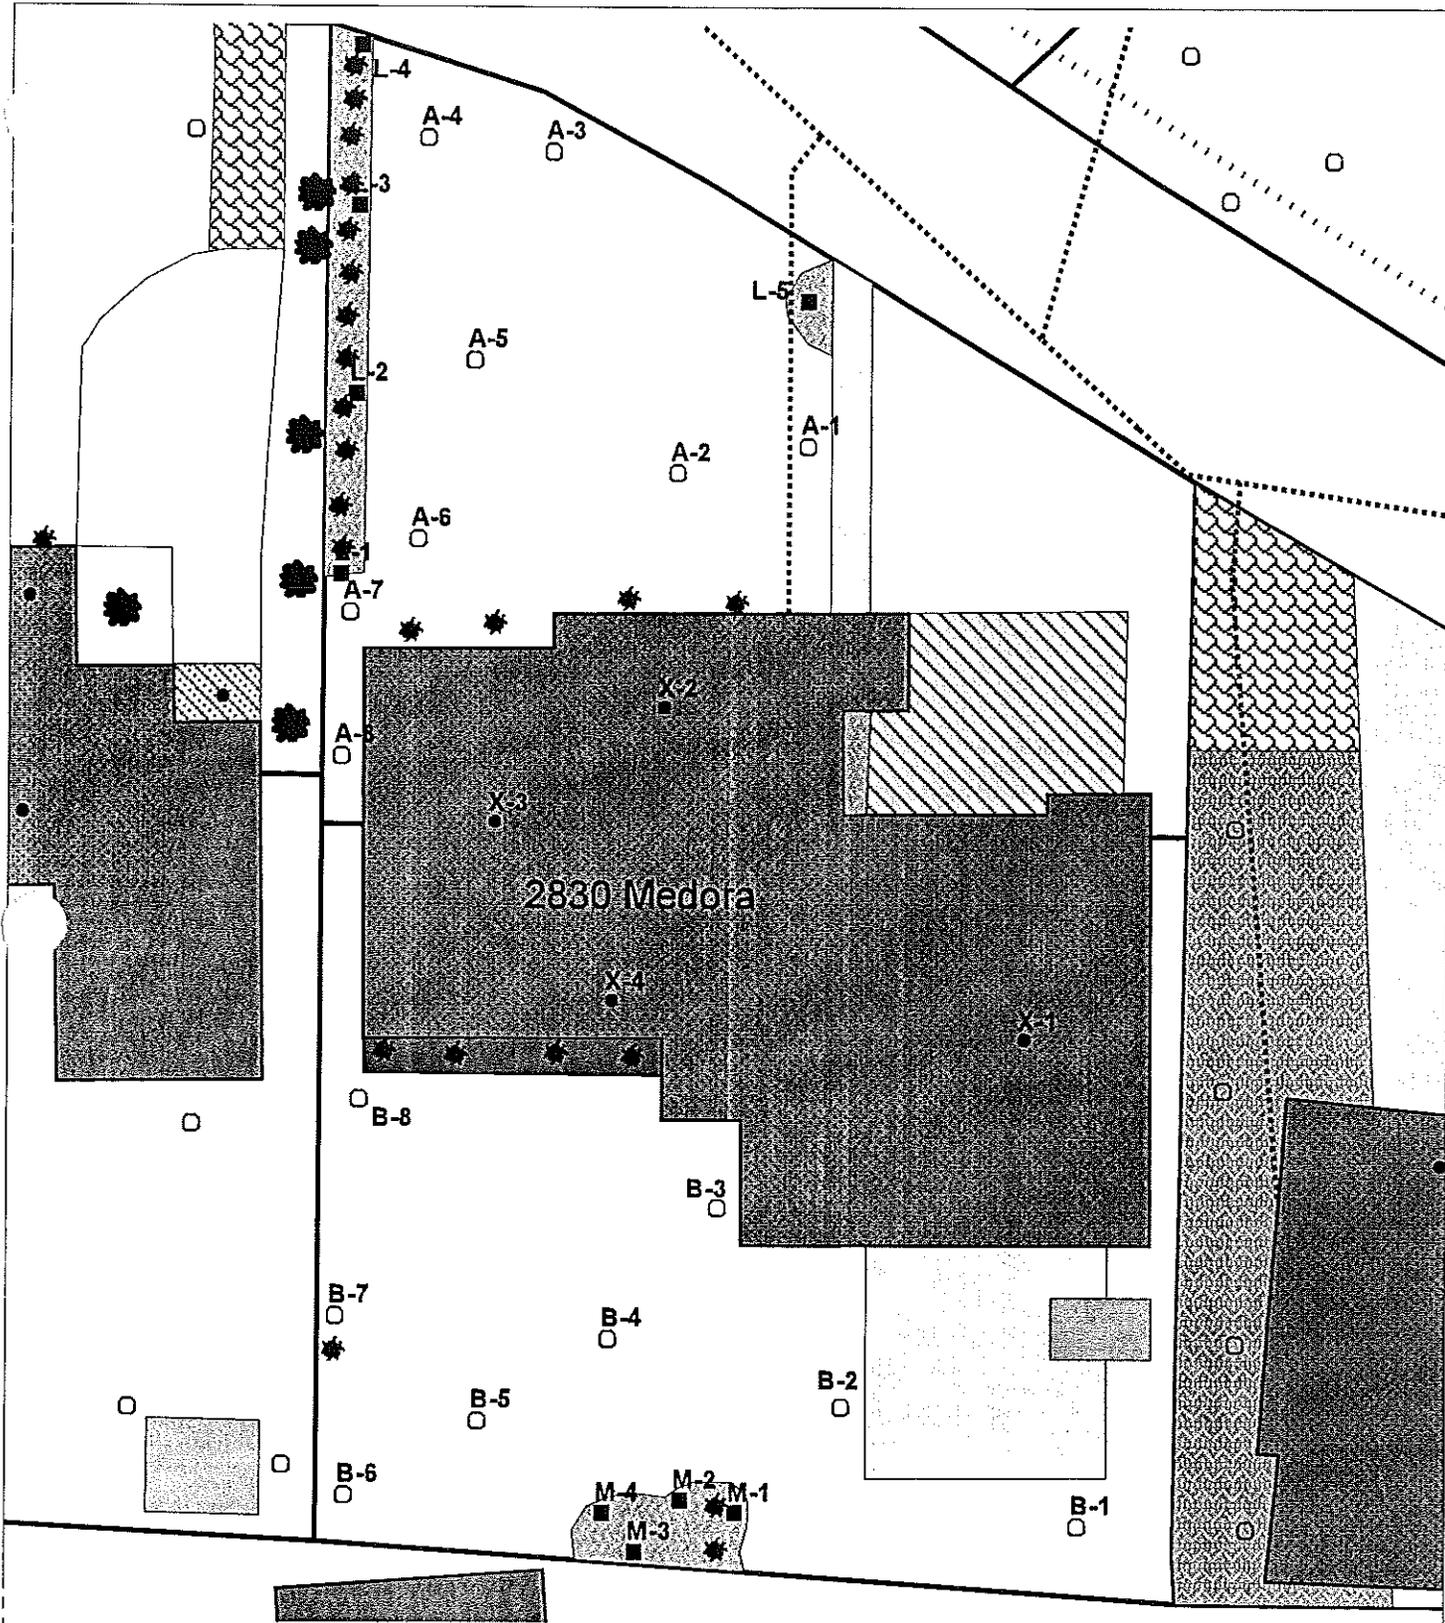
2830 Medora

This property was divided by Ecology into two Decision Units, A and B, as shown on the attached map, for purposes of pre-cleanup sampling and decision-making regarding the depth to which excavation was required. The following is a summary of the work done in the remediation of the property within each of the decision units.
