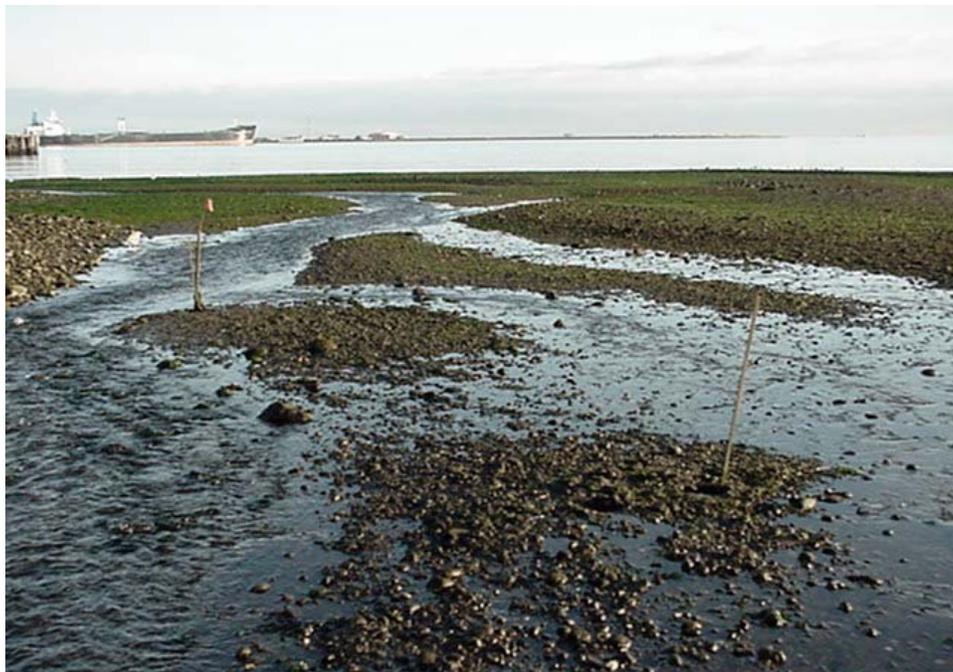
Photograph 1. Mouth of Ennis Creek looking north. Note staked deltaic sample locations.

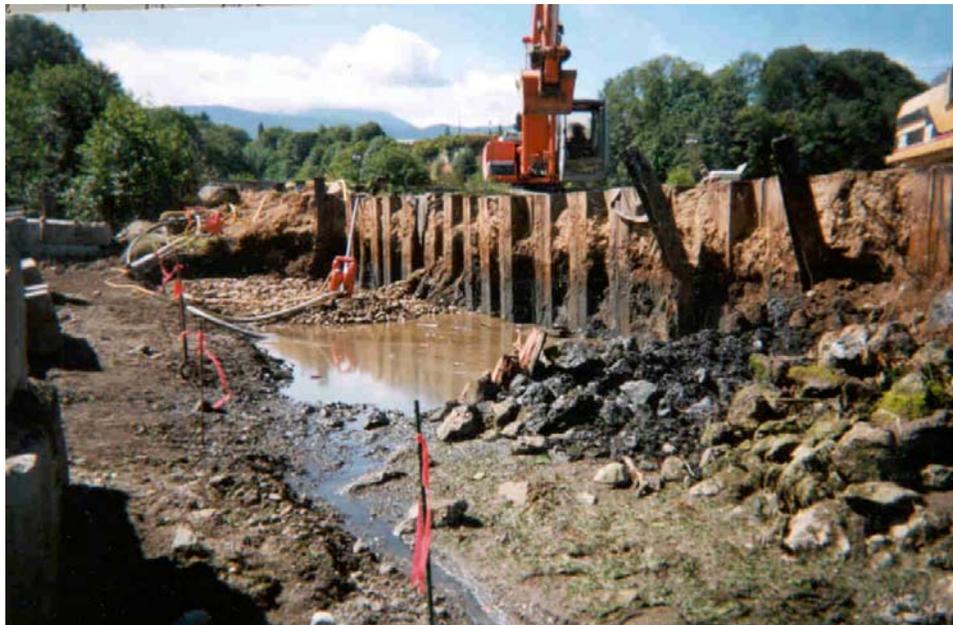
Photograph 2. Excavation of contaminated materials east of sheetpile wall in Ennis Creek. Note the staked flagline marking the eastern extent of excavation along the approximate centerline of Ennis Creek. Also note the rapid recharge of groundwater in local area. Diaphragm pumps sending oily water to a 28,000-gallon oil-water separator.

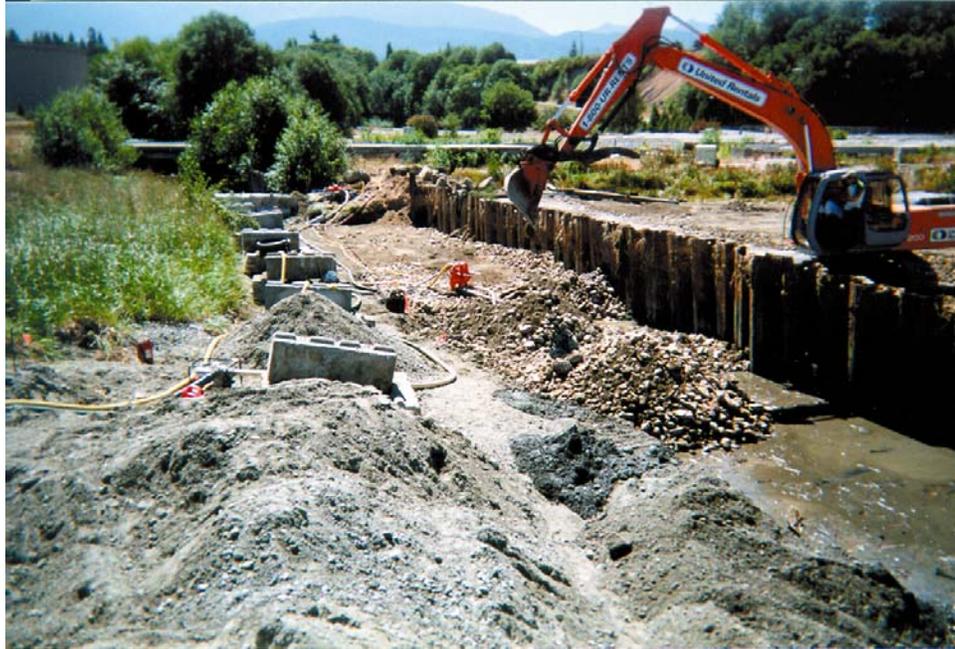
Photograph 3. Excavation continues east of sheetpile wall in Ennis Creek. Note the clean backfill being placed and compacted with excavator bucket following excavation and sampling activities on a daily basis.

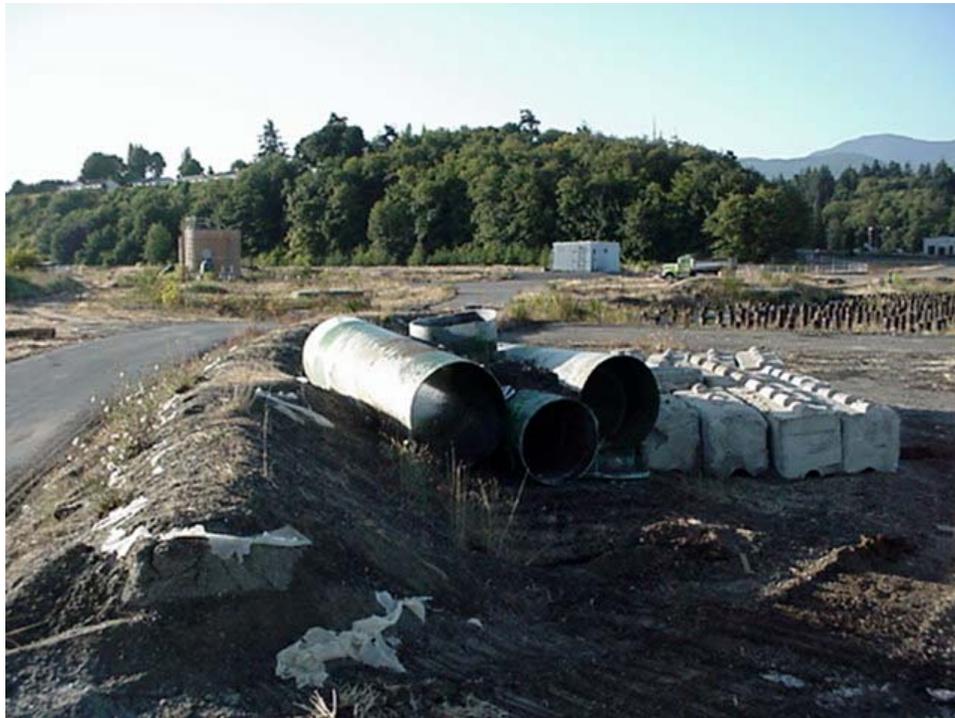
Photograph 4. Cut fiberglass pipes on east side of Ennis Creek. Pipes were cut and capped below grade.

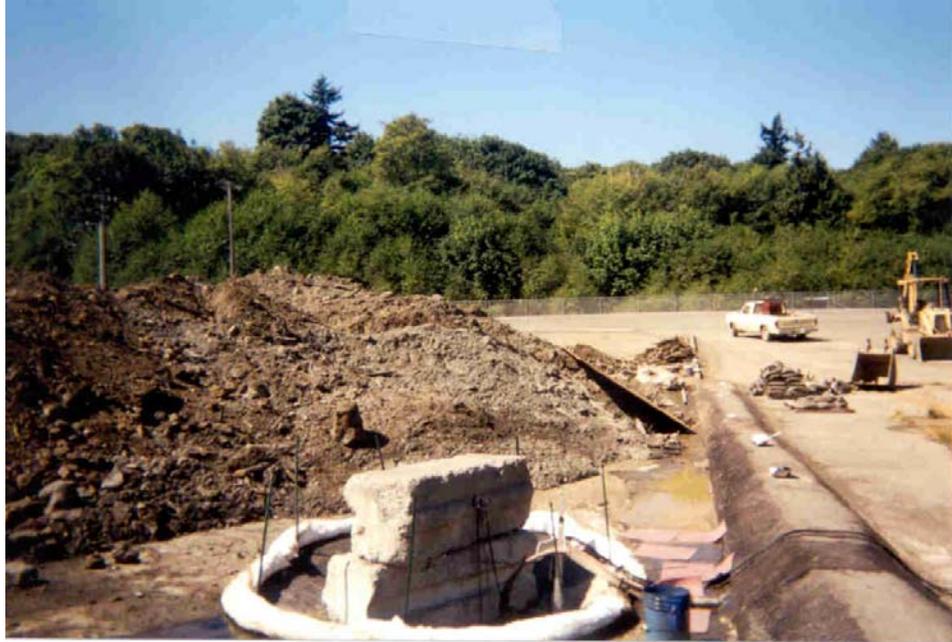
Photograph 5. Stockpile of contaminated material removed from Ennis Creek. The soil containment area is located on the northeast corner of the site.

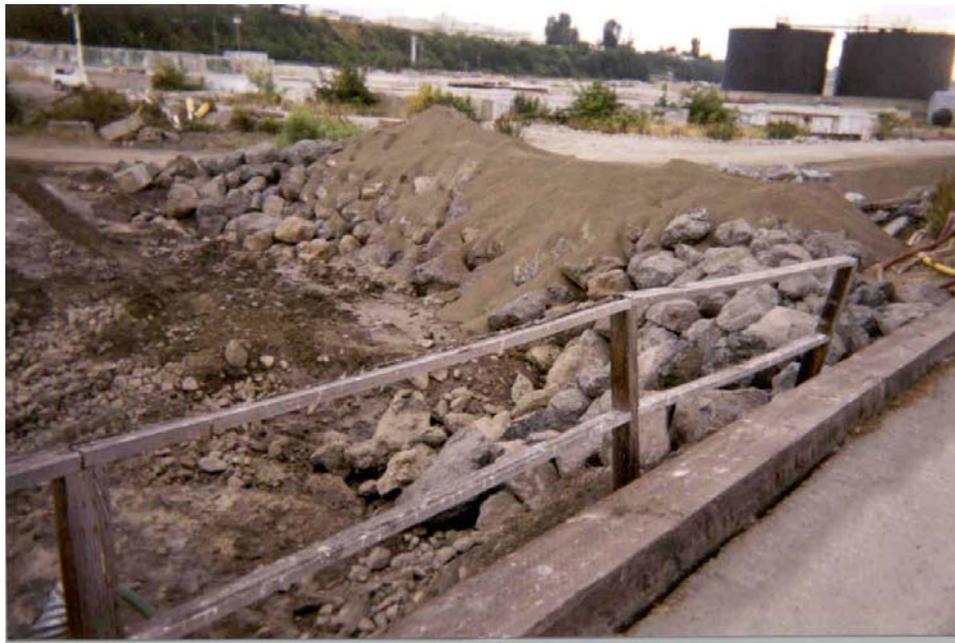
Photograph 6. Riprap armor placed at the northern end of Finishing Room Area. Note clean, well-graded material placed over riprap armor.

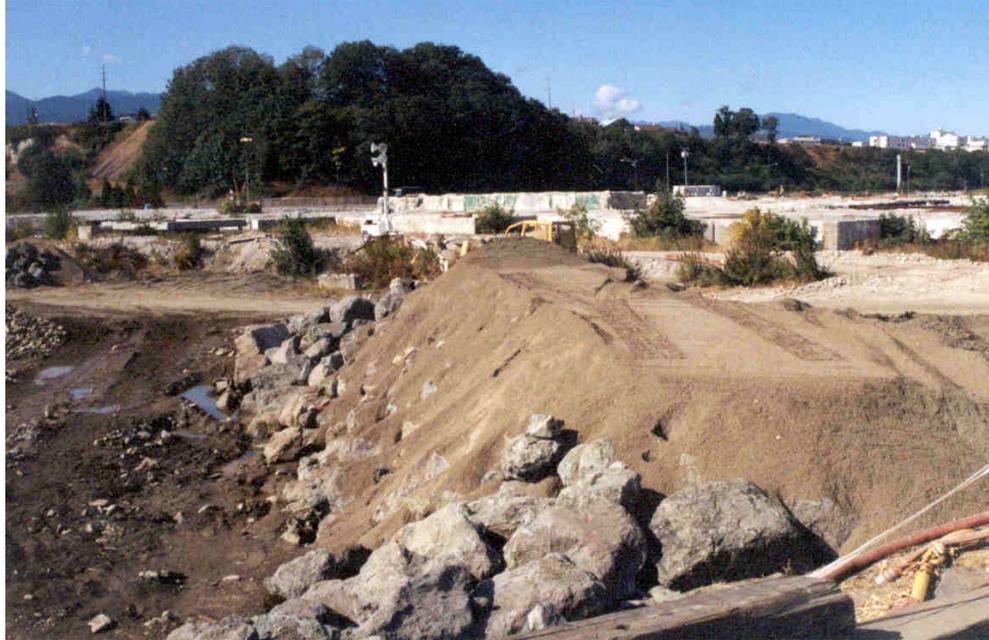
Photograph 7. Material being compacted over riprap armor to berm design height. Note dewatering of Ennis Creek Area continues routing water to oil-water separator to the west.

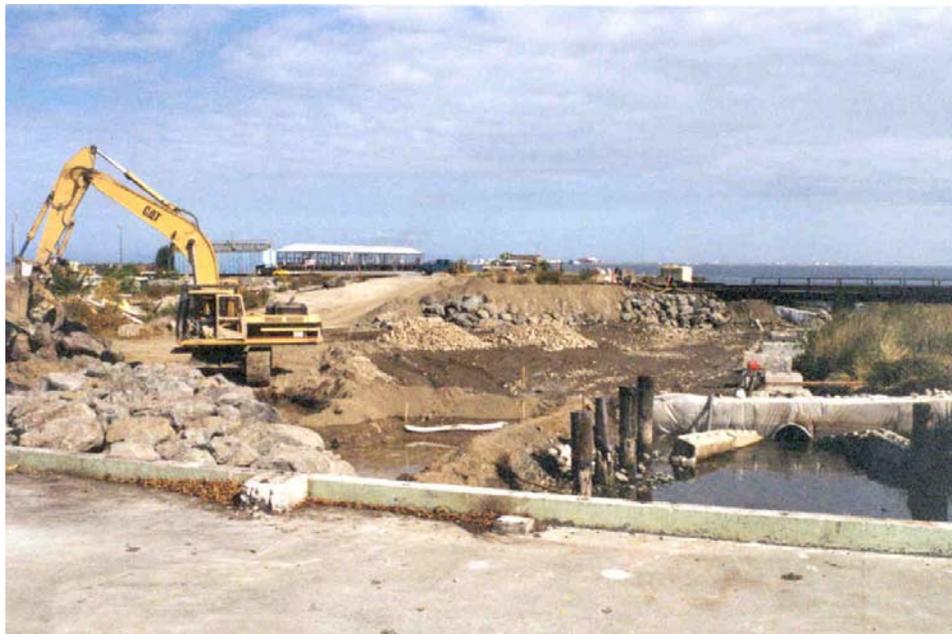
Photograph 8. Berm construction continues (photo looking north). Note headwall to Ennis Creek temporary bypass pipe. Also note 28,000-gallon oil-water separator in background (behind excavator arm).

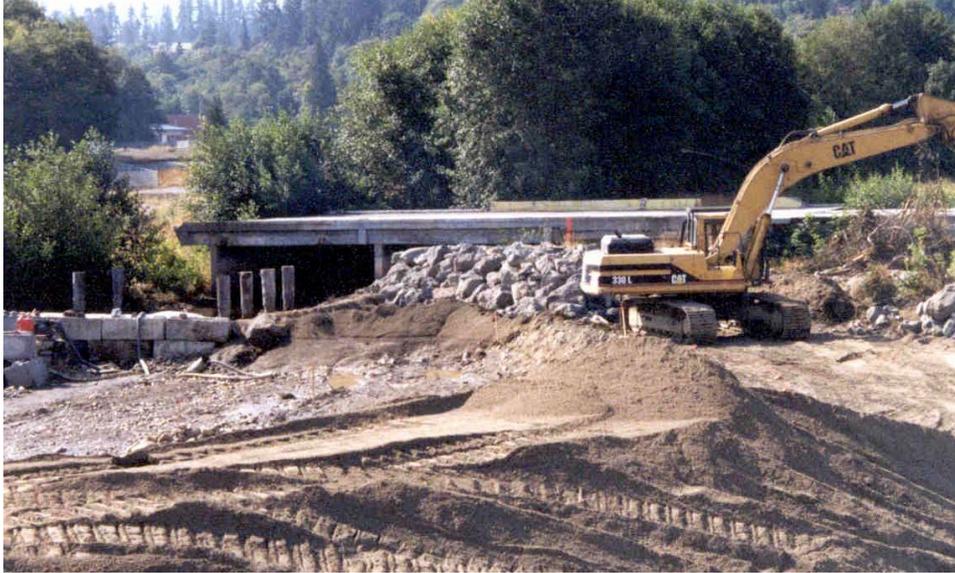
Photograph 9. Finishing Room Area looking south. Berm construction continues.

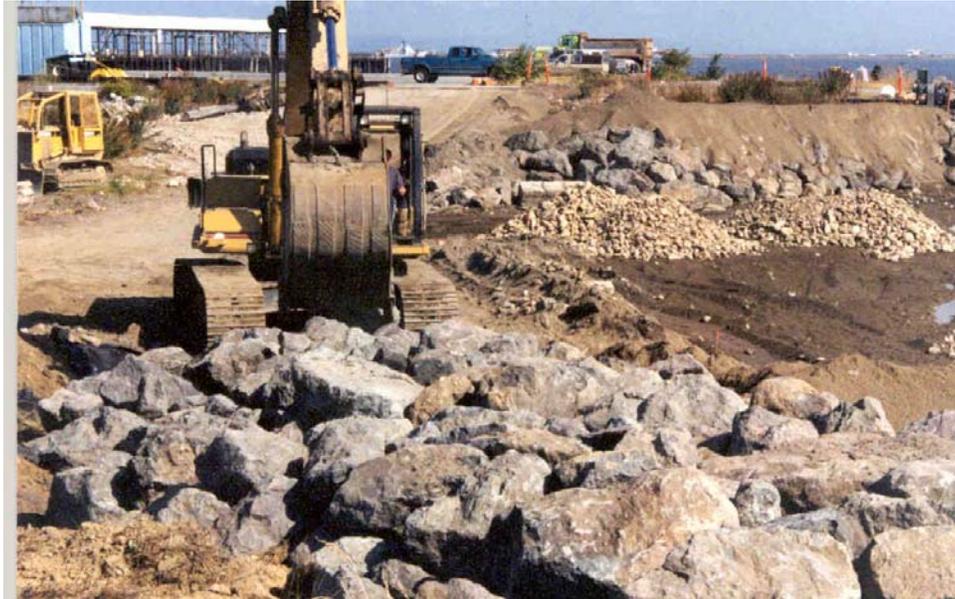
Photograph 10. Top of riprap armor being bucket-tamped prior to placement of overlying material.

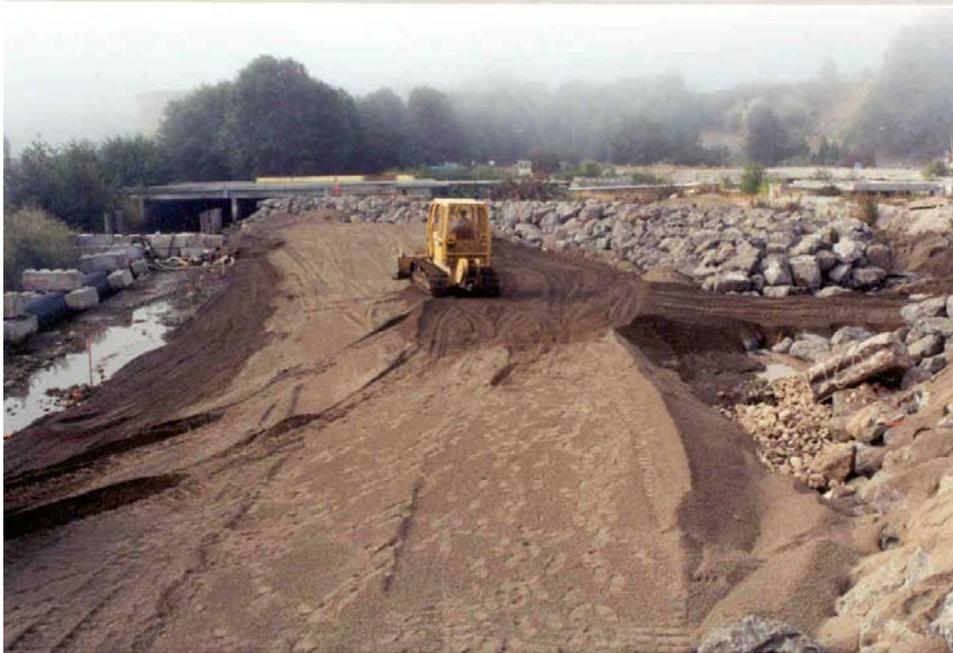
Photograph 11. Ennis Creek inundation area being compacted, smoothed, and graded at a slope of 6H:1V.

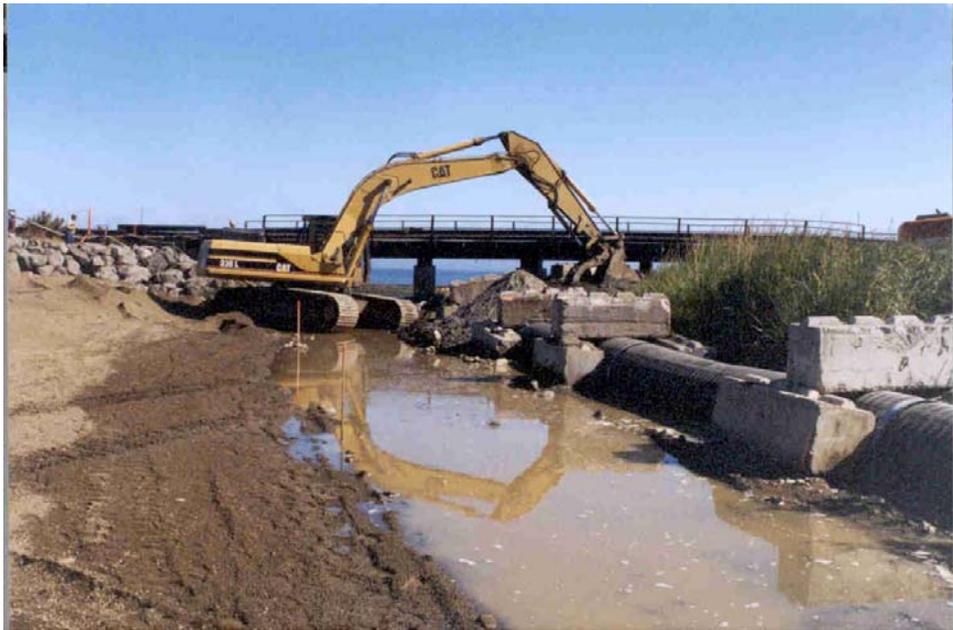
Photograph 12. Removal of temporary creek bypass pipe near endwall.

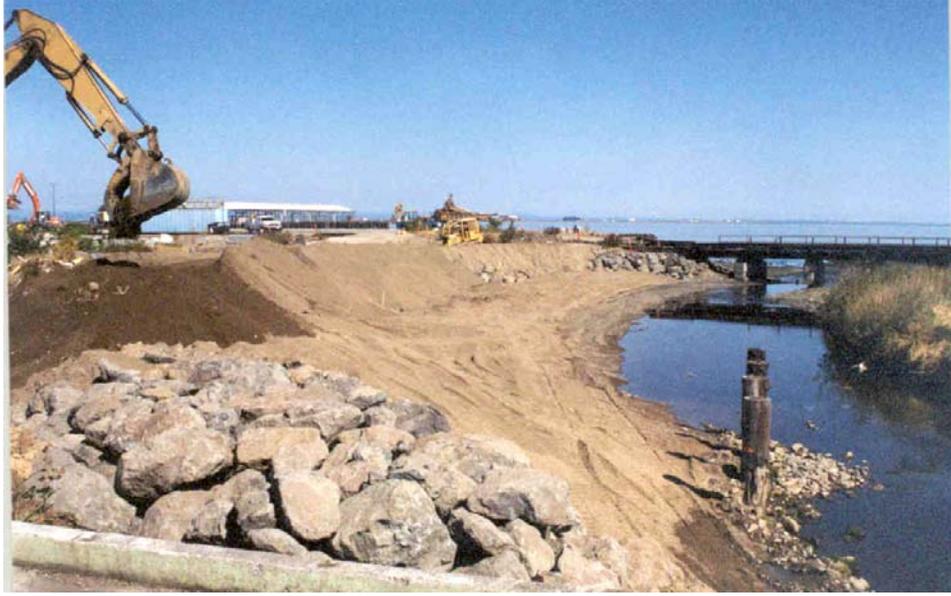
Photograph 13. Ennis Creek following removal of temporary bypass system.

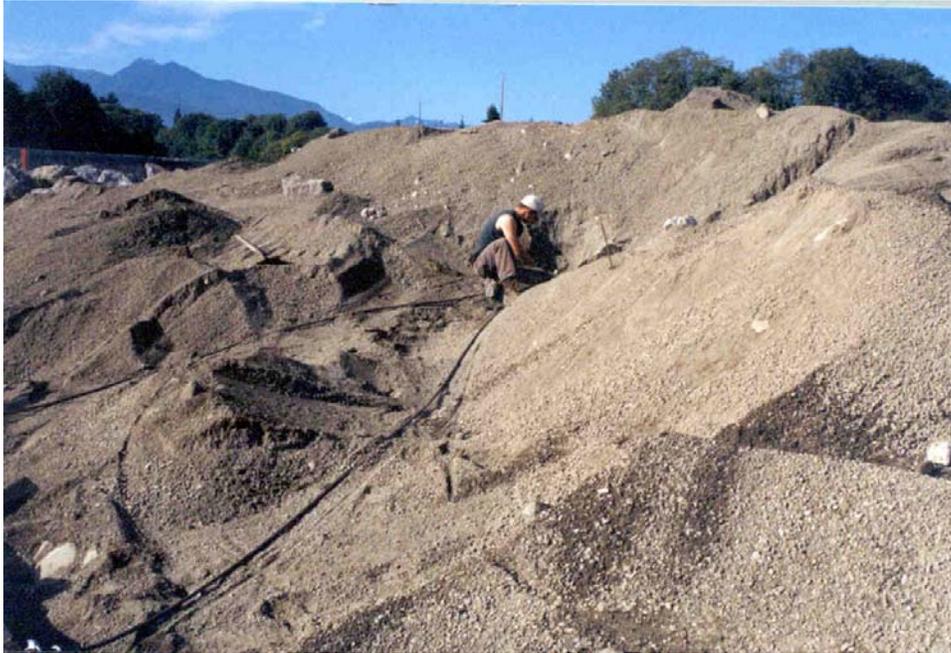
Photograph 14. Logs with root wads (shown in next photo) being anchored to Ecology Blocks, which have been embedded in riprap armor

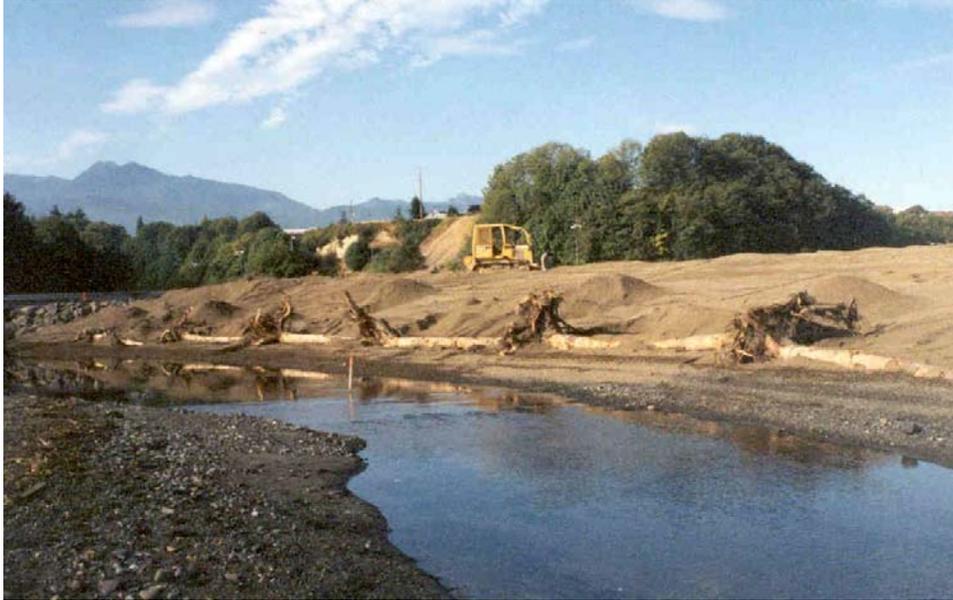
Photograph 15. Logs with root-wads anchored in place just below Mean Higher High Water (MHHW).

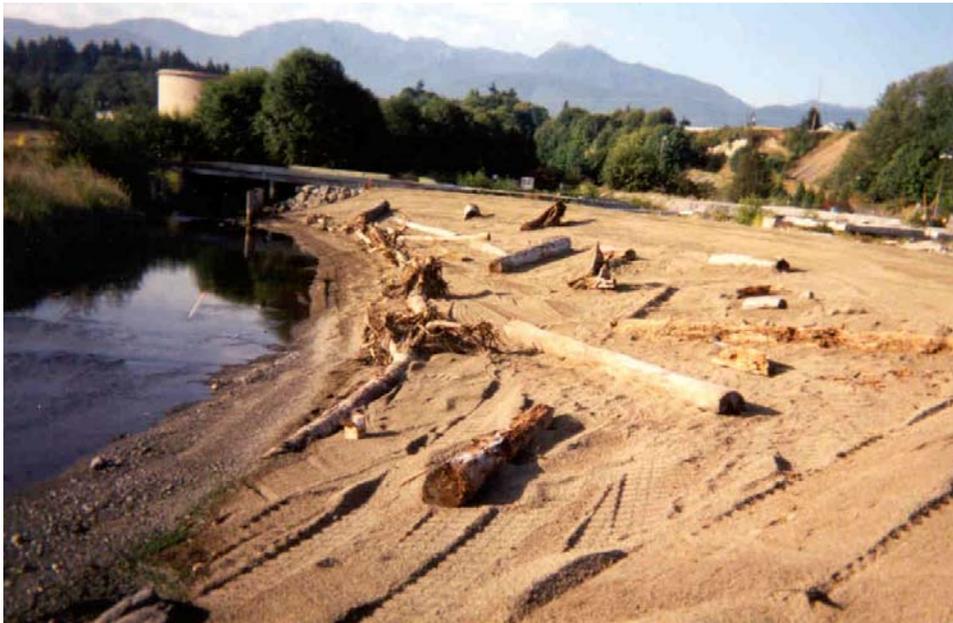
Photograph 16. Ennis Creek inundation area near completion. Note other woody structure placed between MHHW and the berm design elevation.

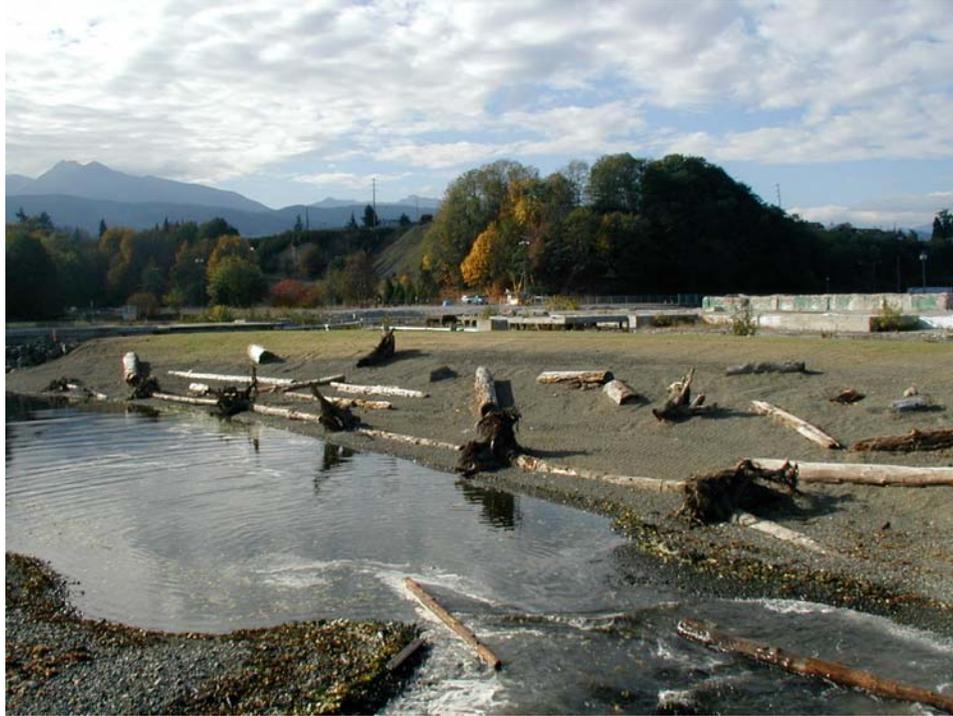
Photograph 17. Ennis Creek and inundation area looking south-southwest. Photo taken in November 2002 – two months after completion of Interim Actions on the Former Rayonier Mill Site.

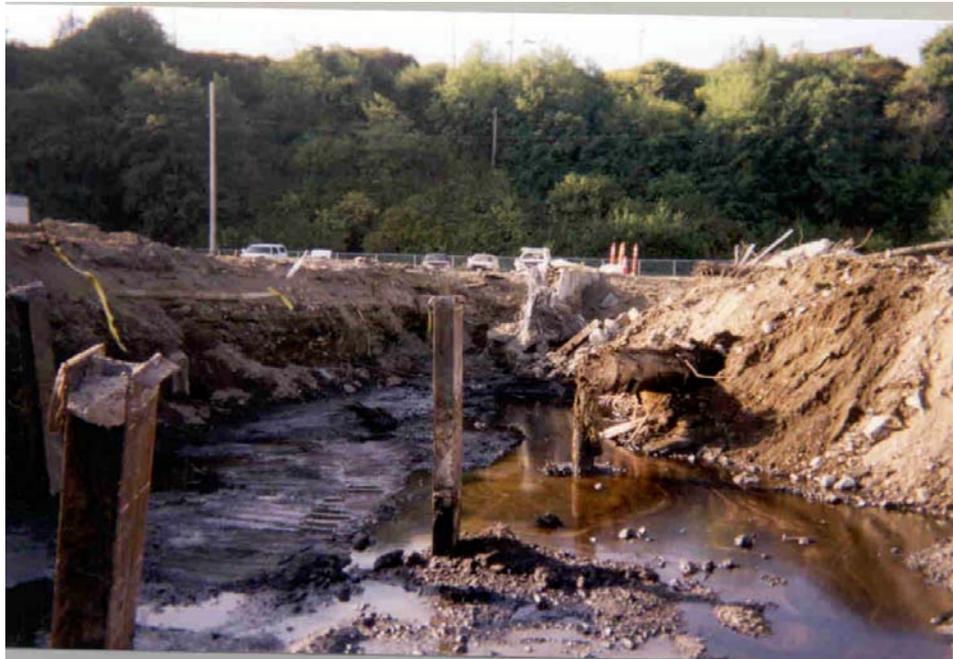
Photograph 18. Excavation of contaminated material from the former Fuel Oil Tank Number 2 (FOT2) Area. Photo looking south towards the former tank “footprint”.

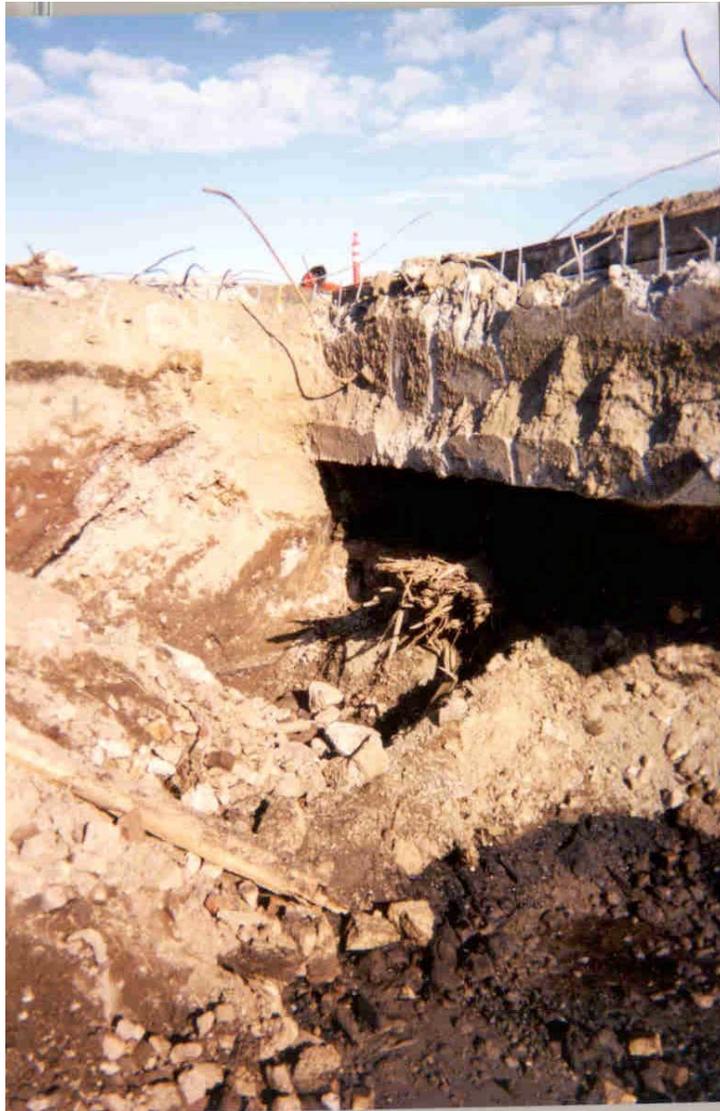
Photograph 19. Excavation under the southwest end of the former Autoshop, located just north-northeast of the former tank “footprint”.

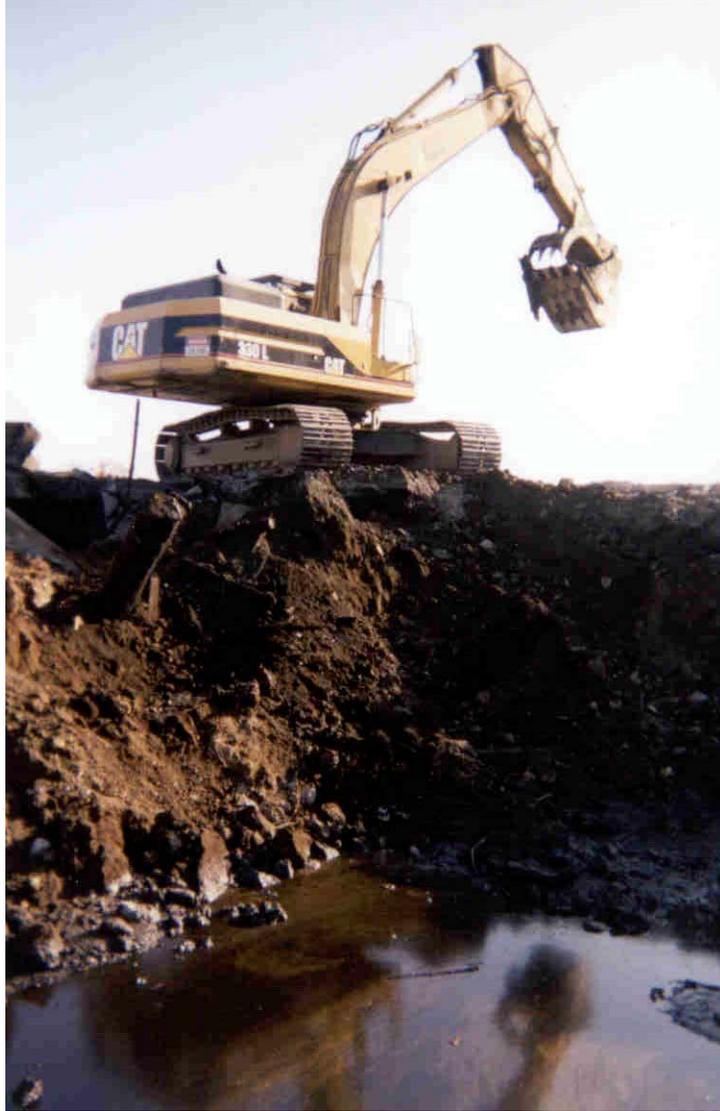
Photograph 20. Excavation of contaminated material from the FOT2 Area near the completed Hog Fuel Area Excavation. Photo looking west.

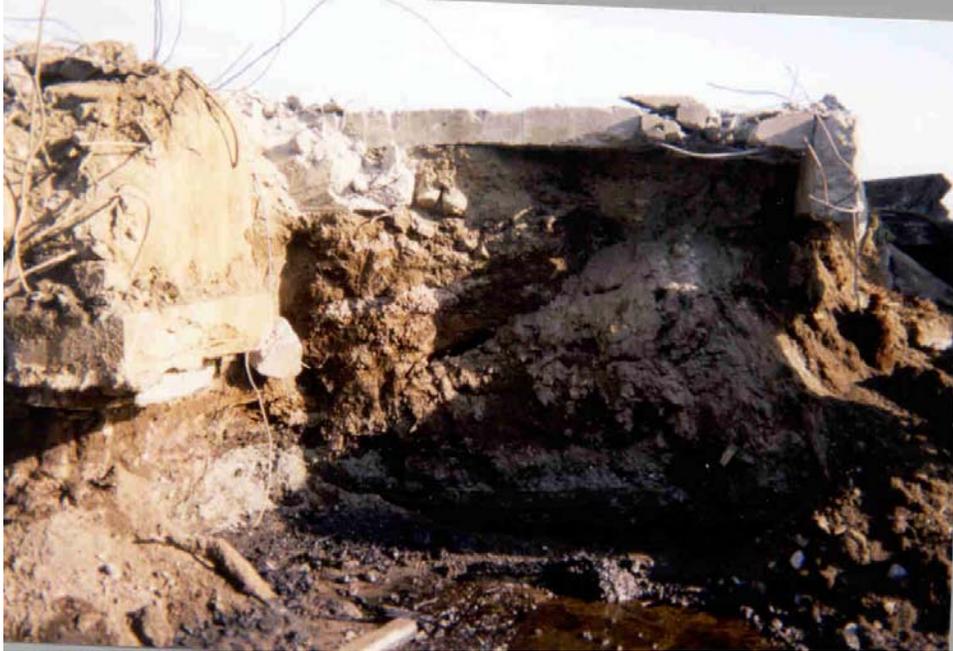
Photograph 21. Concrete broken back from south end of former Autoshop to continue excavation of an oily seam running southwest to northeast. Photo facing north, taken just east of Photograph 19.

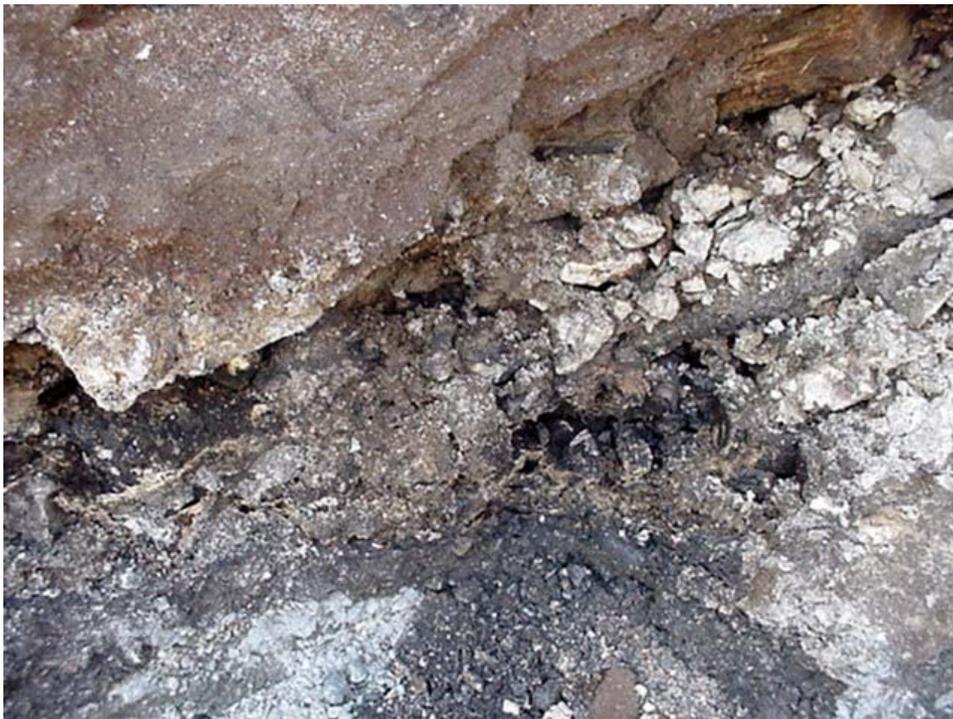
Photograph 22. Oily seam running southwest to northeast under the southeast corner of the former Autoshop.

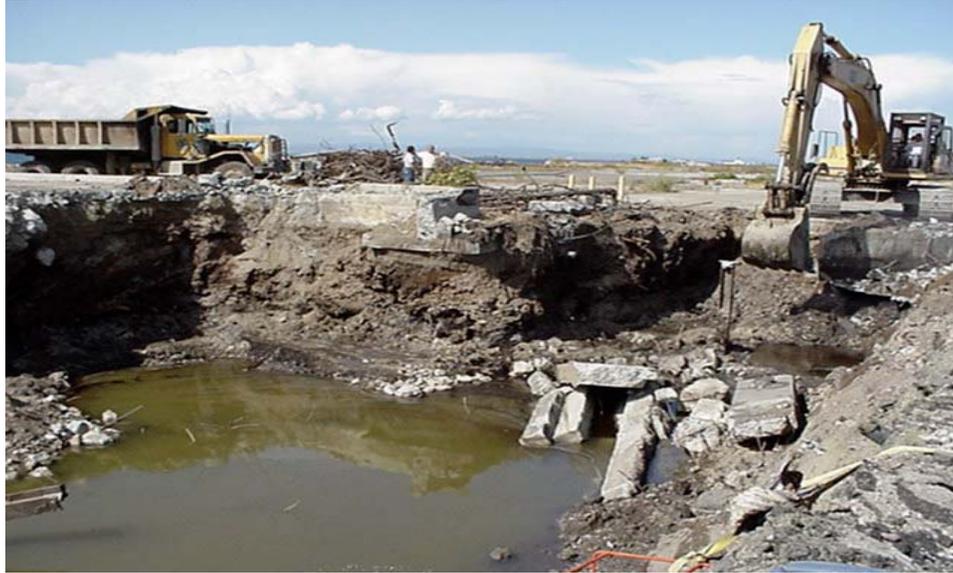
Photograph 23. View of the north end of the FOT2 excavation area. Excavator working just west of an old utility corridor that ran through this portion of the site. Note concrete broken back towards the west from the former Autoshop to remove oily seam.

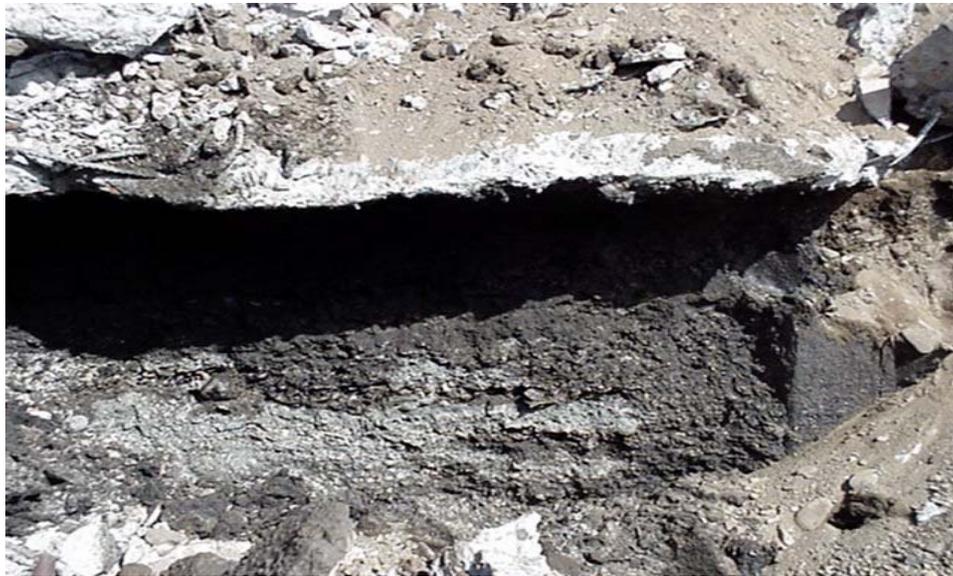
Photograph 24. Sample Location FOT-0086 collected directly under the old utility corridor (approximately 3.0-3.5 feet above groundwater) at this location on the north end of the FOT2 excavation area. Note that sample FOT-0087 was collected just above groundwater at this same location and reports results well below the cleanup level criteria.

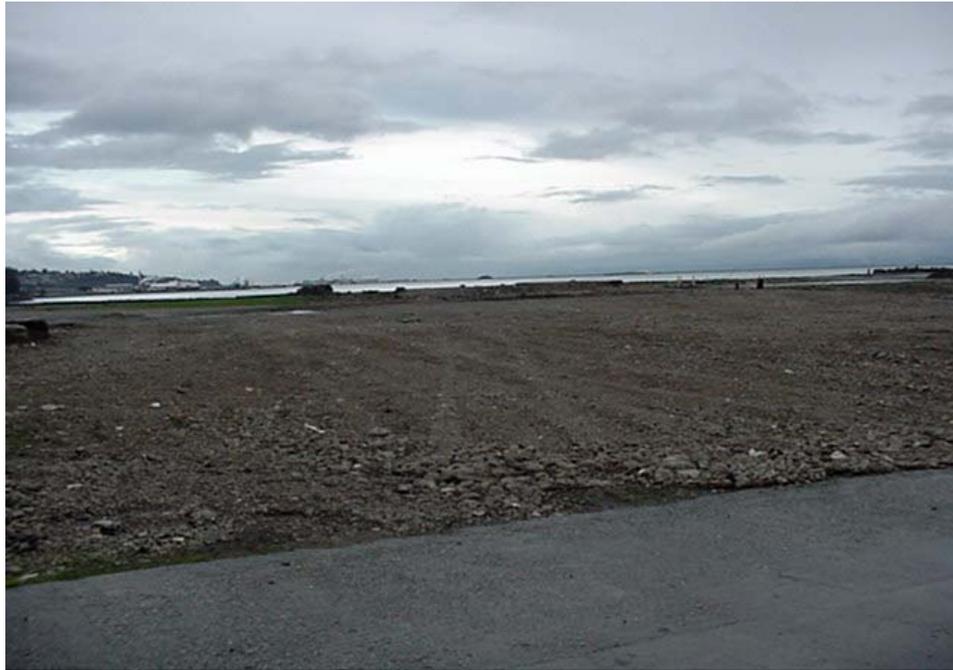
Photograph 25. View of the completed FOT2 excavation looking west. Photo taken from the east side of the former Hog Fuel excavation.

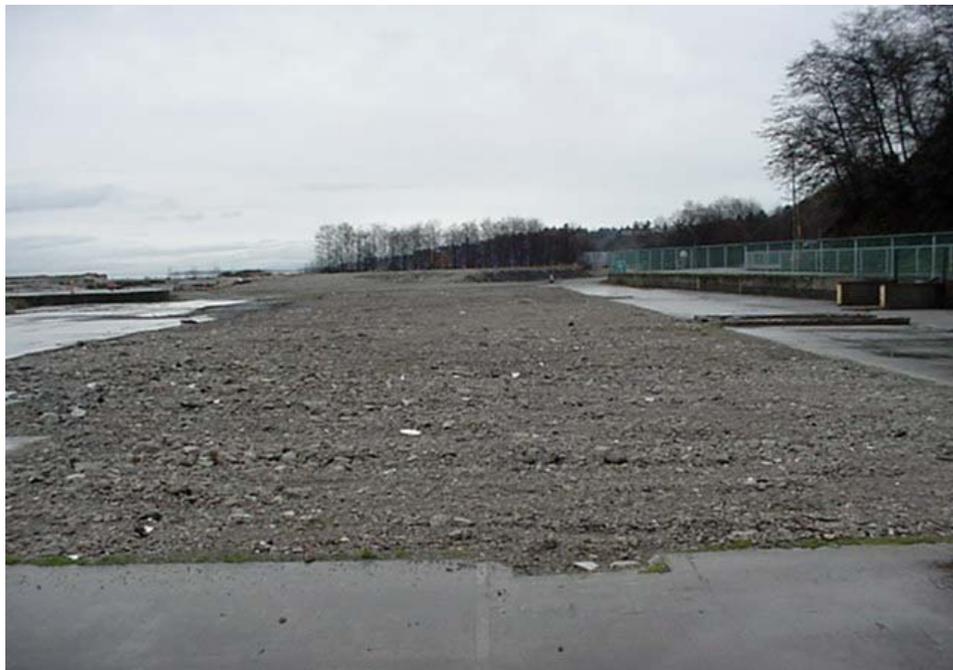
Photograph 26. View of the completed Machine Shop excavation. Photo looking east.
