Re: Washington State Department of Ecology (Ecology) Assessment Report for Field Monitoring Activities conducted November 12, 2012 of the waste material near Riser 83 of the 241-AY-102 Double Shell Tank (DST)

ASSESSMENT REPORT

Project: 241-AY-102 Field Monitoring, Riser 83 Video

Location: 241-AY-102, 200 East Area, Hanford

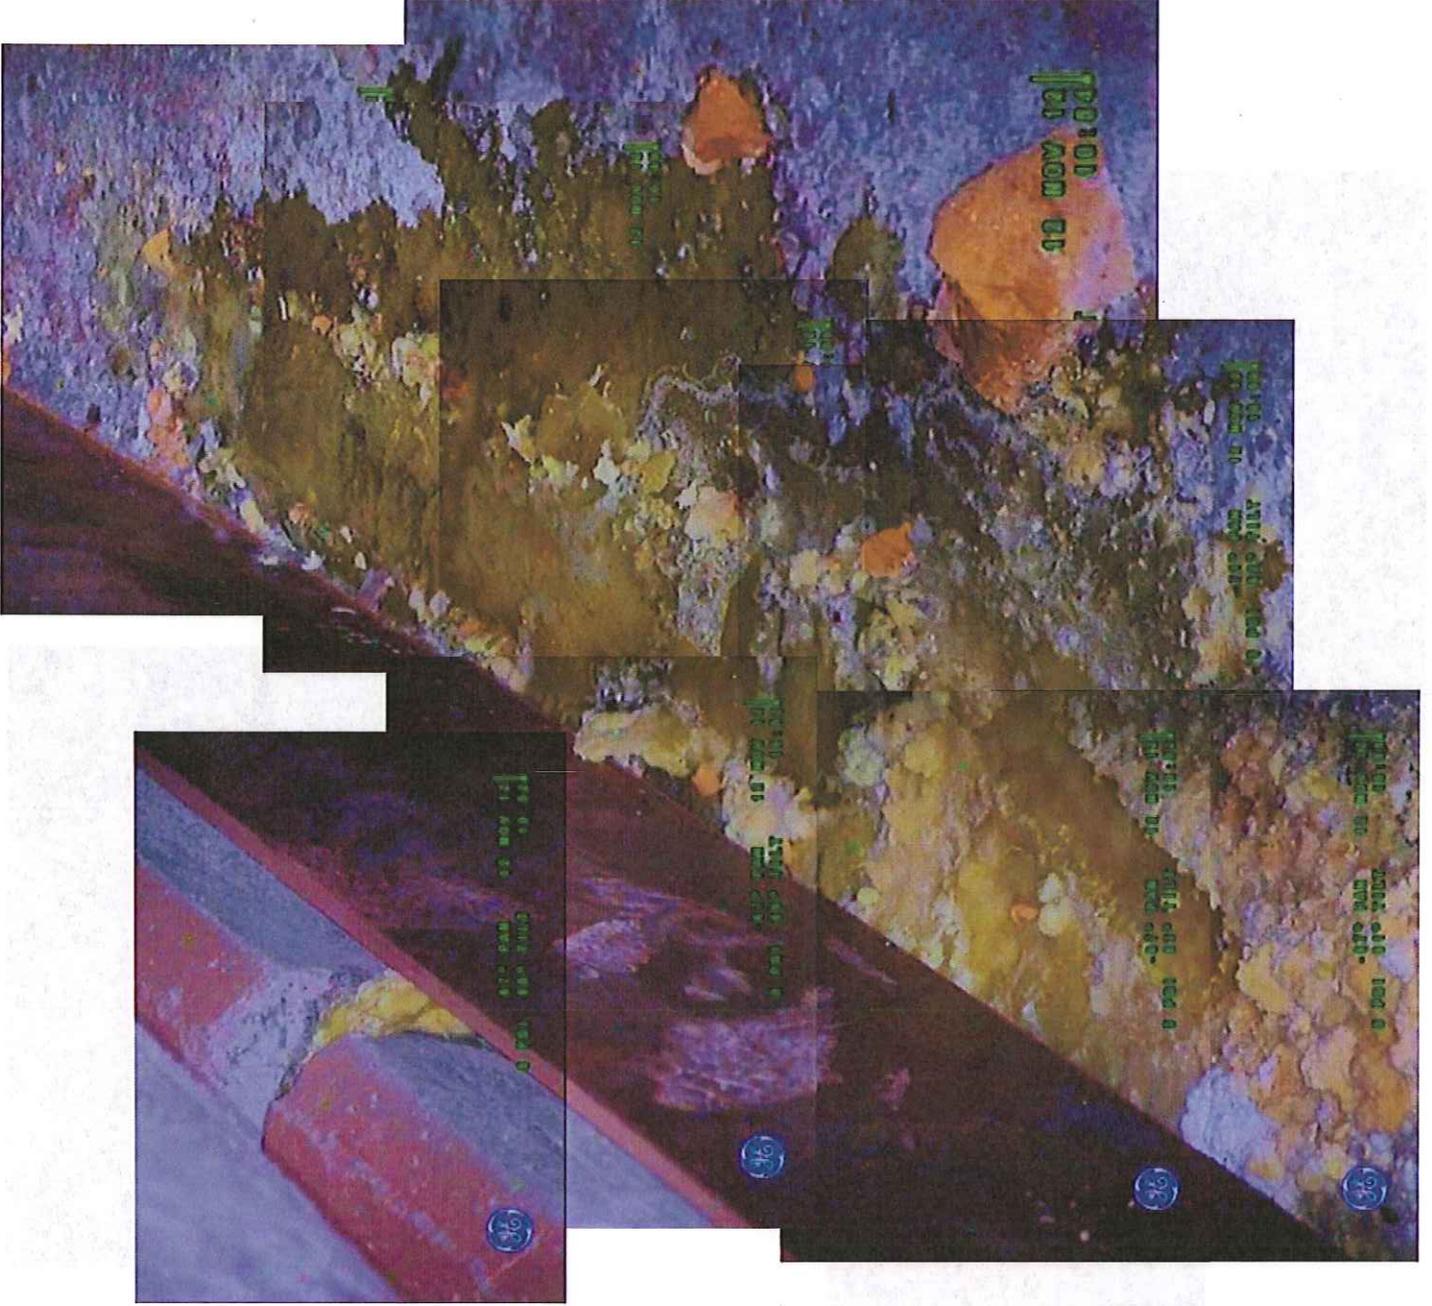
11/12/2012

- The extent of the area of the waste material with respect to the annulus “landmarks” (orange foam pieces, black pebble, the ventilation slot, etc.) appeared to slightly grow as compared to the amount of material viewed during the visual inspection conducted 10/18/12 and 10/25/12.

- The moisture streaks on either side of the waste within the ventilation slot near Riser 83 once again appeared to be wet, indicating that the slow leak is still present and has not “self-healed”.

- An increased amount of white mineralization on the outside perimeter of the waste material within the annulus space.
- The waste material near the 6-inch refractory/connector ring had turned color from yellow to white. The size or height of the white waste material appeared to “grow” or crystalize. This increase in waste height, in turn created the appearance of “deeper” waste pools and finger channeling of the green and darker yellow colored waste.
