Re: Washington State Department of Ecology (Ecology) Assessment Report for Field Monitoring Activities Conducted December 27, 2012, of the Waste Material Near Riser 83 of the 241-AY-102 Double Shell Tank (DST)

ASSESSMENT REPORT

Field Monitoring Activities

Project: 241-AY-102 Field Monitoring, Riser 83 Video

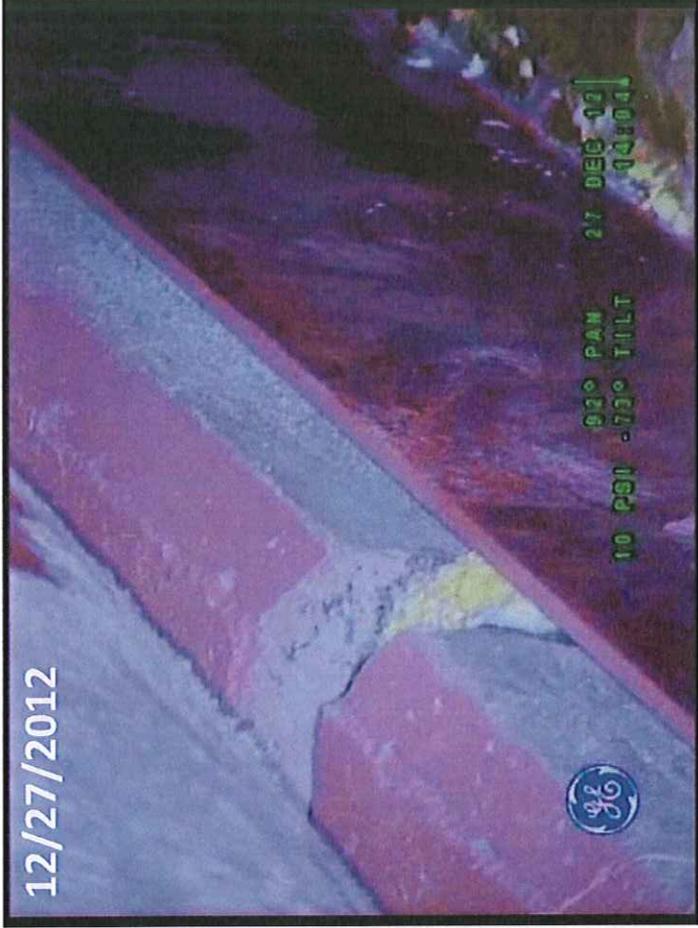
12/27/2012

- Ecology noted that the waste material in the ventilation slot appeared to be wider and thicker, especially on the base near the 6 1/2 inch ring. The top of the material appeared to have dried where it contacted the concrete. However, moisture streaks on either side of the waste material within the ventilation slot were again visible.

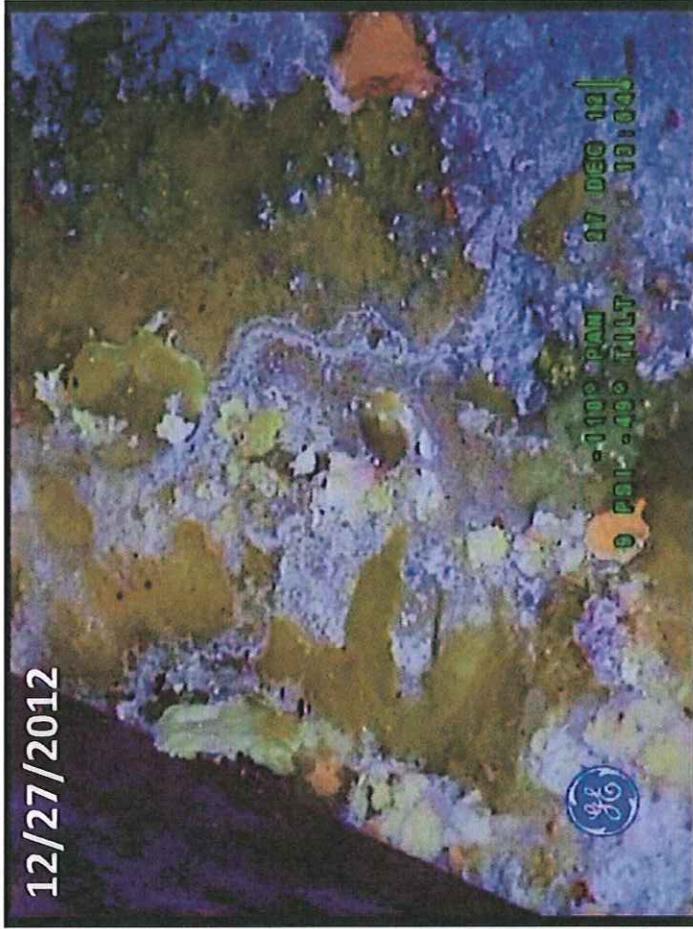
12/27/2012

- Ecology also noted that the waste material the finger channels of the waste or pools of waste (that are dark green, light green, and yellow) appear to look deeper, extend in length, and had split to flow toward another direction creating an additional finger channel.
