BULK CARRIER WEB FRAME DAMAGE

M/V CAPETAN LETERIS, IMO #: 8309414

February 4, 1999

At Todd Shipyard, Seattle, Washington

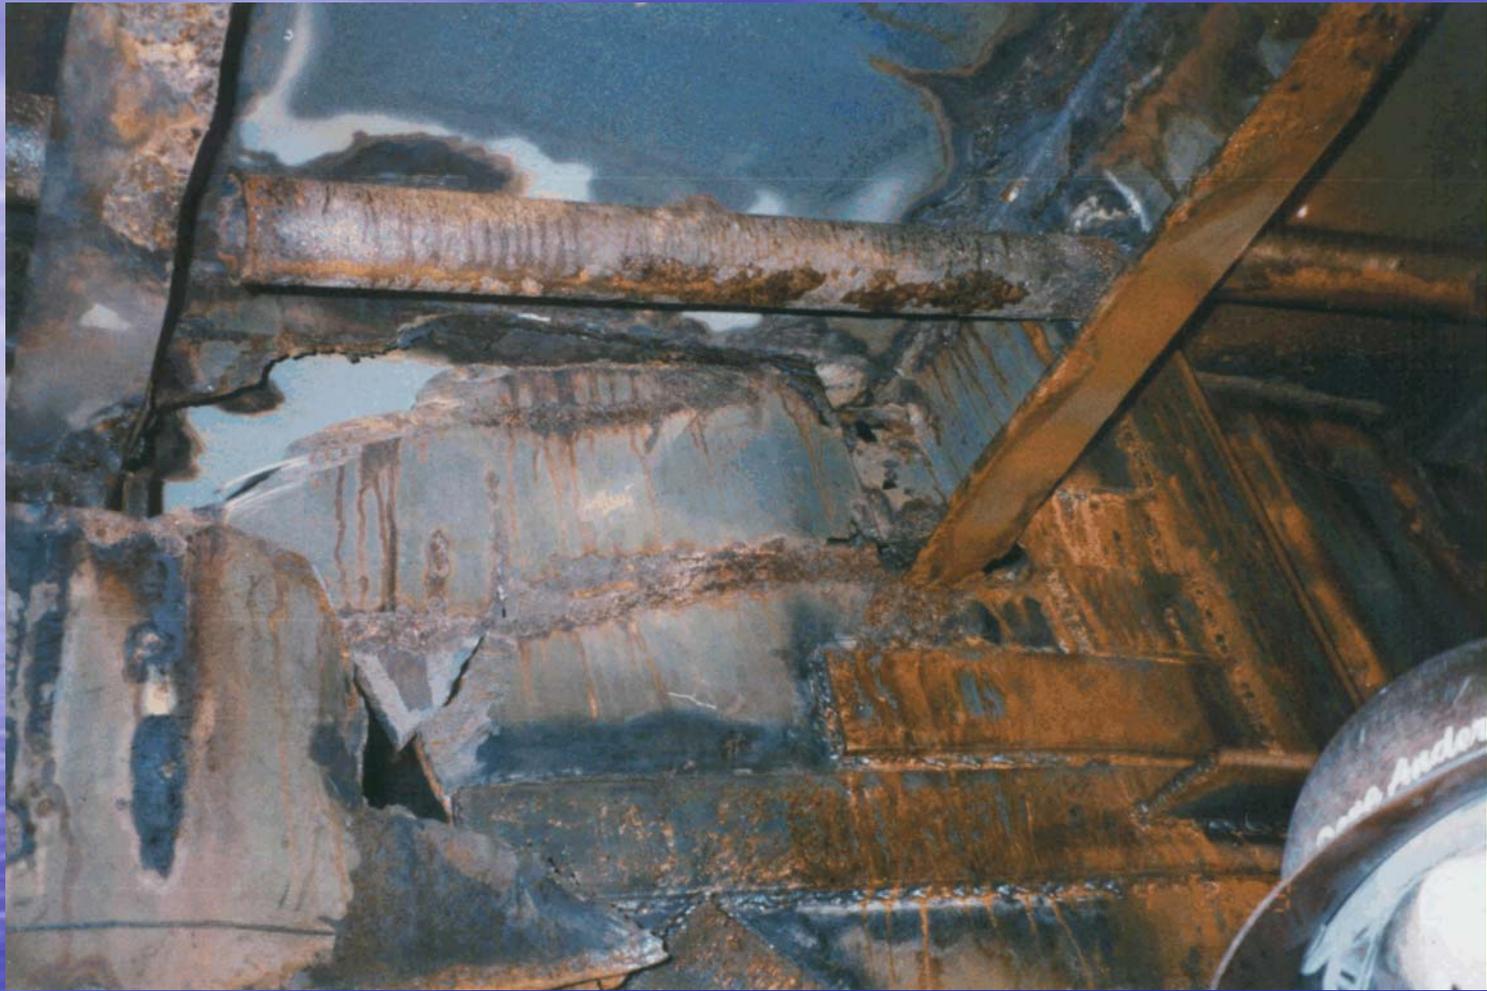
**Interior of #3 Port Wing Tank looking forward.
View of transverse web frame, underside of
deck plating, and deck longitudinals.**

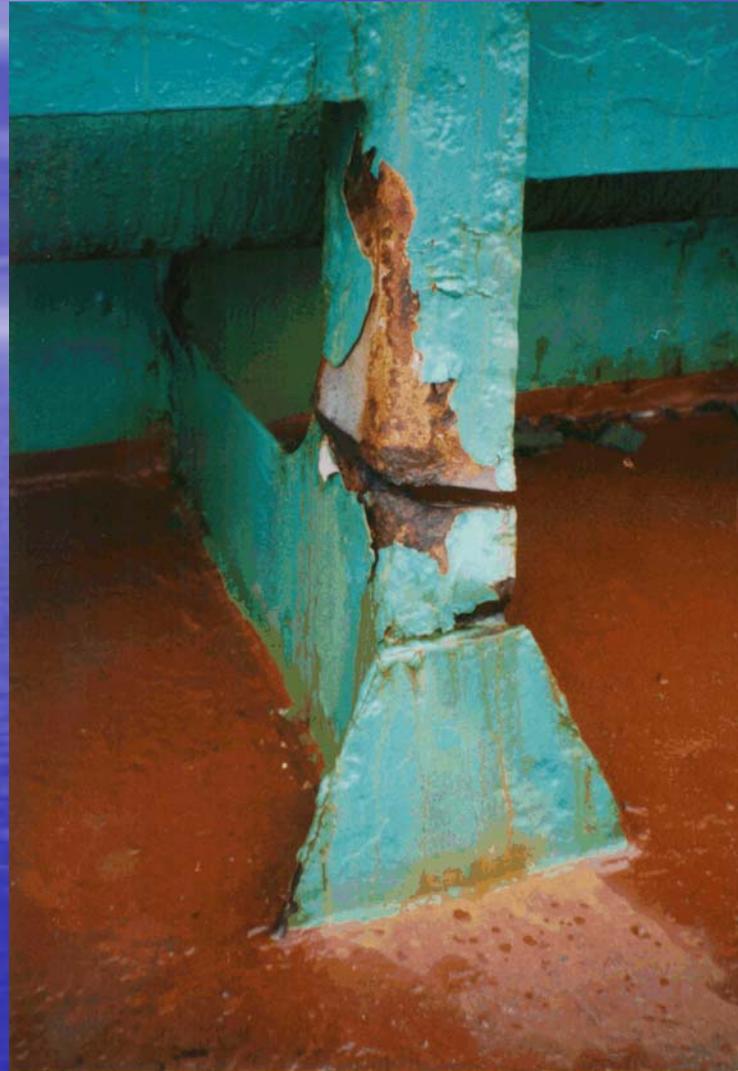
Port side Hold #3 hatch side bracket.

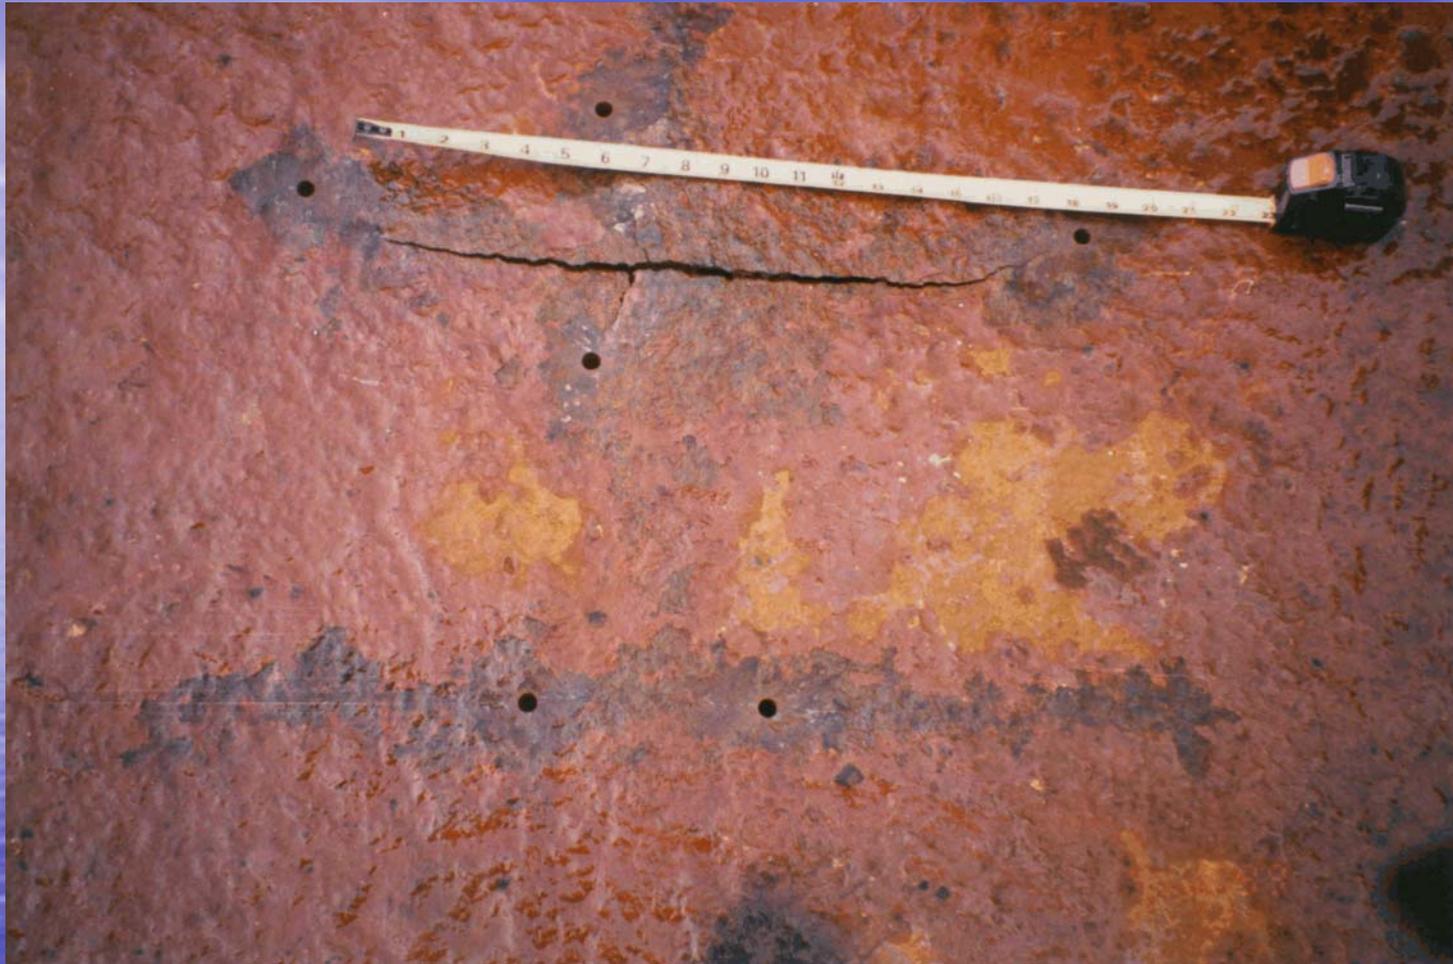
First of three port side deck plate fractures adjacent to Hold #3.

- **Upon inspection, the #3 hold hatch coaming showed significant damage. There were numerous hatch coaming brackets on the port side of #3 hold that were cracked and that had temporary repair braces welded on them. There were three distinct deck fractures of approximately twelve inches in length and 1/8 inch wide located above three transverse web frames on the main deck on the port side of #3 hold. The damaged deck area is immediately above #3 Port Ballast Wing Tank.**

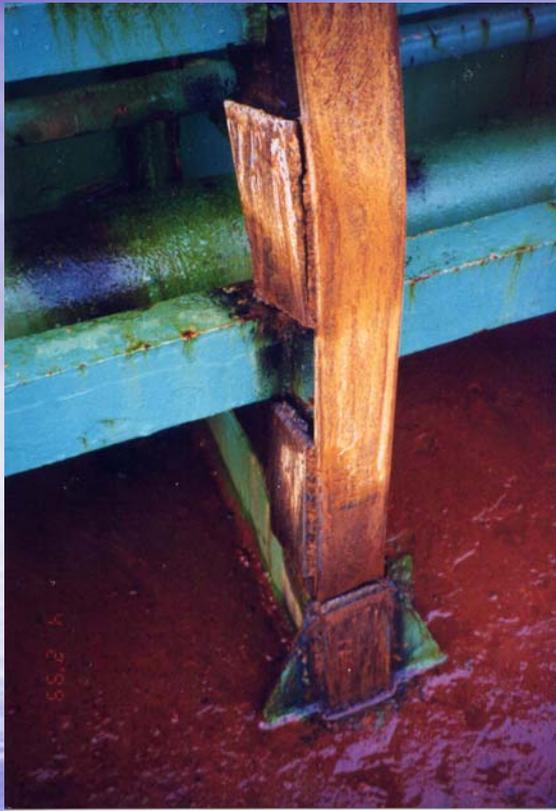
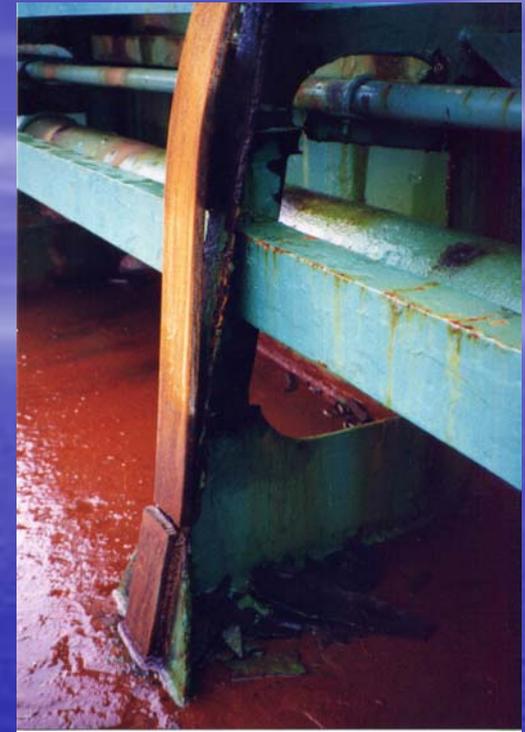
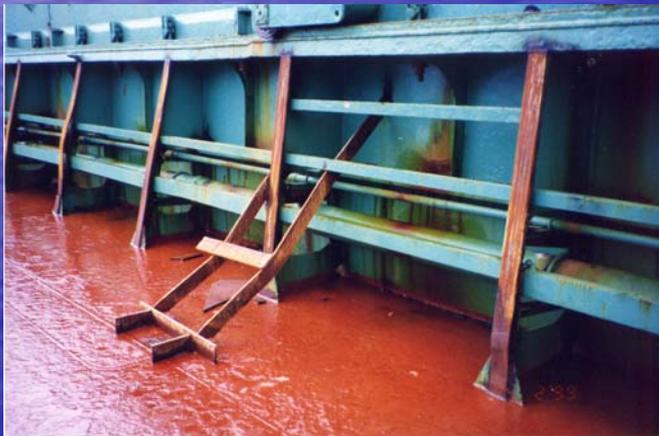
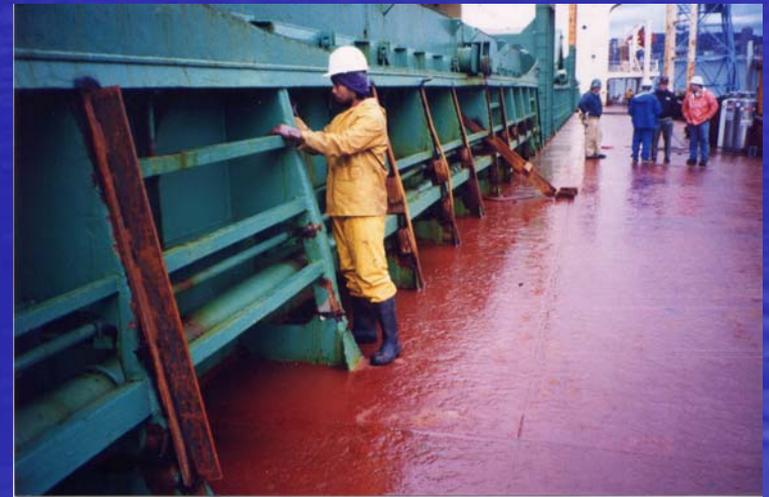
#3 Hatch Port Side

Temporary
Hatch
Coaming
Bracket
Bracing

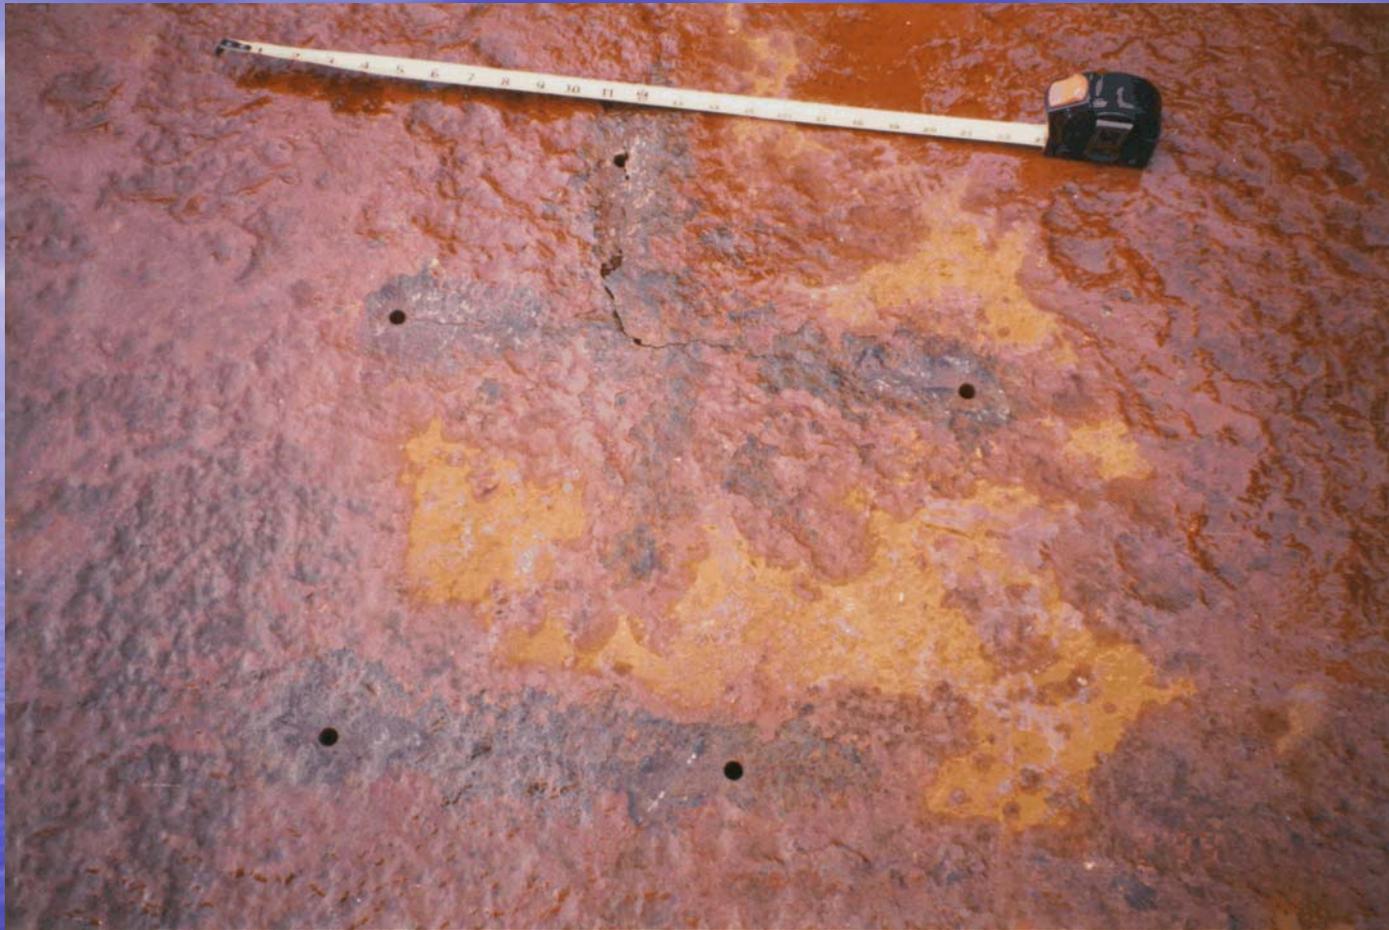
Second of three port side deck plate fractures adjacent to Hold #3.

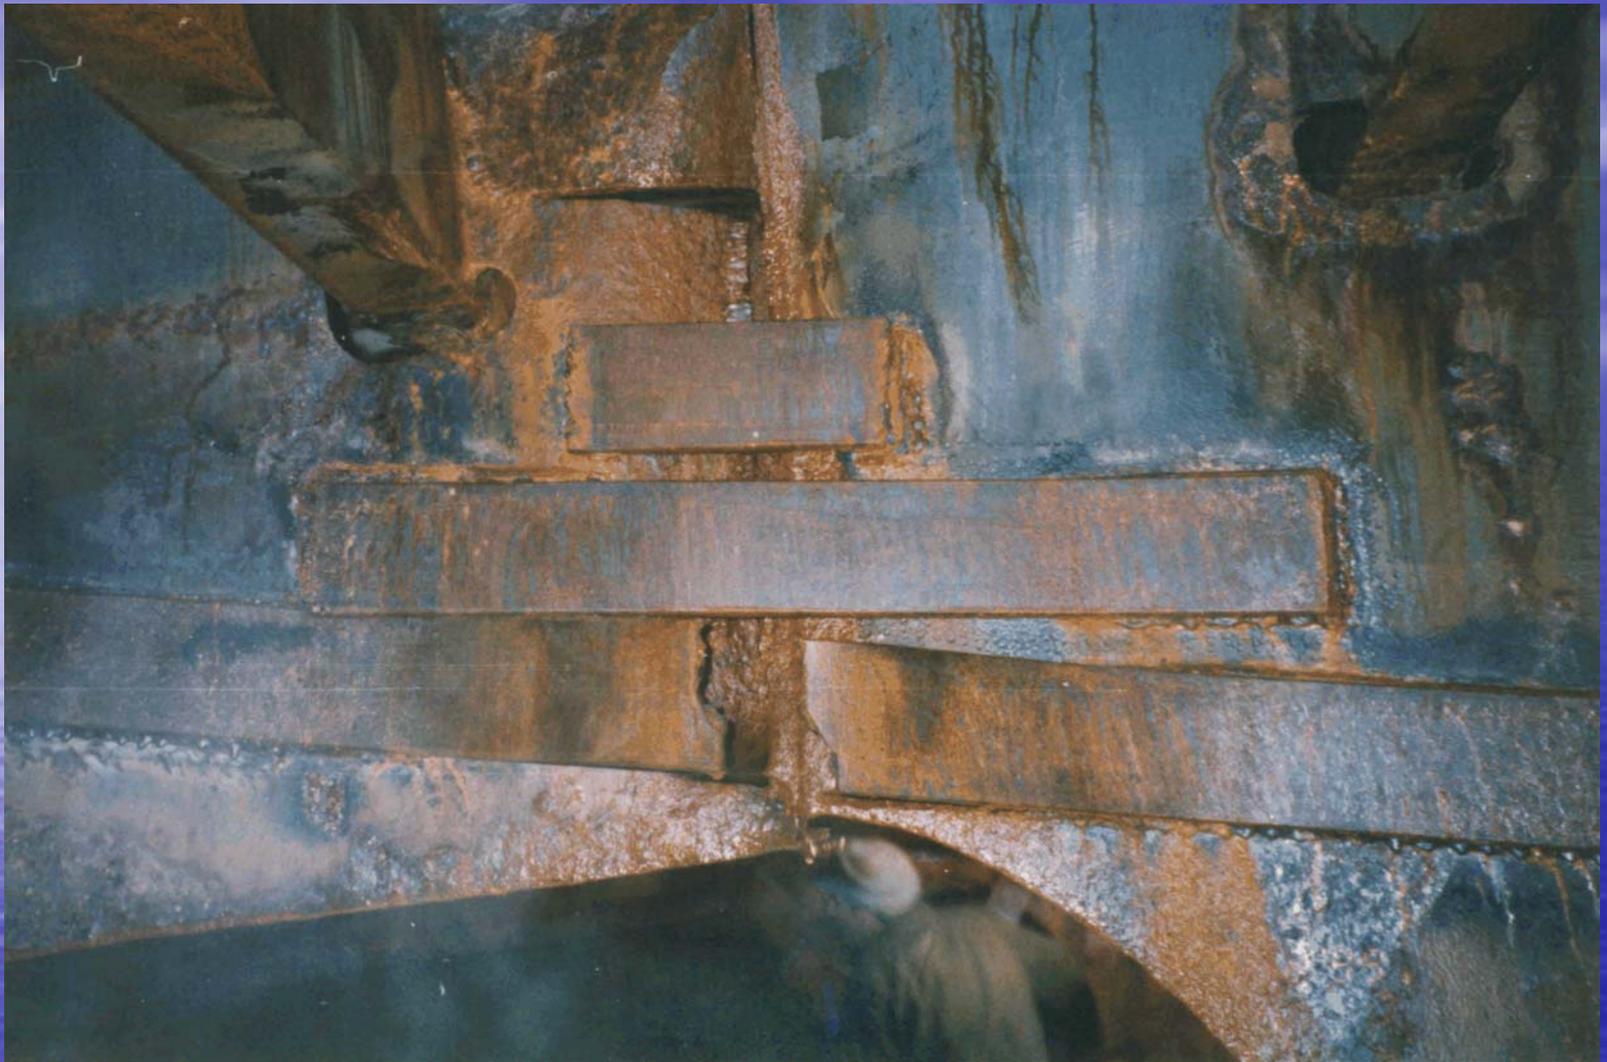
- **The aft bulkhead for #3 Port Ballast Wing Tank is located at frame #109 and the forward bulkhead is at frame #144. There are six transverse web frames between the fore and aft bulkheads of #3 Port Ballast Wing Tank. Upon entering the #3 Port Ballast Wing Tank it was noted that all six transverse web frames were structurally damaged. Each of the six frames had three distinct areas in common where cracking and deformation had occurred. There were numerous plates welded across the fractures and breaks in order to tie them together. Padeyes connected with turnbuckles were also attached across fractures and breaks.**

**Interior of #3 Port Wing Tank looking forward.
View of transverse web frame, and deck
longitudinal.**

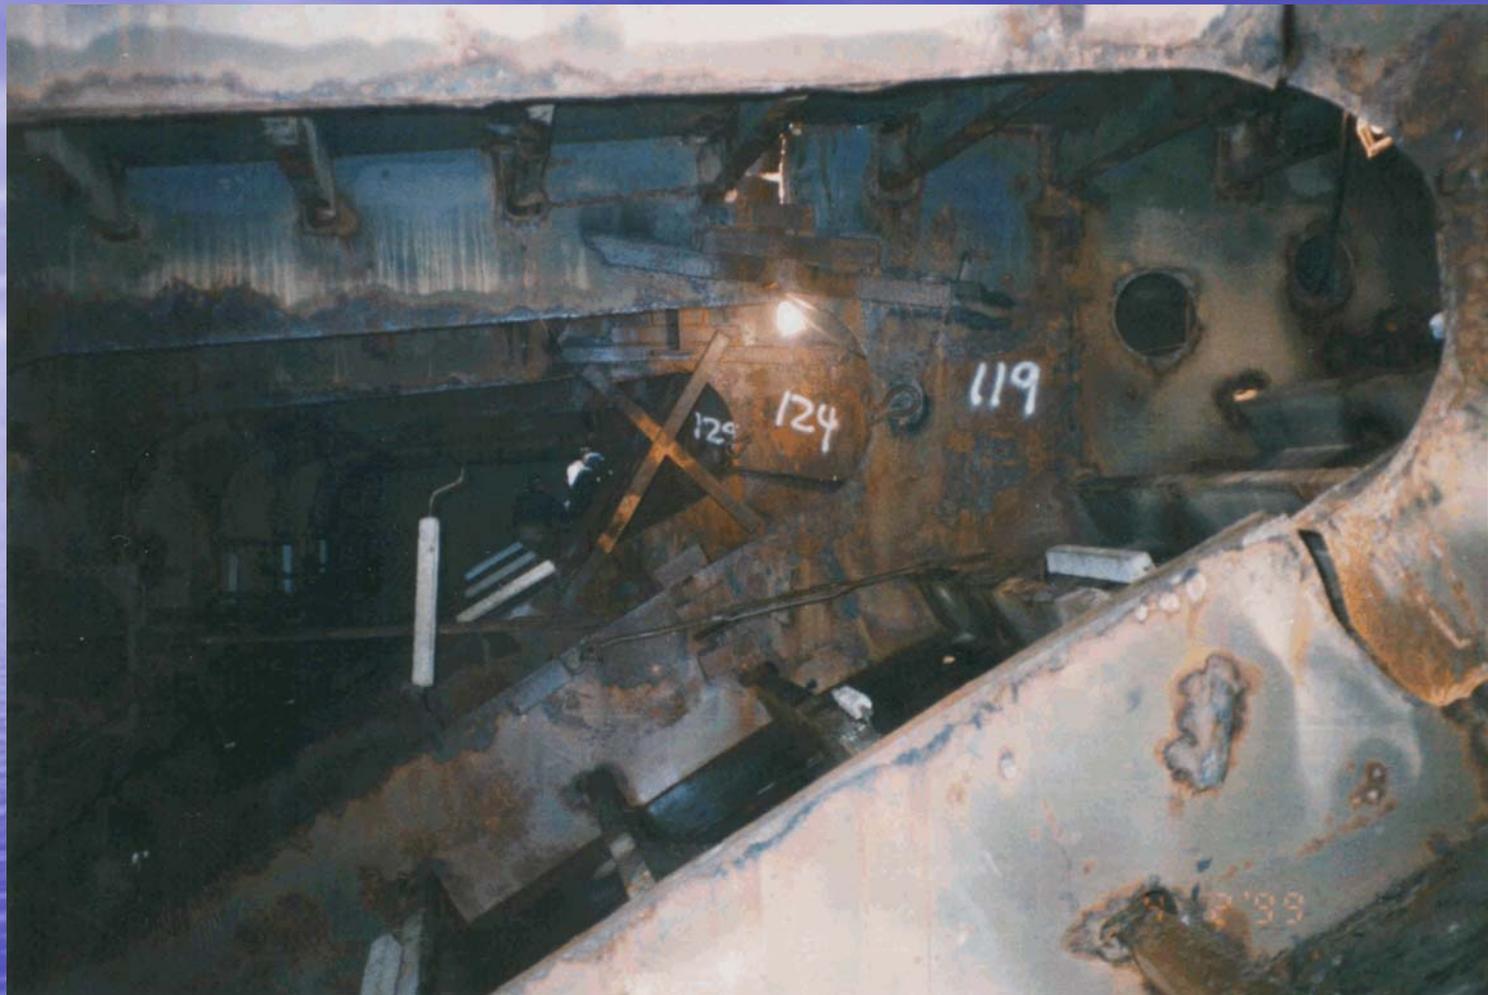
Interior of #3 Port Wing Tank looking forward. View of transverse web frame, underside of deck plating, deck longitudinals, and forward tank bulkhead.

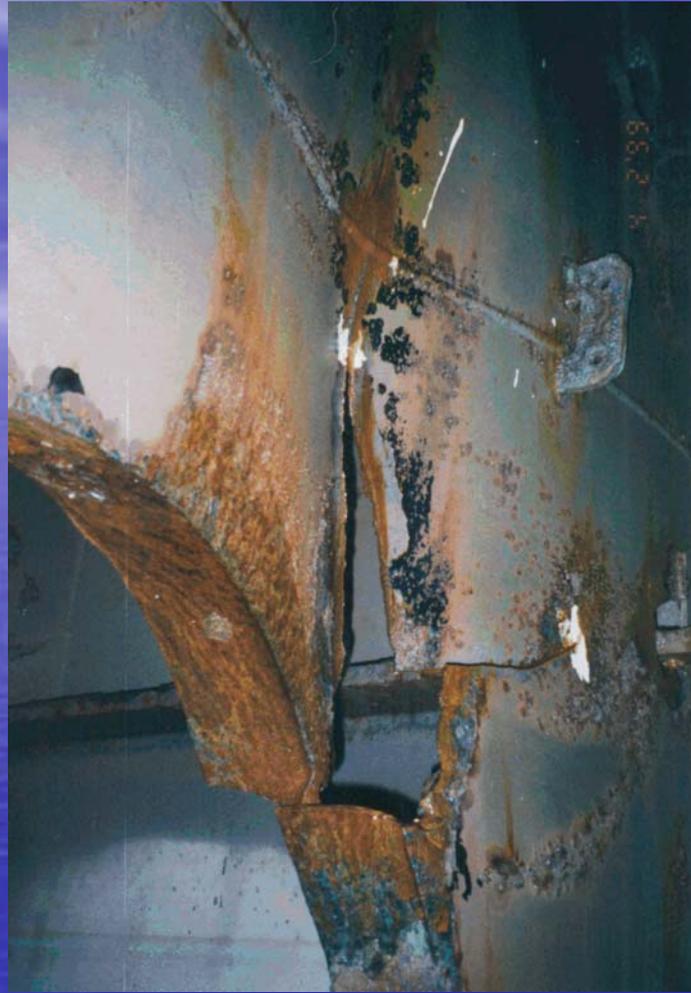
Interior of #3 Port Wing Tank looking forward. View of transverse web frame.

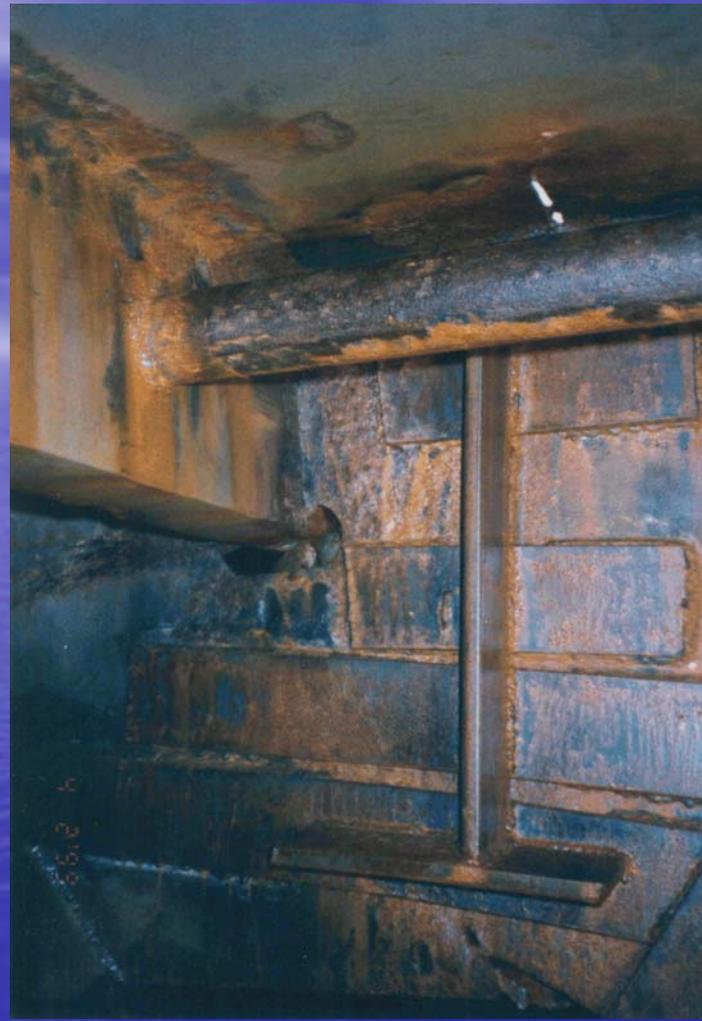
Interior of #3 Port Wing Tank looking forward. View of transverse web frame, underside of deck plating, and deck longitudinal.

NOTE: Light through deck crack in upper right corner.

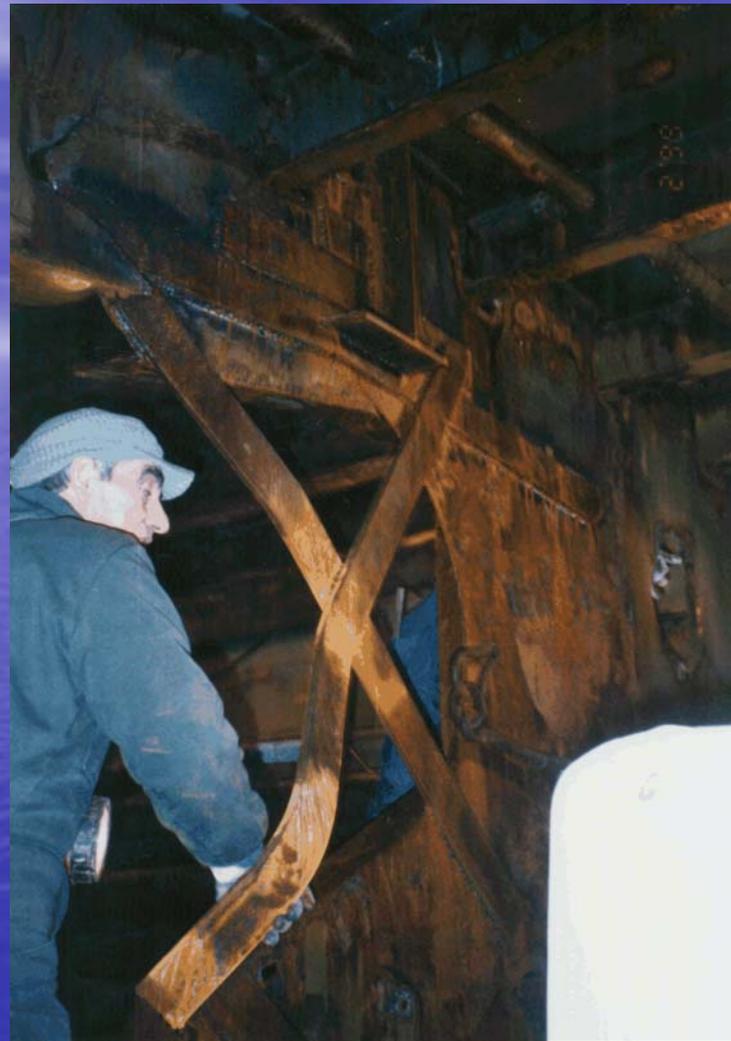
**Interior of #3 Port Wing Tank looking forward.
View of transverse web frame, underside of
deck plating, and deck longitudinals.**

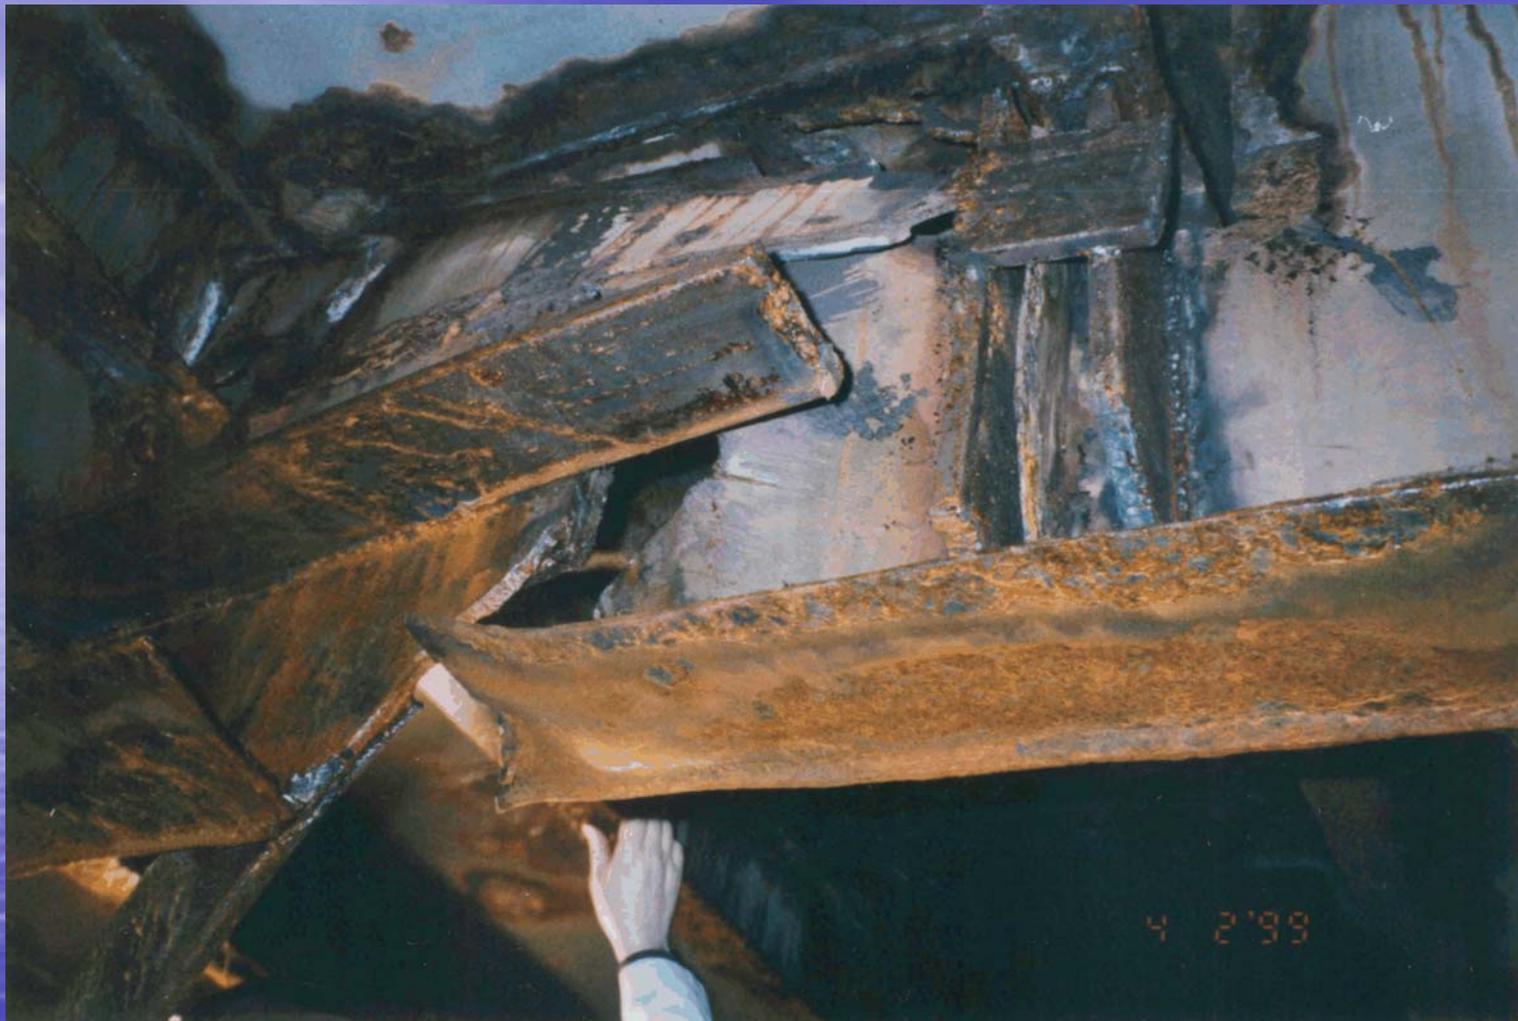
Interior of #3 Port Wing Tank looking aft.
View of transverse web frame.

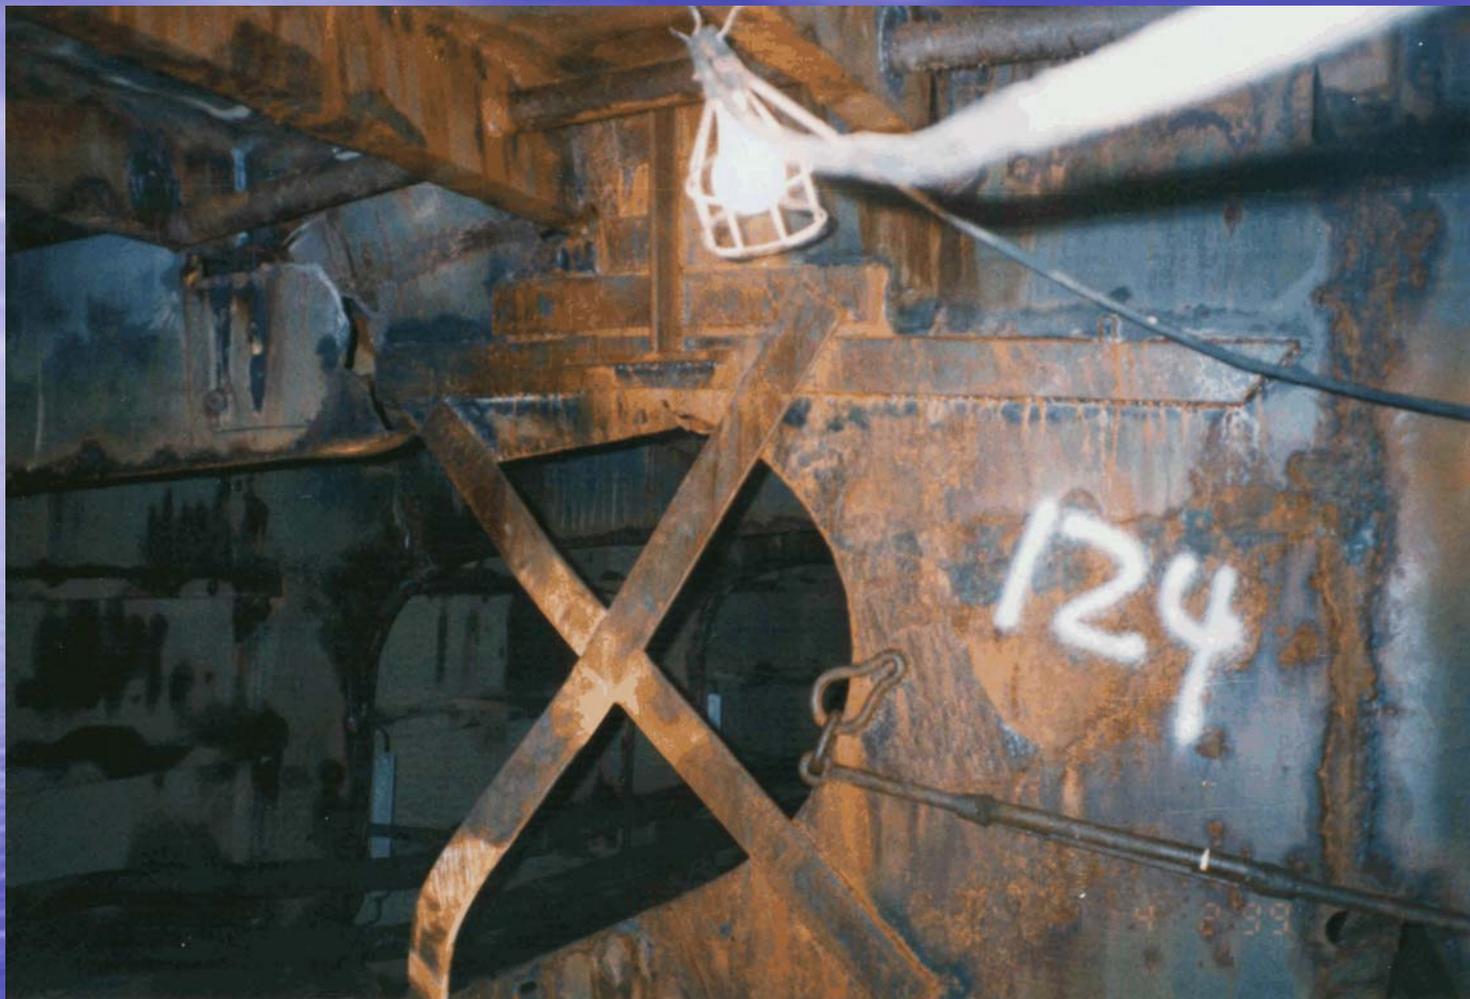
**Interior of #3 Port Wing Tank looking forward.
View of transverse web frame, and deck
longitudinals.**

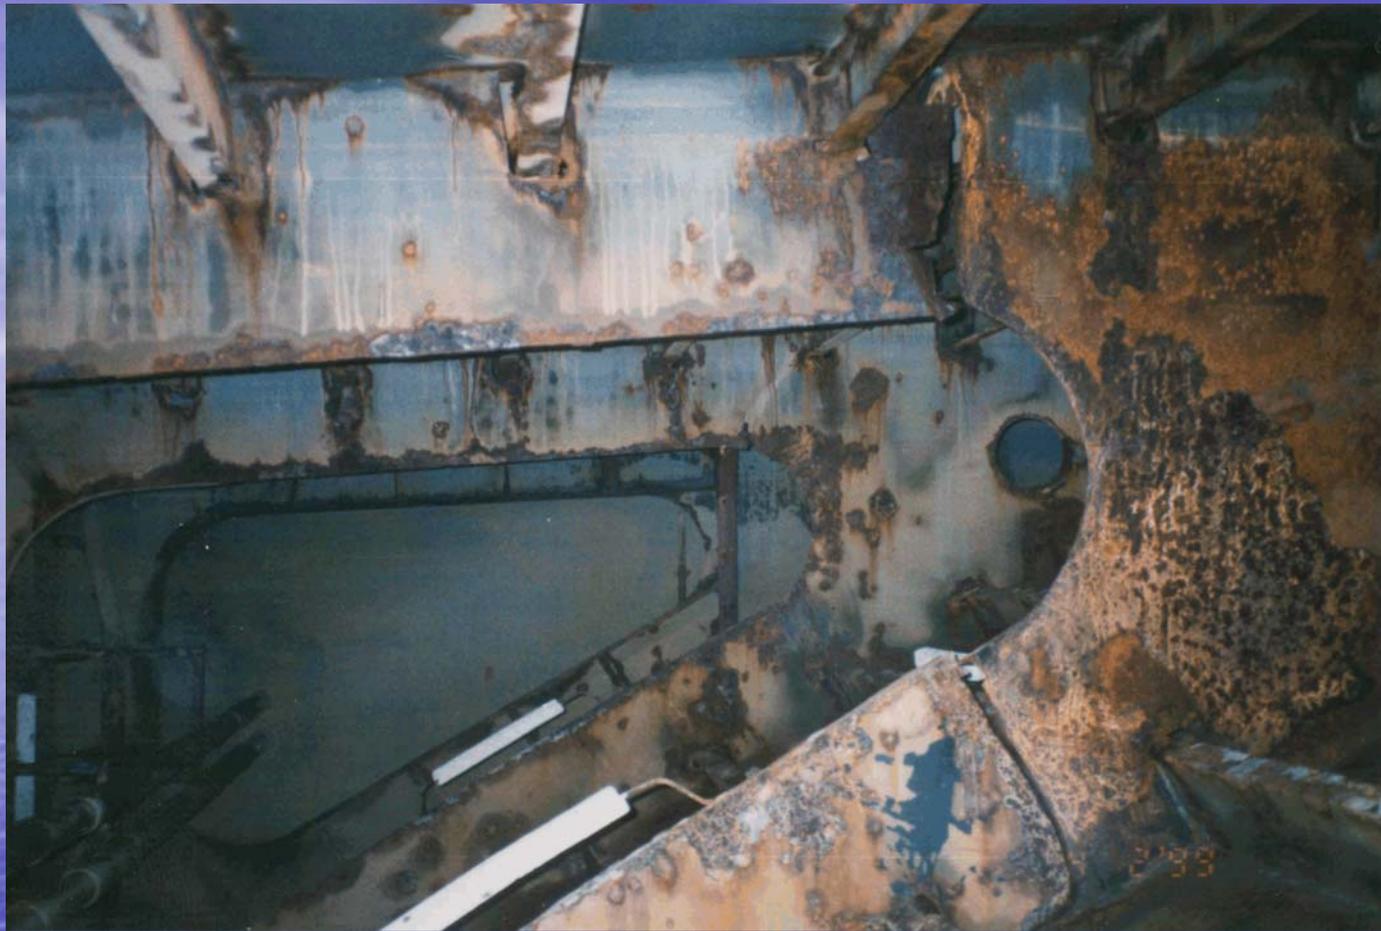
**Interior of #3 Port Wing Tank looking forward.
View of transverse web frame, underside of
deck plating, deck longitudinals, and forward
tank bulkhead.**

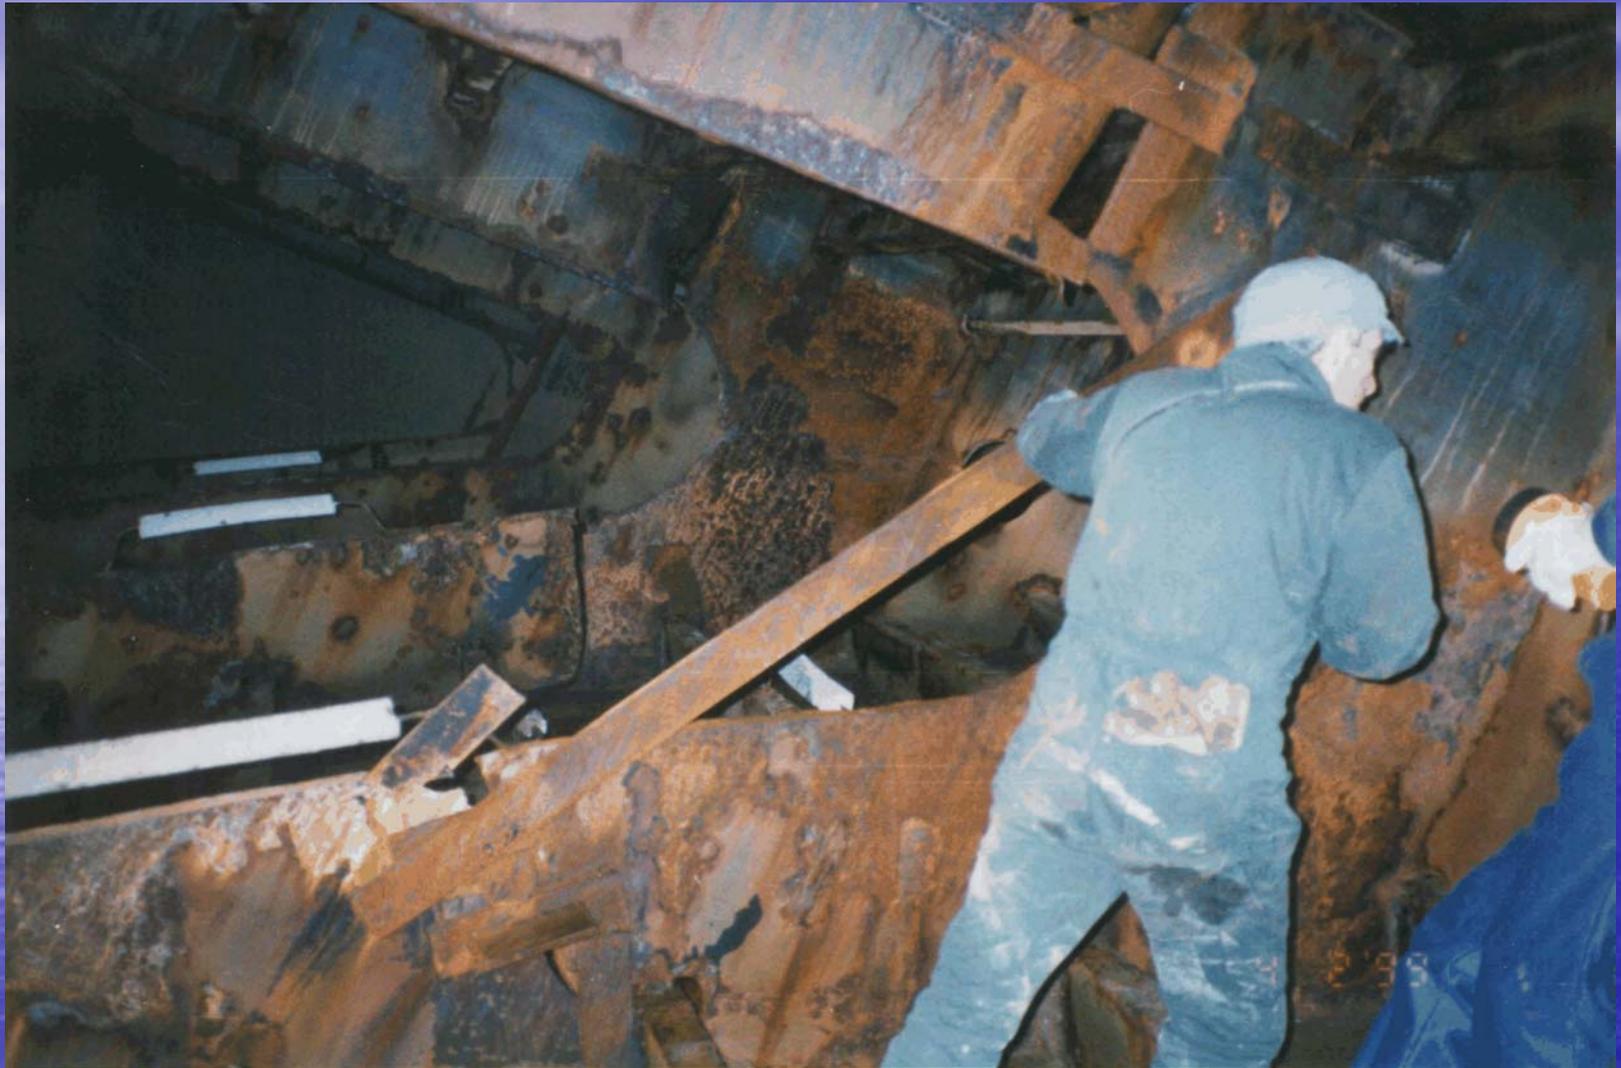
**Interior of #3 Port Wing Tank looking forward.
View of transverse web frame, and forward tank
bulkhead.**

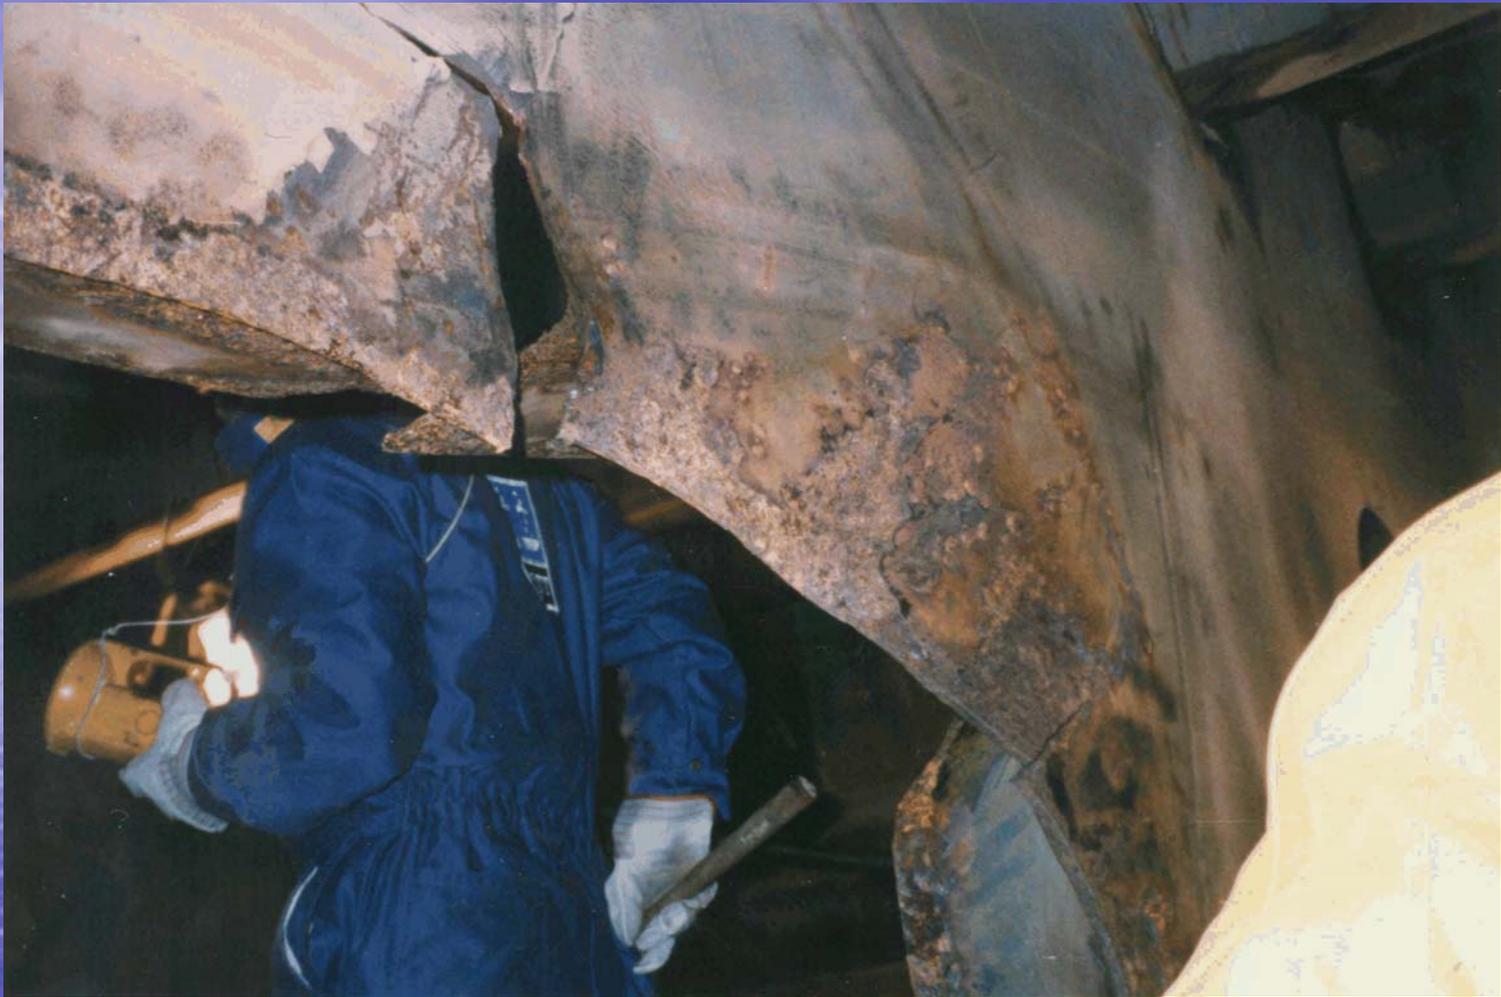
**Interior of #3 Port Wing Tank looking forward.
View of transverse web frame, and deck
longitudinals.**

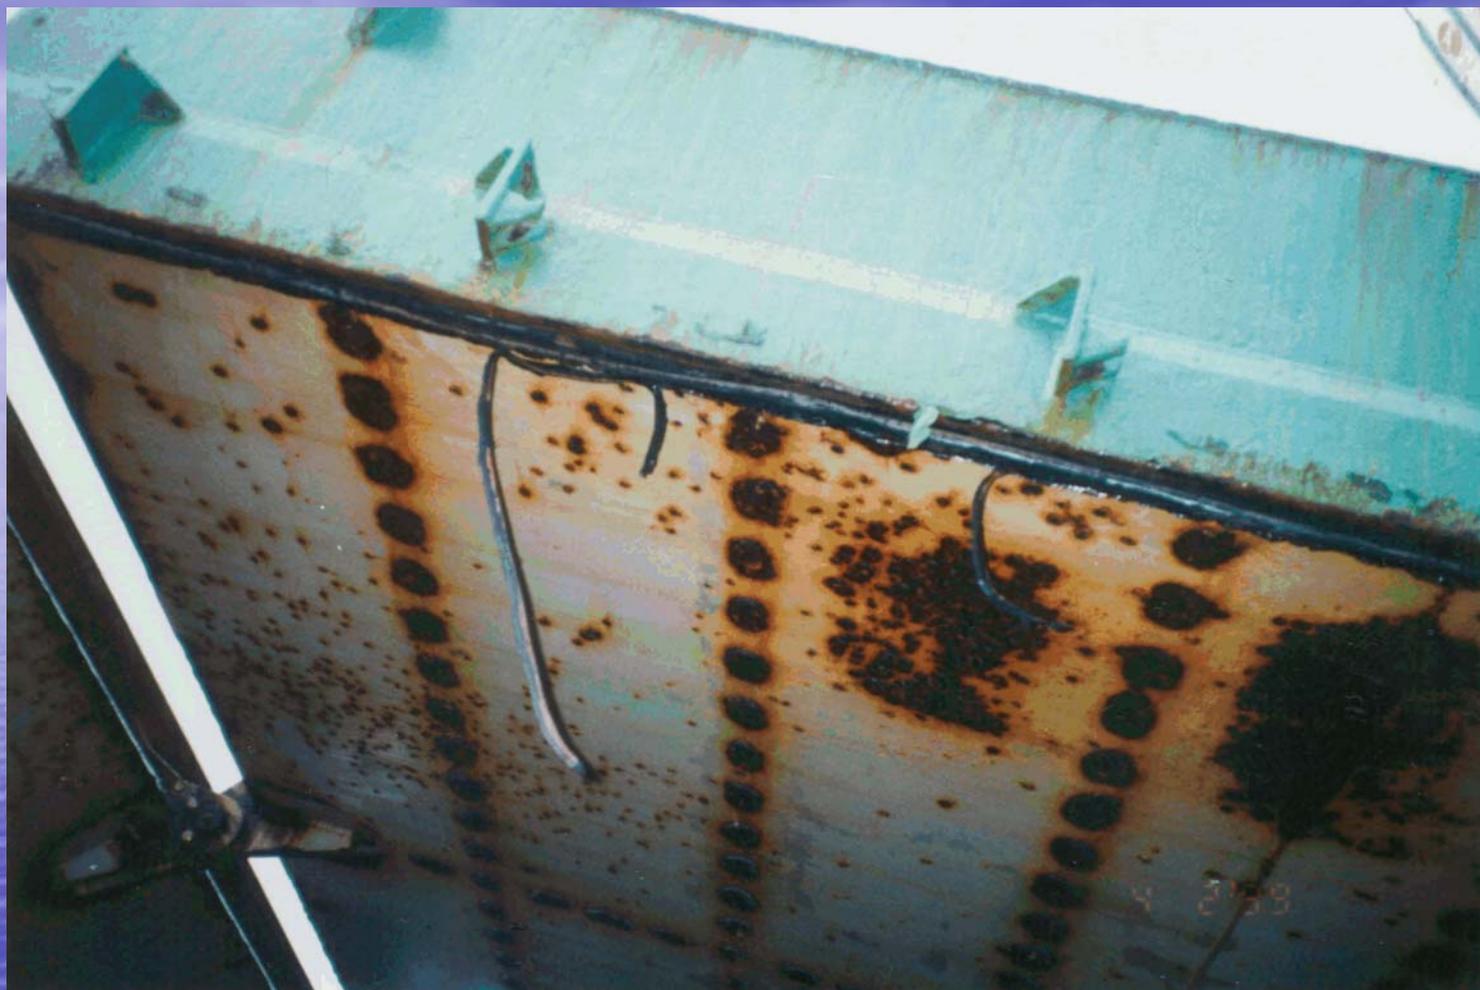
Port side Hold #3 hatch lid. Note deteriorated cover gasket material.
