Professional Engineer's Statement  
Everett Smelter Cleanup  
March 17, 2003

### 2002 Cleanup

Address:              226 Bridgeway  
Everett, WA 98201

# 226 Bridgeway (Home 55)

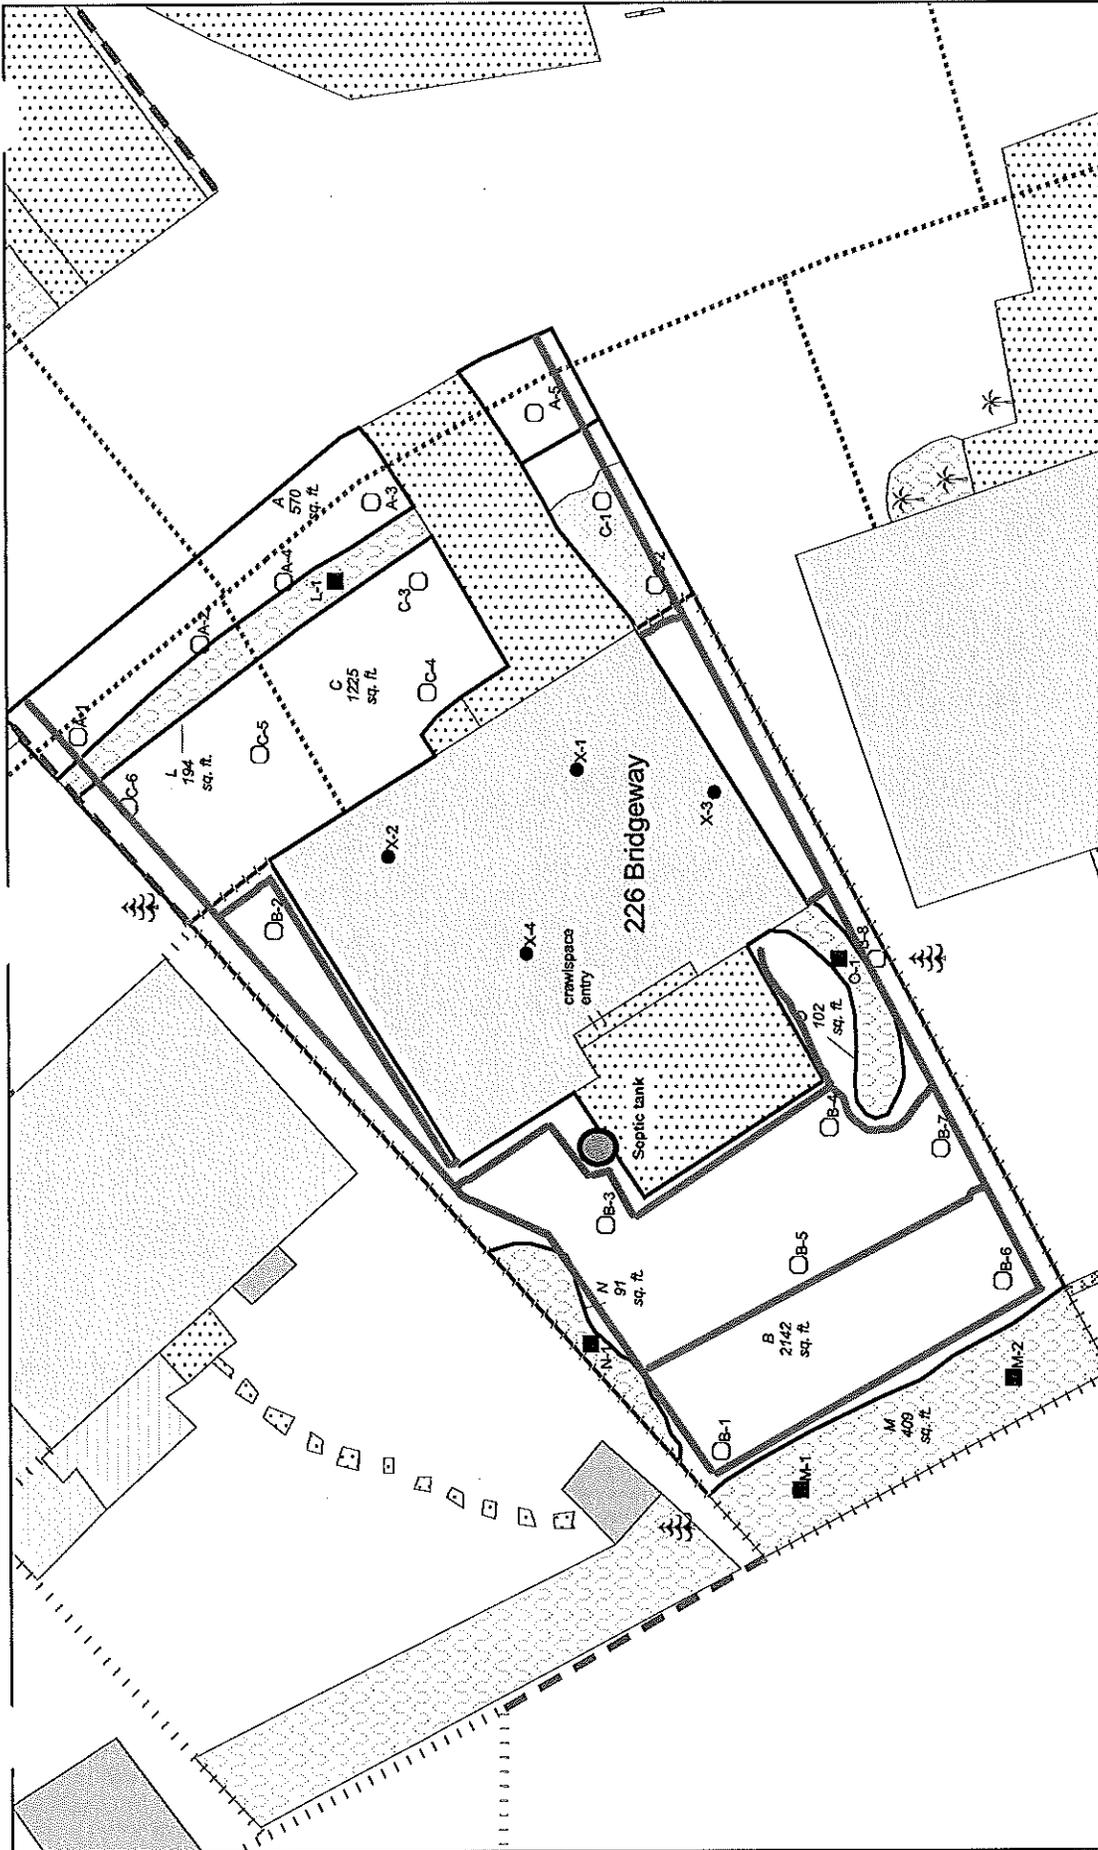
For the purposes of sampling to determine the depth to which excavation would be required, this property was divided into three Decision Units, A, B and C, as shown on the attached map. The following is a summary of the work done to remediate the property within each of the decision units.
