Everett Smelter Site

Cleanup 2007

109 Bridgeway

Details of Cleanup Activities for 109 Bridgeway

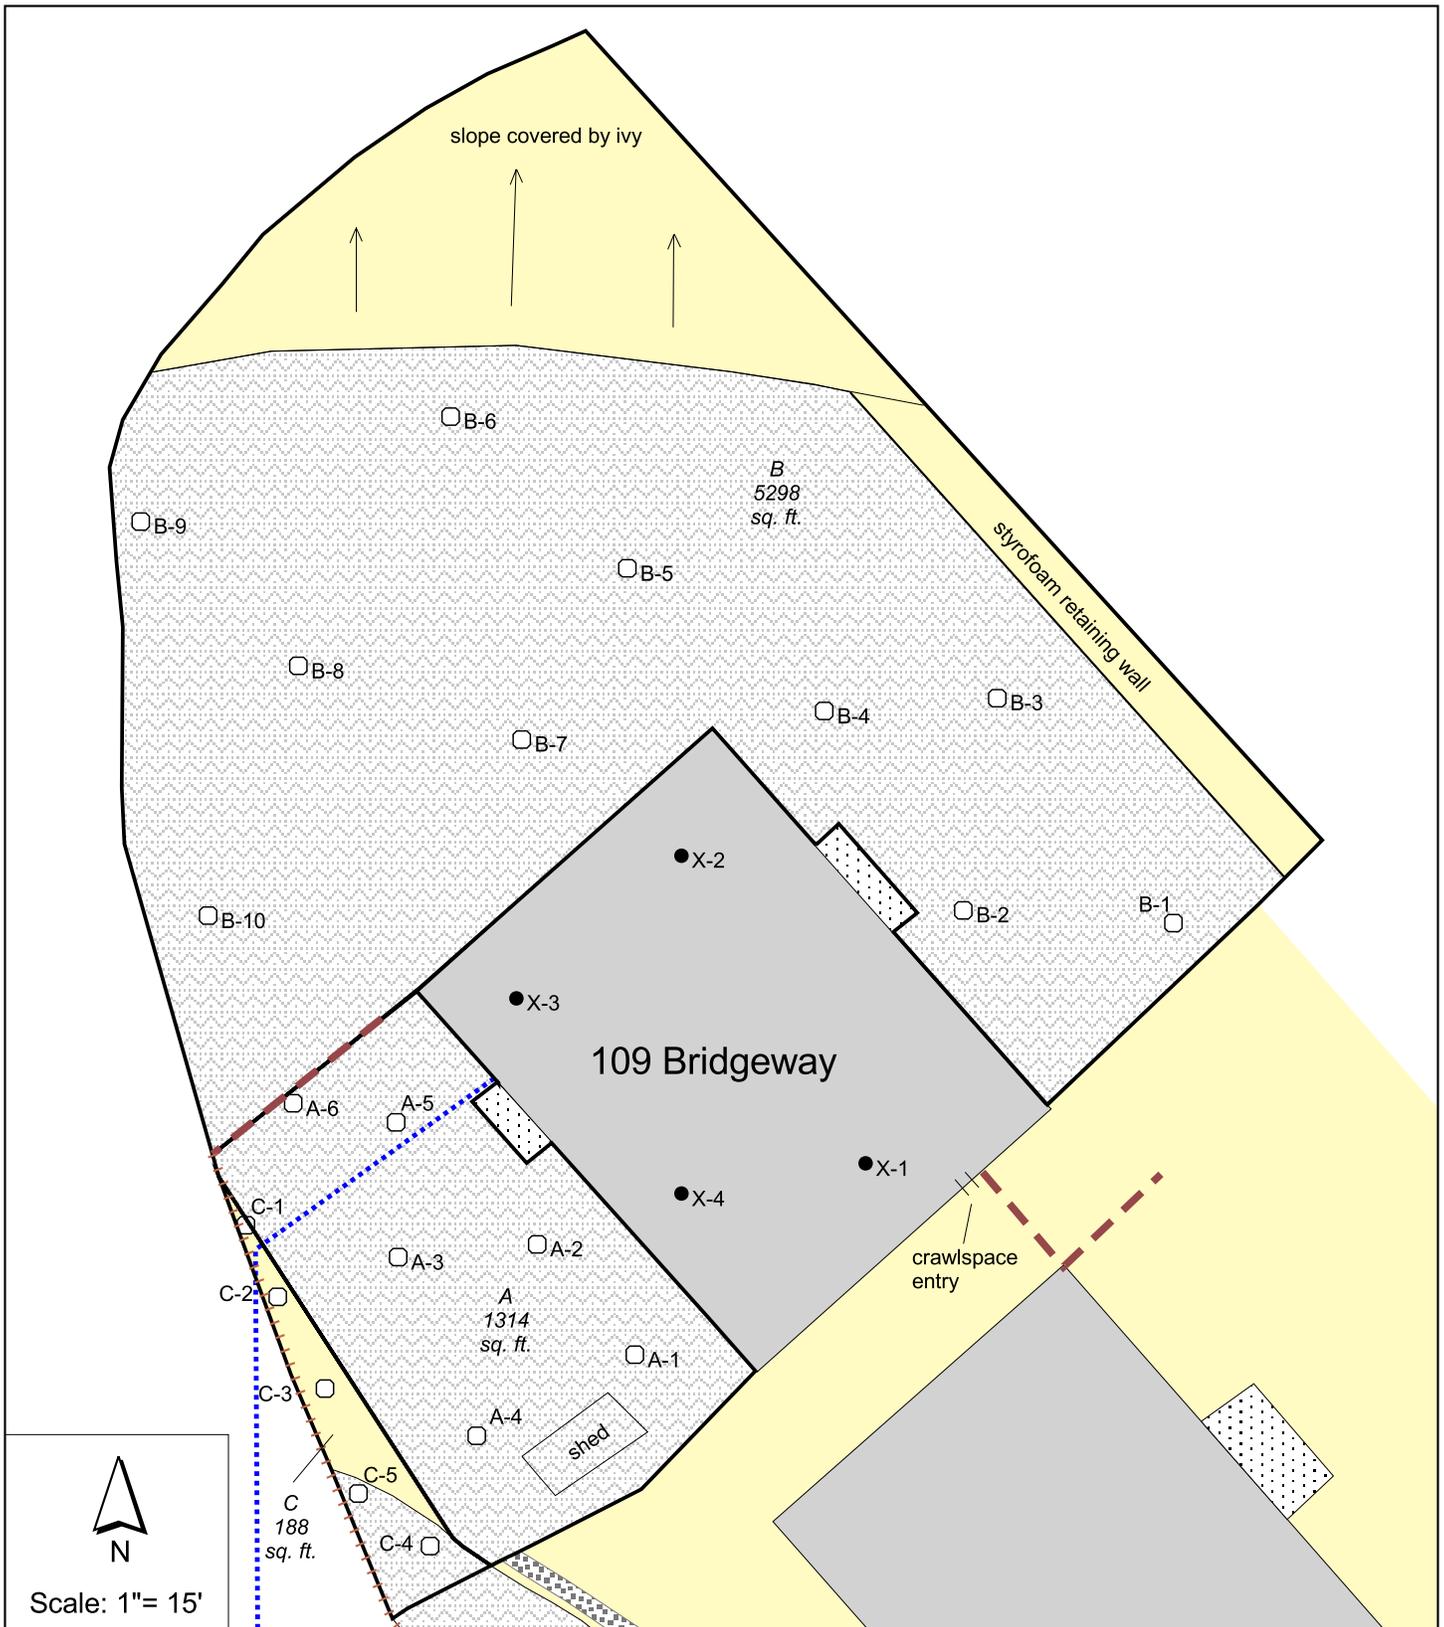
109 Bridgeway (Home 43)

The purpose of sampling was to determine the required depth of excavation for this property. The property was divided into three *Decision Units*, A, B, and C, as shown on the attached map. A *rotating laser level* was used to measure the depth of the excavated soil in each decision unit.
