**Washington Department of Ecology  
Everett Smelter Site  
2007 Cleanup**

**Details of Cleanup Activities for 215 Bridgeway**

Property Owner	Joshua & Michelle Allen
Address:	215 Bridgeway Everett, WA 98201
Snohomish County	
State of Washington	
Tax Parcel No.	# 005203-000-046-00

# 215 Bridgeway (Home 50)

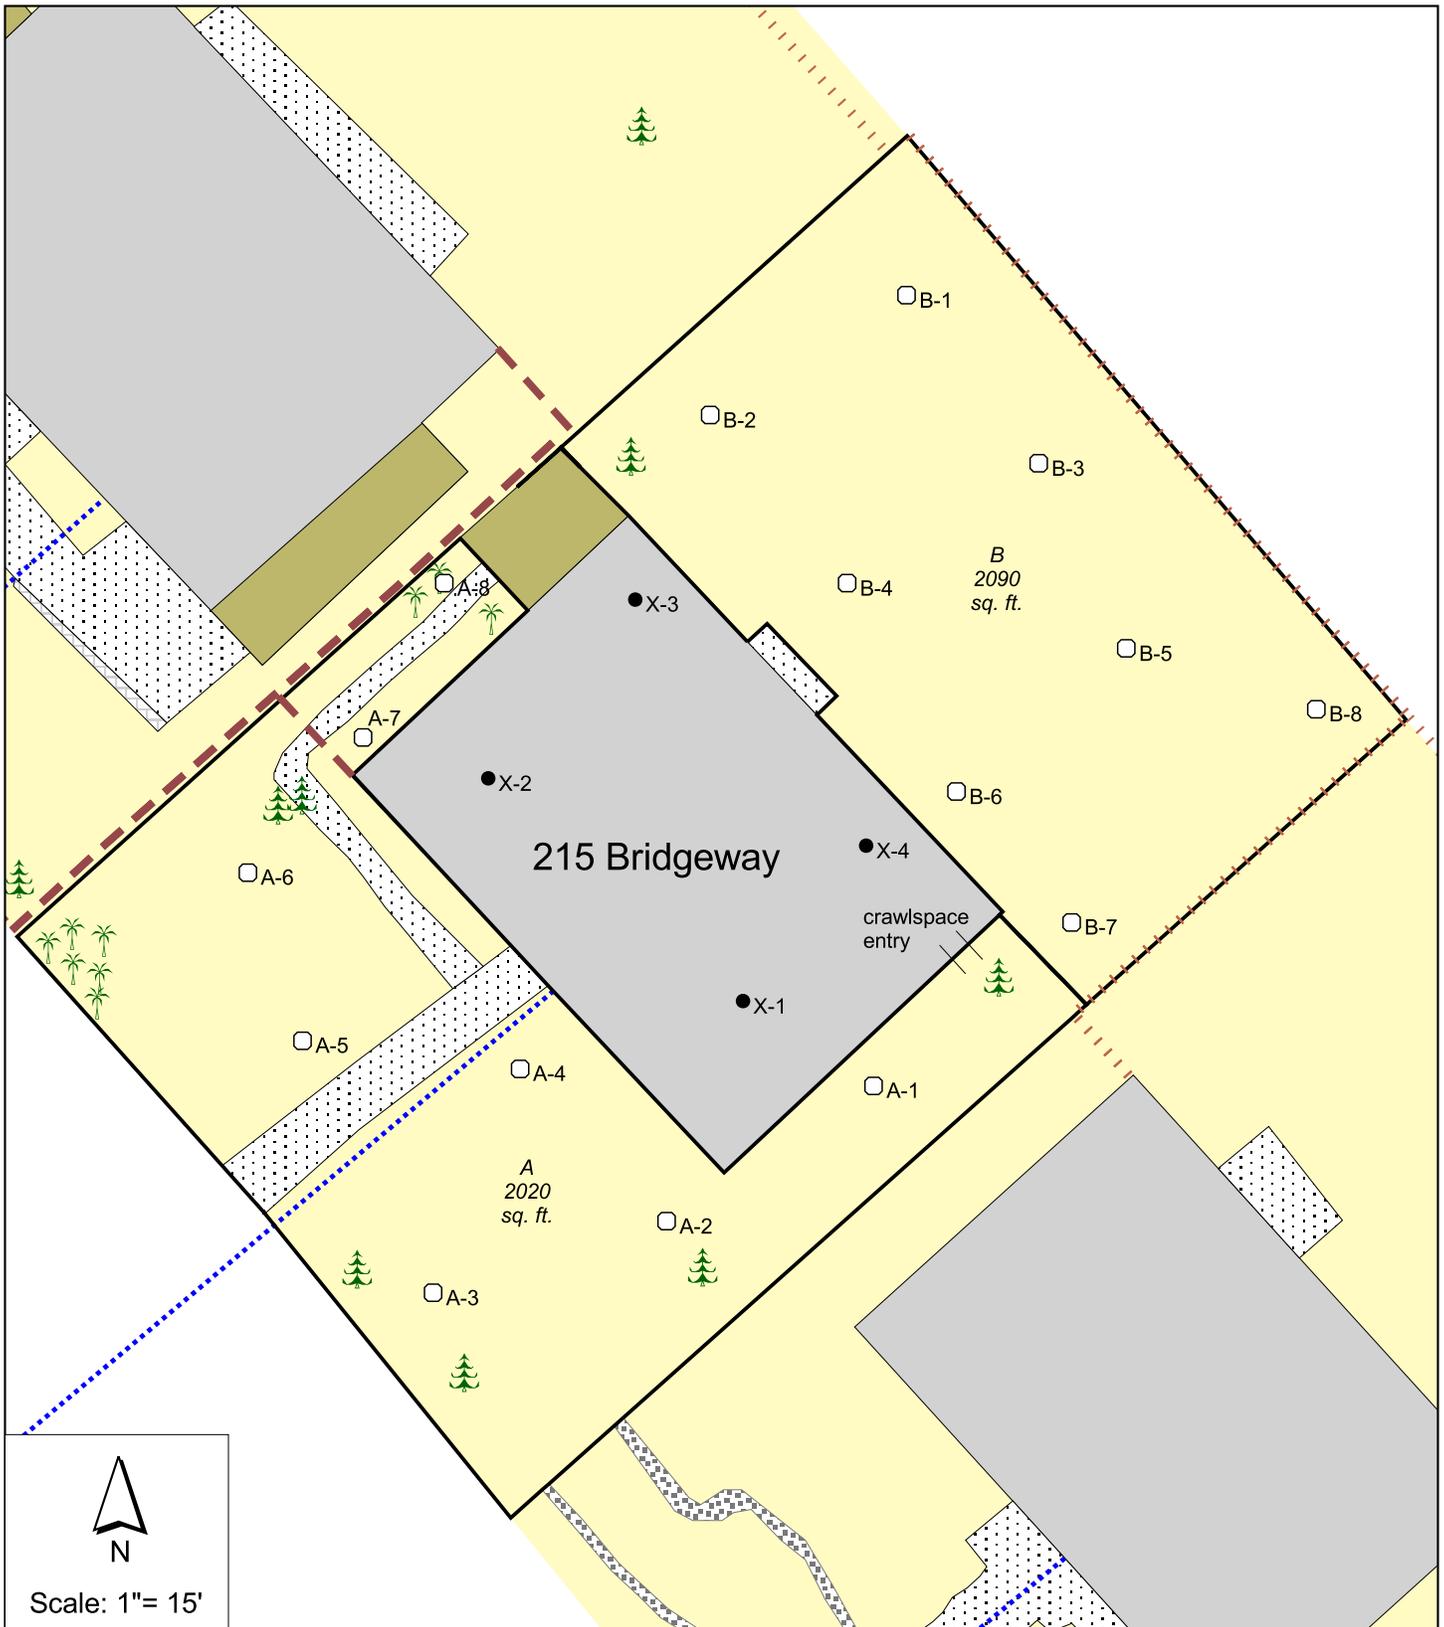
The purpose of sampling was to determine the required depth of excavation for this property. The property was divided into two *Decision Units* A and B, as shown on the attached map in Attachment A. A *rotating laser level* was used to measure the depth of the excavated soil in each decision unit.
