**Professional Engineer's Statement  
Everett Smelter Cleanup, 2000-2001**

# Washington Department of Ecology Everett Smelter Site 2000-2001 Cleanup

Property Owner: Muriel Jones

Address: 110 Bridgeway  
Everett, WA 98201

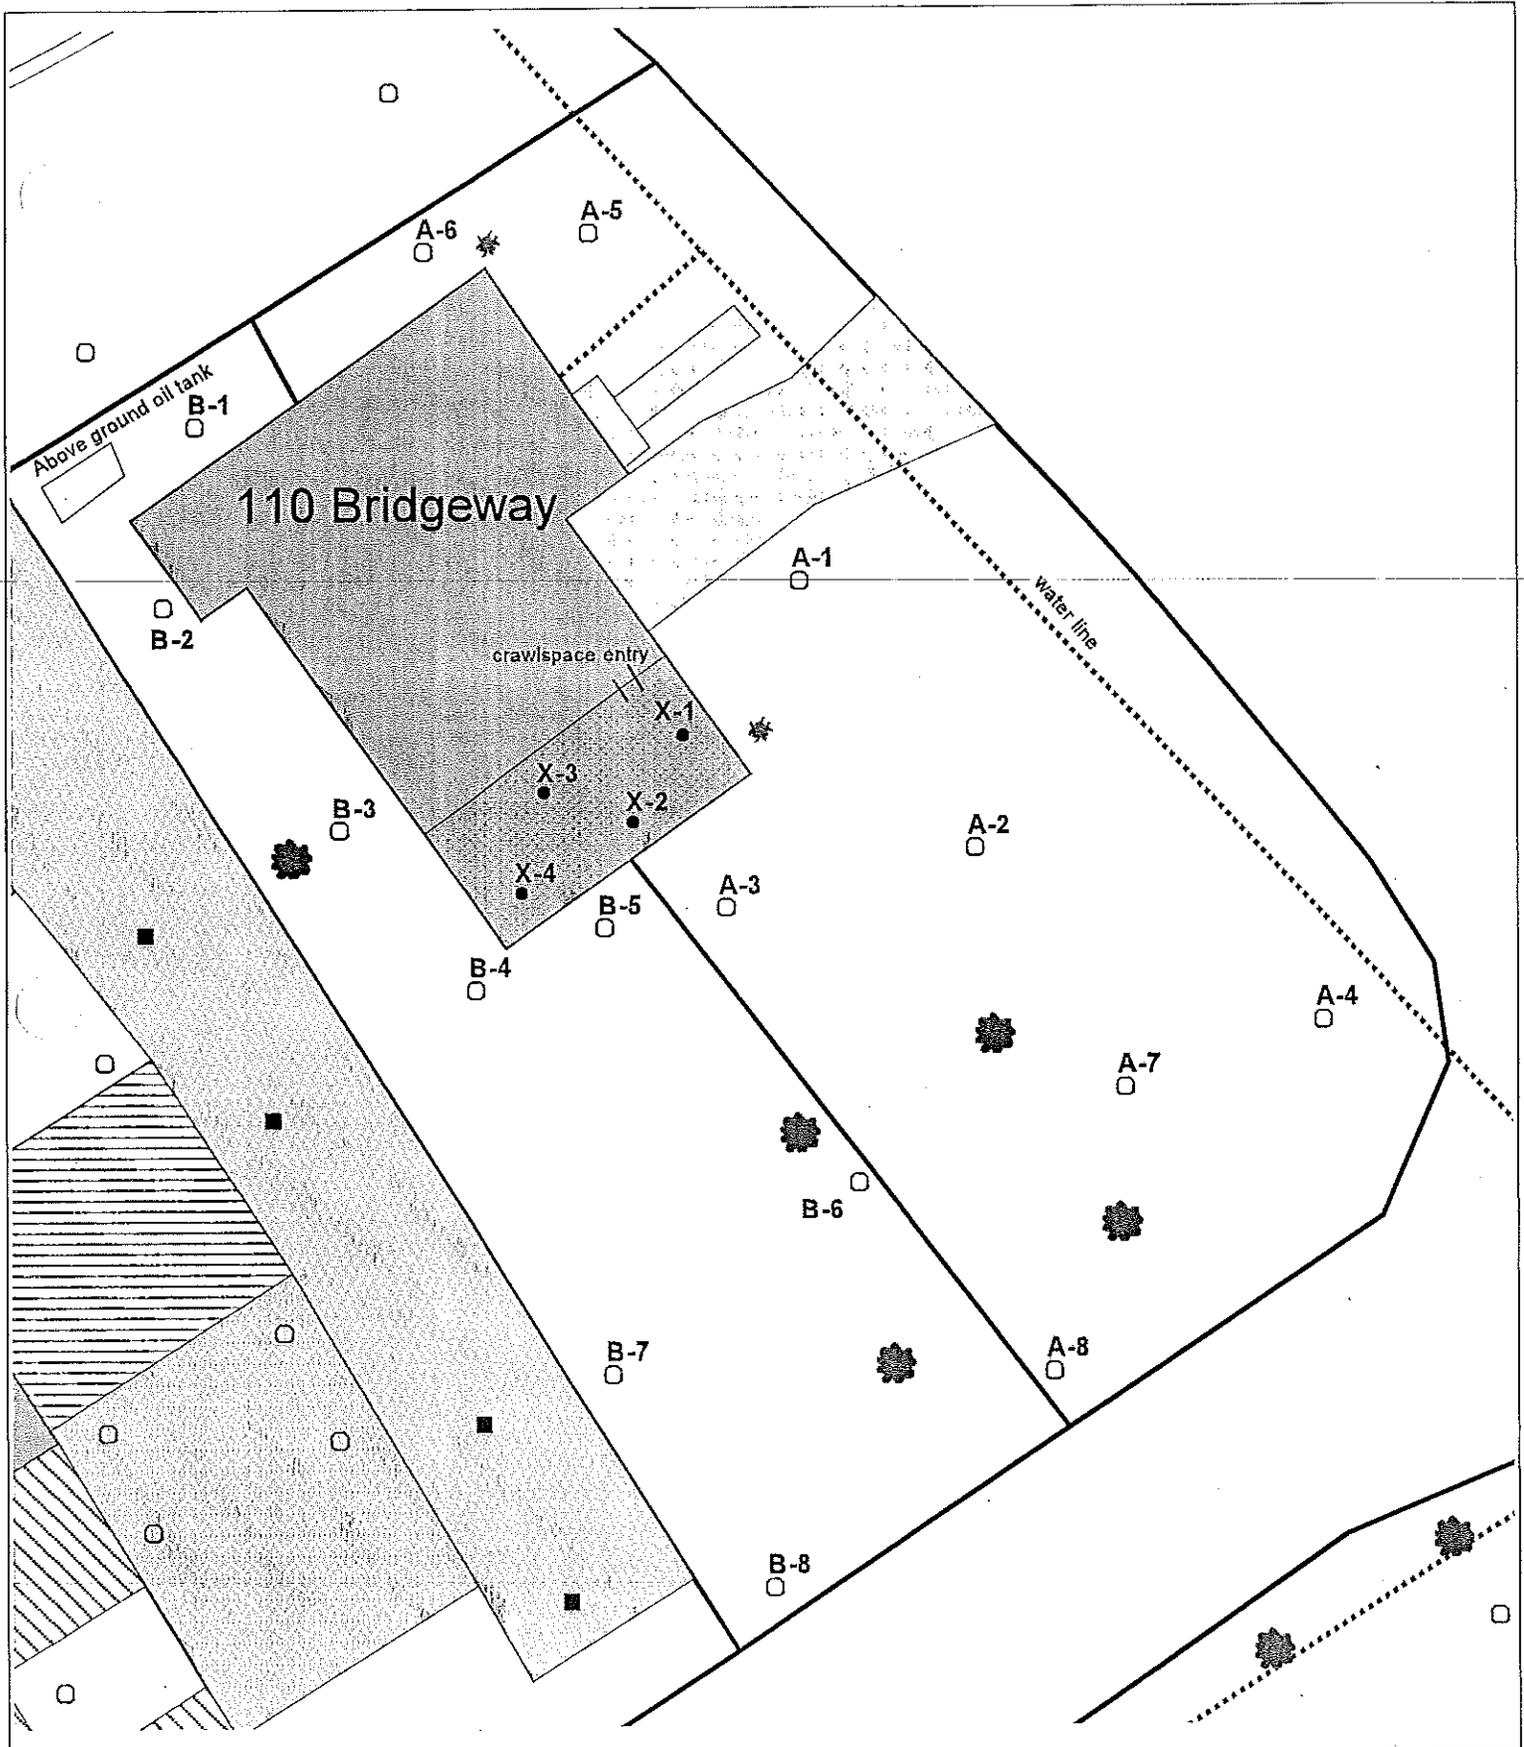
# 110 Bridgeway

This property was divided by Ecology into two Decision Units, A and B, as shown on the attached map, for purposes of pre-cleanup sampling and decision-making regarding the depth to which excavation was required. The following is a summary of the work done in the remediation of the property within each of the decision units.

Results of pre-cleanup sampling indicated 24 inches of soil were to be excavated from within this decision unit. Attachment B shows that below 24 inches, results of composite sample analyses are below the remediation level of 150 parts per million (ppm). However, because the soil below 24 inches contains arsenic levels above the cleanup level of 20 ppm, a geofabric marker was placed.

Results of pre-cleanup sampling indicated 12 inches of soil were to be excavated from within this decision unit. Attachment B shows that below 12 inches, results of composite sample analyses are below the remediation levels of 60 and 150 ppm. Because the soil below 12 inches contains arsenic levels below the cleanup level of 20 ppm, no geofabric marker was necessary.
