**Professional Engineer's Statement
Everett Smelter Cleanup, 2000-2001**

Washington Department of Ecology Everett Smelter Site 2000-2001 Cleanup

Details of Cleanup Activities

Address:
320 Skyline Drive
Everett, WA 98201

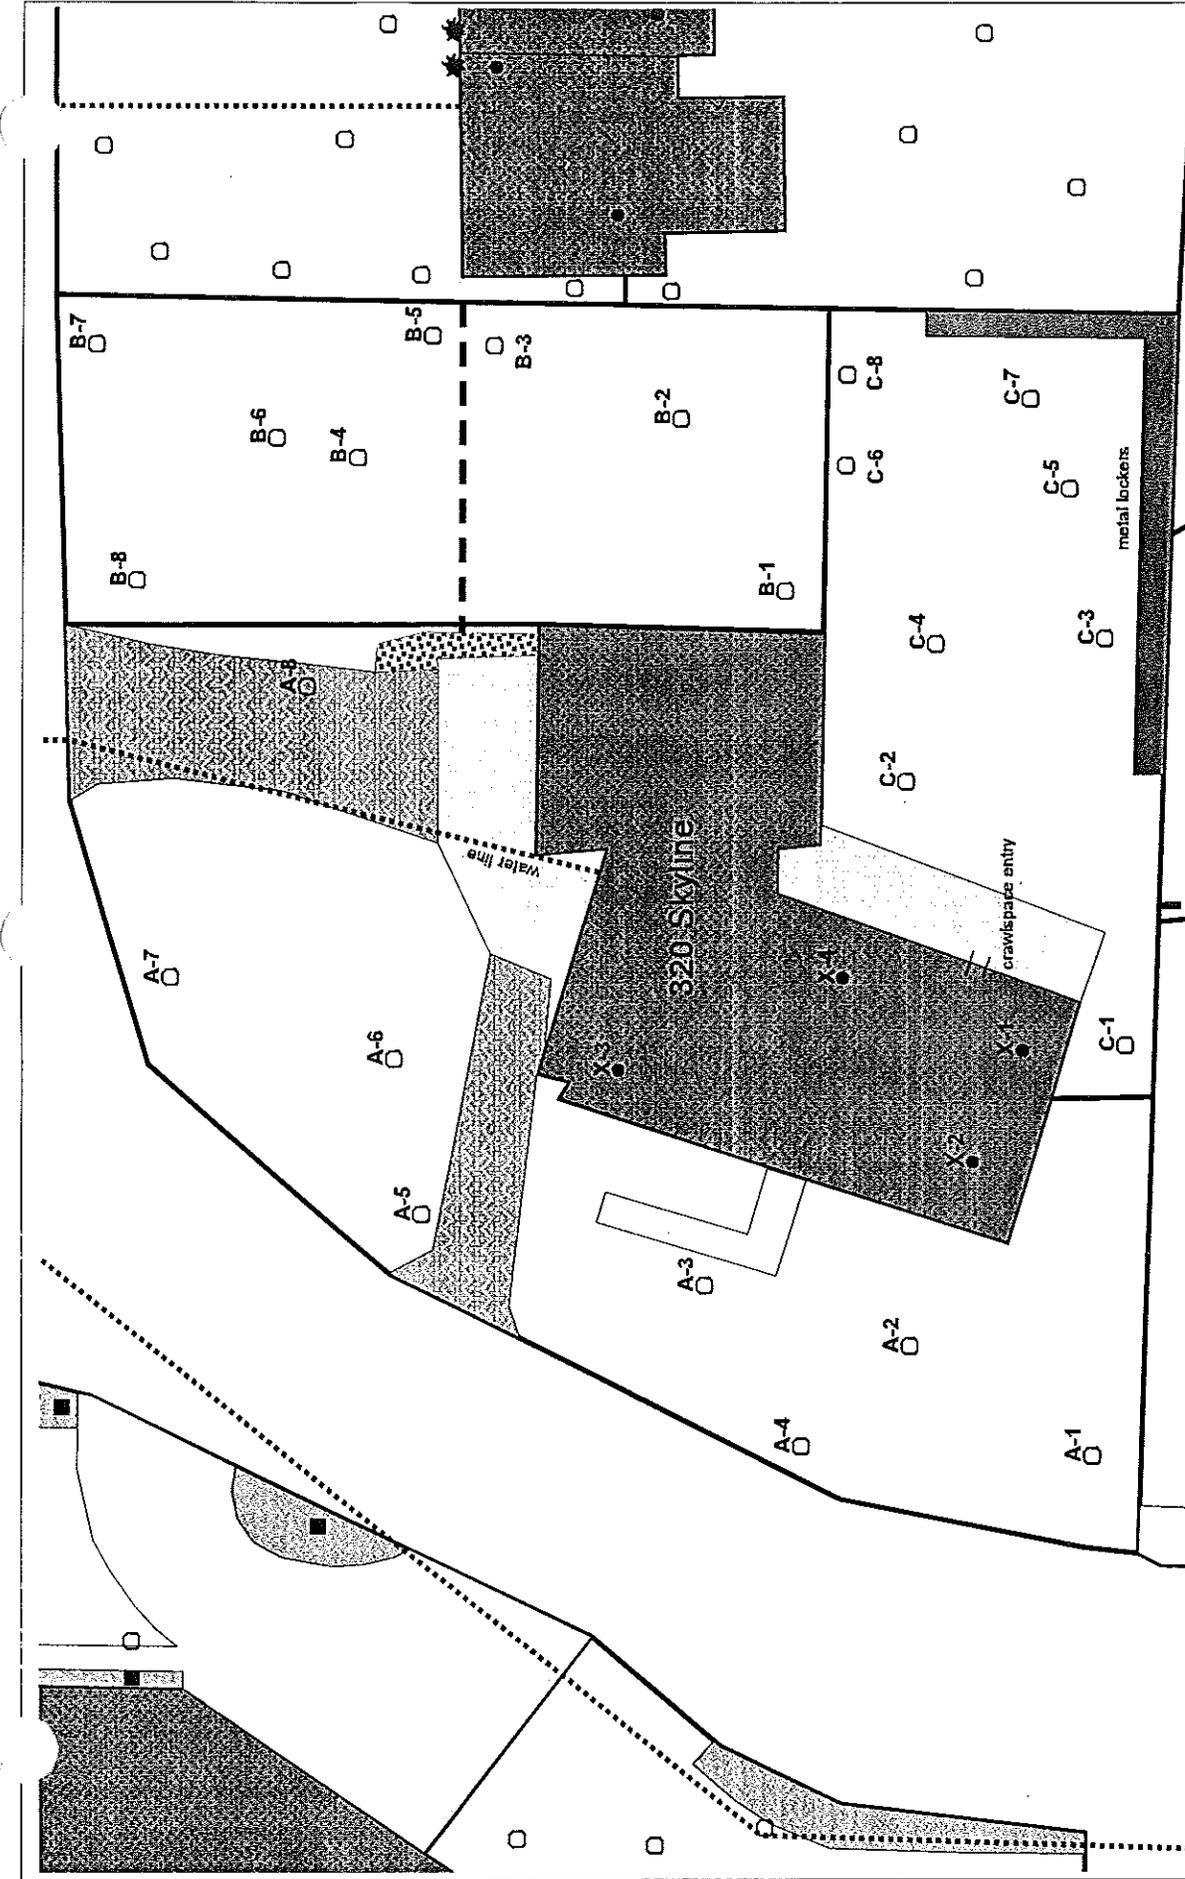
320 Skyline
 Everett Smelter Homesite Cleanup
 Source: Snohomish Health District

This property was divided by Ecology into three Decision Units, A, B, and C, as shown on the attached map, for purposes of pre-cleanup sampling and decision-making regarding the depth to which excavation was required. The following is a summary of the work done in the remediation of the property within each of the decision units.
