**Professional Engineer's Statement  
Everett Smelter Cleanup, 2000-2001**

**Washington Department of Ecology  
Everett Smelter Site  
2000-2001 Cleanup**

**Details of Cleanup Activities**

Address:  
323 Skyline Drive  
Everett, WA 98201

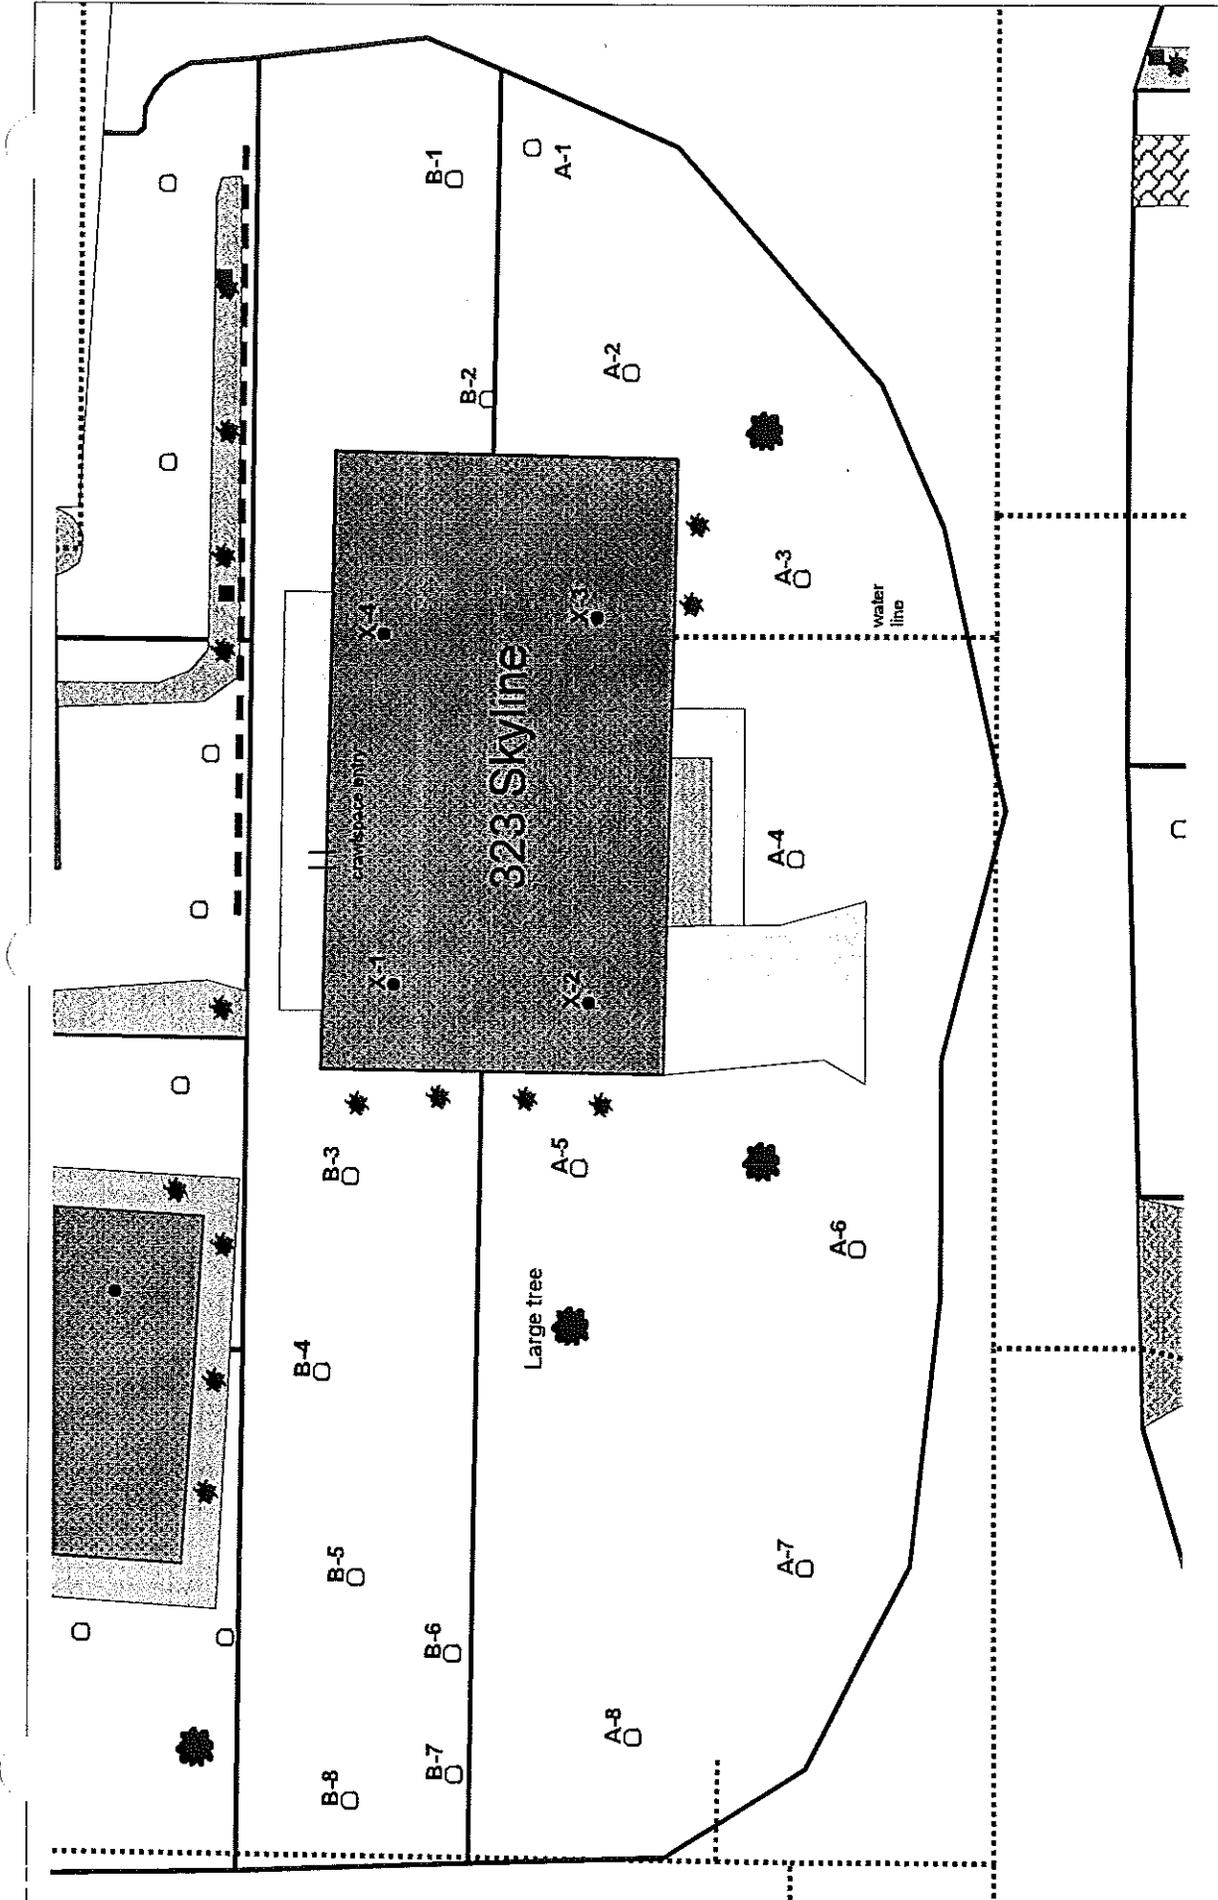
# 323 Skyline

This property was divided by Ecology into two Decision Units, A and B, as shown on the attached map, for purposes of pre-cleanup sampling and decision-making regarding the depth to which excavation was required. The following is a summary of the work done in the remediation of the property within each of the decision units.
