ASSORTED  
LATE ENTRIES  
ALPHA

**EARTHEN STRUCTURAL REVIEW**

**B. Summarize review for structural data evaluation**

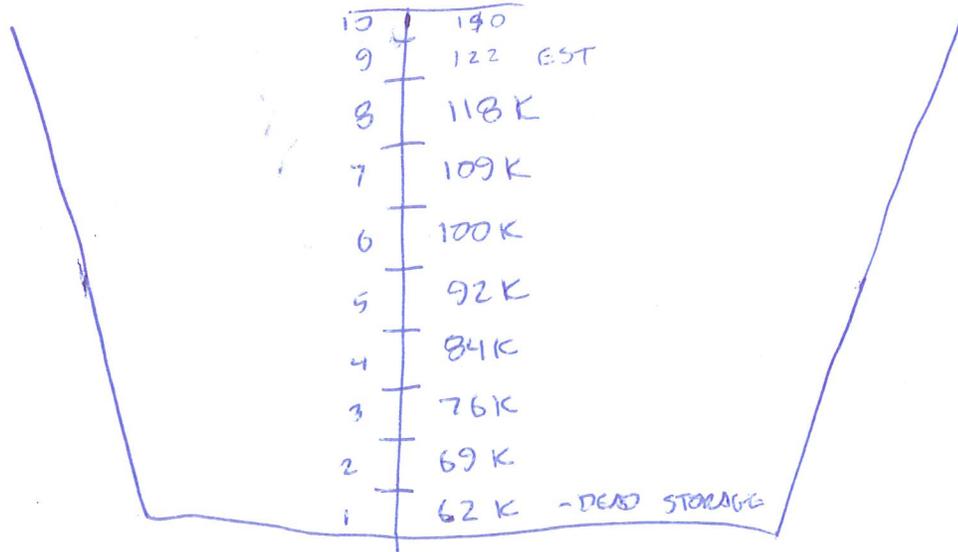
GROSS 1,028,000  
FREEBOARD 127,000  
STORM 234,000  
DEAD 62,000  
NET 605,000

2nd Nearly Full in DBase "IN THE WOODS"

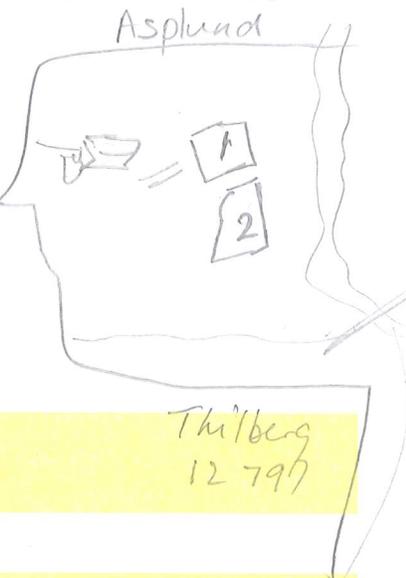
*manure pipe crossing Nooke chapt creek*
