A. Site inventory

AGID: 5375 FARM NAME: GREG SMIT DAIRY

LAGOON ID: 5375-1 N Lat: 48.971223 Long: -122.517461

REVIEW INVENTORY DATE: 9/13/2012

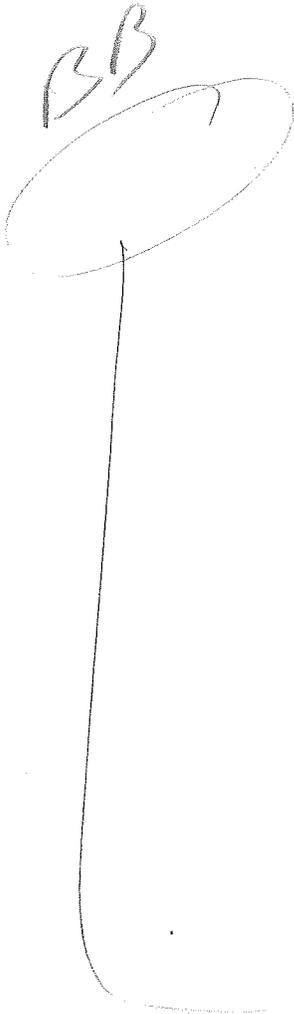
compost pile
w/ cow bones
stickney
out.

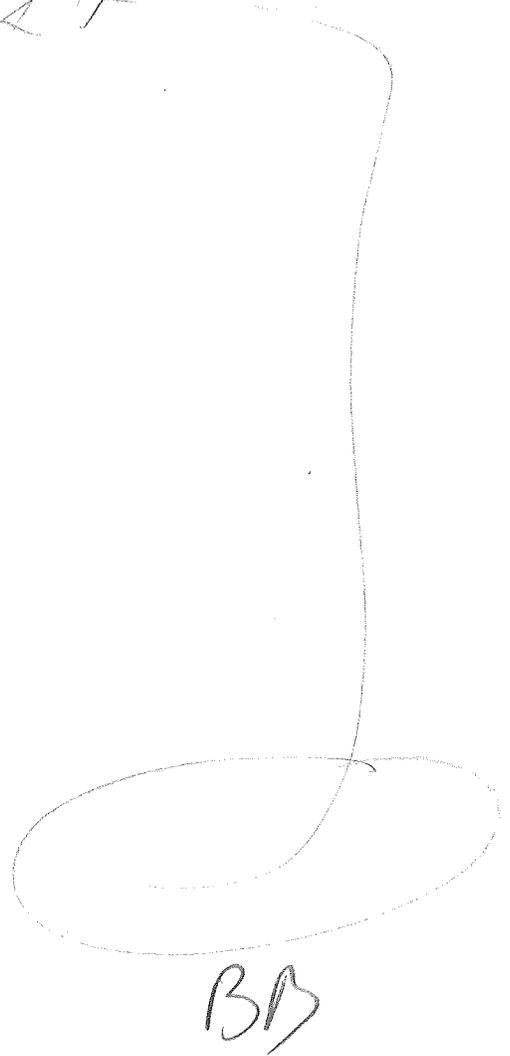
some
mide / gophers
sign
X
X

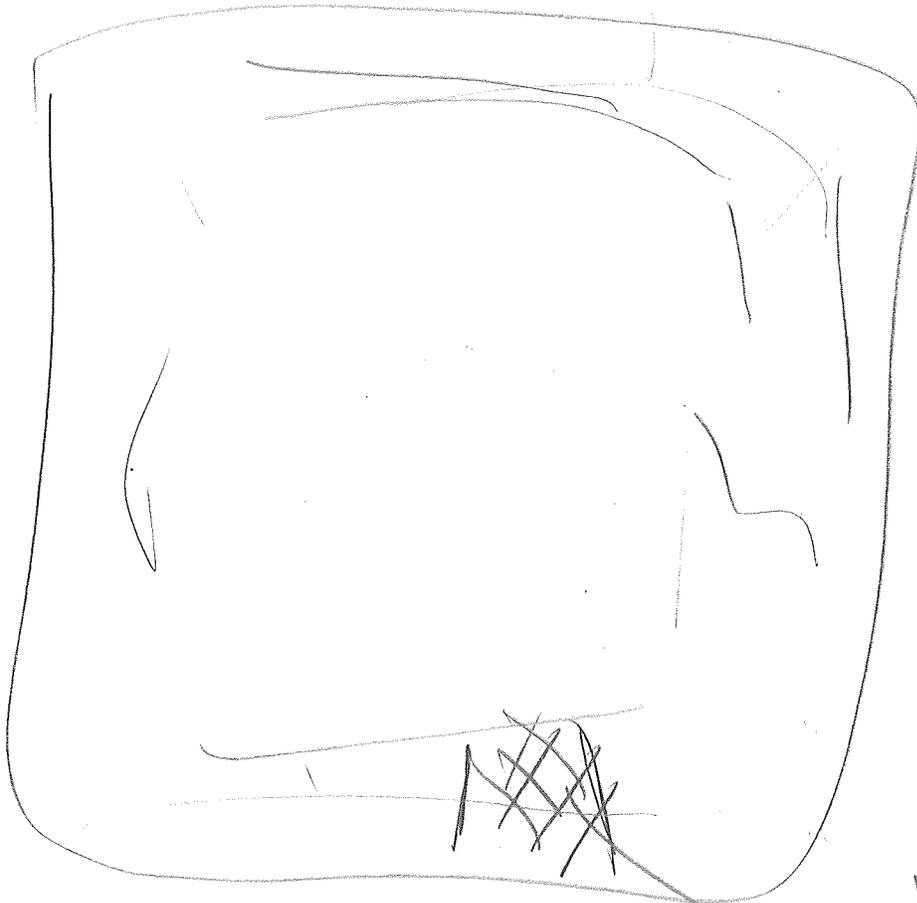
across
pasture
two trees
sent out

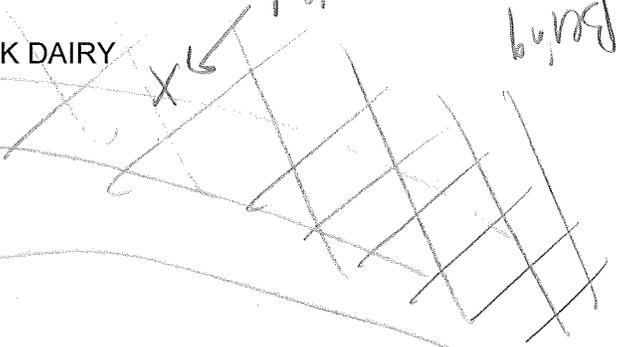
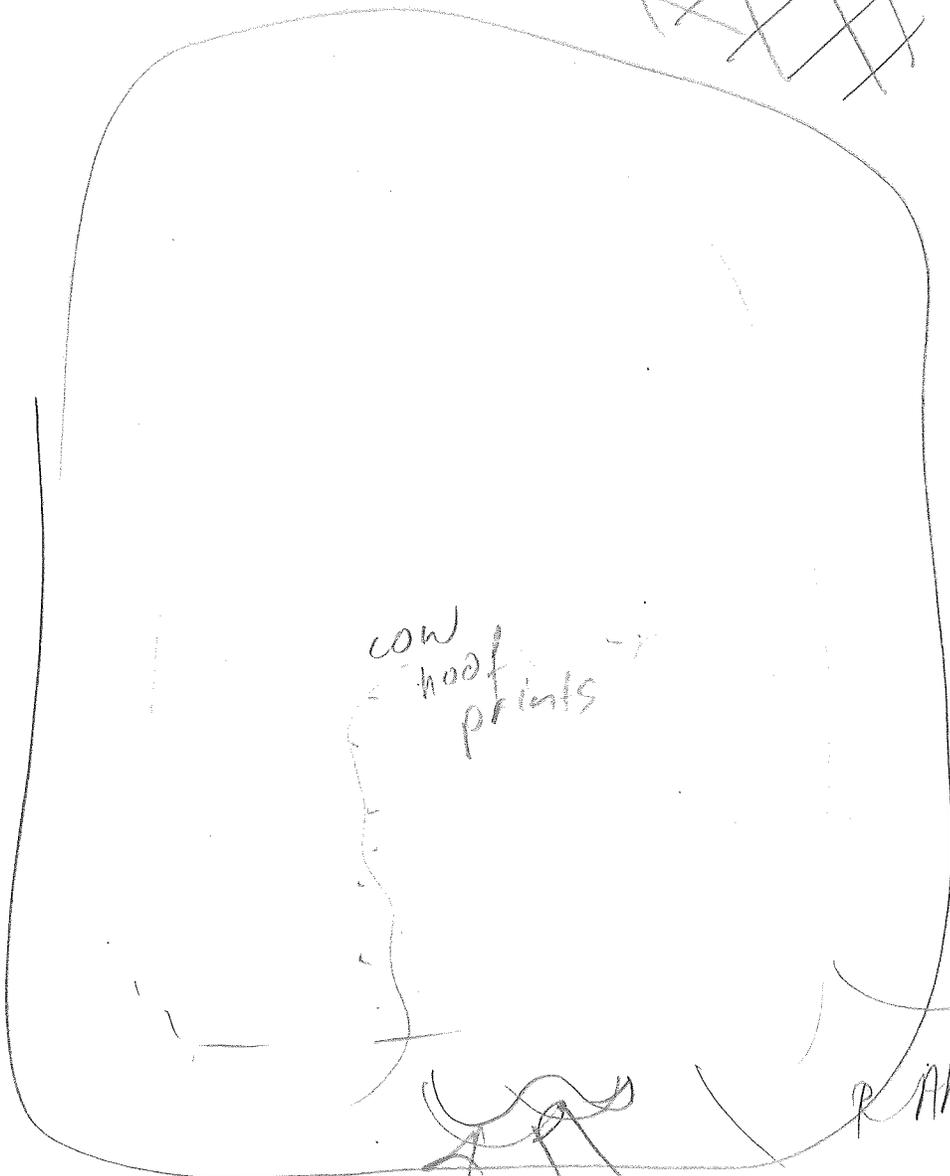
stream ditch
at or under
Boring
