## **4.0 PROCESS INFORMATION**

### **4.2 COMPONENT CHEMICAL WASTE TANK (CCWT)**

## Tank Integrity Assessment Report for Areva Component Chemical Waste Tank System

## VET-1583-RPT-001

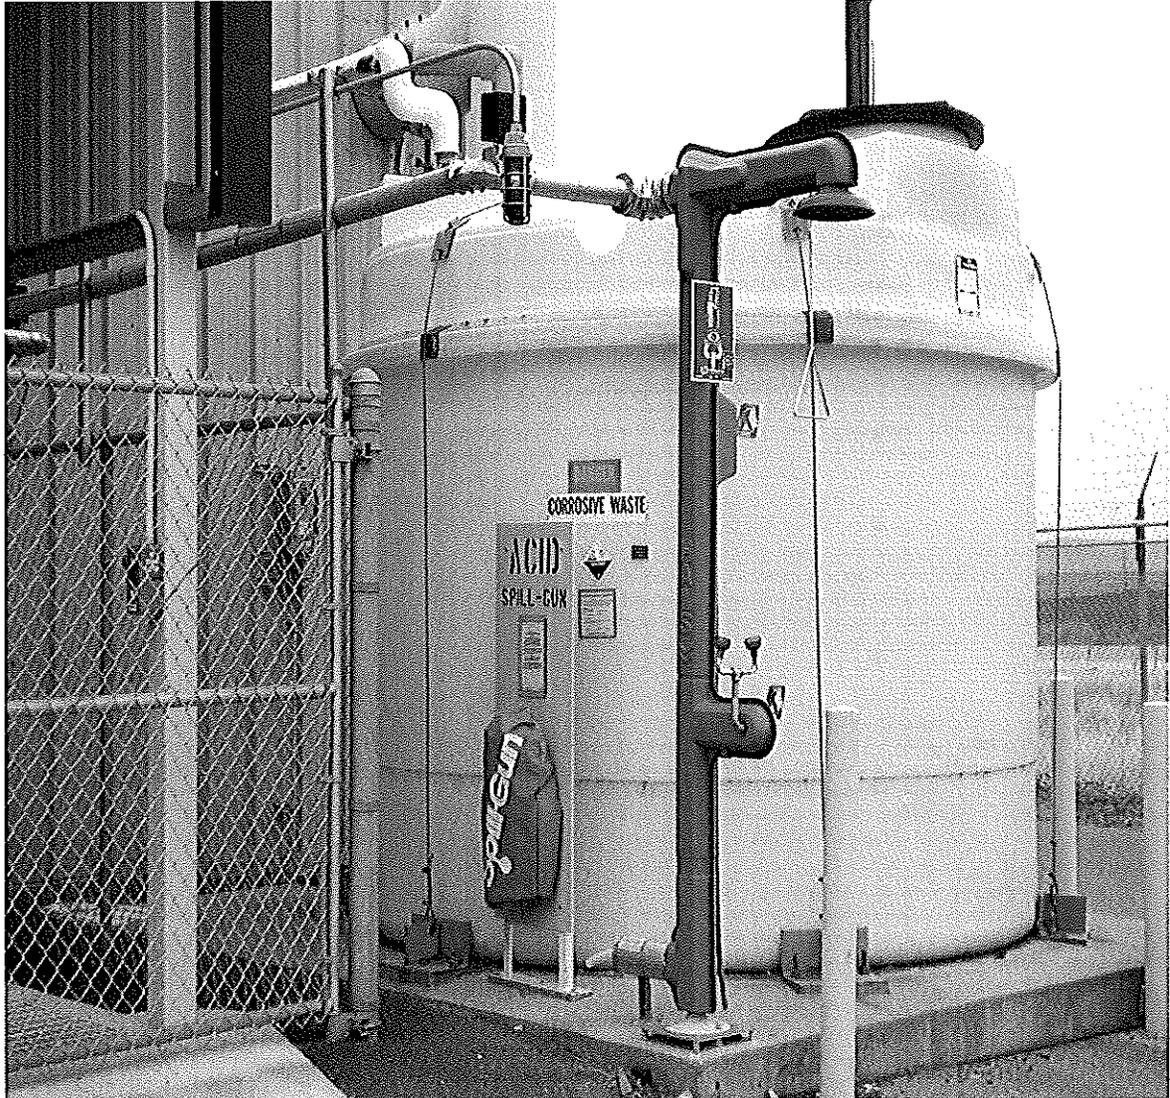
Attachment 4.1 Component Chemical Waste Tank

The Component Chemical Waste Tank (CCWT) is a 2,000 gallon capacity, high-density cross-linked polyethylene, double containment vessel (see Attachment 4.1). The inner tank is 7'5" O.D. and 7'2" high, while the outer tank is

10' O.D. Per applicable American Society for Testing and Materials (ASTM) - 1998-91 standards at the time the tanks were manufactured, the minimum wall thickness of either tank is 0.187". Shell thickness of high-density cross-linked polyethylene is not expected to diminish during the lifespan of the tank. The outer tank is constructed of two sections which are mated together above the containment level using a bolted flange. The tanks are fabricated as seamless, one-piece construction with no linings or coatings. Because the tanks and ancillary equipment are non-metallic, corrosion protection is not required.
