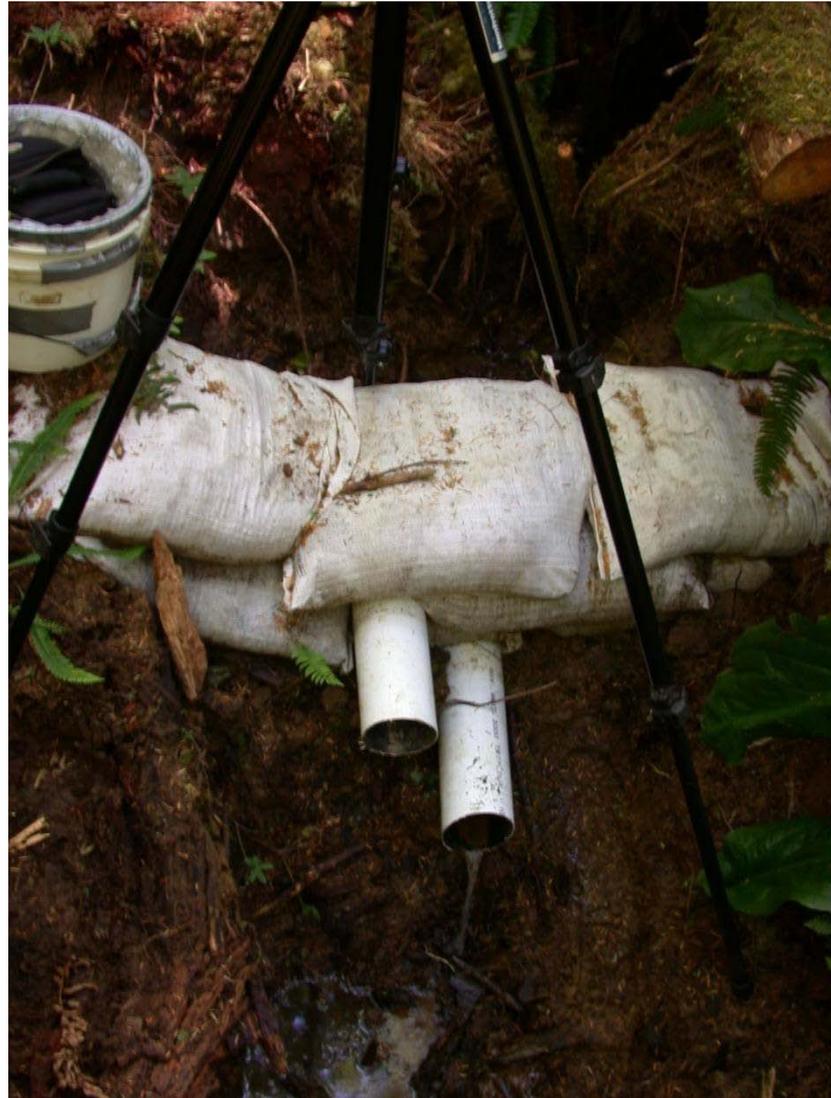
Pre-logging condition of a study channel showing a camera tripod straddling a sandbag weir and typical trickling late-summer flow.

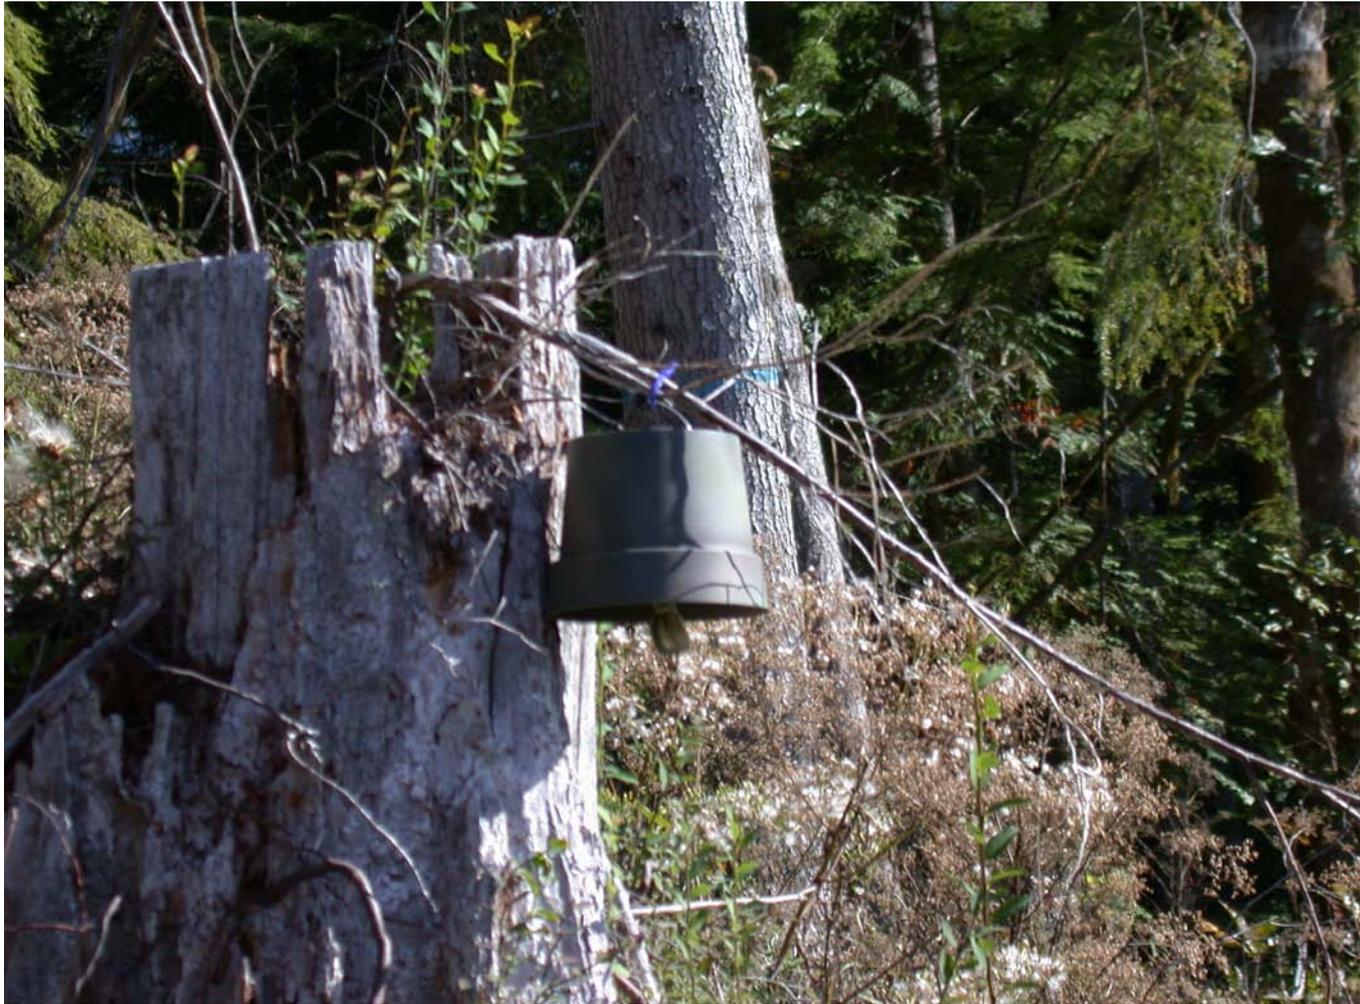
Air temperature monitoring in a clearcut study catchment, showing data logger suspended from an inverted plastic flower pot -- our shading system.

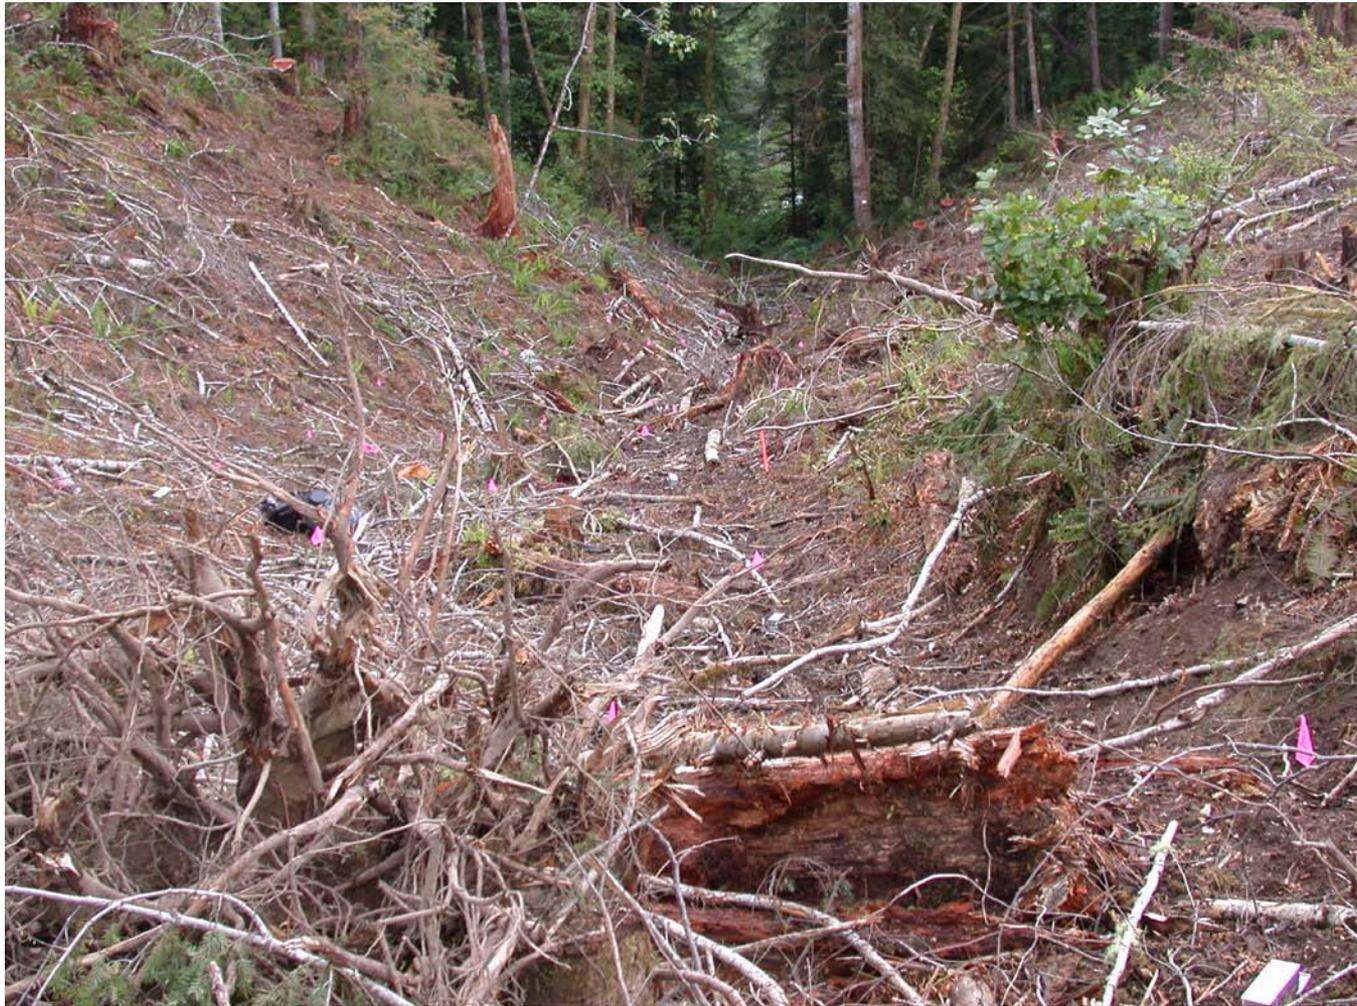
Looking down into a study catchment after clearcutting, showing RMZ edge below (i.e. top of photo).

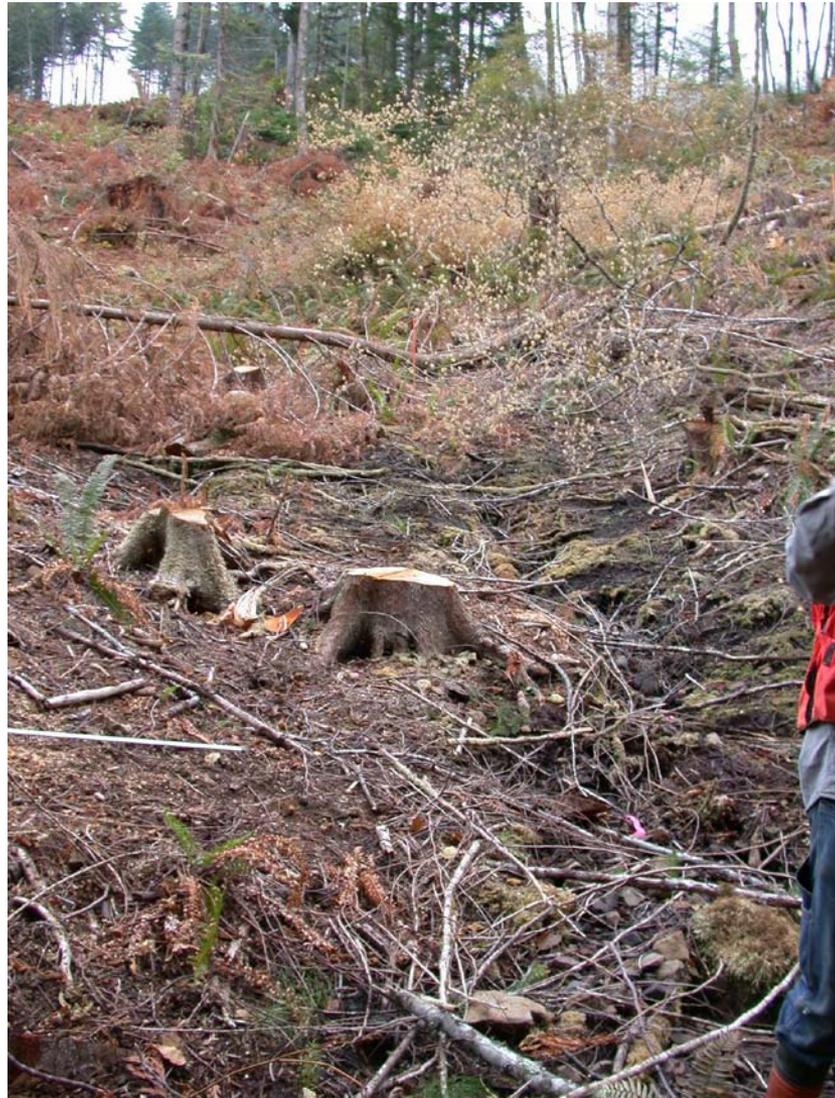
Small study channel after patch cutting,
with part of patch buffer just visible above.

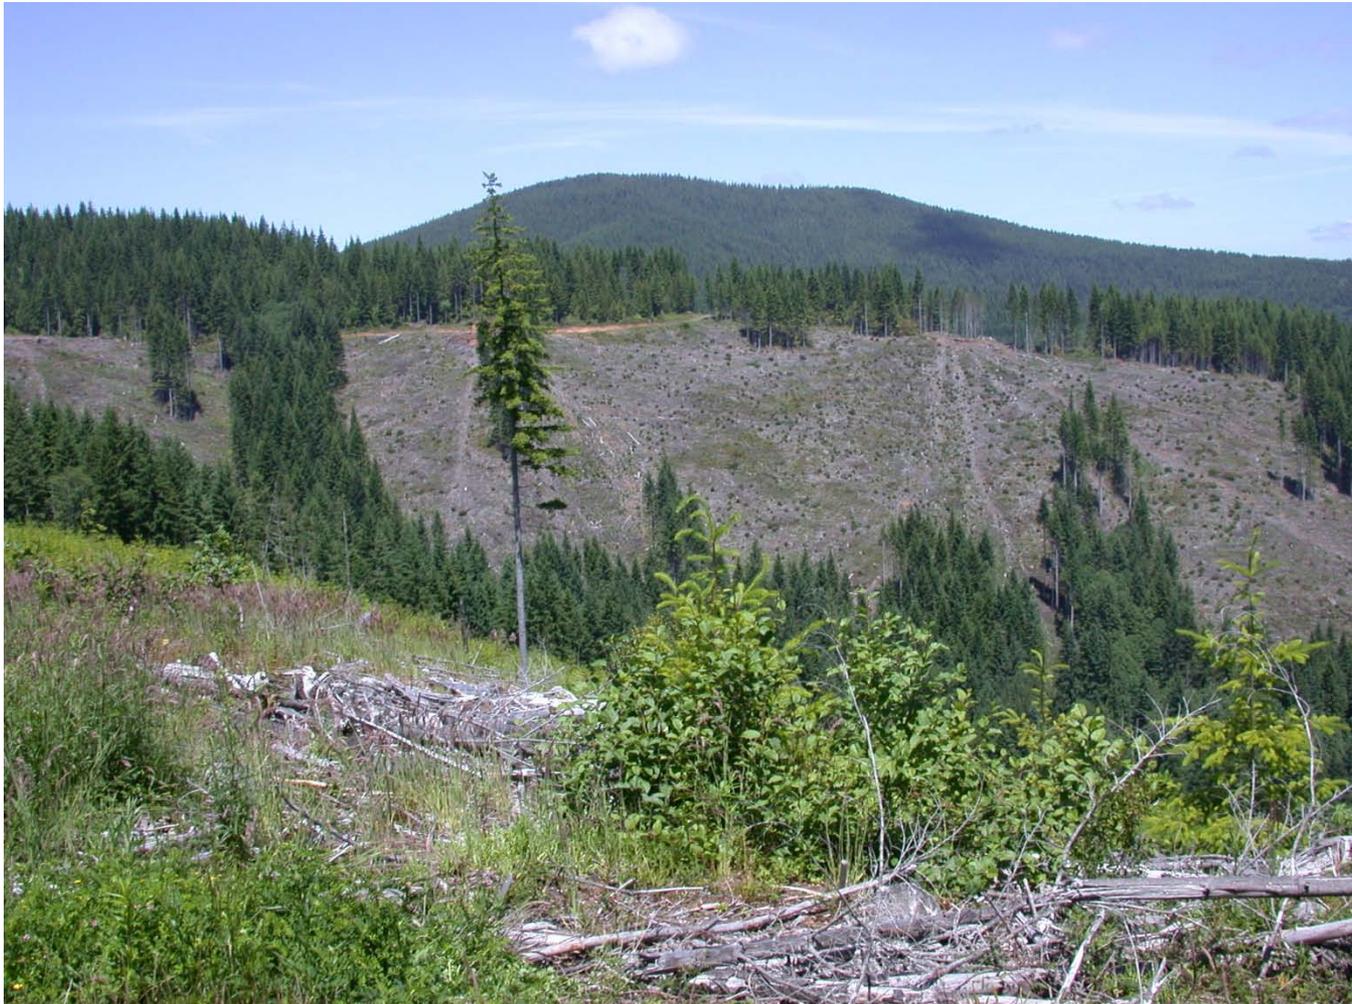
View of one of the harvest units from the opposite basin ridge showing, left to right, a continuously buffered channel, a clearcut channel, and a mixture of leave tree areas and patch buffers.

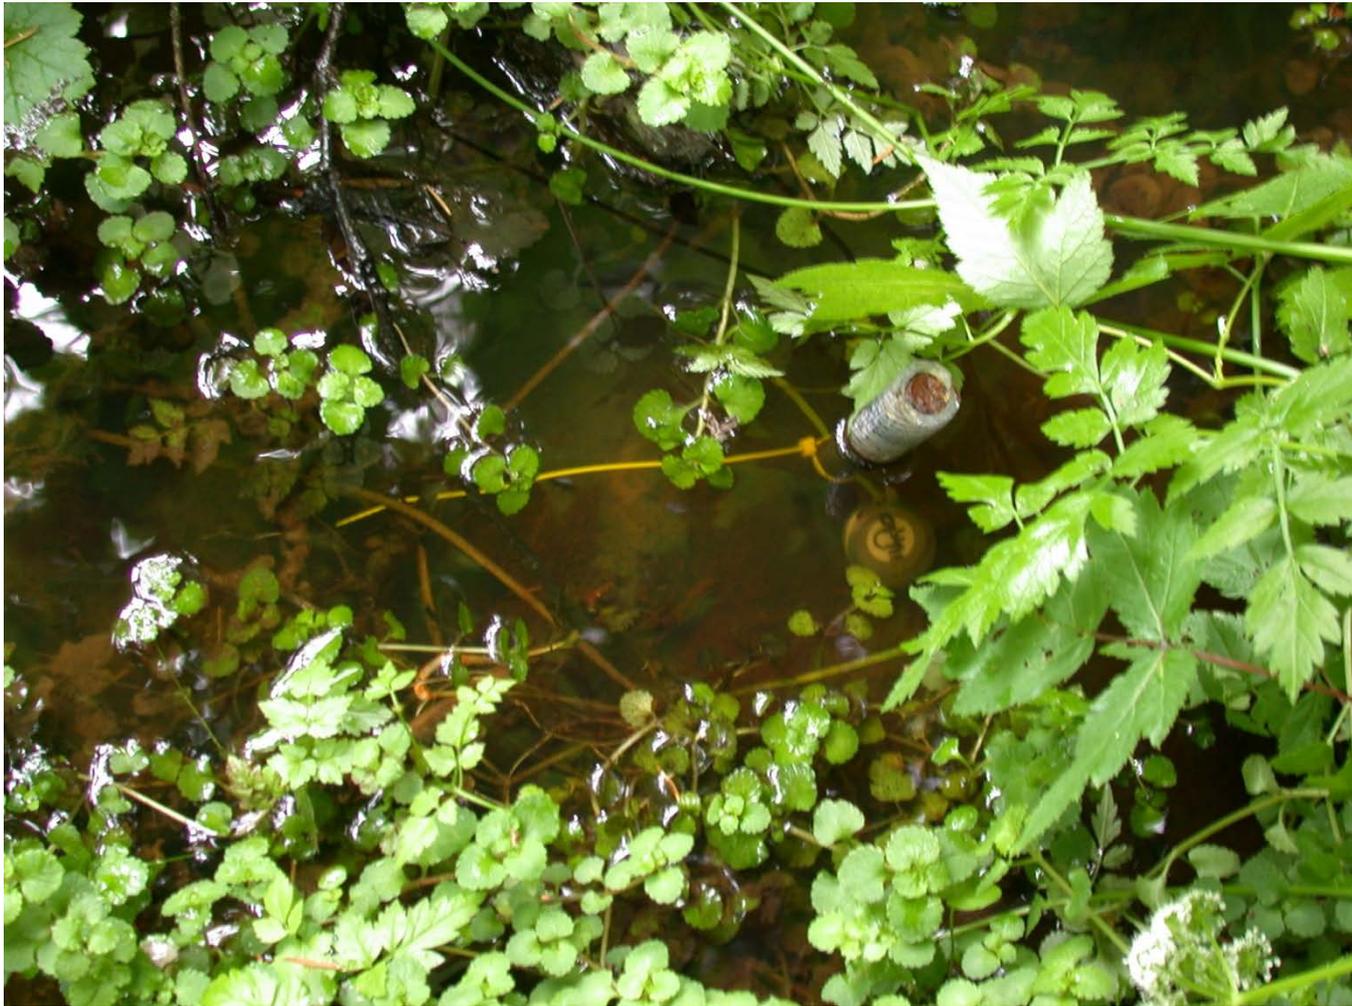
Water temperature station, showing data logger tied to capped rebar in shallow flowing pool.

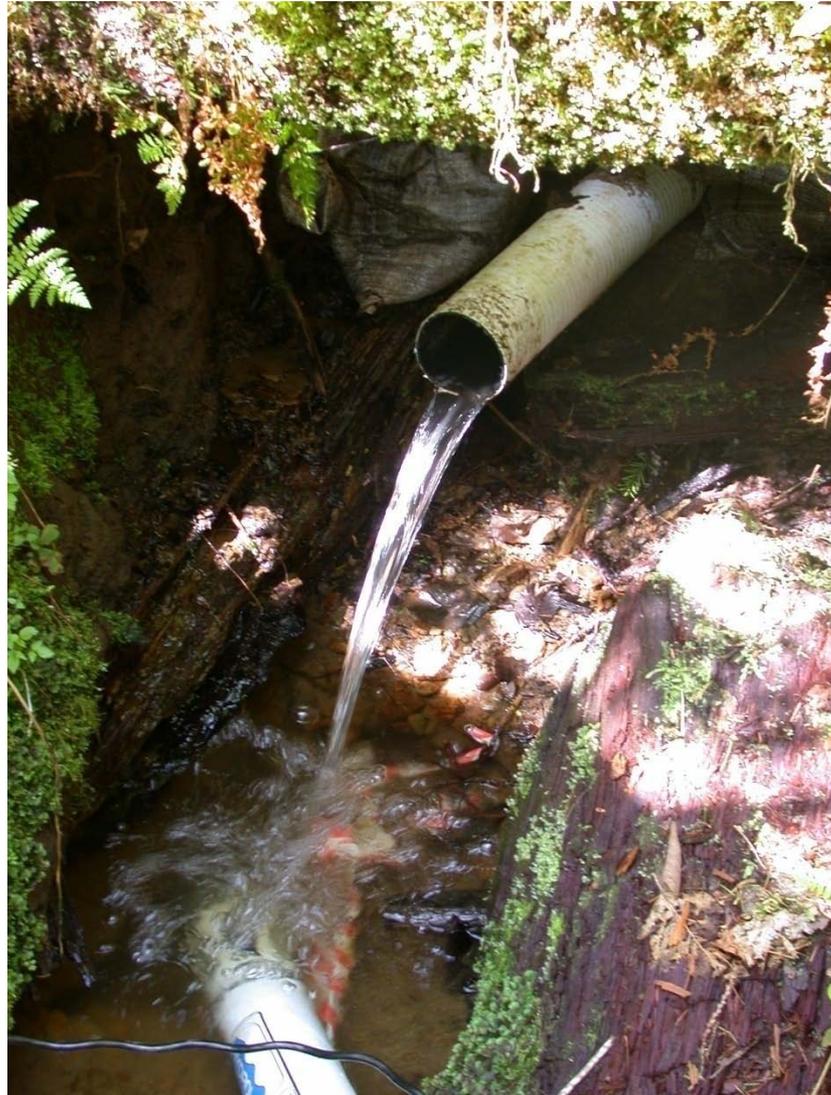
Estimation of early summer stream velocity at weir via Hydrolab trials.

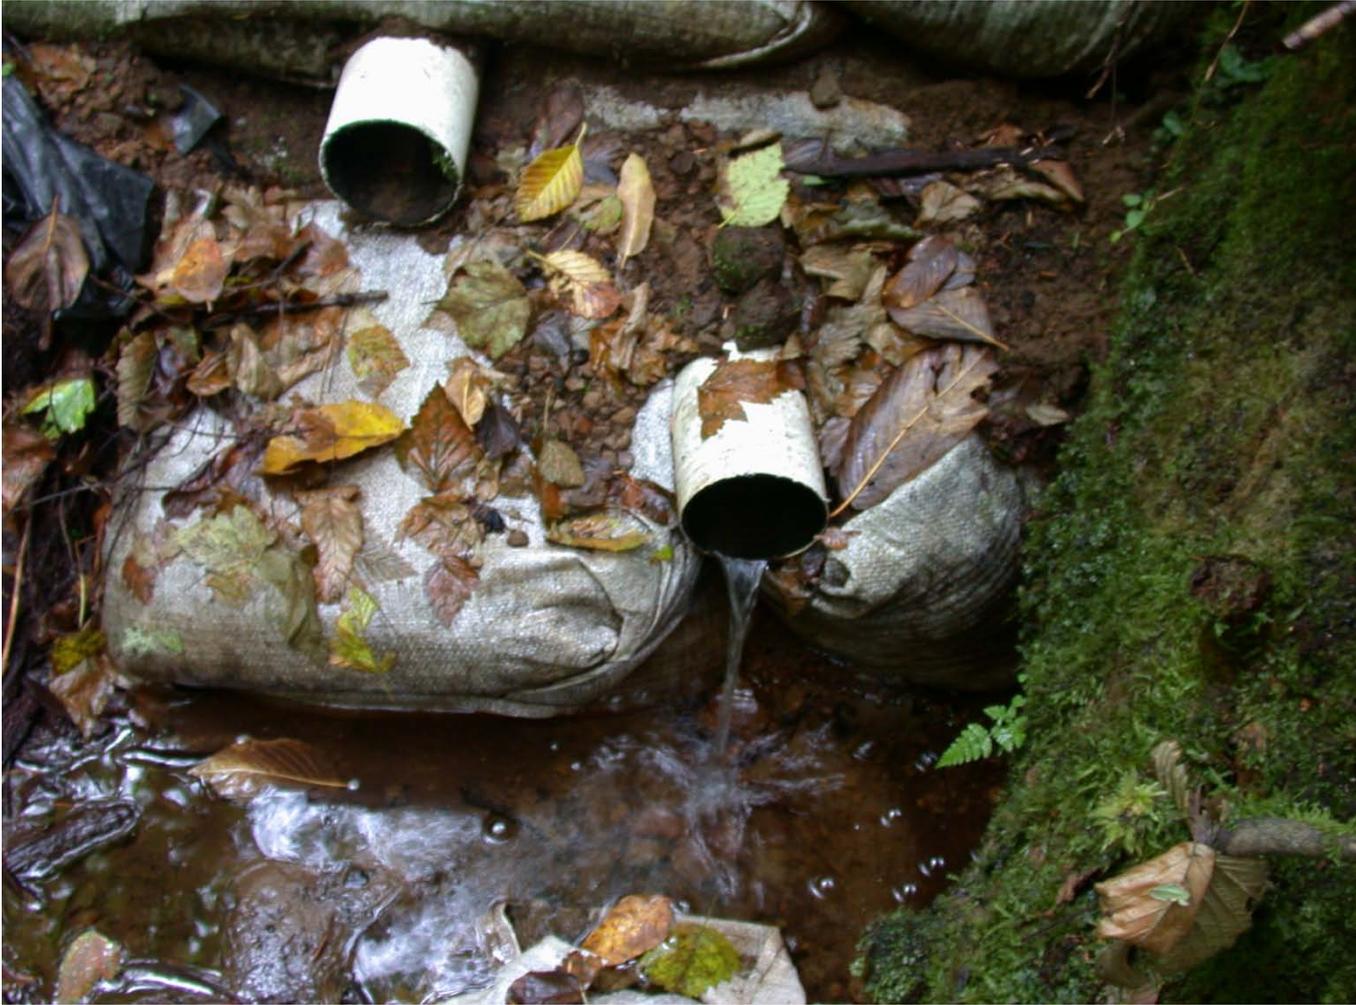
Autumn low flow at sandbag weir.

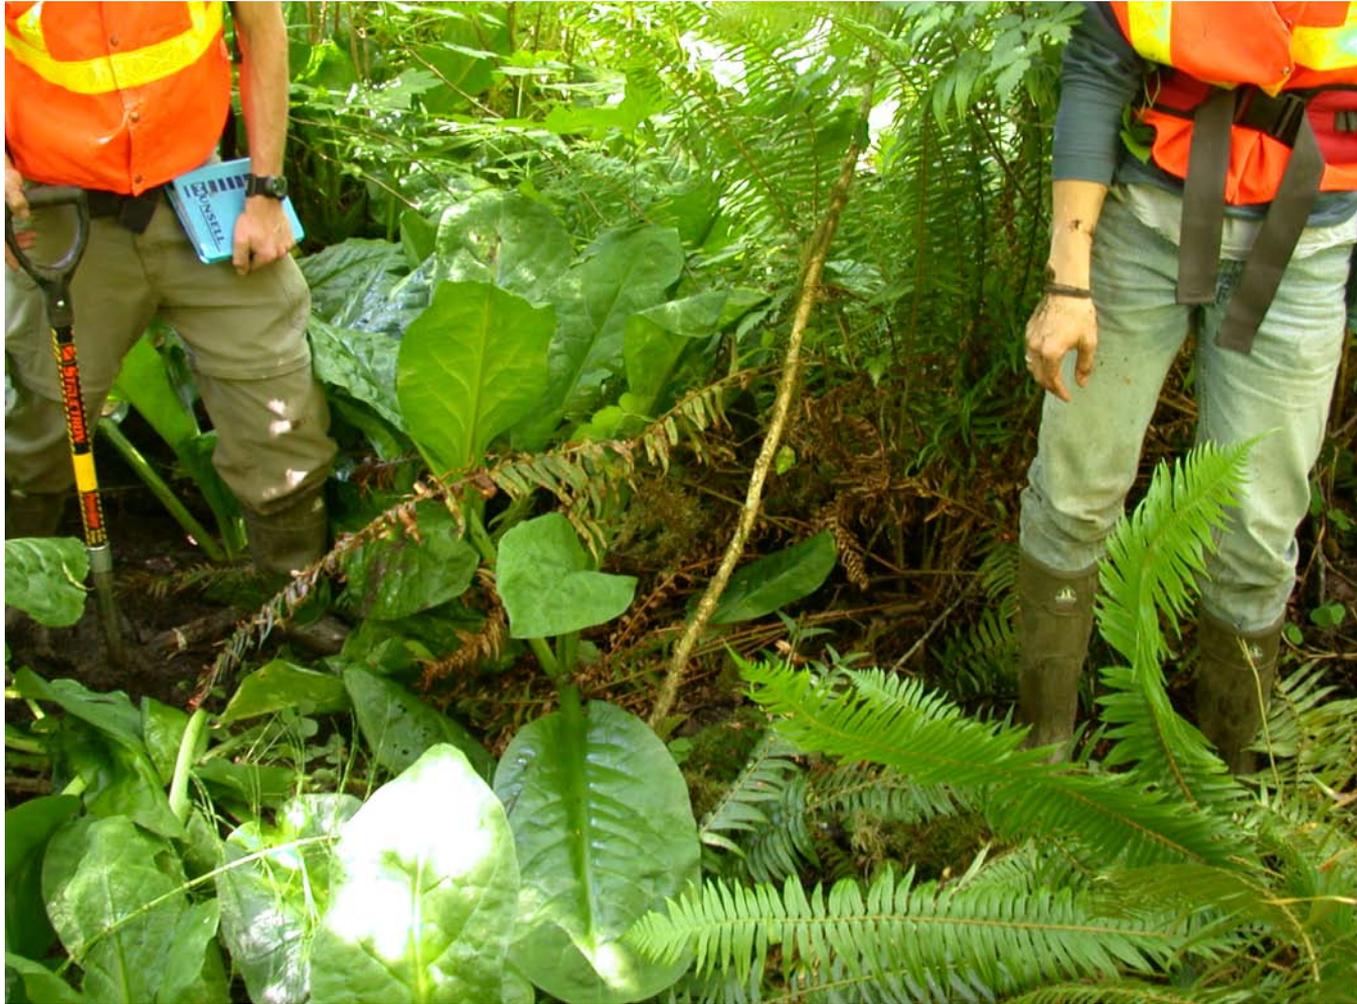
Abrupt transition between wetland soils (left) and upland soils (right)—headwaters wetland survey.

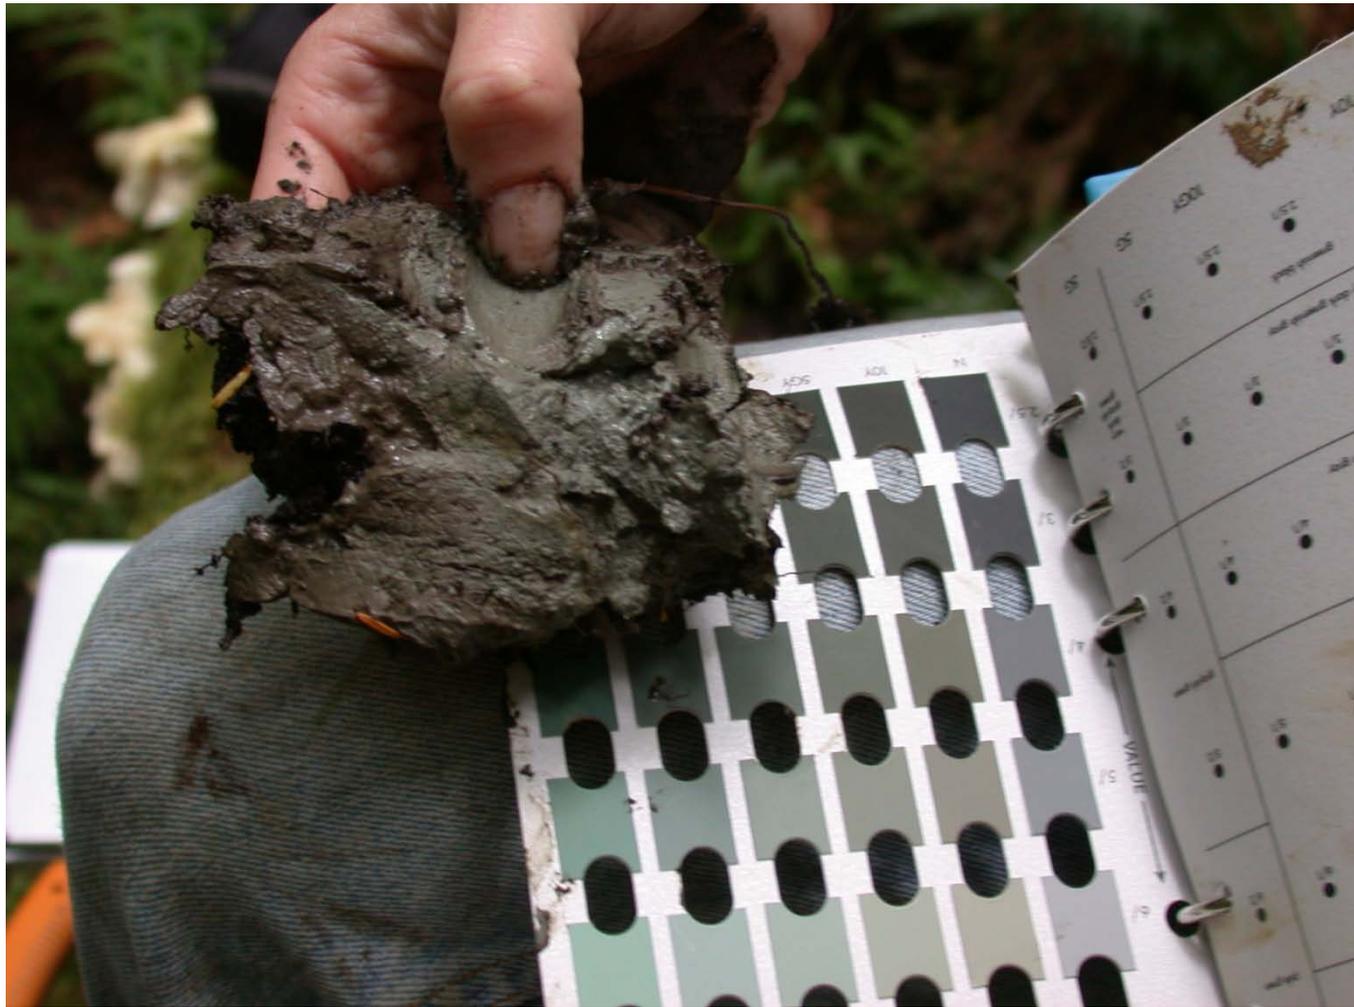
Examining gleyed soils—headwaters wetland survey.

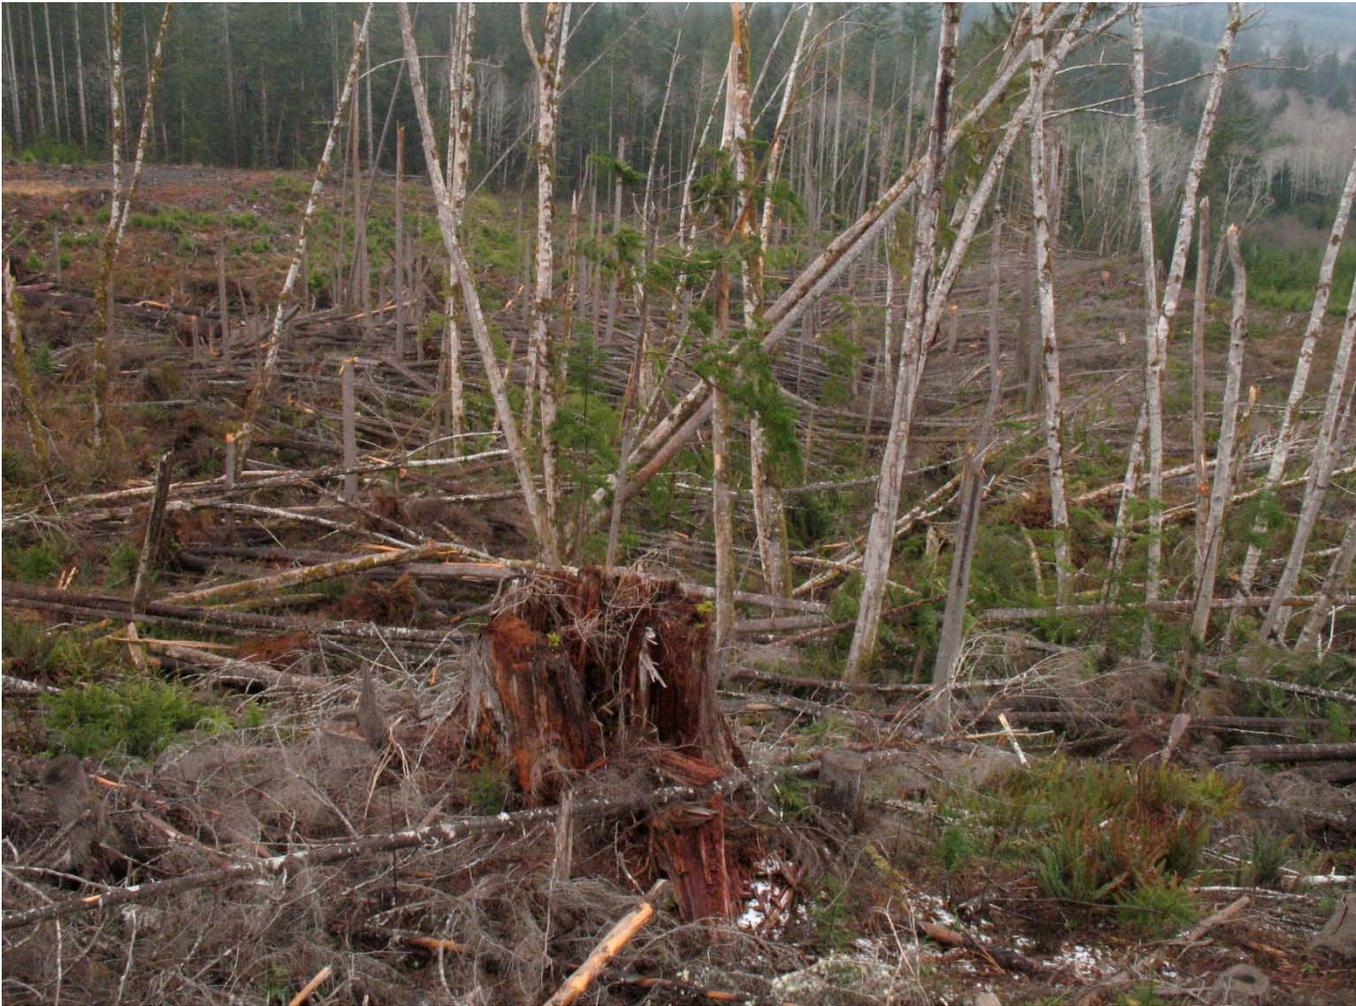
Remains of continuous buffer applied to study channel after 2007 windstorm. Study channel is visible as a subtle v-shaped depression just to the right of the stump and cutting through the center of the wind-throw.

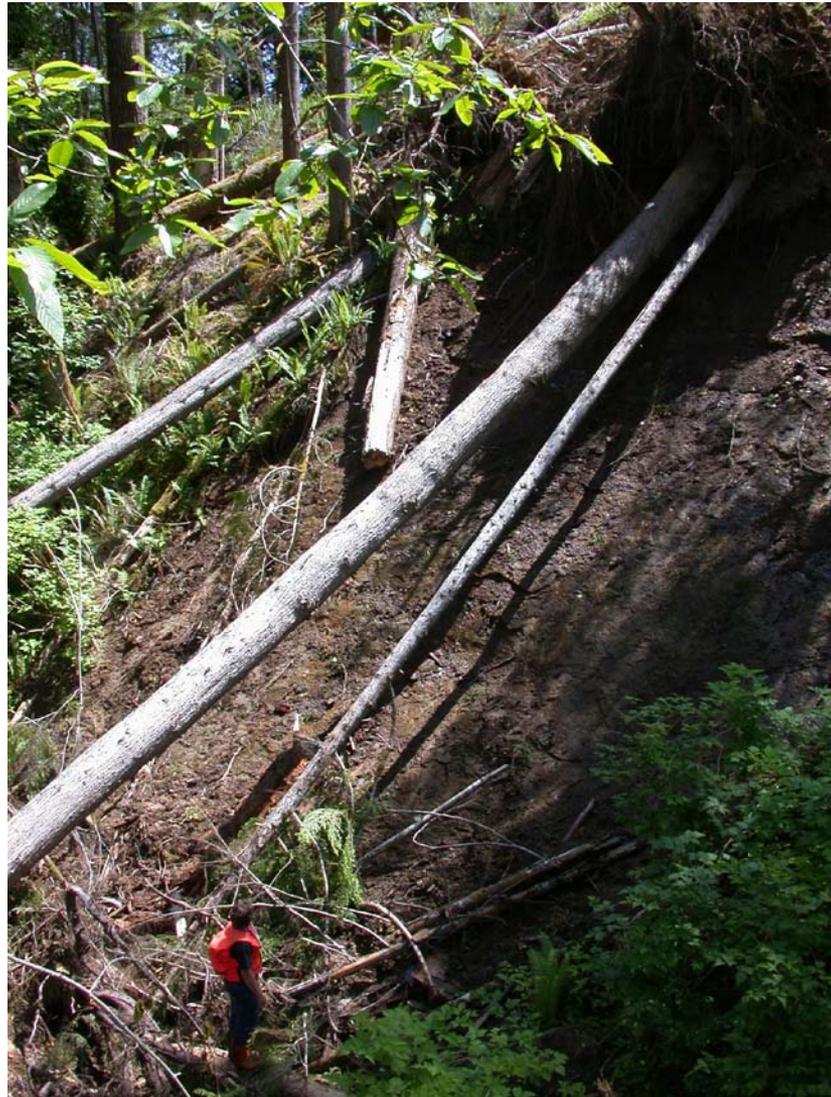
Slide into channel exposing marine sediments.

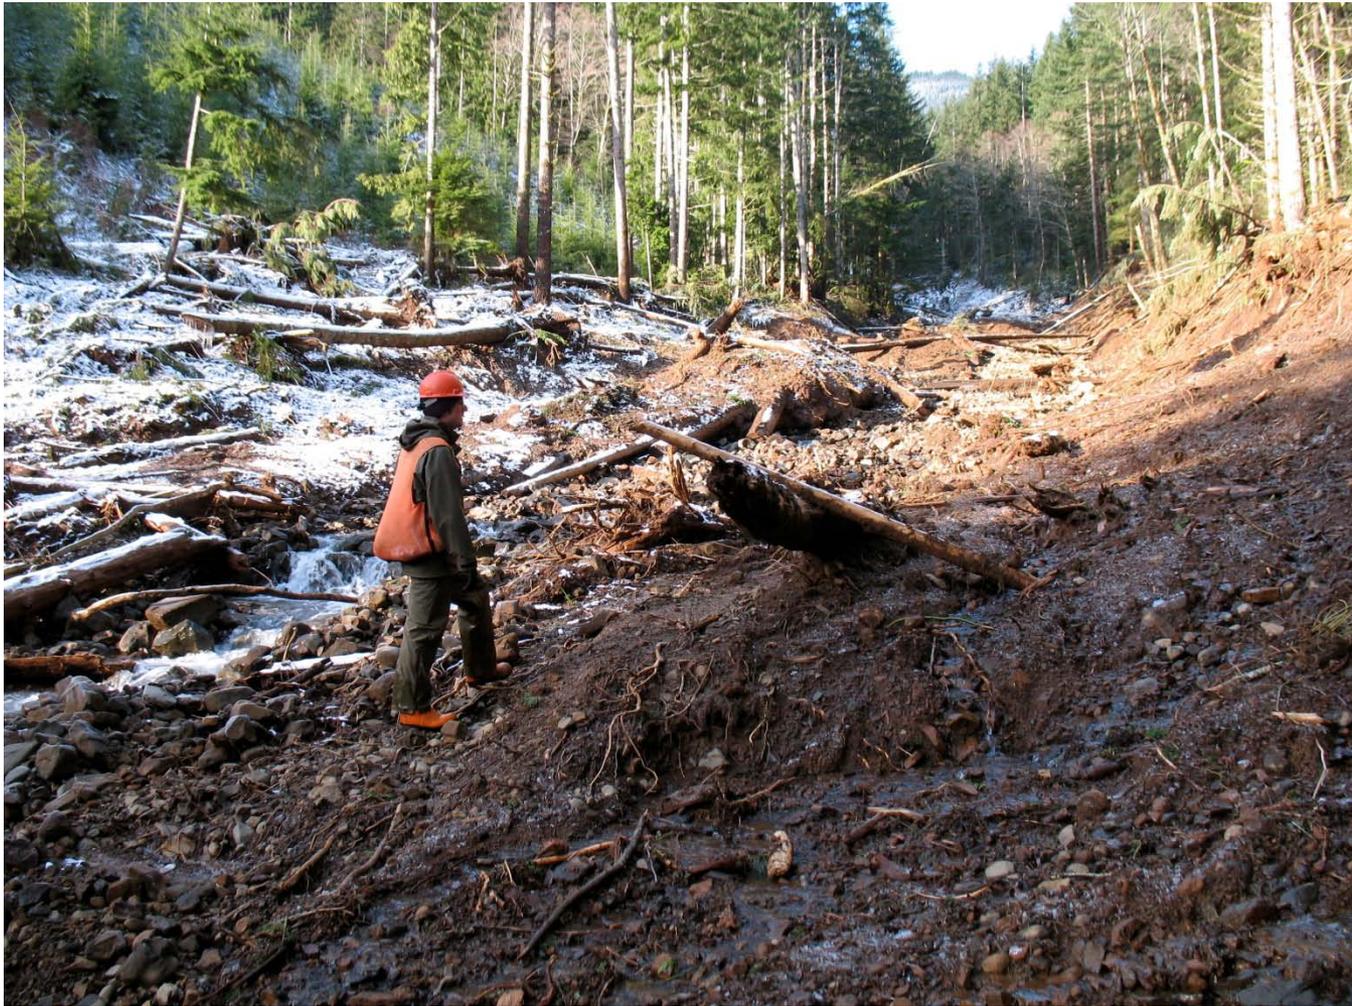
Upchannel on study site mainstem after 2007 storm debris flow. This event has become an opportunity to study stream recovery.
