State of Washington Department of Ecology
Cruise Ship Memorandum of Understanding, Cruise Operations in Washington State Inspection Report

Amy Jankowiak, Washington State Department of Ecology (Ecology) Northwest Regional Office, Water Quality Program (NWRO-WQ) conducted the inspection of the Carnival Cruise Line CARNIVAL SPIRIT on September 13, 2011. The main contact on board the CARNIVAL SPIRIT was Prabhashan Kuttan, Safety Environmental Health Officer for the CARNIVAL SPIRIT. Prior notification of the visit was given on September 6, 2011 for security protocol. The purpose of the inspection was to evaluate compliance with the *Memorandum of Understanding Cruise Operations in Washington State (MOU)*, as amended and to follow up on an unauthorized discharge that was reported by Carnival Cruise Line and occurred on September 5, 2011. The CARNIVAL SPIRIT is not approved to discharge in MOU waters. The vessel has not been discharging and is holding effluent until outside MOU waters, with the exception of the one unauthorized discharge.

The CARNIVAL SPIRIT was built in 2001 and is 963 feet long with an estimated capacity of 2680 passengers and 961 crew.

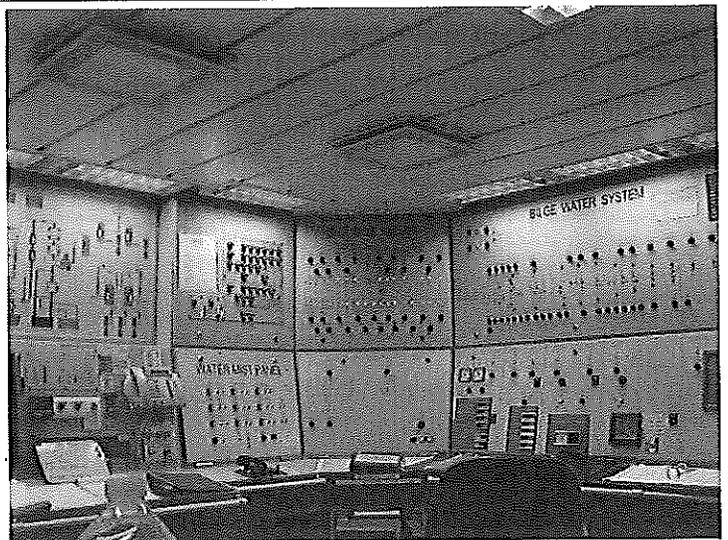
PHOTO #:02 DATE: SEPTEMBER 13, 2011
TAKEN BY: AMY JANKOWIAK FILE No.:P9130017
DESCRIPTION: ENGINE CONTROL ROOM

The discharge policy is to not discharge any treated or untreated blackwater or graywater in waters of the MOU, within 12 nm from land, in the Olympic Coast National Marine Sanctuary (OCNMS) or in special areas. The discharge protocol for wastewater includes setting out a plan at the beginning of the cruise season and then the bridge gives approval to the engineer on watch that they are in an area to discharge or that all discharge ports must be closed. The ports are closed about 1 hour before entering MOU waters. Discharges are then recorded both on the bridge log and the control room discharge log book. The Chief Officer verifies the records. The discharge ports are padlocked and there is a log for key usage. The ECR also has a light system (photo #03) to show which discharge ports are opened and closed.

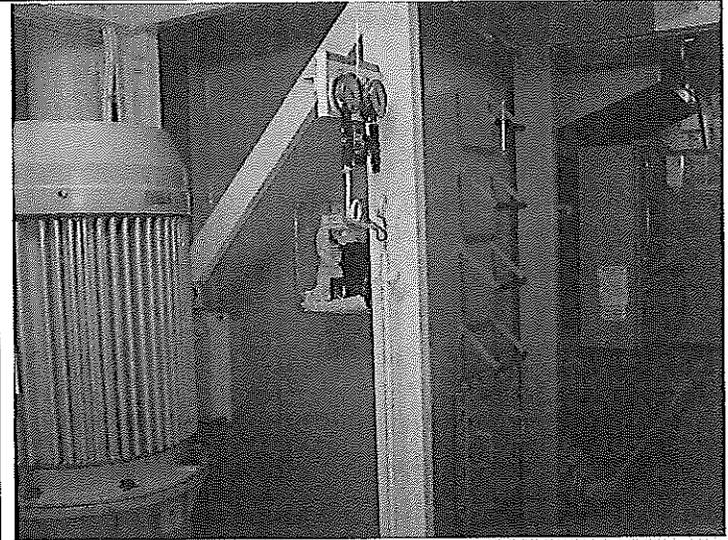
PHOTO #:04 DATE: SEPTEMBER 13, 2011
TAKEN BY: AMY JANKOWIAK FILE No.:P9130021
DESCRIPTION: MARINE SANITATION DEVICE

The vessel includes three different types of wastewater treatment. There is a traditional marine sanitation device, Triton, which is used for blackwater treatment and includes screening, aeration, settling and chlorination (photos #05, #06, and #07). There is an advanced wastewater treatment system (AWTS) for blackwater (photos #15, #16, #17, #18, #19 and #20) that has not been working and is not being used at all. And there is an AWTS for accommodation graywater only that is a Rochem low pressure reverse osmosis system (photos #08, #09, #10, and #11) with UV disinfection (photo #12) that is only used when in special areas of Alaskan waters and is not used at all while in MOU waters. Laundry, galley and other graywater does not go through any wastewater treatment system and is held separately and then discharged outside of MOU waters. No discharges occur in the Olympic Coast National Marine Sanctuary. Medical floor drains go to the blackwater collection tanks.

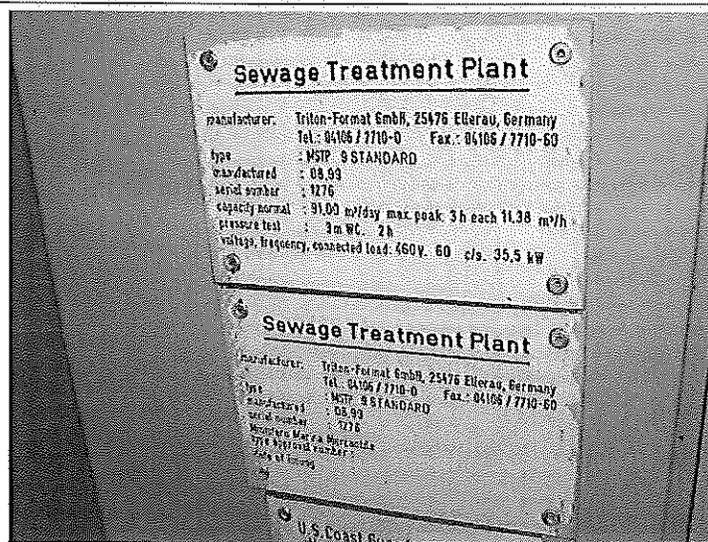
PHOTO #:05 DATE: SEPTEMBER 13, 2011
TAKEN BY: AMY JANKOWIAK FILE No.:P9130022
DESCRIPTION: MARINE SANITATION DEVICE - TRITON

There are four Triton units on board. Blackwater is collected by vacuum to collection tanks and then to a feed unit that disperses the blackwater to the four units. Each unit includes screening, aeration, settling and chlorination. Analysis is done for DO, solids and chlorine to assure proper operations and dosing.

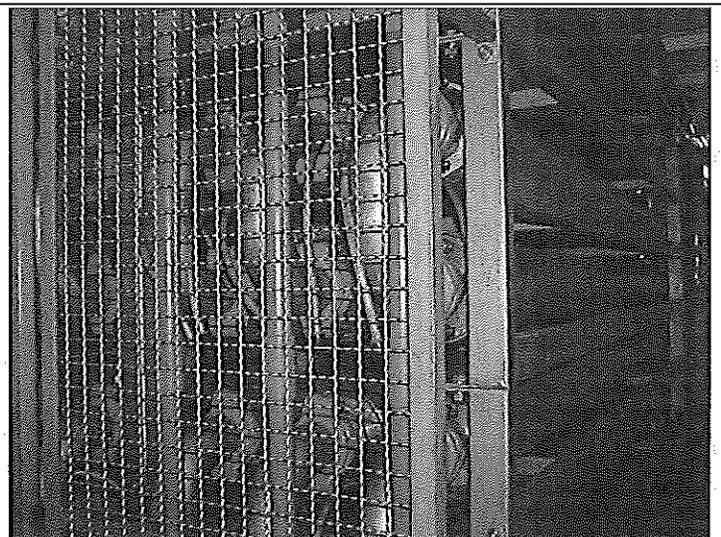
PHOTO #:08 DATE: SEPTEMBER 13, 2011
TAKEN BY: AMY JANKOWIAK FILE No.:P9130025
DESCRIPTION: ROCHEM AWTS FOR GRAYWATER FILTERS

The Rochem low pressure reverse osmosis system is used for accommodation graywater while in Alaskan waters. It includes collection, screening with a SWECO filters, reverse osmosis filtration, and ultraviolet light disinfection.

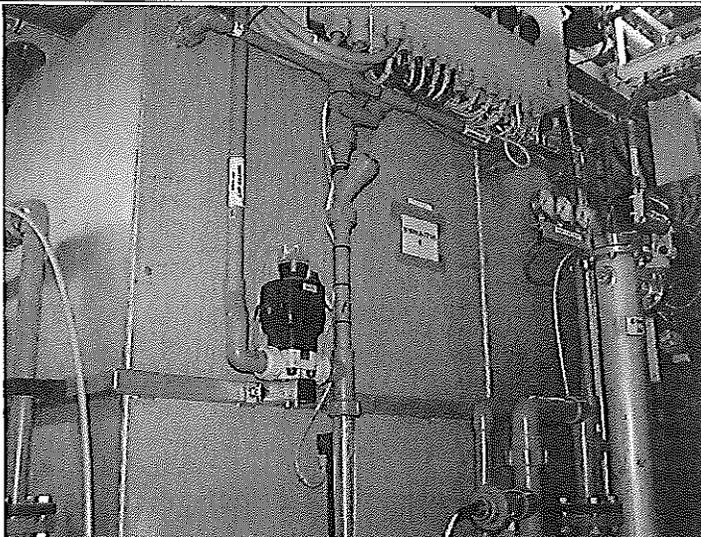
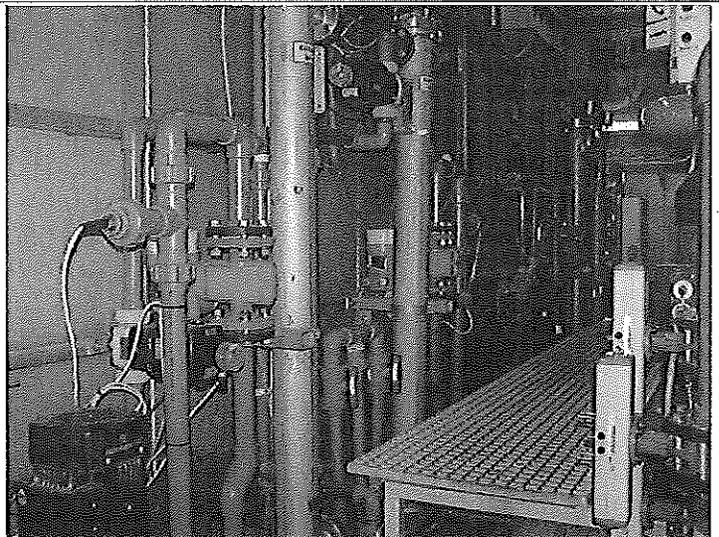
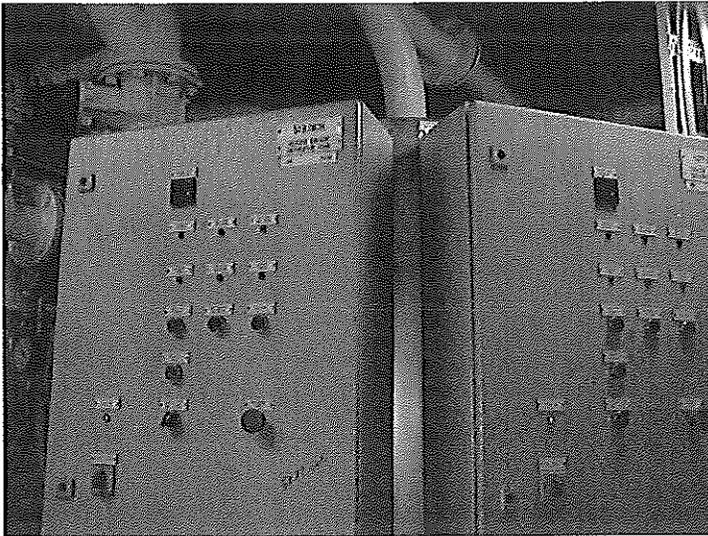
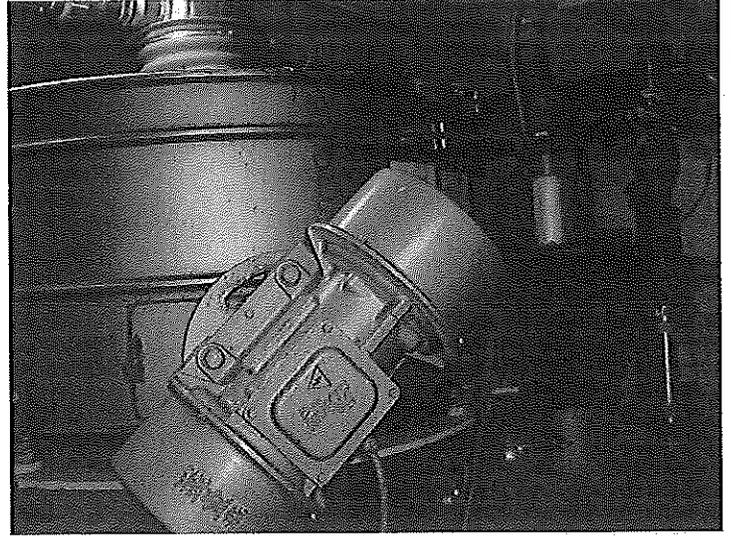
PHOTO #:15 DATE: SEPTEMBER 13, 2011
TAKEN BY: AMY JANKOWIAK FILE No.:P9130029
DESCRIPTION: AWTS FOR BLACKWATER (NOT WORKING)

PHOTO #:16 DATE: SEPTEMBER 13, 2011
TAKEN BY: AMY JANKOWIAK FILE No.:P9130030
DESCRIPTION: AWTS FOR BLACKWATER (NOT WORKING)

PHOTO #:17 DATE: SEPTEMBER 13, 2011
TAKEN BY: AMY JANKOWIAK FILE No.:P9130031
DESCRIPTION: AWTS FOR BLACKWATER (NOT WORKING)

PHOTO #:18 DATE: SEPTEMBER 13, 2011
TAKEN BY: AMY JANKOWIAK FILE No.:P9130032
DESCRIPTION: AWTS FOR BLACKWATER (NOT WORKING)

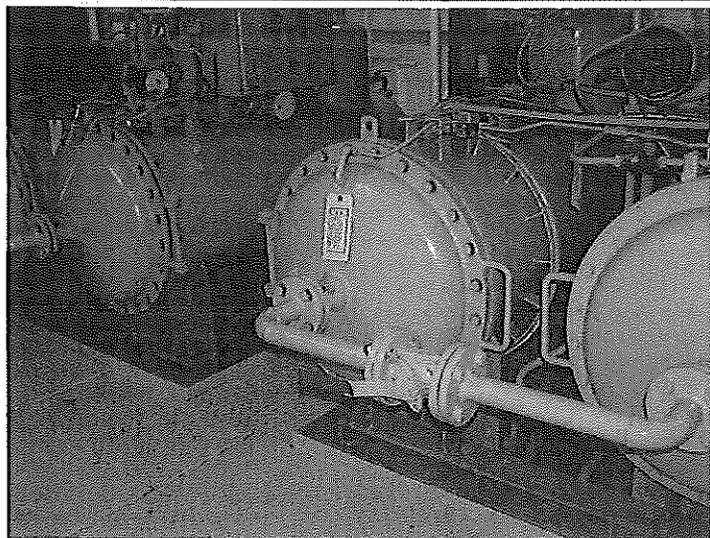
PHOTO #:21 DATE: SEPTEMBER 13, 2011
TAKEN BY: AMY JANKOWIAK FILE No.:P9130039
DESCRIPTION: OILY WATER SEPARATOR SYSTEM FOR OILY
BILGE WATER

Oily bilge is treated and with a Norddeotche oily water separator system (photo #21). Discharges occur at less than 15 ppm and outside of MOU waters. A white box (photo #22) is used to prevent discharges of more than 15 ppm. Oily sludge is drummed and offloaded for proper disposal.

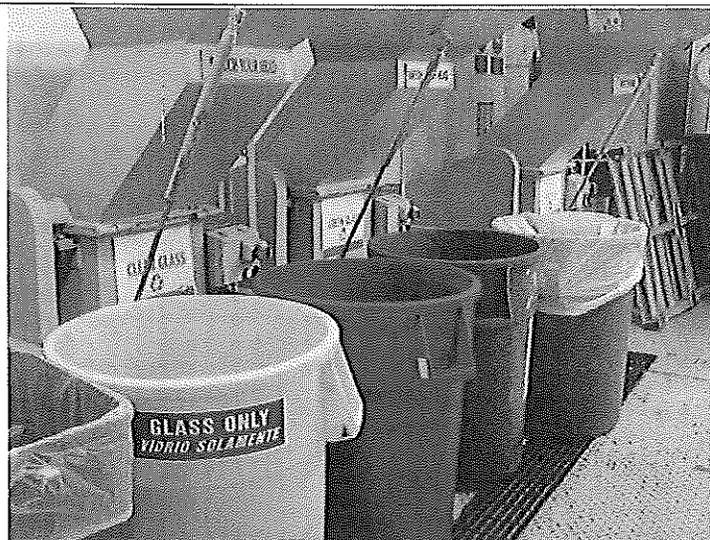
PHOTO #:23 DATE: SEPTEMBER 13, 2011
TAKEN BY: AMY JANKOWIAK FILE No.:P9130041
DESCRIPTION: GARBAGE ROOM - GLASS SORTING/CRUSHING

Solid waste (garbage, recyclables, etc.) is managed properly. The various solid waste streams are collected, sorted, stored, and sent ashore or incinerated as appropriate. The garbage record book was reviewed and showed consistency with requirements. Glass is recycled (photo #23) and not discharged.

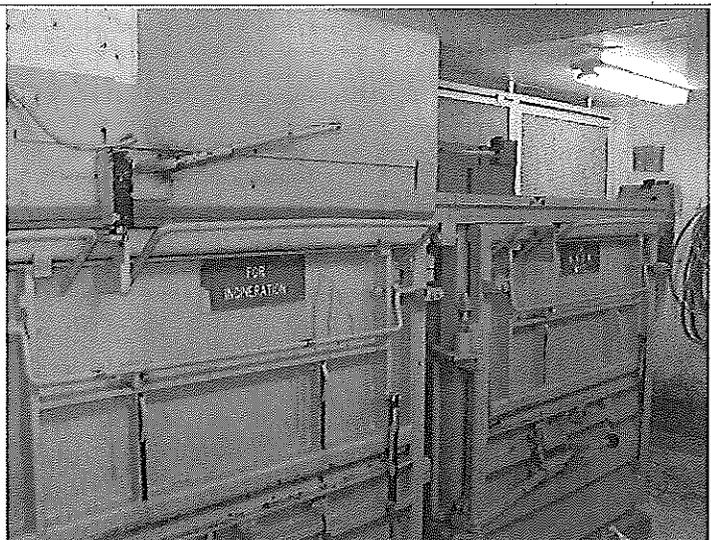
PHOTO #:24 DATE: SEPTEMBER 13, 2011
TAKEN BY: AMY JANKOWIAK FILE No.:P9130043
DESCRIPTION: CARDBOARD COMPACTOR FOR INCINERATORS

Incinerator ash is offloaded and tested annually. Results have passed. Incinerators (photo #25) are not to be used in MOU waters, >12nm, per protocol. Records showed consistency. Some food waste is incinerated along with some cardboard (photo #24), biohazardous waste, narcotics and other materials.

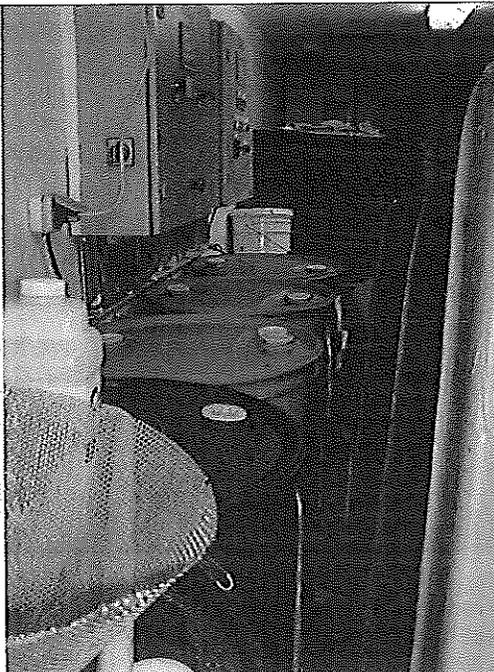
PHOTO #:26 DATE: SEPTEMBER 13, 2011
TAKEN BY: AMY JANKOWIAK FILE No.:P9130045
DESCRIPTION: PHOTO WASTE

Waste from the photo processing is collected, drummed (photo #26) and offloaded as hazardous waste (no silver recovery on board). X-rays are done digitally.

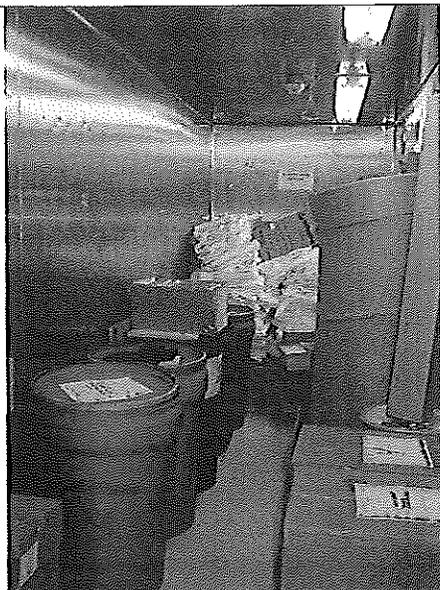
PHOTO #:27 DATE: SEPTEMBER 13, 2011
TAKEN BY: AMY JANKOWIAK FILE No.:P9130046
DESCRIPTION: RECYCLE MATERIALS

Glass, aluminum, tin, scrap metal, some plastics, some paper, cardboard and other materials are recycled (photo #27). Reduction and reuse opportunities are broadly used to prevent the amount of waste.
