CITY OF SUMNER

SHORELINE INVENTORY

**Adolfson Associates, Inc.
5309 Shilshole Avenue NW, Suite 200
Seattle, Washington 98107**

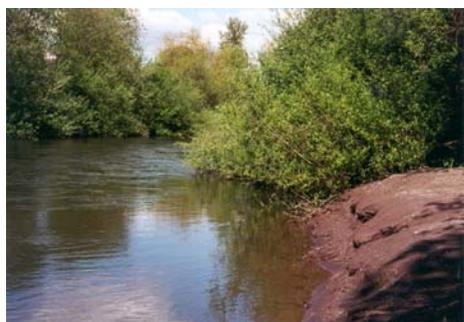
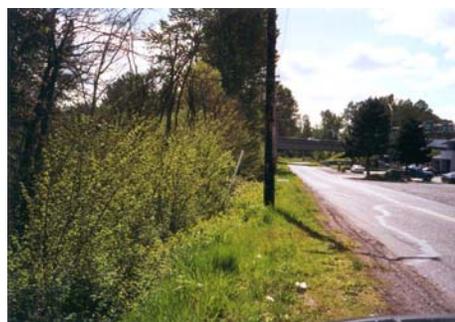
At certain points within this segment, land is cleared to the top of bank, leaving only a limited riparian fringe between the top of the bank and the ordinary high

water mark. Some areas have only a narrow strip of riparian vegetation, approximately 10 to 40 feet wide including big leaf maple, cottonwood, and alder with an understory of snowberry. In other areas, the riparian zone is completely cleared to the river’s edge. Streambank erosion was noted in several of these areas. In most areas within this segment, however, the riparian corridor

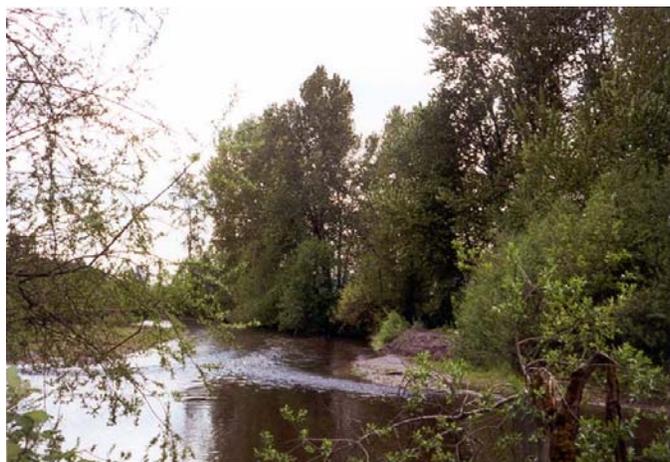
The outfall from the Dieringer Powerhouse/Lake Tapps enters the right bank of the White River at RM 3.5 within this segment. High velocity flows attract migrating adult salmonids into this discharge channel causing delays in their upstream migration.
