WHATCOM CREEK RESTORATION PROJECT REPORT: 2007-2008

**Associated with the
Whatcom Creek Restoration Plan
Developed for the June 10, 1999
Olympic Pipe Line Gasoline Spill**

March 2009

Brenna Forester
City of Bellingham
Department of Environmental Resources
Bellingham, WA

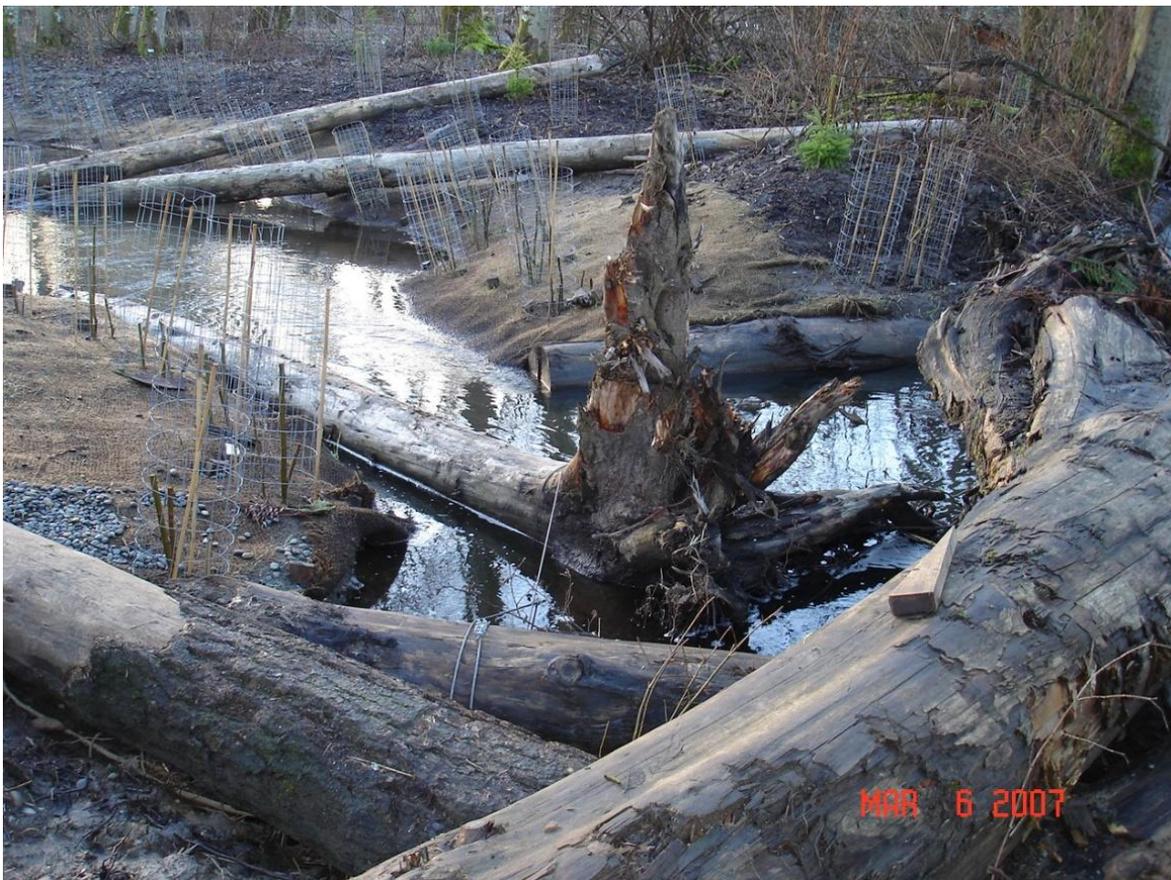
Figure 2-1. Photo showing recently constructed stream channel in Cemetery Creek, with newly planted conifers, willow stakes and deciduous shrubs; March 6, 2007.

Infill planting and the installation of additional willow cuttings occurred the following winter (2007). Supplementary infill planting, including additional sedges in swales and around pond margins occurred in April 2008.

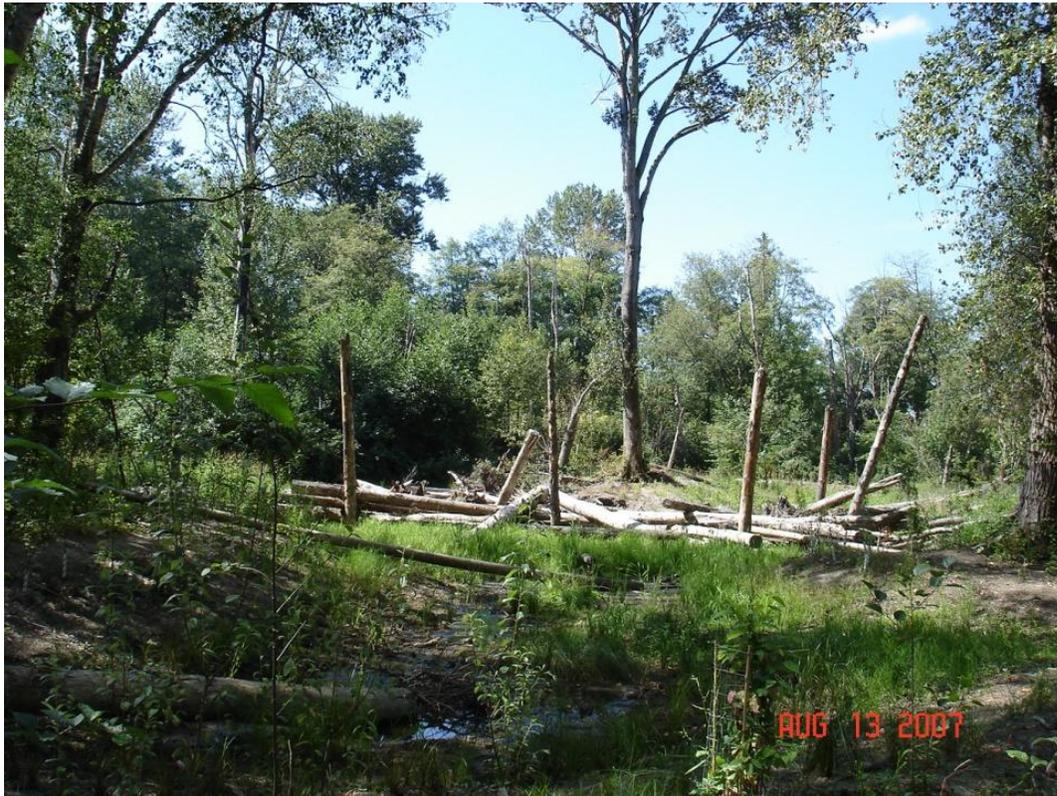
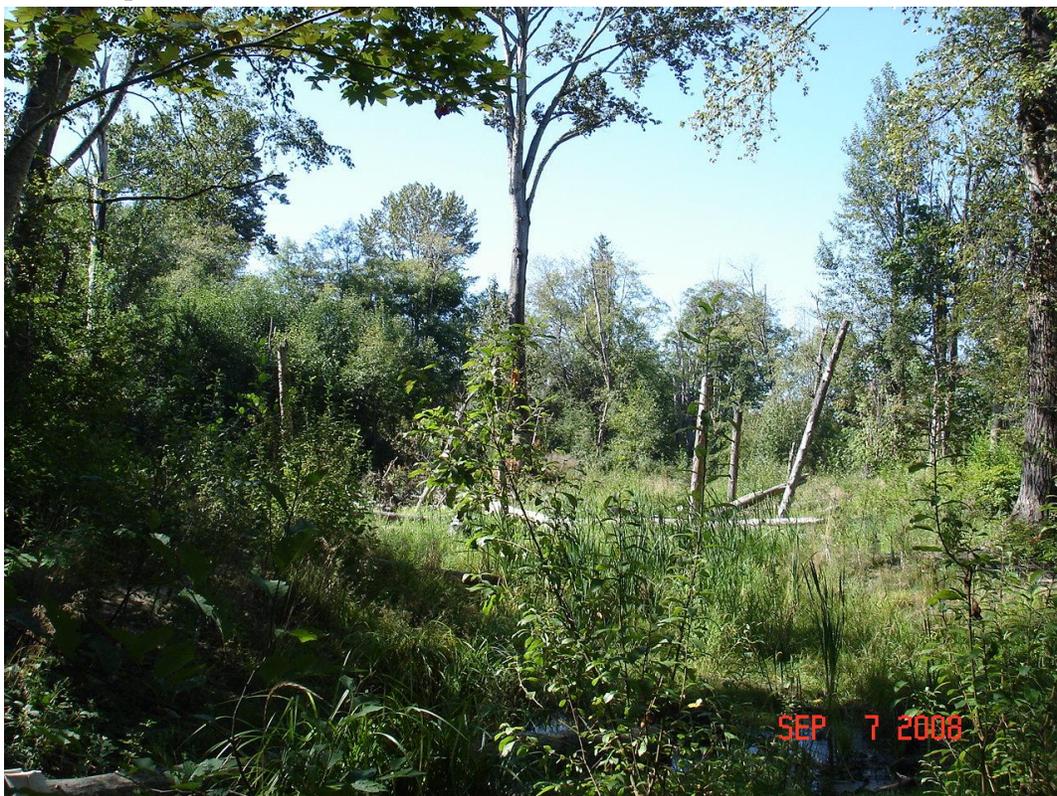
Figure 2-3. Photopoint 1a – Salmon Park restoration site.

Photos: Photos of vegetation transects were started in 2008. Since photos were not taken of transects in 2007, find below selected comparison photos from established photopoints taken August 13, 2007 and September 7, 2008 (Figure 2-3, Figure 2-4 and Figure 2-5). Note changes in plant growth between 2007 and 2008.

(a) August 13, 2007.

(b) September 7, 2008.

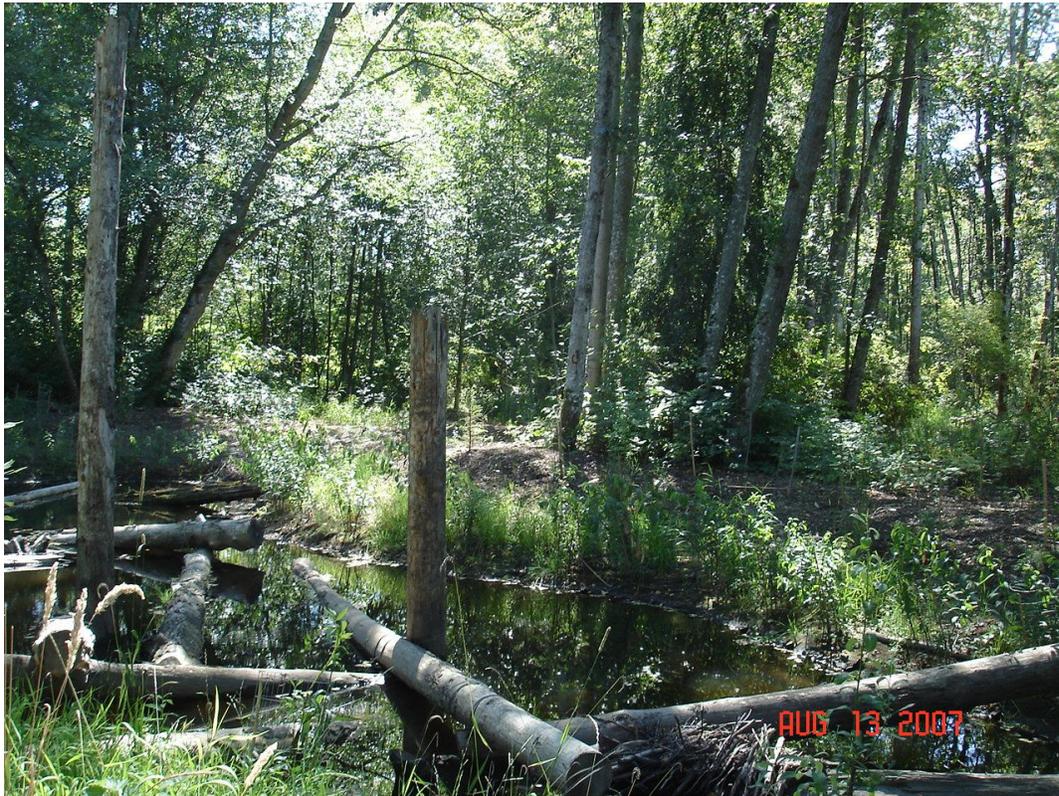
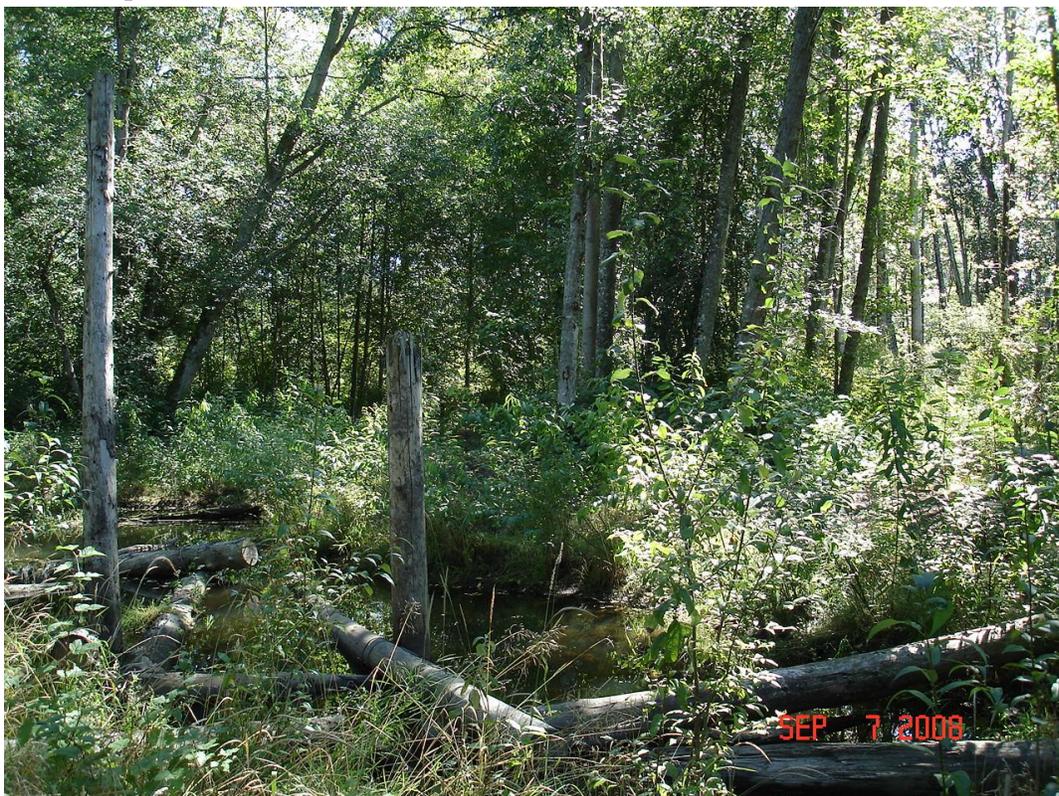
Figure 2-4. Photopoint 10a – North Pond, Cemetery Creek restoration site.
(a) August 13, 2007.

(b) September 7, 2008.

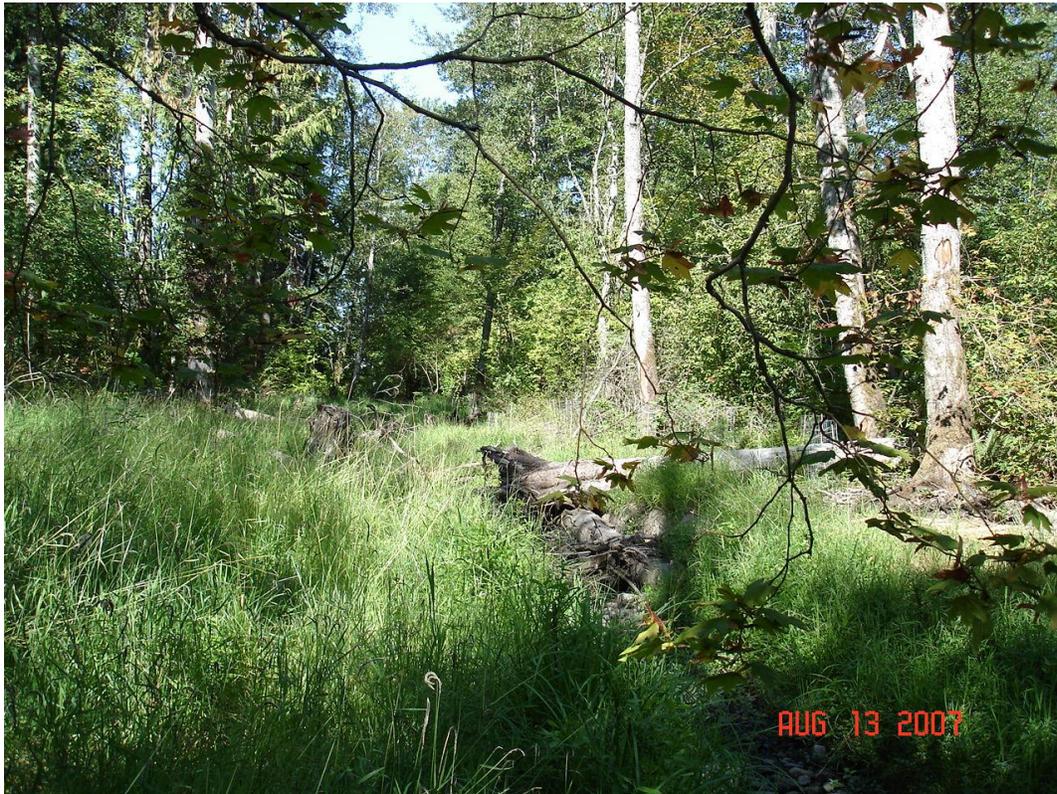
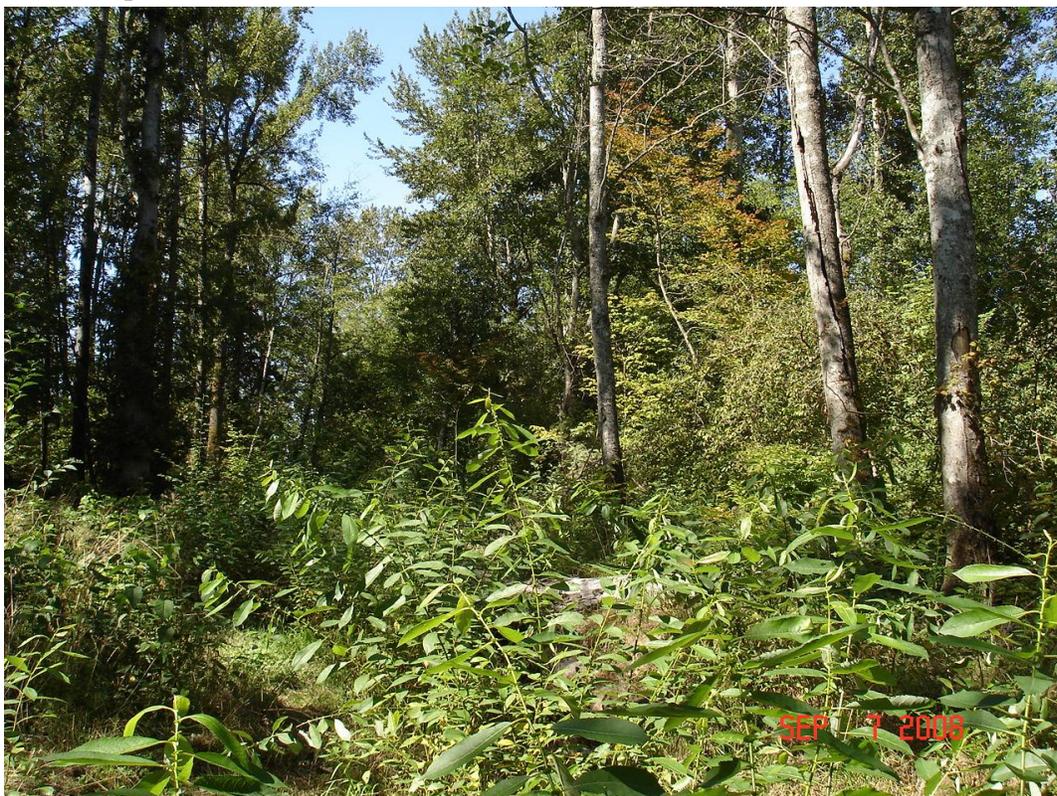
Figure 2-5. Photopoint 14b – Cemetery Creek restoration site.
(a) August 13, 2007.

(b) September 7, 2008.

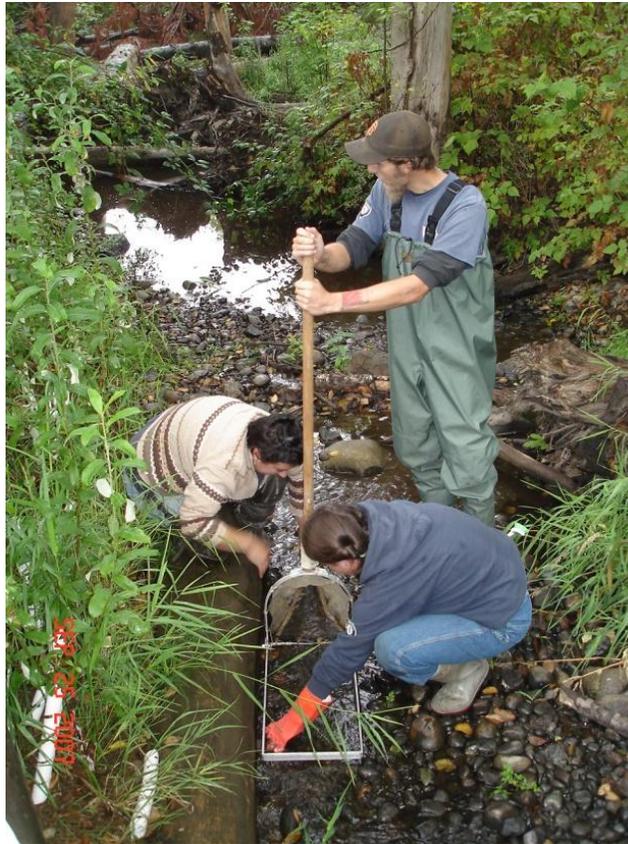
Figure 2-13. WCC staff collecting a macroinvertebrate sample using the D-frame kick net.

Macroinvertebrate sampling follows the methodology found in “Benthic Macroinvertebrate Biological Monitoring Protocols for Rivers and Streams” (Plotnikoff and Wiseman, 2001), with some modifications. Four substrate samples are taken from riffles within each of the three sites. Samples are collected using a D-frame kick net with a 2.0 ft² delineation square (Figure 2-13). Rocks within the frame are brushed for collection and sediment is disturbed to release a larger number of macroinvertebrates. Samples are contained separately in half and one-liter polycarbonate containers and are preserved in 85 percent ethanol. Each sample includes a waterproof label with watershed and stream name, site number and riffle number, the date and collector’s name.

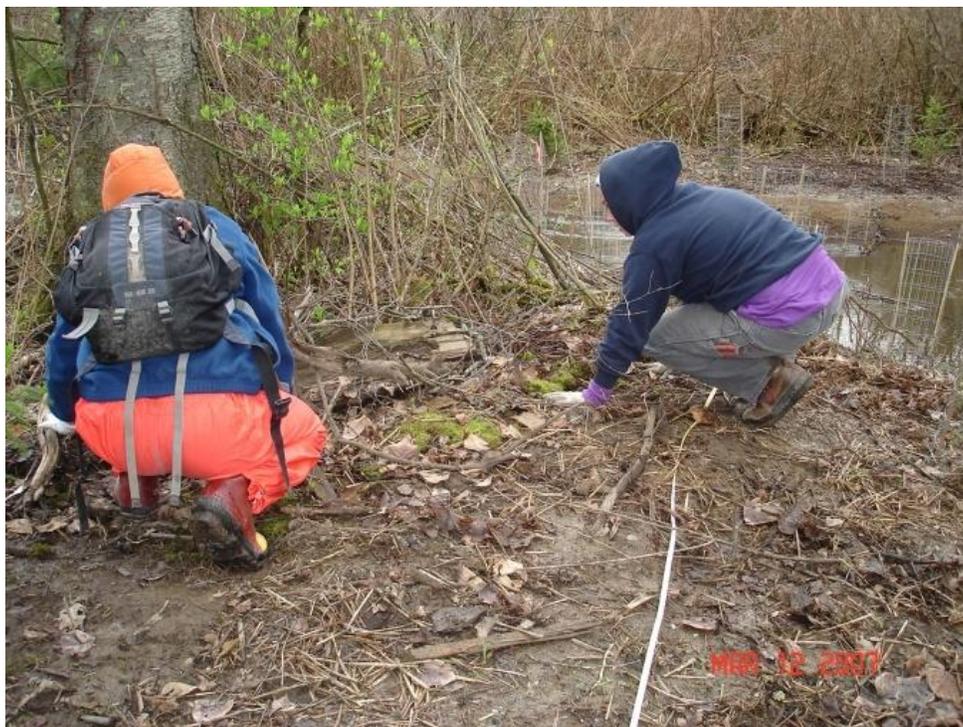
Figure 2-15. Surveyors lifting logs and debris while completing amphibian surveys in 2007. Note lack of vegetative cover.
