Whatcom Creek:

Ten-Years After Summary Report

City of Bellingham
Department of Public Works
Environmental Resources

R2 Resource Consultants, Inc.
15250 NE 95th Street
Redmond, Washington 98052

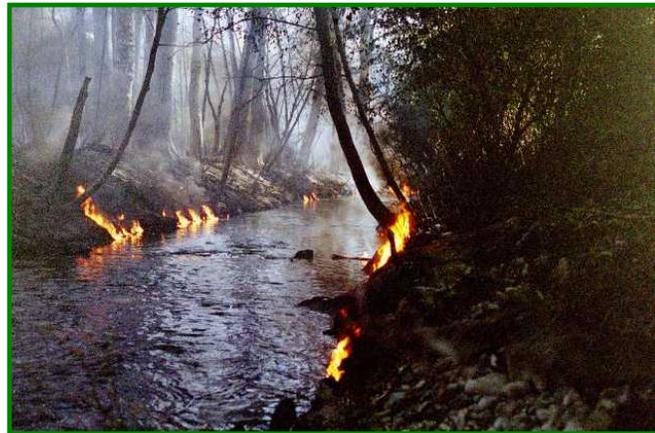
Fire Along Whatcom Creek June 1999

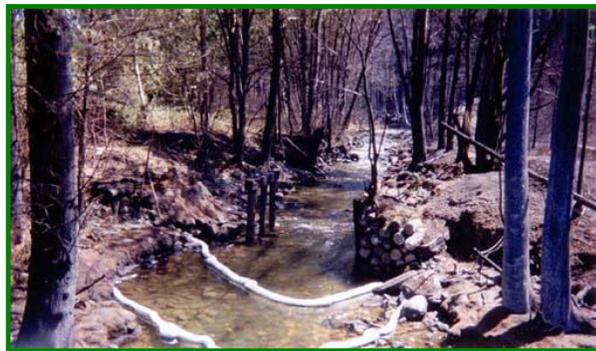
Source: U.S. Environmental Protection Agency
Absorbent Boom in Whatcom Creek

Hannah and Whatcom creeks were heavily impacted by the incident. After skimming as much gasoline as possible from the water, the stream channel was cleaned by excavating and removing contaminated soil and logs, and taking the material to a hazardous waste depository. Where excavation was impossible, stream bed gravel was manually washed and flushed.

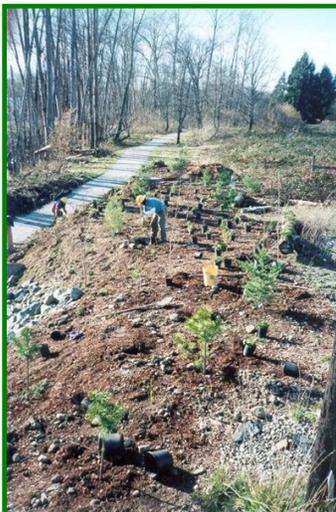
Source: City of Bellingham
Planting in Burn Zone

Adjacent cedar trees and fern plants were transplanted in appropriate locations. Over 30,000 native tree seedlings were planted within the burned zone.

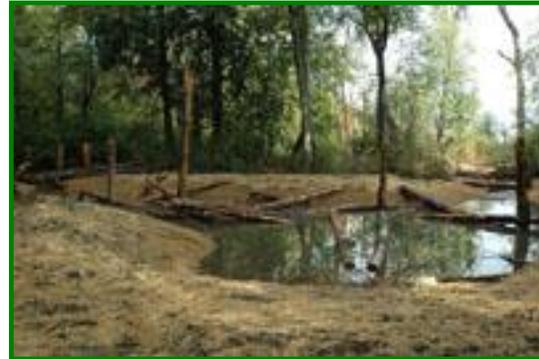
Source: City of Bellingham
Pond Created at Cemetery Creek

The Salmon Park and Cemetery Creek projects were completed in 2006. These projects are located near the confluence of Cemetery Creek and Whatcom Creek. The Salmon Park Project covers over 350 feet of the Whatcom Creek stream bank to the north, while the Cemetery Creek Project encompasses approximately 250 feet along the south bank of Whatcom Creek and over 1,300 feet along Cemetery and West Cemetery creeks. Project elements included construction of backwater habitats along Whatcom Creek, creation of three small

ponds, and reconfiguration of the Cemetery Creek channel to include large woody debris, meanders, pools, backwaters and complex habitats in the formerly channelized stream. Ponds and backwaters provide refuge for salmon during high flows and wetland habitat for amphibians and other wildlife throughout the summer months. These projects enhanced habitat conditions throughout the area, while minimizing impacts to surrounding vegetation and ground surfaces. In addition, portions of an anthropogenic gravel berm were removed from the Salmon Park area, restoring geomorphic function by allowing Whatcom Creek to access and migrate within its associated floodplain.

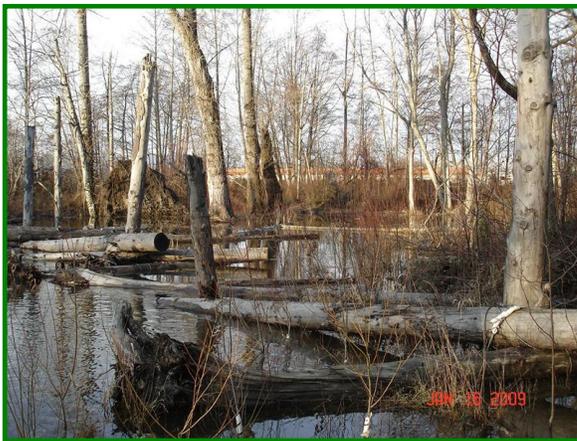
Source: City of Bellingham
Salmon Park Wetland and Backwater Habitat

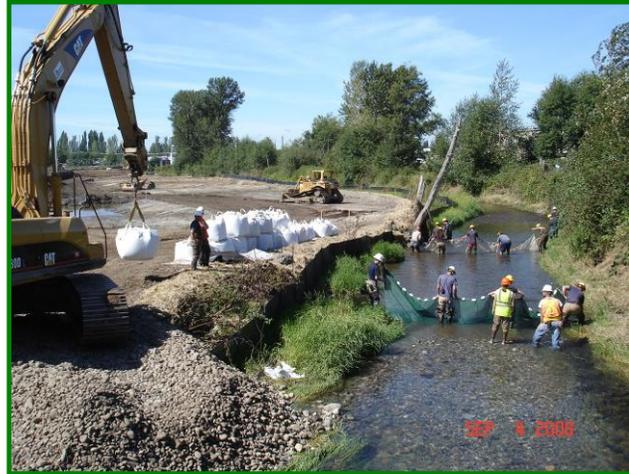
Fish removal during Red Tail Reach construction

The Red Tail Reach Project was completed in April 2009. The project improved 1,550 linear feet of the Whatcom Creek stream bank and floodplain. The project area is located on the south side of Whatcom Creek between I-5 and Racine Street. The project removed 30,000 cubic yards of man-made fill from the floodplain, re-contoured sections of the existing stream bank, created three new backwater areas that emulate the appearance and function of historic channel oxbows, and placed large wood in the stream to enhance pools and provide cover for salmon. Following construction, 14,600 native plants were planted throughout the site, replacing a vegetation community that had previously consisted almost entirely of invasive weeds.

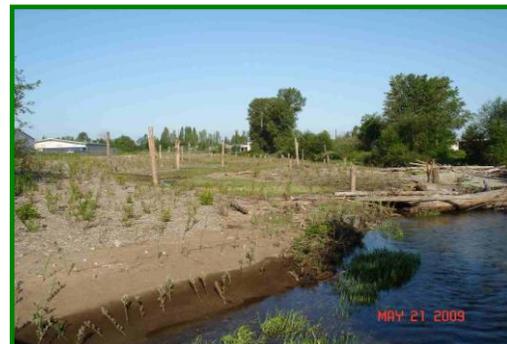
Red Tail Reach Site in the Spring After Planting

The site was planted in 2008 through the cooperative efforts of the City of Bellingham Public Works and Parks Departments, city-sponsored Washington Conservation Corps crews, and the Nooksack Salmon Enhancement Association (NSEA). Willows, sedges, ferns, and other plants were added in April 2009. The Red Tail Reach Project increases rearing habitat for juvenile salmonids and holding habitat for adults by improving pools. In addition, the project provides winter rearing habitat and refuge from high flows in backwater areas. The increased habitat complexity and future native forest will benefit all salmon lifestages as well as other wildlife species.

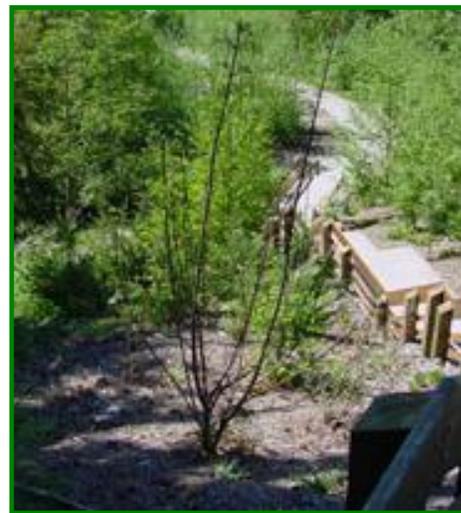
Source: City of Bellingham
Heart Attack Hill Trail after Construction

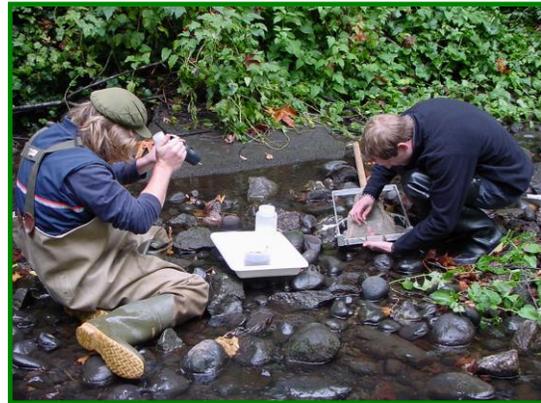
Source: City of Bellingham
Macroinvertebrate Sampling

Aquatic insects (macroinvertebrates) in Whatcom Creek were sampled at three sites for five years following the fire (1999-2003), and again in 2007. These data were compared to samples collected by the Washington Department of Ecology in

Results of the comparative analysis indicate a shift away from aquatic insect species that graze on algae and other materials on streambed gravels (scrapers), towards a community of species that gather fine particulate matter (collector-gatherers). The reduction of percent scrapers in 1999 suggests that Whatcom Creek is not as productive as it was before the fire, at least in terms of algal growth. Two indices that are commonly applied in macroinvertebrate studies are the Community Tolerance Index (CTI) and Benthic Index of Biological Integrity (B-IBI). Results using CTI give scores ranging from 6.1 to 7.2, with an overall average CTI score of 6.6. On a biotic index scale of 0 to 10, this average score indicates “fair” conditions, often a result of “fairly significant organic pollution.” Scores for the B-IBI ranged from 12 to 28, out of a possible total of 50, indicating that the sites on Whatcom Creek are in “poor” to “fair” condition. It is

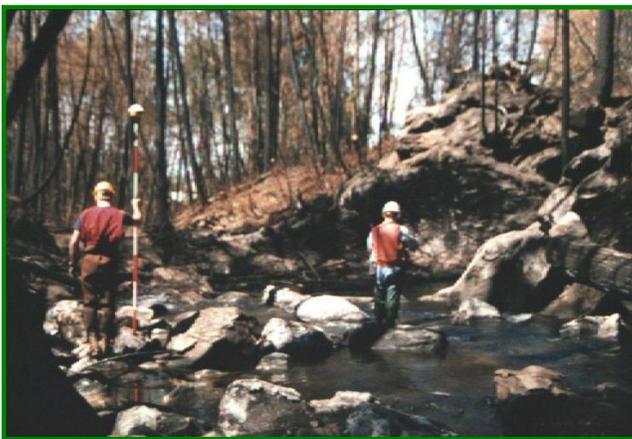
Source: R2 Resource Consultants
Crew Conducting Habitat Surveys after Burn

Stream habitat was surveyed immediately following the burn in 1999, and again following the emergency response restoration actions in 1999 and 2000. Additional surveys were conducted in 2007 and 2009 to track changes over time. Prior to the emergency response actions, aquatic habitat conditions in Whatcom Creek were considered poor according to all available criterion. Wood placement and pool excavation as part of the

emergency response resulted in short-term improvements of habitat. Subsequent instream habitat restoration projects have maintained improved habitat conditions, particularly downstream of Woburn Street. Throughout the stream, the amount of wood and the number of pools is similar to, or better than in 1999. Off-channel habitats and the meandering channel configuration established by restoration projects at Salmon Park, Cemetery Creek, and Red Tail Reach have improved habitat complexity, and substantially increased backwater habitat that serves as refuge for juvenile salmon during floods.

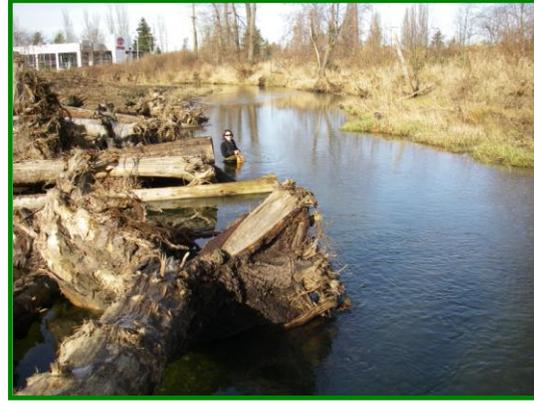
Source: City of Bellingham
Conducting Survey of Large Woody Debris

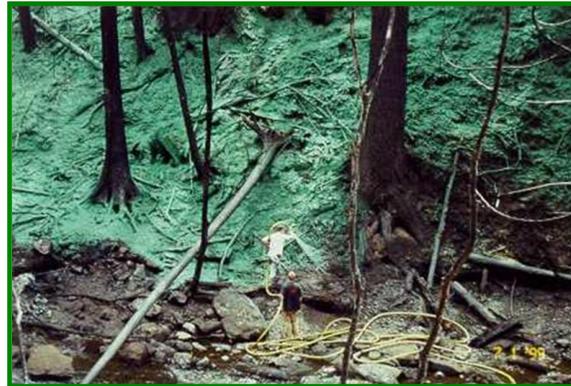
Source: Polaris Applied Sciences
Hydroseeding Exposed Slopes Following the Fire

One of the greatest fears immediately following the fire was that slopes would undergo severe erosion during heavy fall rains following the fire. Immediate treatment and riparian plantings, in combination with recovery of plants whose roots survived underground prevented this from happening. No major areas of erosion that could be directly related to the 1999 fire were observed in 2009. In general, slopes in these areas are well vegetated and appear stable.

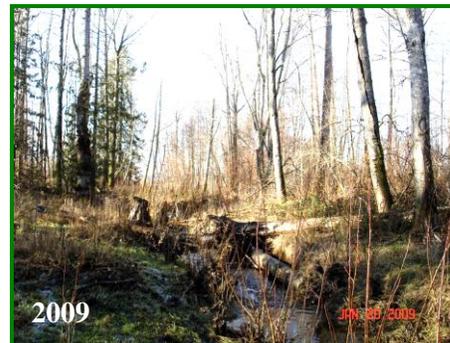
Cemetery Creek Immediately after Restoration

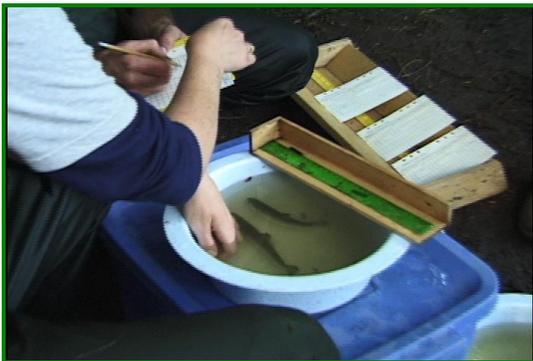
Source: City of Bellingham
Smolt Trap Data Collection

The smolt trap is constructed on Cemetery Creek just downstream of the West Pond. Juvenile fish moving downstream in Cemetery Creek are intercepted in a screened box; the box is checked at least twice a day, and more often during high flows. Fish are identified to species and recorded by size class. Trapping occurred in 2007, and is underway in the spring of 2009. In 2007, a total of 1,984 fish were collected from the trap between March 28 and June 7. Coho salmon and cutthroat trout dominated out-migration. Non-native species such as smallmouth bass, and goldfish were also occasionally encountered. As of May 15, 2009, almost 1000 salmonids had been counted at the trap, predominantly coho salmon and cutthroat trout.

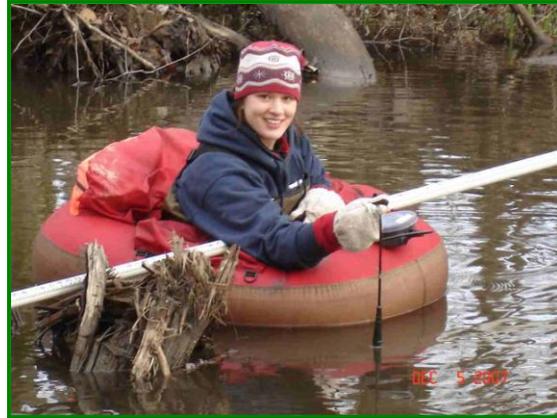
Source: City of Bellingham
Measuring Water Quality in Cemetery Creek North

Water quality is monitored monthly or more frequently in the ponds and streams at the Cemetery Creek sites. Water quality conditions are generally good during the wet season. Temperatures in the ponds and in Cemetery Creek exceed the state standard of 16°C during the summer, while the groundwater-fed West Cemetery Creek generally meets the state water quality requirements. In all cases, temperatures in the Cemetery Creek system are lower than in mainstem Whatcom Creek.

Dissolved oxygen (DO) levels also vary both seasonally and spatially. DO levels are generally high during the wet season. In the summer, flows in Cemetery Creek are very low (at times subsurface), and DO levels do not meet Washington State water quality standards. In contrast, flows in the groundwater-fed West Cemetery Creek are more consistent, and DO levels, while somewhat lower than state standards, are considerably higher than in the mainstem. DO levels drop in the ponds, and may reach levels considered to be potentially detrimental to salmonid fishes; however, higher DO levels have been identified near pond outlets. DO levels downstream of the ponds increase somewhat, and, except for the season immediately following construction, appear to be consistent with pre-project values.

Conductivity and pH in the Cemetery Creek restoration site meet state standards. Extremely high fecal coliform levels were occasionally identified in inflows to the project sites. Fecal coliform levels generally drop slightly through the restoration site. Very high values are reported to City's stormwater management division for follow-up surveys as part of the ongoing NPDES permit and TMDL compliance.
