U.S. Department of
Homeland Security
**United States
Coast Guard**

Incident Report: Davy Crockett Emergency Response

Update as of Sept. 6, 2011

DAVY CROCKETT VESSEL REMOVAL COMPLETED – Sept. 6, 2011

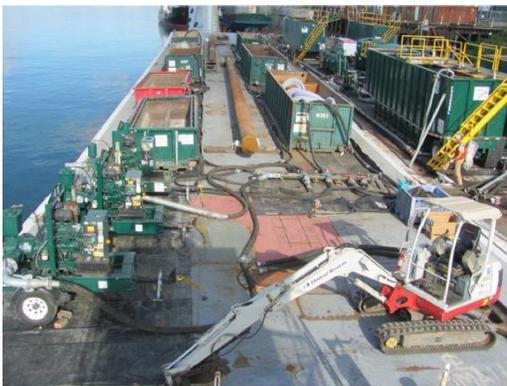
Barge containing sediment collection/ dewatering tanks and pumps prior to departure to Davy Crockett worksite. (9/2/11)

Dive crews began dredging tar balls, slag and contaminated sediments from inside the cofferdam on Saturday, Sept. 3, 2011 (see photo gallery). The dredge material is being pumped into sediment collection/dewatering tanks and the water is run through a filtration system. The treated wastewater is discharged back into the cofferdam.

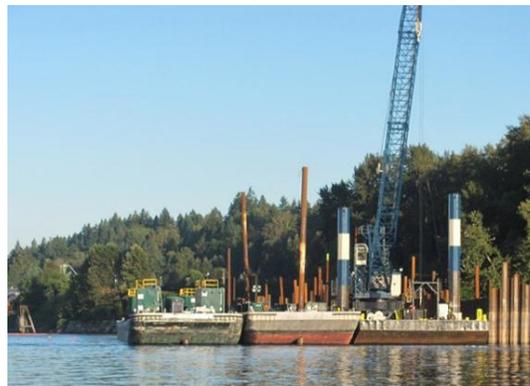
Barge containing water filtration system prior to departure to Davy Crockett worksite. (9/2/11)

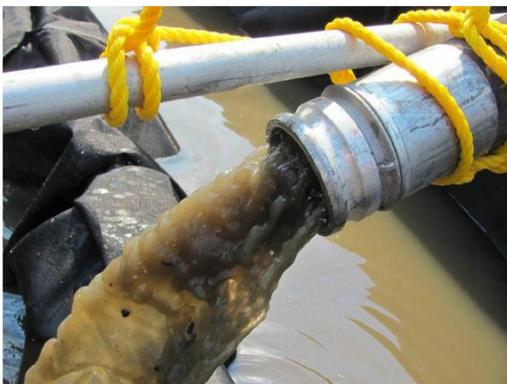
"Slurry" containing water and sediments being pumped from inside the cofferdam. (9/3/11)

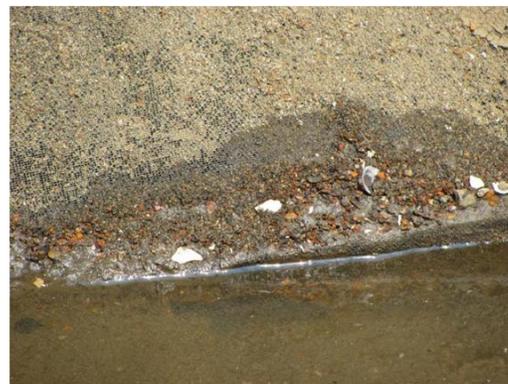
Dredge material consisting of gravel, sand, metal scale, shells and fine grained sediment. Tar balls and wood debris have also been recovered. (9/3/11)
