State of Washington Department of Ecology  
**Cruise Ship Memorandum of Understanding, Cruise Operations in Washington State Inspection Report**

Amy Jankowiak, Washington State Department of Ecology (Ecology) Northwest Regional Office, Water Quality Program (NWRO-WQ) conducted the inspection of the Princess Cruises GOLDEN PRINCESS on July 30, 2011. The main contact on board the GOLDEN PRINCESS was Dario Oseo, Environmental Officer for the GOLDEN PRINCESS. Prior notification of the visit was given on July 25, 2011 for security protocol. The purpose of the inspection was to evaluate compliance with the *Memorandum of Understanding Cruise Operations in Washington State* (MOU), as amended. The GOLDEN PRINCESS is not approved to discharge in MOU waters. The vessel has not been discharging and is holding effluent until outside MOU waters.

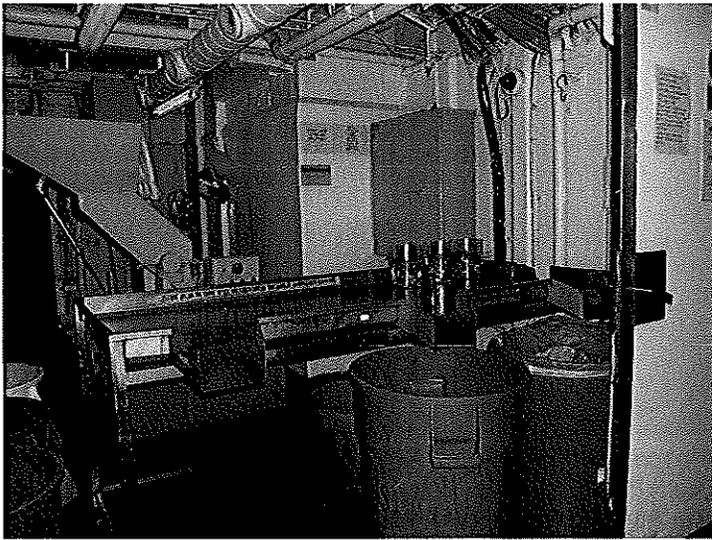
Solid waste (garbage, recyclables, etc) is collected sorted (photo #01) and either reused, recycled, donated, incinerated or offloaded to shore as appropriate. The garbage record book was reviewed and showed consistency with requirements.

PHOTO #:01 DATE: JULY 30, 2011  
TAKEN BY: AMY JANKOWIAK FILE No.: P73000017  
DESCRIPTION: GARBAGE/RECYCLING SORTING AREA

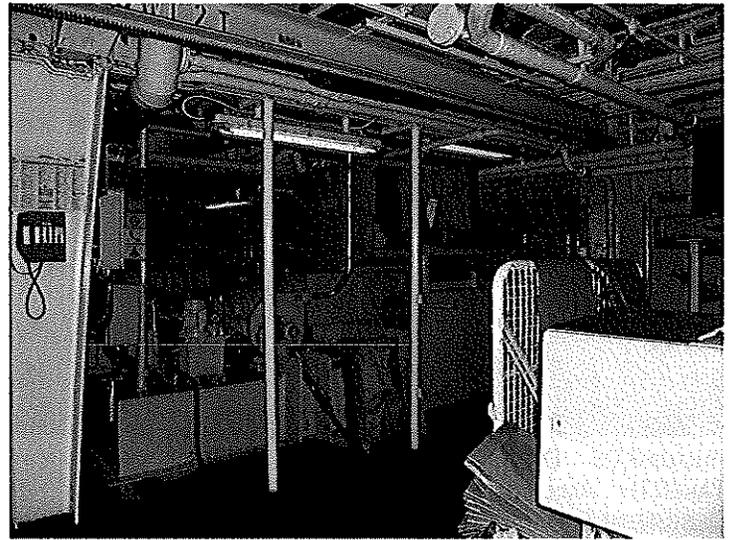
Glass (photo #03), aluminum, tin, scrap metal, some plastics, some paper and cardboard (photo #02) and used cooking oil are recycled. Reduction and reuse opportunities are broadly used to prevent the amount of waste.

PHOTO #:02 DATE: JULY 30, 2011  
TAKEN BY: AMY JANKOWIAK FILE No.: P73000018  
DESCRIPTION: GARBAGE/RECYCLING - COMPACTORS

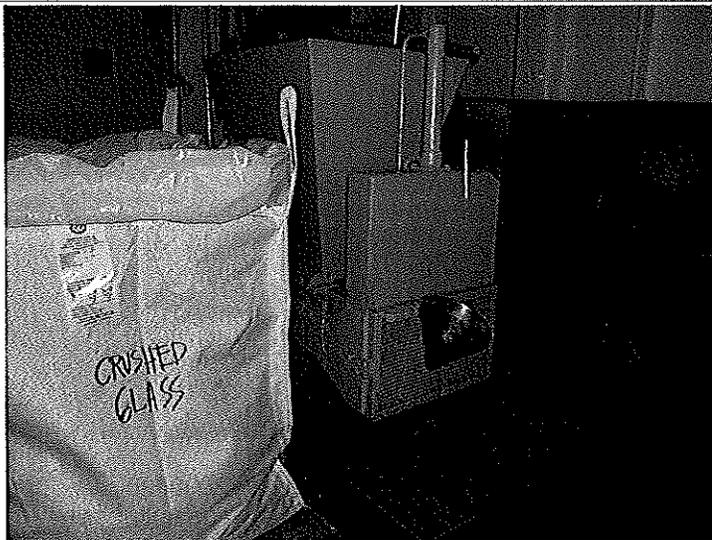
PHOTO #:03 DATE: JULY 30, 2011  
TAKEN BY: AMY JANKOWIAK FILE No.: P73000020  
DESCRIPTION: GLASS CRUSHER (LEFT) COMPACTOR WITH  
CONTAINMENT TO GRAY WATER TANKS (RIGHT)

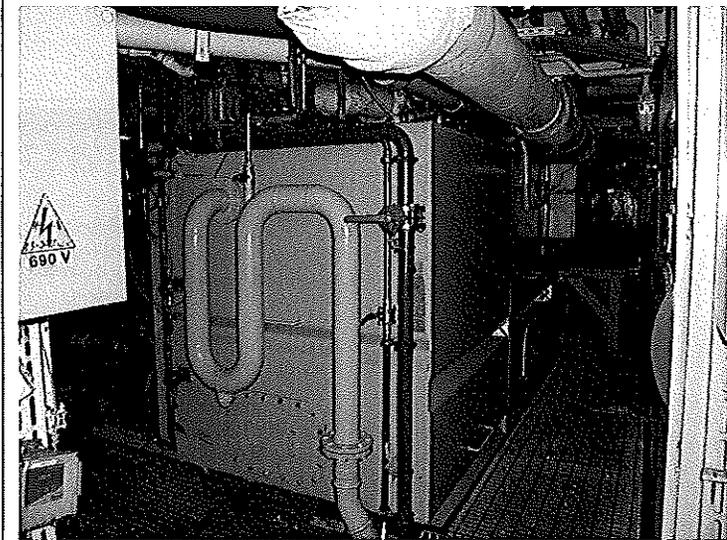
Black water is collected (photos #05 and #6) by vacuum collection tanks and is then sent to one of the MBRs. Gray water which includes sink and shower water is piped to one of the gray water collection tanks prior to going to MBRs. Black or gray water flow moves to the screen press (photo #07). The solids are screened into bags (photo #08) and are then sent to the incinerator. The liquid moves to the 1<sup>st</sup> stage (photo #11) of the membrane bioreactor where aeration occurs. From the 1<sup>st</sup> stage, flow moves to the Inter-stage Russel filters (photo #12). The inter-stage filtered solids are returned back to the screen press. The liquid moves onto the 2<sup>nd</sup> stage of the MBR for further aeration. From the 2<sup>nd</sup> stage MBR, flow is sent to the membrane modules (photo #10) for ultrafiltration. Effluent from the membrane modules are sent to a permeate tank (photo #09) where turbidity is monitored (photo #13). Flow then combines with the other two MBR's for ultraviolet (UV) disinfection (photos #14 and #15). Disinfected effluent either goes directly overboard (photos #16 and #17) or to a holding tank if not in an approved area for discharge. The held effluent will eventually go back through the UV system before discharge. Currently, effluent is held and discharged outside of MOU waters. There is a sample port for treated effluent after UV disinfection.

PHOTO #:05 DATE: JULY 30, 2011  
TAKEN BY: AMY JANKOWIAK FILE No.: P73000022  
DESCRIPTION: HAMWORTHY SYSTEM BUFFER TANK (1 OF 3)

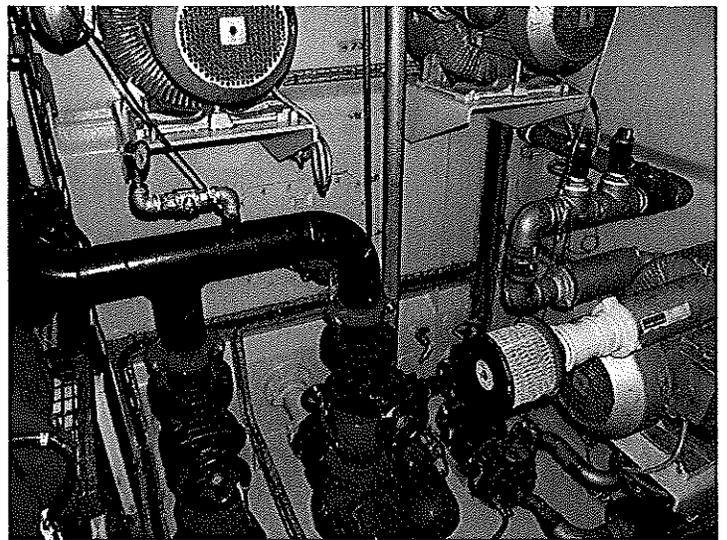
PHOTO #:06 DATE: JULY 30, 2011  
TAKEN BY: AMY JANKOWIAK FILE No.: P73000023  
DESCRIPTION: HAMWORTHY BUFFER TANK PUMPS

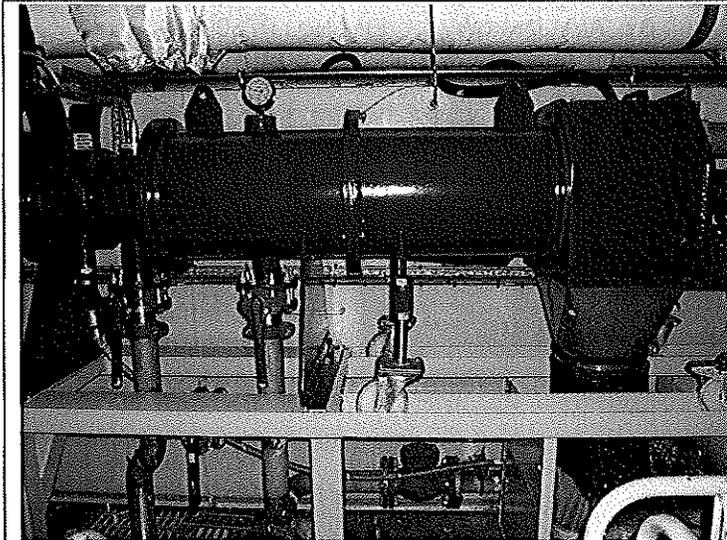
PHOTO #:07 DATE: JULY 30, 2011  
TAKEN BY: AMY JANKOWIAK FILE No.: P73000024  
DESCRIPTION: HAMWORTHY SCREEN PRESS (1 OF 3)

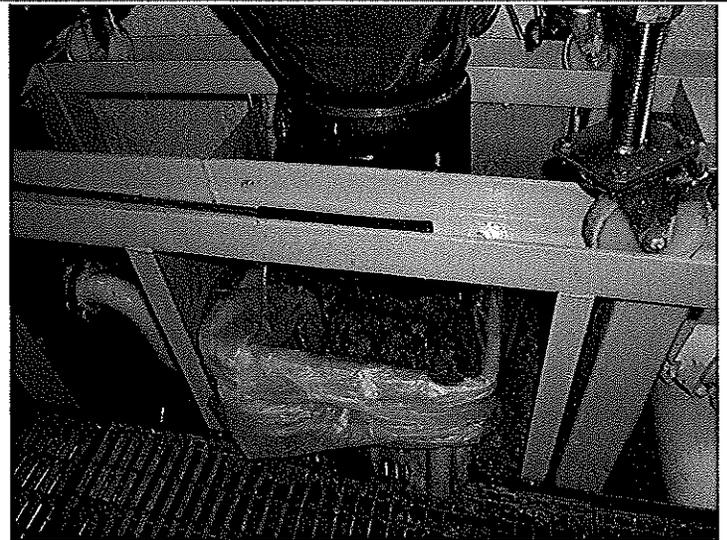
Screenings and grit from the Hamworthy system are collected and incinerated. The solids separated out by the bioreactors is discharged outside of MOU waters, >12 nautical miles from shore, and outside of the Olympic Coast National Marine Sanctuary.

PHOTO #:08 DATE: JULY 30, 2011  
TAKEN BY: AMY JANKOWIAK FILE No.: P73000025  
DESCRIPTION: HAMWORTHY SCREEN PRESS SCREENINGS (TO INCINERATOR)

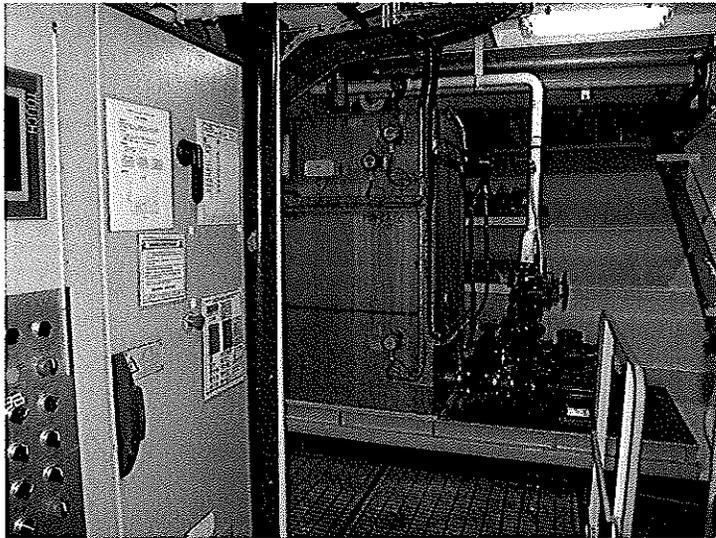
PHOTO #:09 DATE: JULY 30, 2011  
TAKEN BY: AMY JANKOWIAK FILE No.: P73000026  
DESCRIPTION: HAMWORTHY PERMEATE TANK (1 OF 3)

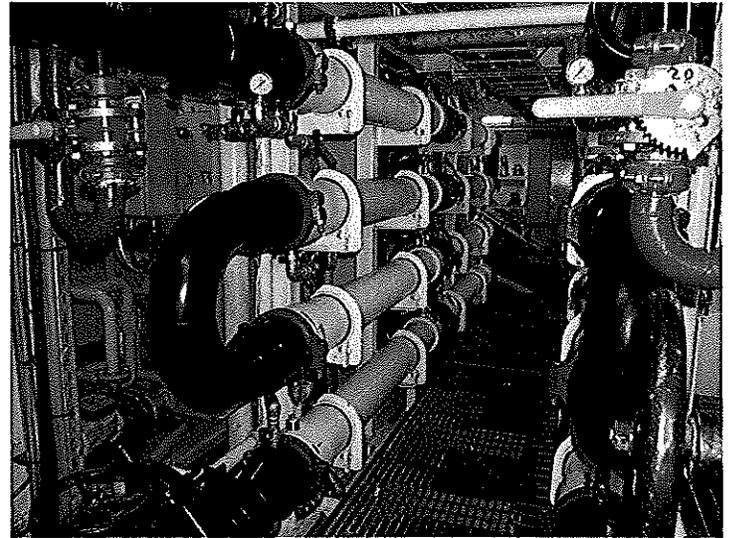
Blackwater, which includes toilet waste and graywater which includes sink and shower water is treated with a Hamworthy advanced wastewater treatment system and is currently discharged outside of MOU waters. The Hamworthy system, which was just installed in the spring of 2010, consists of three separate membrane bioreactors (MBRs). Two of the MBRs treat graywater and one MBR treats blackwater. This is a change from previous practice where all MBRs treated combined black and gray water. This change has helped the performance of the MBRs.

PHOTO #:10 DATE: JULY 30, 2011  
TAKEN BY: AMY JANKOWIAK FILE No.: P73000027  
DESCRIPTION: HAMWORTHY MEMBRANE FILTERS (1 OF 3)

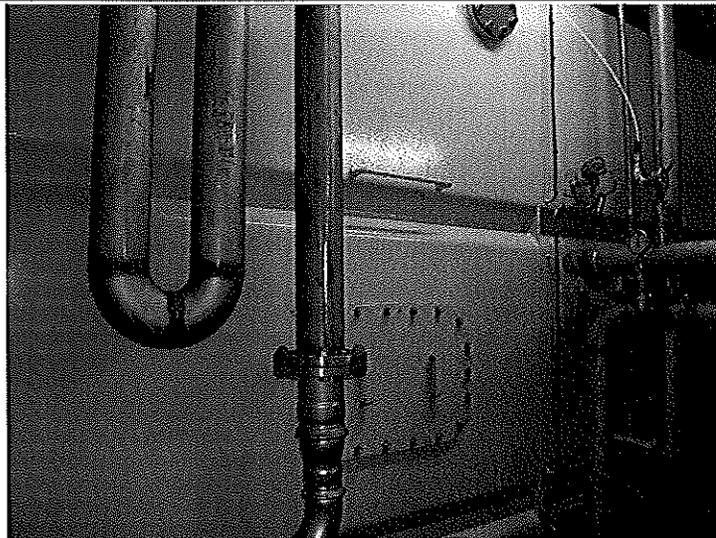
PHOTO #:11 DATE: JULY 30, 2011  
TAKEN BY: AMY JANKOWIAK FILE No.: P73000028  
DESCRIPTION: HAMWORTHY STAGE 1 AND STAGE 2 MBR TANKS  
(1 OF 3)

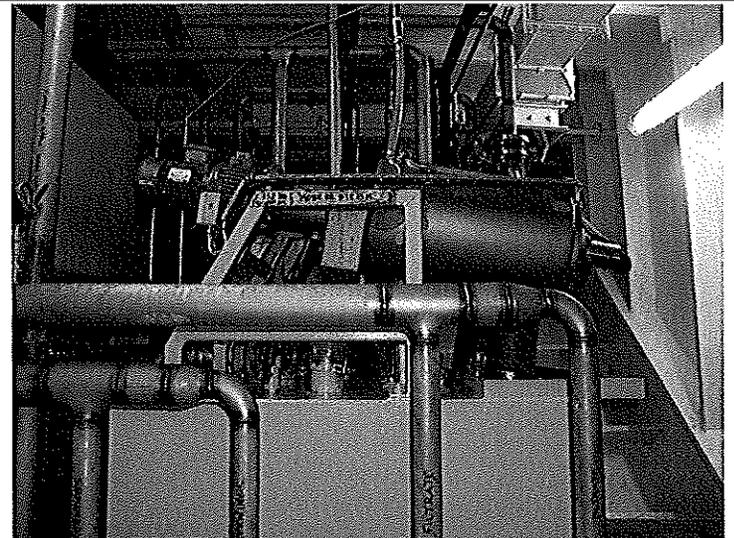
PHOTO #:12 DATE: JULY 30, 2011  
TAKEN BY: AMY JANKOWIAK FILE No.: P73000029  
DESCRIPTION: HAMWORTHY INTERSTAGE RUSSEL FILTERS (1 OF 3)

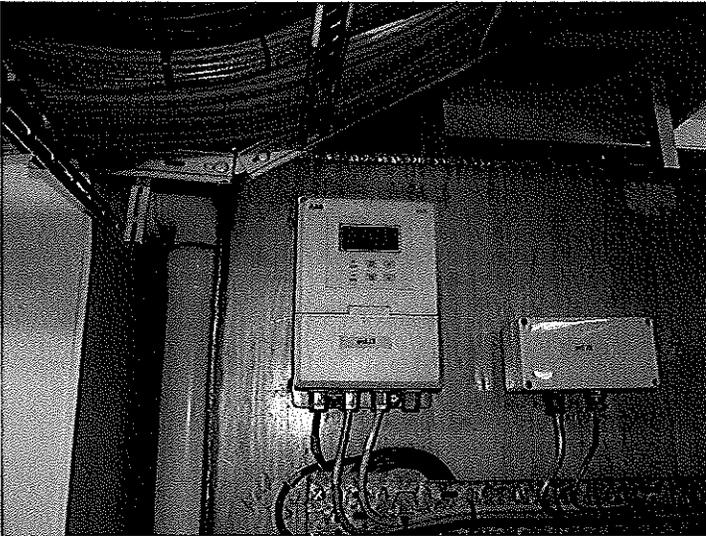
Turbidity is measured continuously on each of the MBR permeate tanks. The UV system consists of 6 bulbs which are alarmed. The maintenance system provides details of when all maintenance is needed.

PHOTO #:13 DATE: JULY 30, 2011  
TAKEN BY: AMY JANKOWIAK FILE No.:P73000030  
DESCRIPTION: HAMWORTHY TURBIDITY METER (1 OF 3)

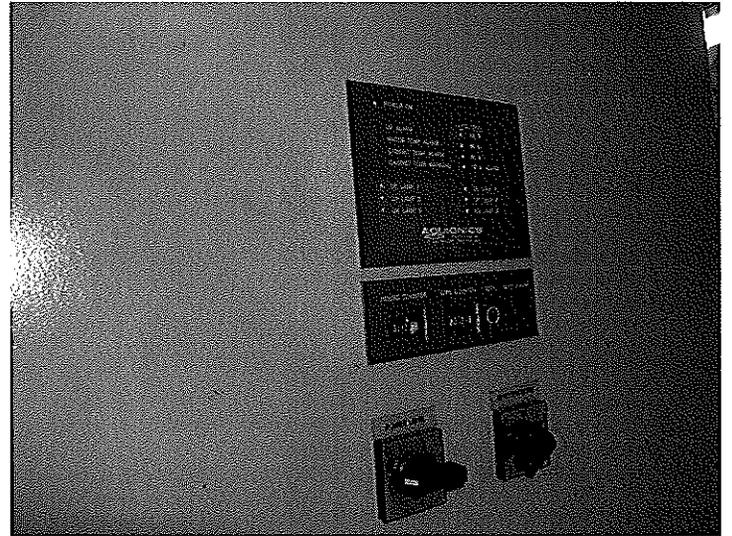
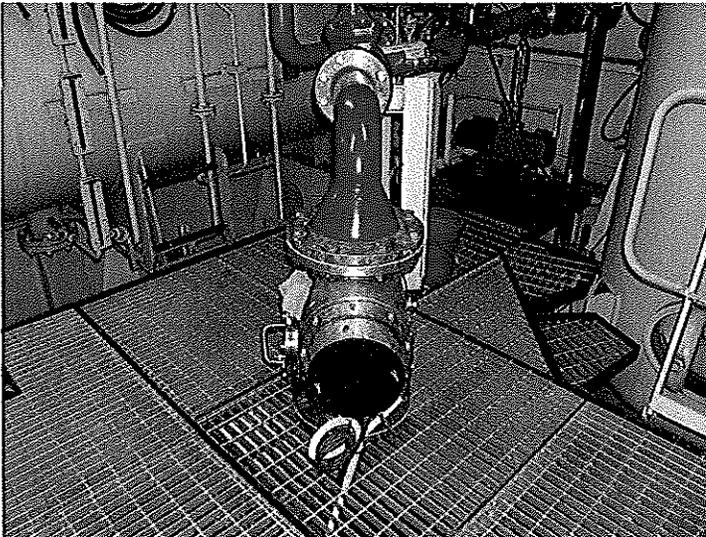
PHOTO #:14 DATE: JULY 30, 2011  
TAKEN BY: AMY JANKOWIAK FILE No.: P73000031  
DESCRIPTION: HAMWORTHY ULTRAVIOLET DISINFECTION  
SYSTEM

PHOTO #:15 DATE: JULY 30, 2011  
TAKEN BY: AMY JANKOWIAK FILE No.: P73000032  
DESCRIPTION: HAMWORTHY ULTRAVIOLET DISINFECTION  
SYSTEM

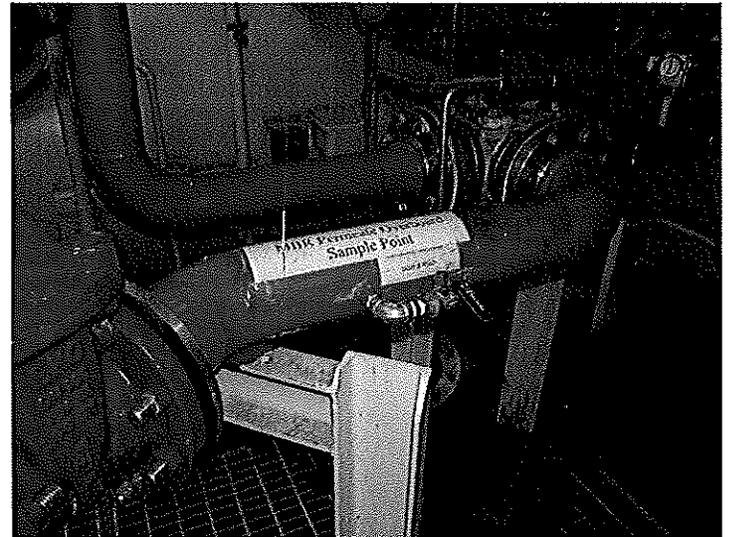
PHOTO #:16 DATE: JULY 30, 2011  
TAKEN BY: AMY JANKOWIAK FILE No.: P73000033  
DESCRIPTION: HAMWORTHY MBR PERMEATE OVERBOARD  
SAMPLE POINT

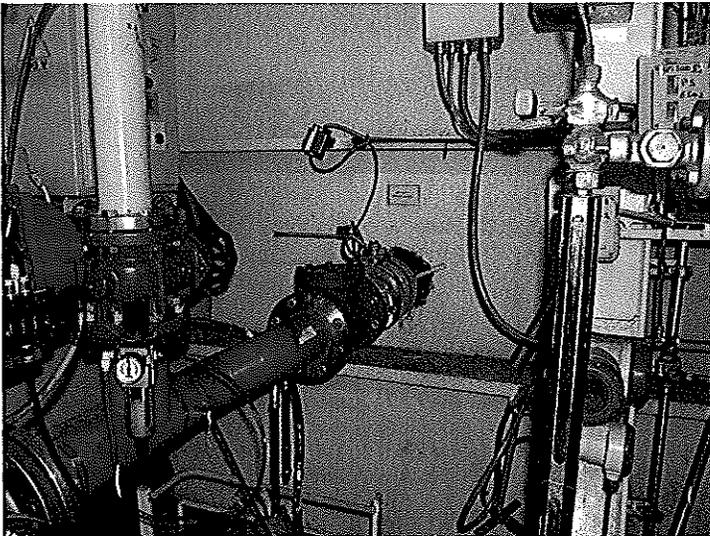
PHOTO #:17 DATE: JULY 30, 2011  
TAKEN BY: AMY JANKOWIAK FILE No.:P73000034  
DESCRIPTION: HAMWORTHY MBR OVERBOARD PORT

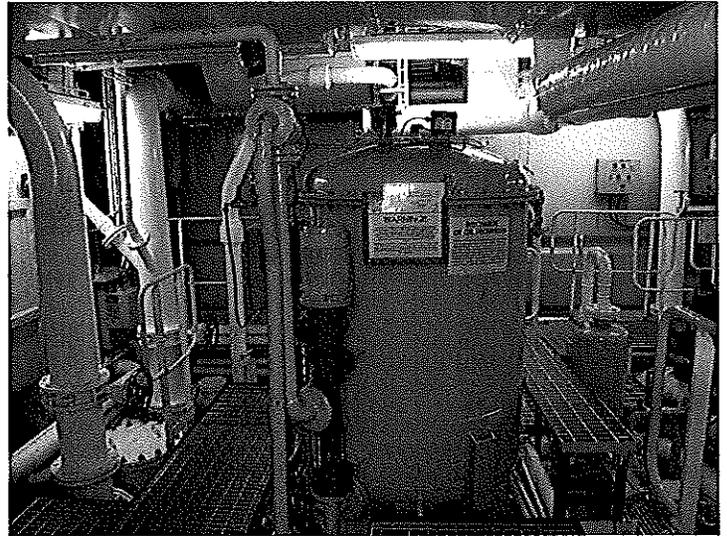
Oily bilge water is treated with an oily water separator (photo #18) and discharged at less than 15 ppm after first going through a white box (photo #19) for monitoring prior to discharge (photo #20) outside of MOU waters.

PHOTO #:18 DATE: JULY 30, 2011  
TAKEN BY: AMY JANKOWIAK FILE No.: P73000035  
DESCRIPTION: OILY WATER SEPARATOR (OWS) SYSTEM

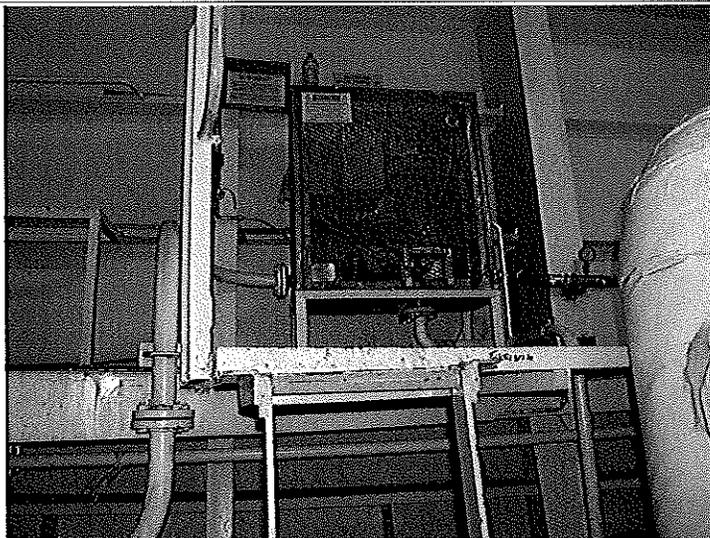
PHOTO #:19 DATE: JULY 30, 2011  
TAKEN BY: AMY JANKOWIAK FILE No.: P73000036  
DESCRIPTION: OWS WHITE BOX

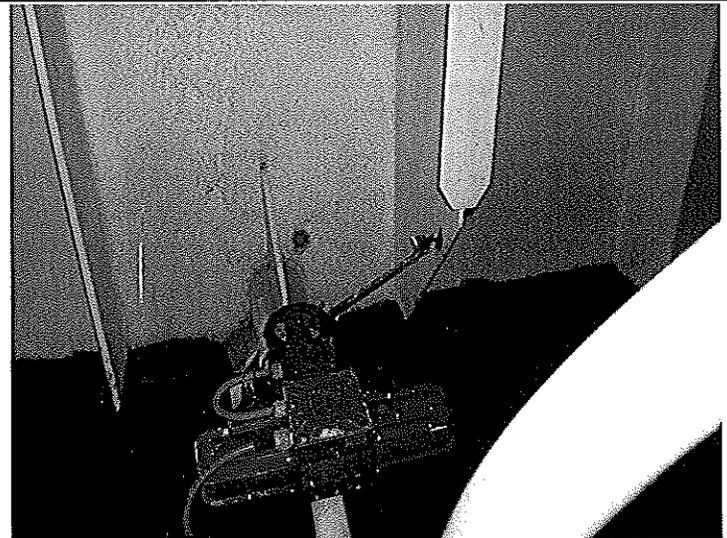
PHOTO #:20 DATE: JULY 30, 2011  
TAKEN BY: AMY JANKOWIAK FILE No.: P73000037  
DESCRIPTION: OWS OVERBOARD PORT
