SUBMITTAL OF ADDITIONAL CLOSURE PLANS FOR CLOSING DANGEROUS WASTE MANAGEMENT UNITS (DWMUs) AT THE T-PLANT COMPLEX

Figure F-1. T-Plant Complex 221-T Tank System

T Plant Cell Photographs
Numbered pages 2-1 through 2-83

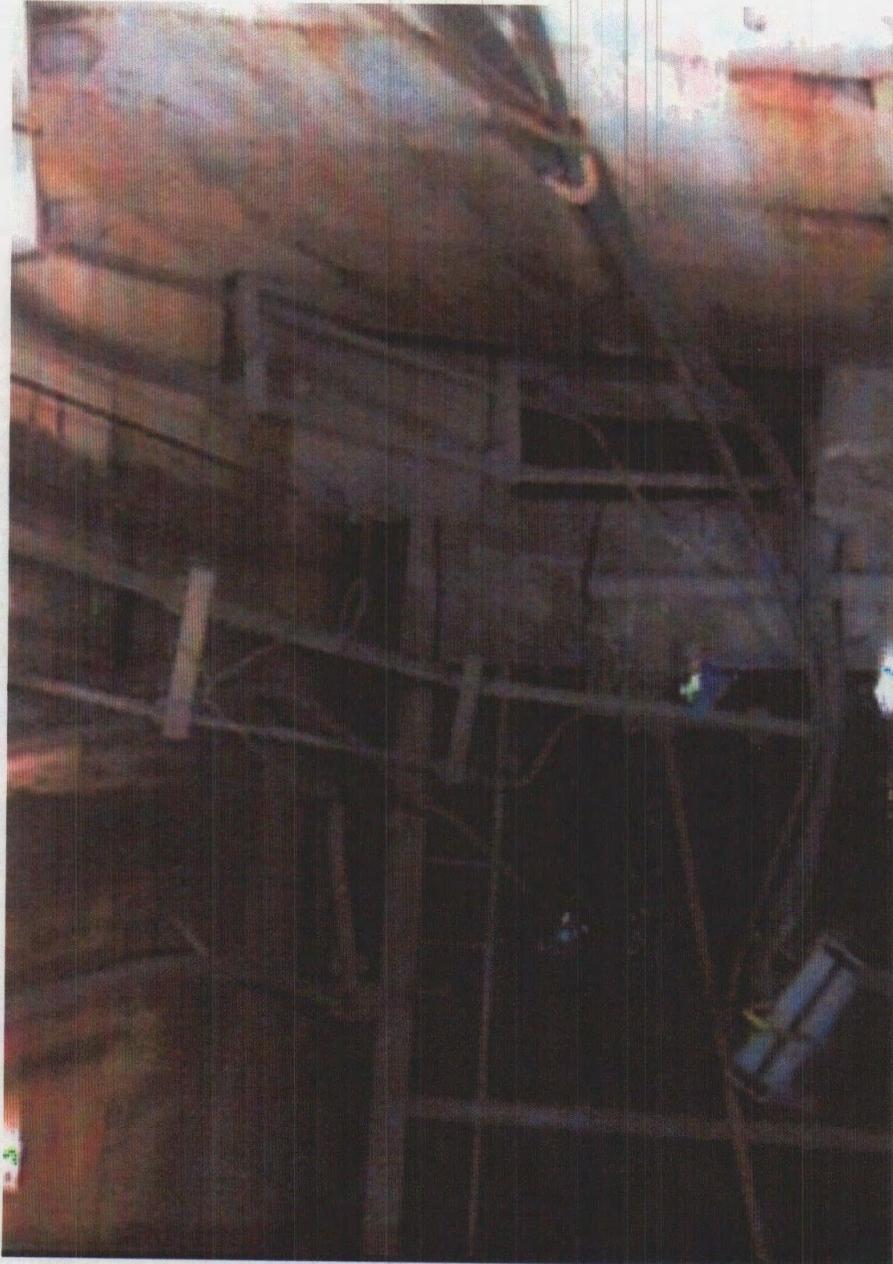
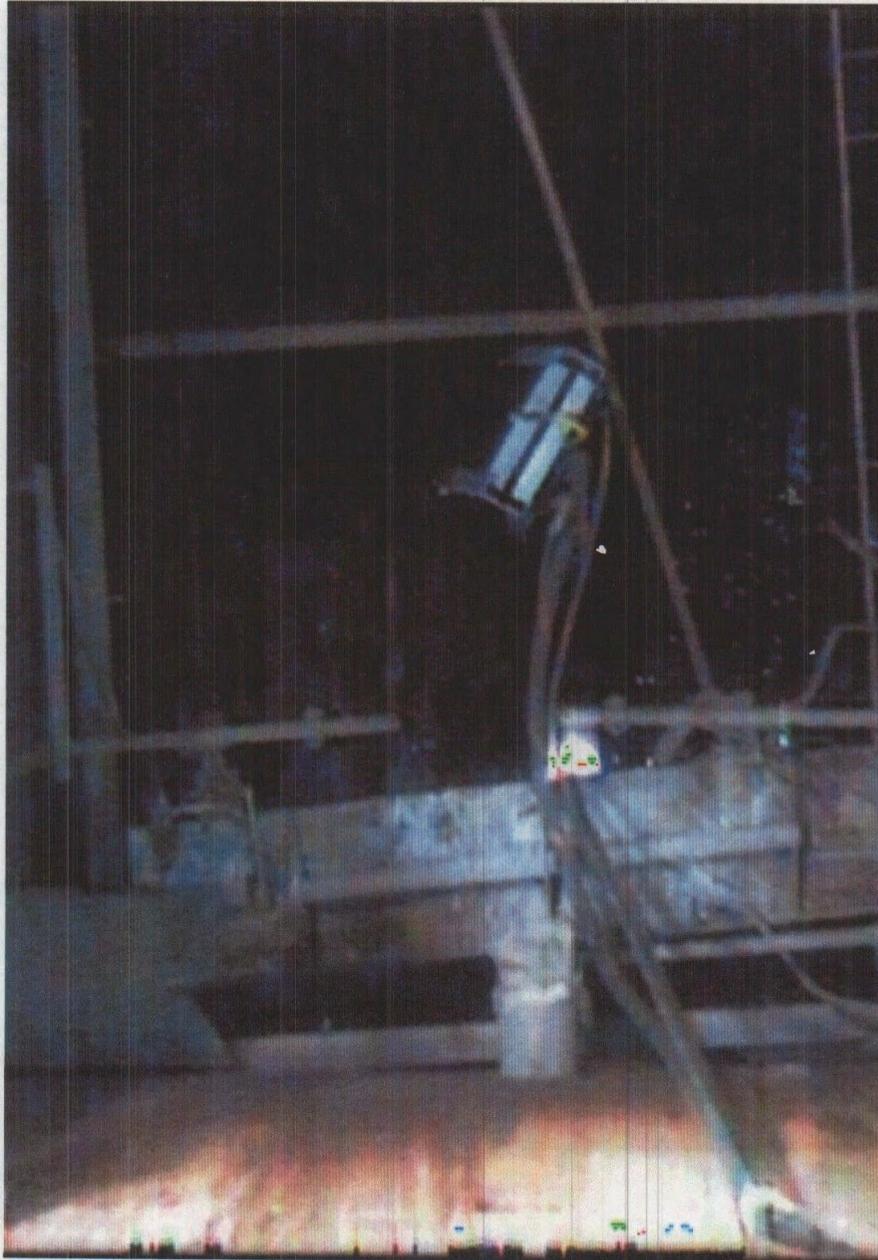
Cell 5R 2001

New Cell No	5R
Old Cell No	10
HNF-1982 Info	Sewage disposal, sewer cell.
MR-0452 Info	Sewage disposal, sewer cell. [Note that this does not mean sanitary sewage, but process sewage].
HNF-1982 Recent	Deepest cell in the plant. Full cell rectangular open-top tank (5-7 tank). The cell is called the 5-8 tank, no longer in use as a tank. It is possible to jet the contents of tank 5-7 to tank 5-9, also 5-7 to 5-6. Jumpers on the wall (~6), and a number of junk jumpers (~4) in the bottom of the cell. One 40' jumper, high [?] side, not connected. Back wall five 40' jumpers to 5-7, one loose. Low side eight 4' jumpers. 24" drain - front corners. Flooded, much sludge.
ISB and LTDES	Original Equipment Tank 5-7 (38,000 L [10,000 gal]) LTDES Decon Function: Radioactive liquid waste storage. Open tank 5-7 (SS, 14,000 gal) and sumps 508 (14' X 16' X 22') The radioactive drain lines from all other cell floors drains in tank 5-7

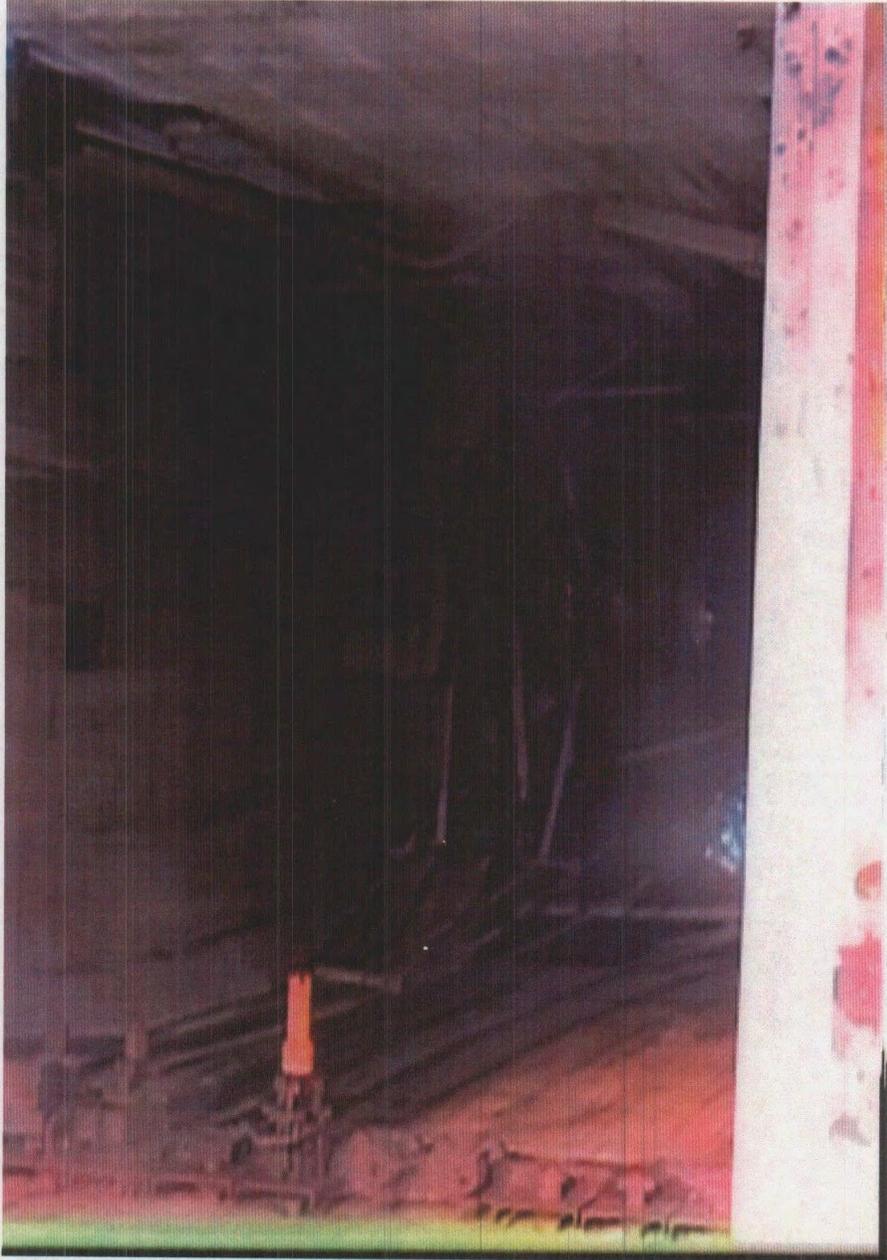
Video Info	1986 - Almost full-size tank in cell with liquid. Liquid was over the level of the top of the tank at this time (tank not visible). Pipes, jumpers. Tank appears to be constructed with a "flared out bottom" (cell widens out in deeper areas). 2001 - Liquid within tank. Cracked sludge on side walls. No jumpers, 45' deep receiver tank, two 24" headers terminate above tank, active bubbling (probably from "nozzle 47 - liquid level and pressure"), rack and pump above water, >2" cracked overflow sludge adjacent to tank, rad sign, plastic bottle, orange stain on walls. (Video footage 19:19-26:23 and 29:46-33:47)
Chemical Info	F001-F005 from tank 5-7 contents; PCBs >500 ppm in waste
Plant Interface	
Radiological Info	
Interview1	
Interview2	
Current Contents	Tank 5-7 (contains liquid and sludge) and installed jumpers.
Property List	Tank (Struthers Wells)
Investigation Status	Complete - opened 2001

Cell 5R 1986

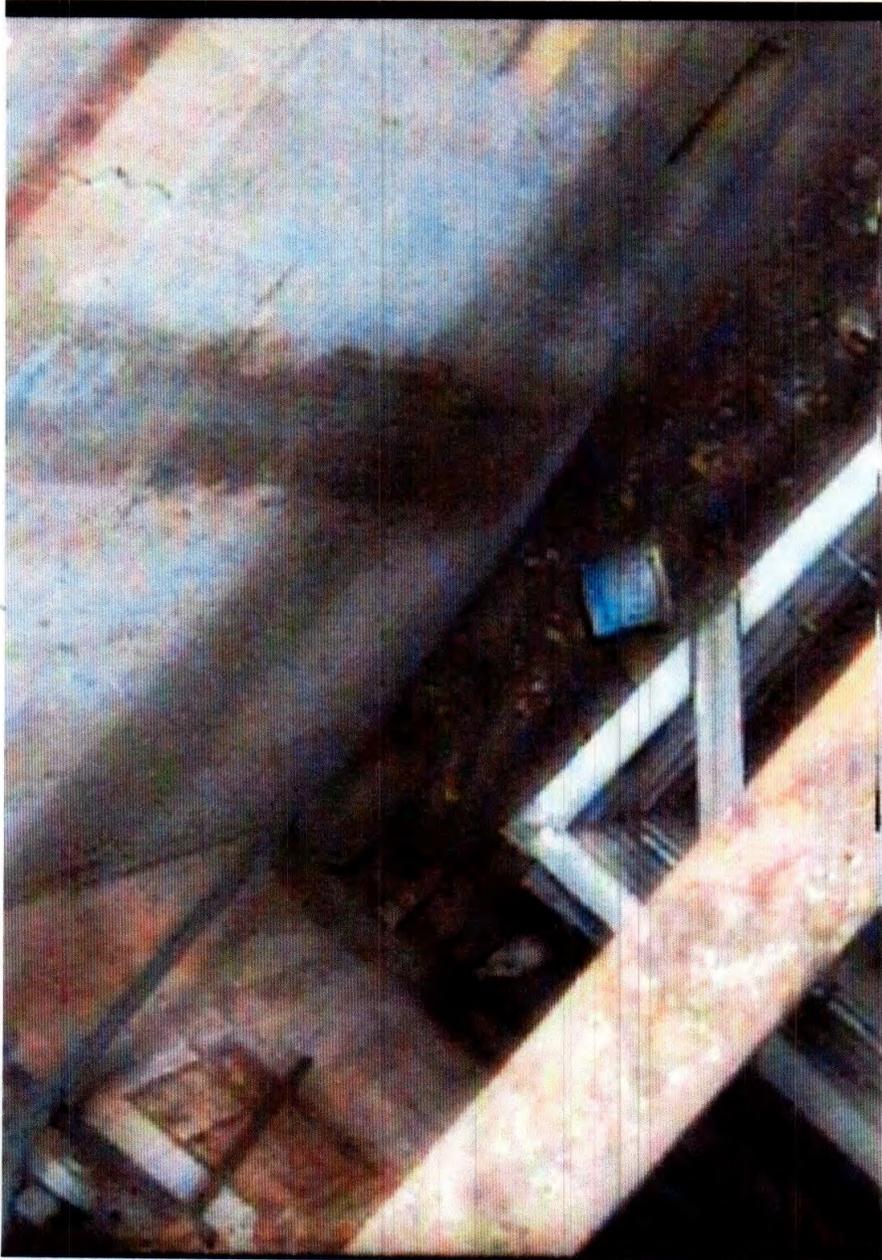
Cell 12R 2001

<i>New Cell No</i>	12R
<i>Old Cell No</i>	24
<i>HNF-1982 Info</i>	Storage and oxidation of metal solution.
<i>MR-0452 Info</i>	Storage and oxidation of metal solution.
<i>HNF-1982 Recent</i>	The cell is open, and contains a small number of misc. jumpers. There is one block installed. The block has a large crack, and must be inspected carefully before lifting.
<i>ISB and LTDES</i>	Decon Cell (Empty) [LTDES] Misc. jumpers. In use as decon. cell. [ISB] LTDES Decon Function: Decon cell. Open cell (no cover block, ~18' X 13' X 22')
<i>Video Info</i>	2001 - Lots of junk. Dry and dirty. Cage used for grit blasting, lots of grit. Aerosol can, plywood, car tire, metal items, chokers, decon cage sprayer, general debris.
<i>Chemical Info</i>	Assume F001-F005 from decontamination activities performed in the cell.
<i>Plant Interface</i>	
<i>Radiological Info</i>	Bottom of cell, 30 - 4700 shallow dose, 5 - 500 deep dose (T Plant handout). 500 mR/hr penetrating dose rate, within 2 feet of bottom of cell. (T Plant video meeting).

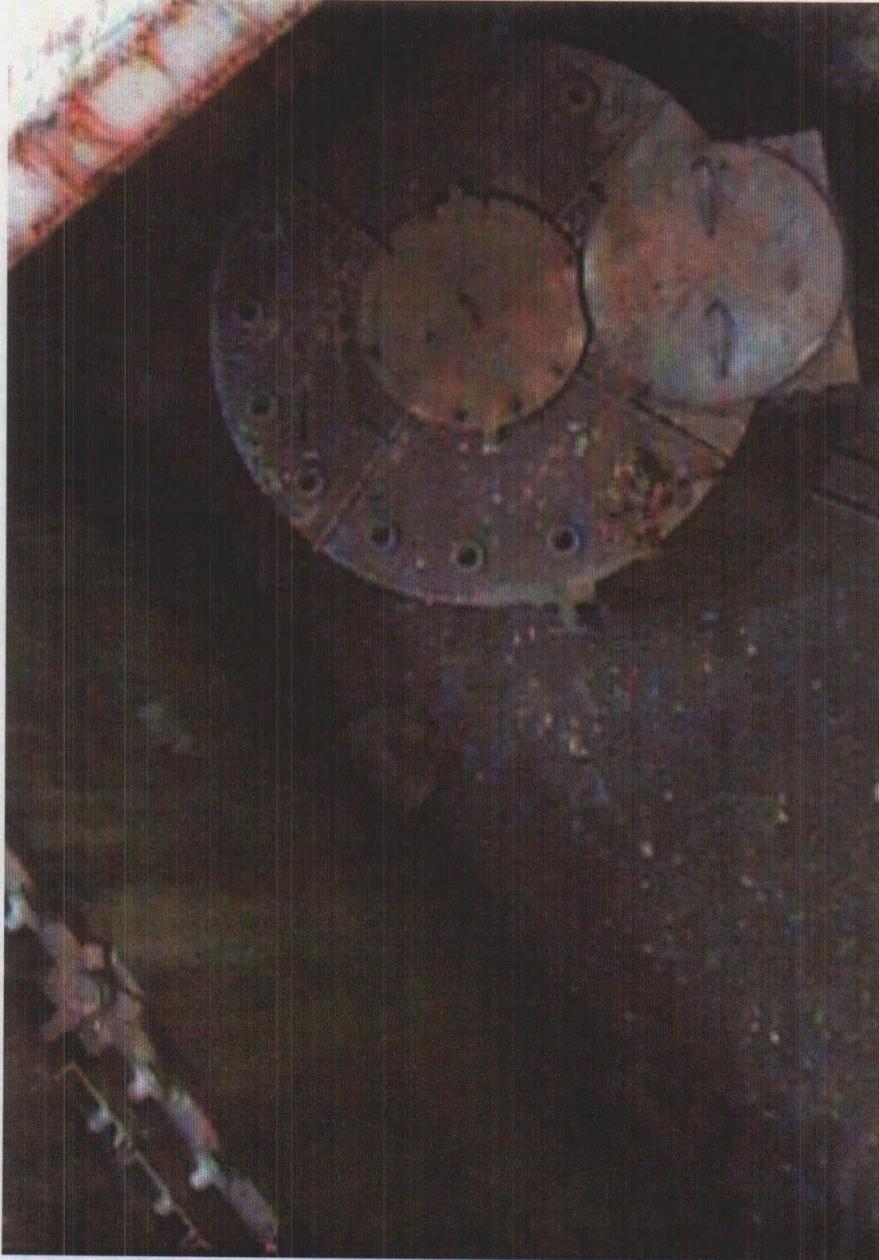
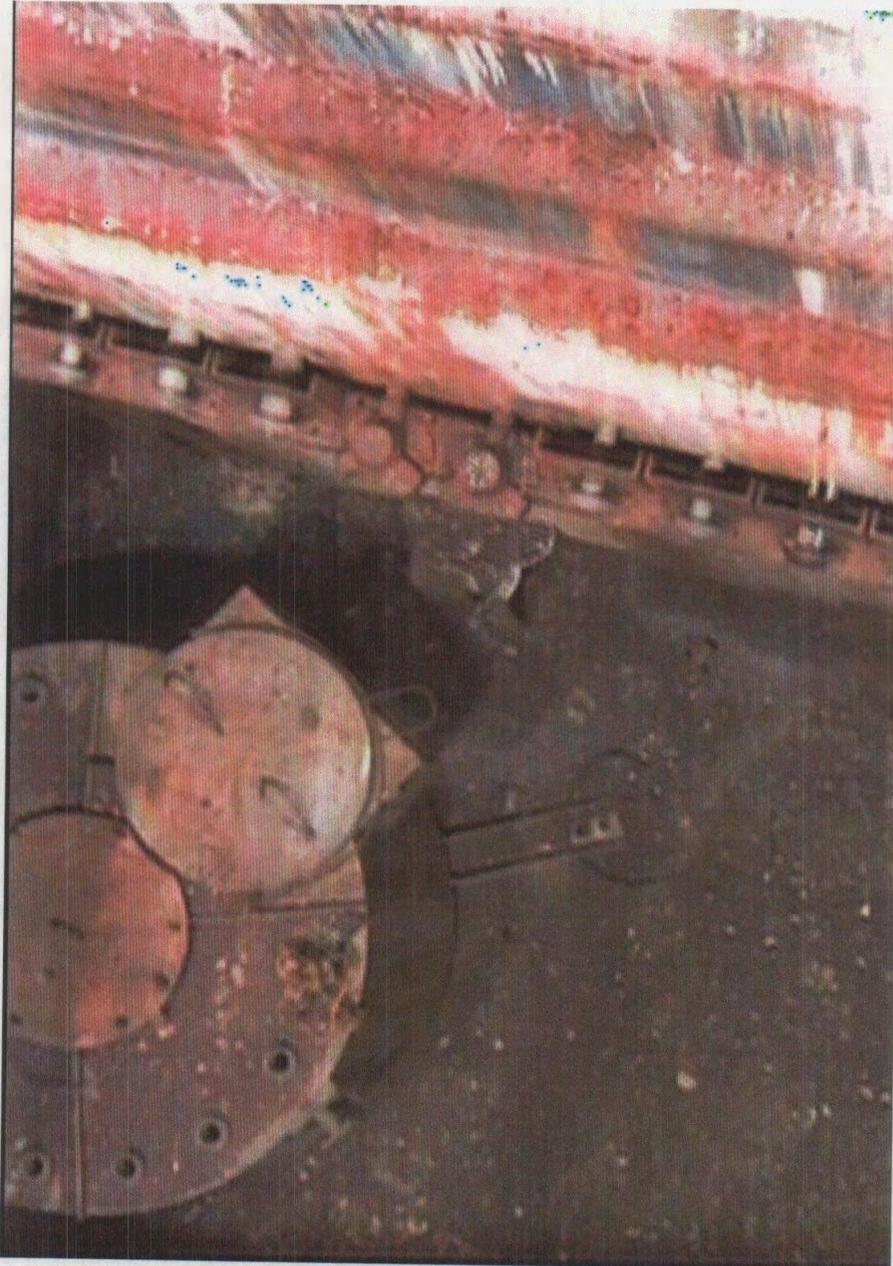
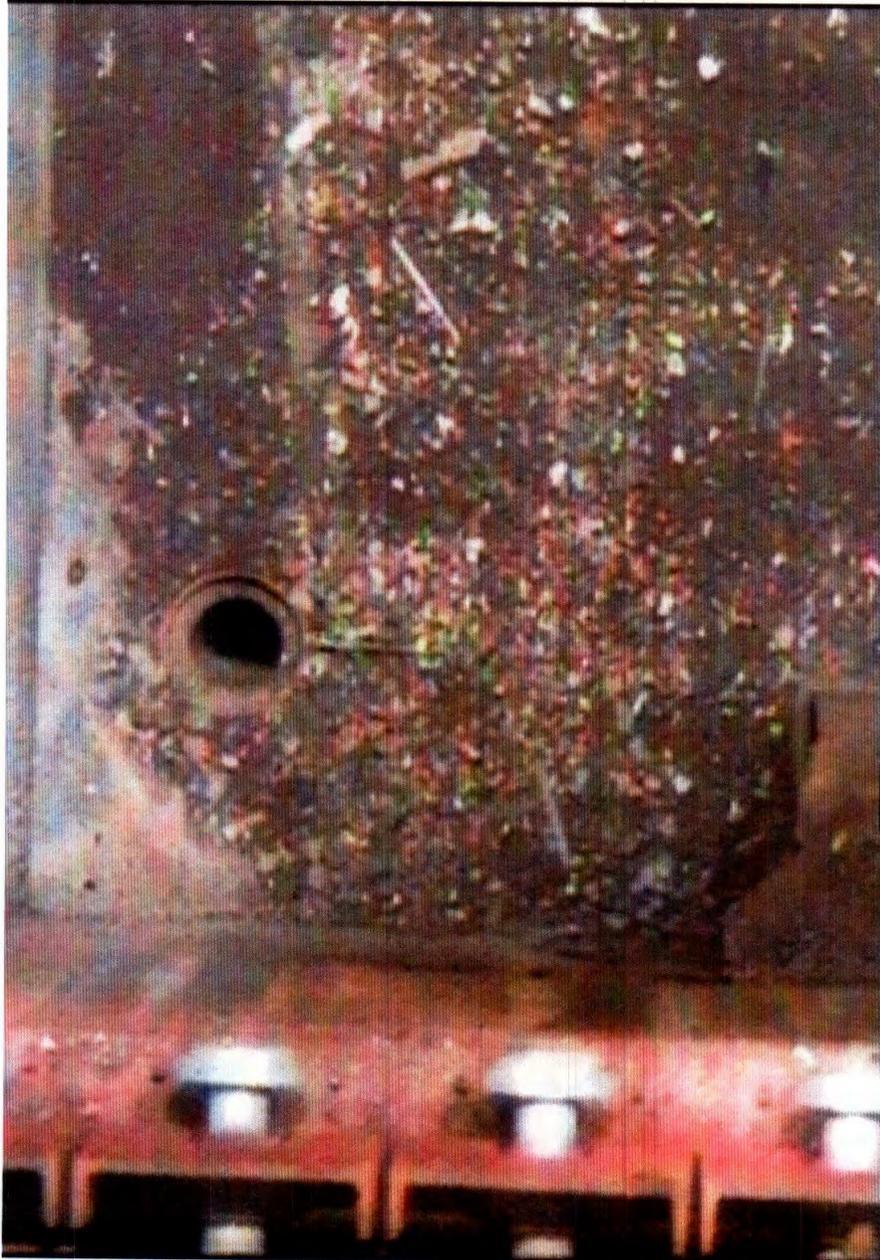
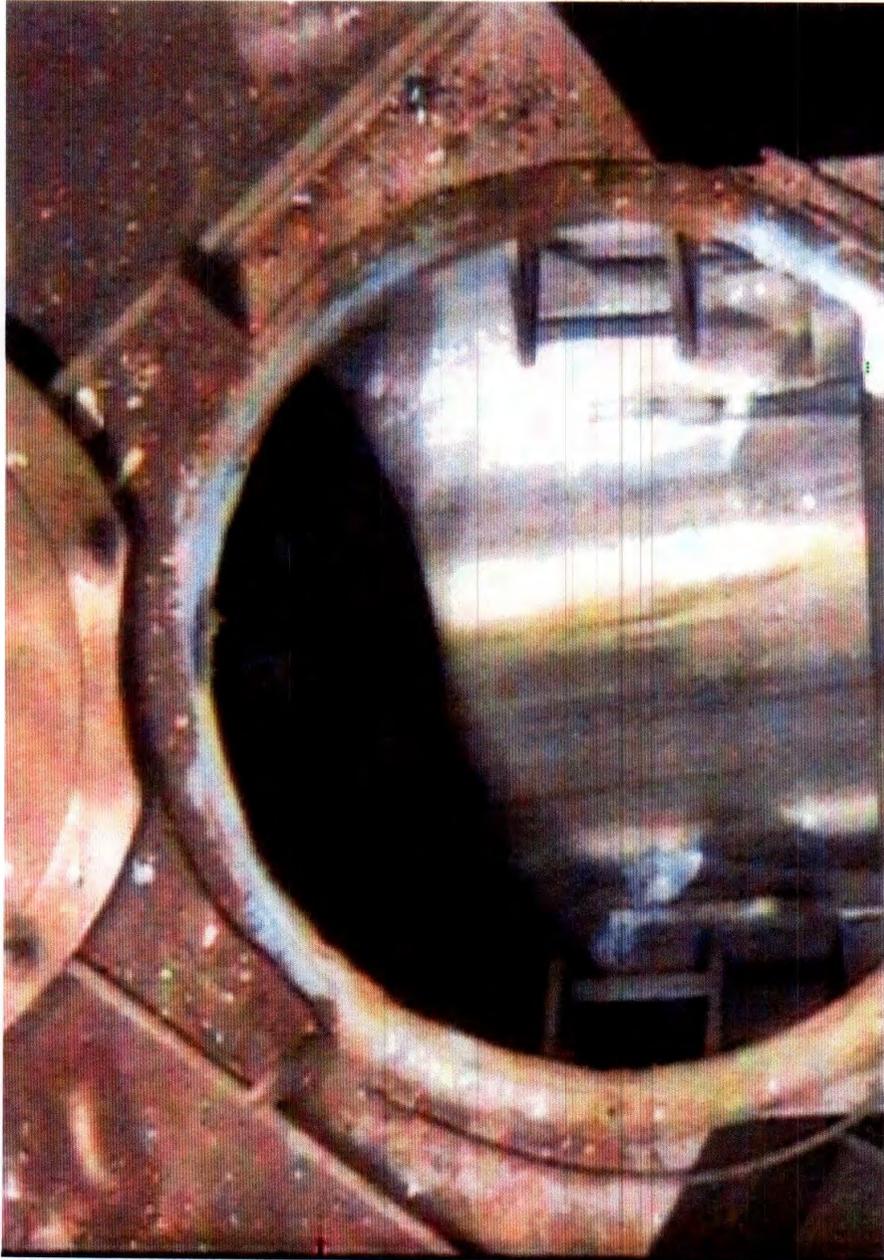
Cell 13L 2001

New Cell No	13L
Old Cell No	25
HNF-1982 Info	First decontamination cycle, by-product precipitation.
MR-0452 Info	First decontamination cycle, by-product precipitation. Section 13 contained a standard grouping of process equipment that consisted of four pieces: a precipitator, a catch tank, a centrifuge, and a solution tank.
HNF-1982 Recent	Contains a large 8' dia. tank in the bottom of the cell. There are no connected jumpers. 1 9 x 9 tank. Some sand at bottom of cell. Drain not plugged. Key block has crack.
ISB and LTDES	PUREX Off-Gas Silver Reactor [LTDES] Tank [ISB]
Video Info	1986 - one large vessel with lid. [5:23 - 6:47] 2001 - as above. Lots of small debris, like paint chips. No silver reactor. Lots of grit (from 12R sandblasting). Tank has small openings from disconnected jumpers, can't see bottom.
Chemical Info	No equipment remaining, but any floor residues removed would be assumed F001-F005 due to decontamination activities performed in the cell.

Chemical Info	Assume F001-F005 from decontamination activities performed in cell. Green staining, probably from electropolisher chromic acid solutions, can be seen.
Plant Interface	
Radiological Info	Dose rates 400 - 84,000 mR/hr window open, 0 - 400 mR/hr window closed, before removal of equipment (survey report TC-001061) Contamination surveys performed on equipment before removal (survey report TC-001083)
Interview1	
Interview2	
Current Contents	Cell is empty
Property List	
Investigation Status	Complete - opened 2002

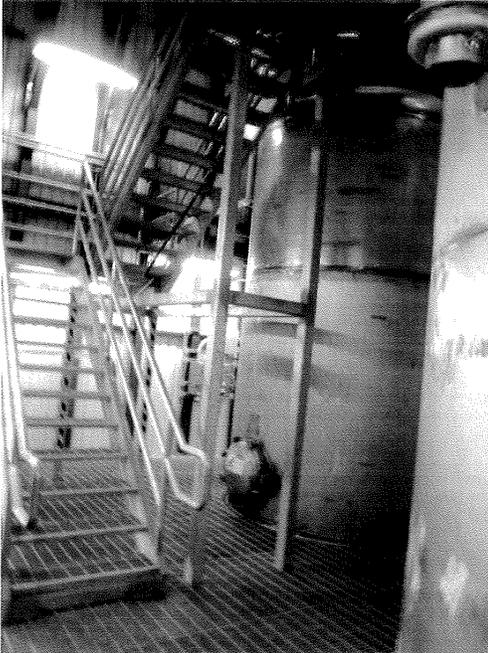
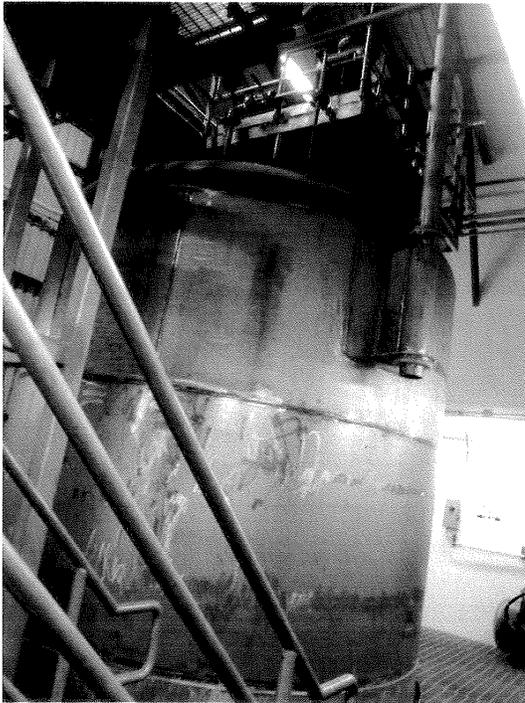
T Plant Complex 2706-TB Building Storage Area

No waste is being stored in this area. The 2706-TB building tanks have been emptied and deactivated (Tank T-XX-2706-220 and T-XX-2706-221). The 2706-TB Building houses a functioning air compressor which is still required for operation of the Drum Venting Assemblies in 2706-T and 2706-TA. This compressors' Automatic 'Blow Down' drain has cause a visible spot in the 2706-TB sump (see photographs). No other spill evidence was noted.

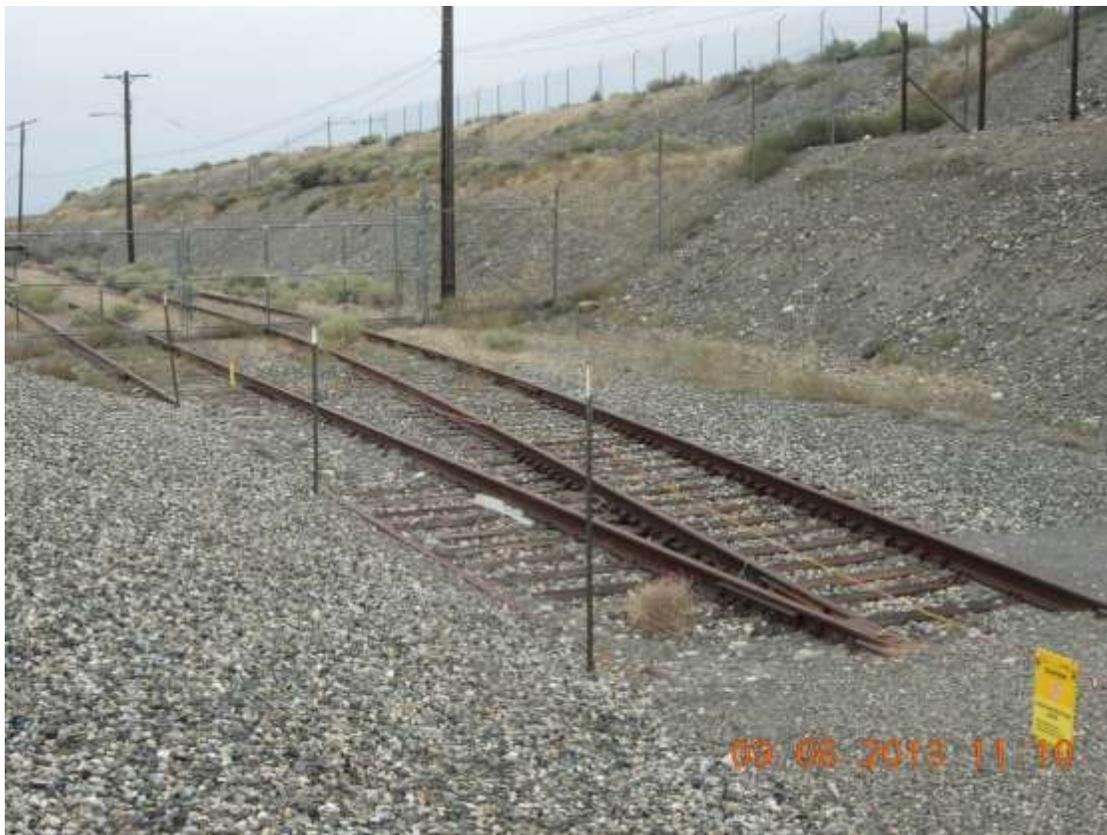
2 No permitted RCRA waste container storage was identified at the 221-T Railroad Cut during the T-Plant
3 operating records review. Therefore, no maximum waste inventory is presented. Weekly inspection
4 records of the <90-day storage area and SAA identified that the 221-T Railroad Cut stored mixed waste.

5
6 **Figure H-1. T-Plant Complex Operating Unit Group 221-T Railroad Cut Outdoor Container Storage Area**

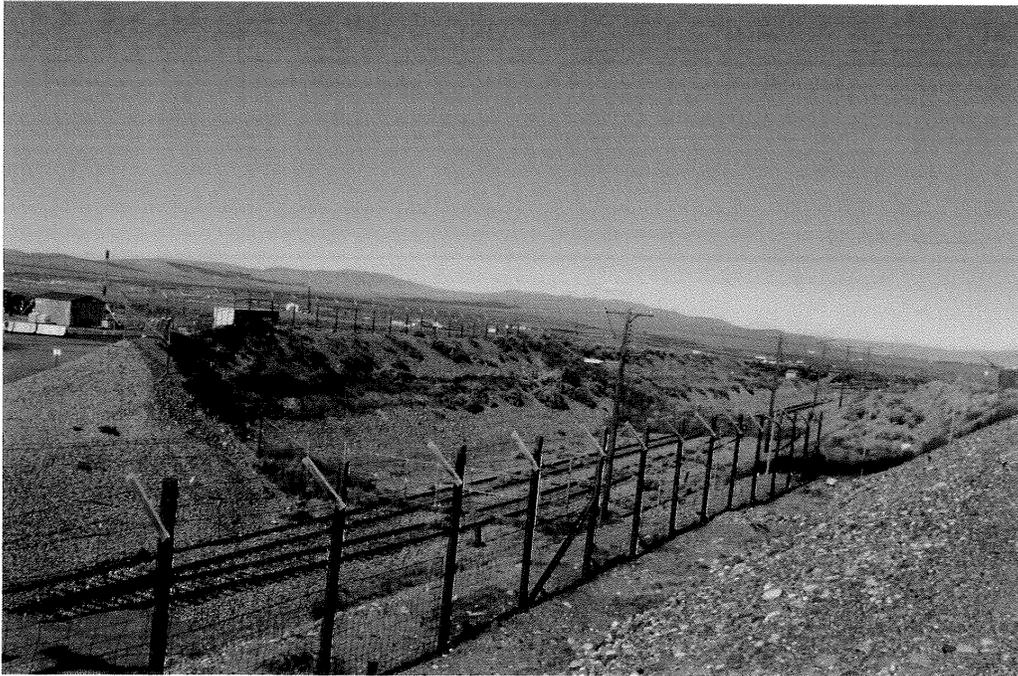
No evidence of spills or staining was noted.

No waste is being stored in this area. Area consists of abandoned rail road tracks, gravel, tumbleweeds, and an inner and outer chain link fence and gates. Some debris was noted at the Western end of the Cut. Debris consists of steel plate, steel pipe, railroad ties, and a metal storage box (see photographs).

T Plant Complex 221-T Railroad Cut Storage Area

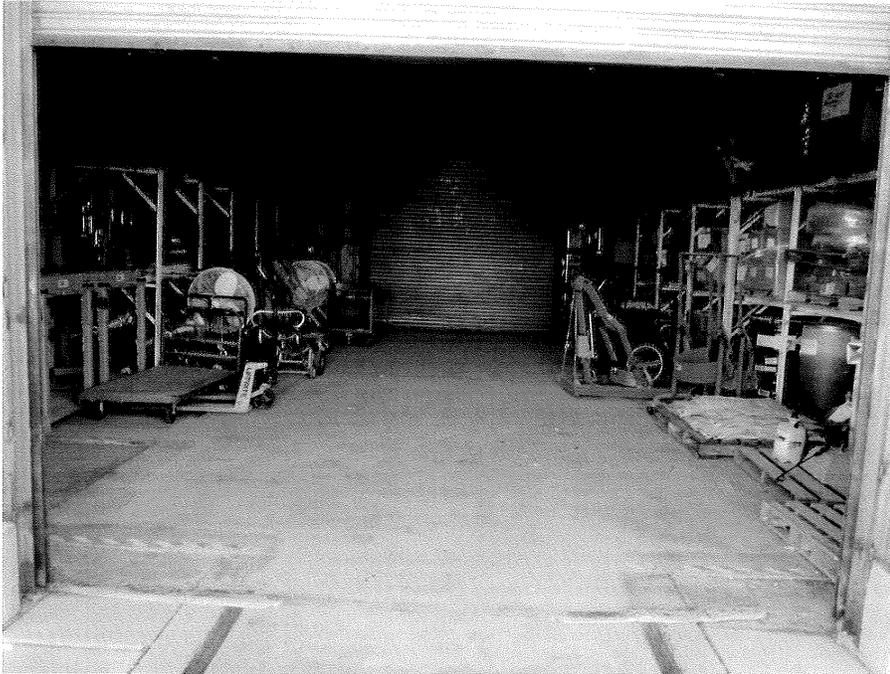
T Plant Complex 277-T Building Storage Area

15 The 277-T Building (Figure I-1) is a single story, pre-engineered, steel structure constructed of I-beams
16 covered with corrugated steel on a concrete slab on grade foundation. It is approximately 10 m
17 (32 ft) wide, by 12 m (40 ft) long, by 7 m (24 ft) high. Rollup doors are located on each end for loading
18 and unloading operations.

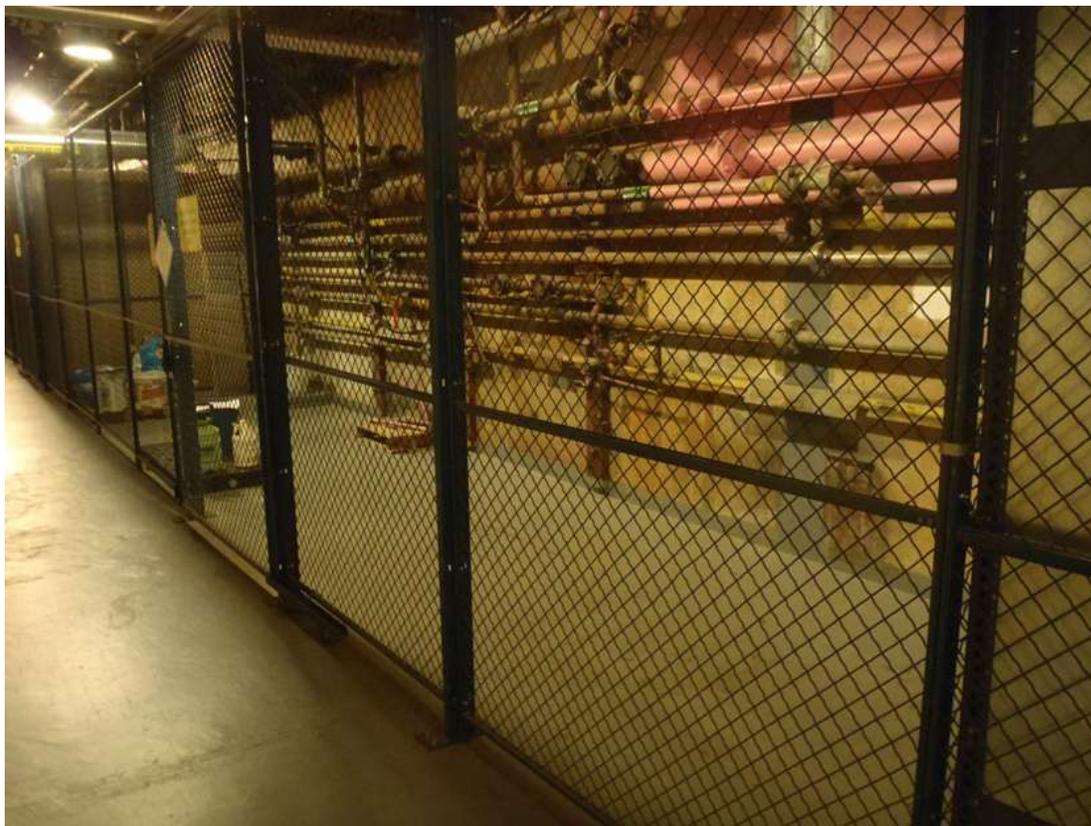
6
7 **Figure J-1. T-Plant Complex 221-T Pipe Gallery Storage Area**

2 No permitted RCRA-regulated waste container storage at the 221-T Pipe Gallery Storage was identified
3 during the T-Plant operating records review. Therefore, no maximum waste inventory is presented.
4 Weekly inspection records of <90-day storage areas and SAAs identified that the 221-T Pipe Gallery
5 Storage managed non-dangerous, dangerous, mixed, and TSCA-PCB waste.

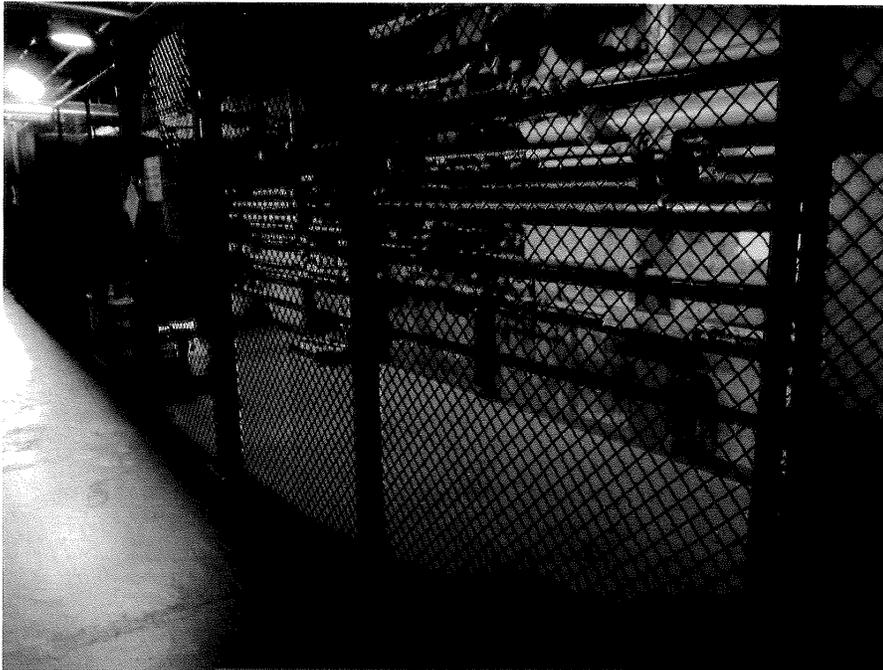
Concrete floor is sealed with paint no evidence of cracking or peeling. Painted floor surface shows no evidence of staining or waste spills. Area contains old process piping along the East wall. Markings on these pipes indicated they are abandoned, no evidence of leakage. No waste is being stored in this area. Area is currently storing spill cleanup material/product; kitty litter and soil cement.

T Plant Complex 221-T Pipe Gallery Storage Area
