100-N D4 Project Facility Completion Form

This document provides information regarding the 1330-N Waste Storage Facility history, characterization and final status at the completion of deactivation, decontamination, decommissioning and demolition (D4) activities.

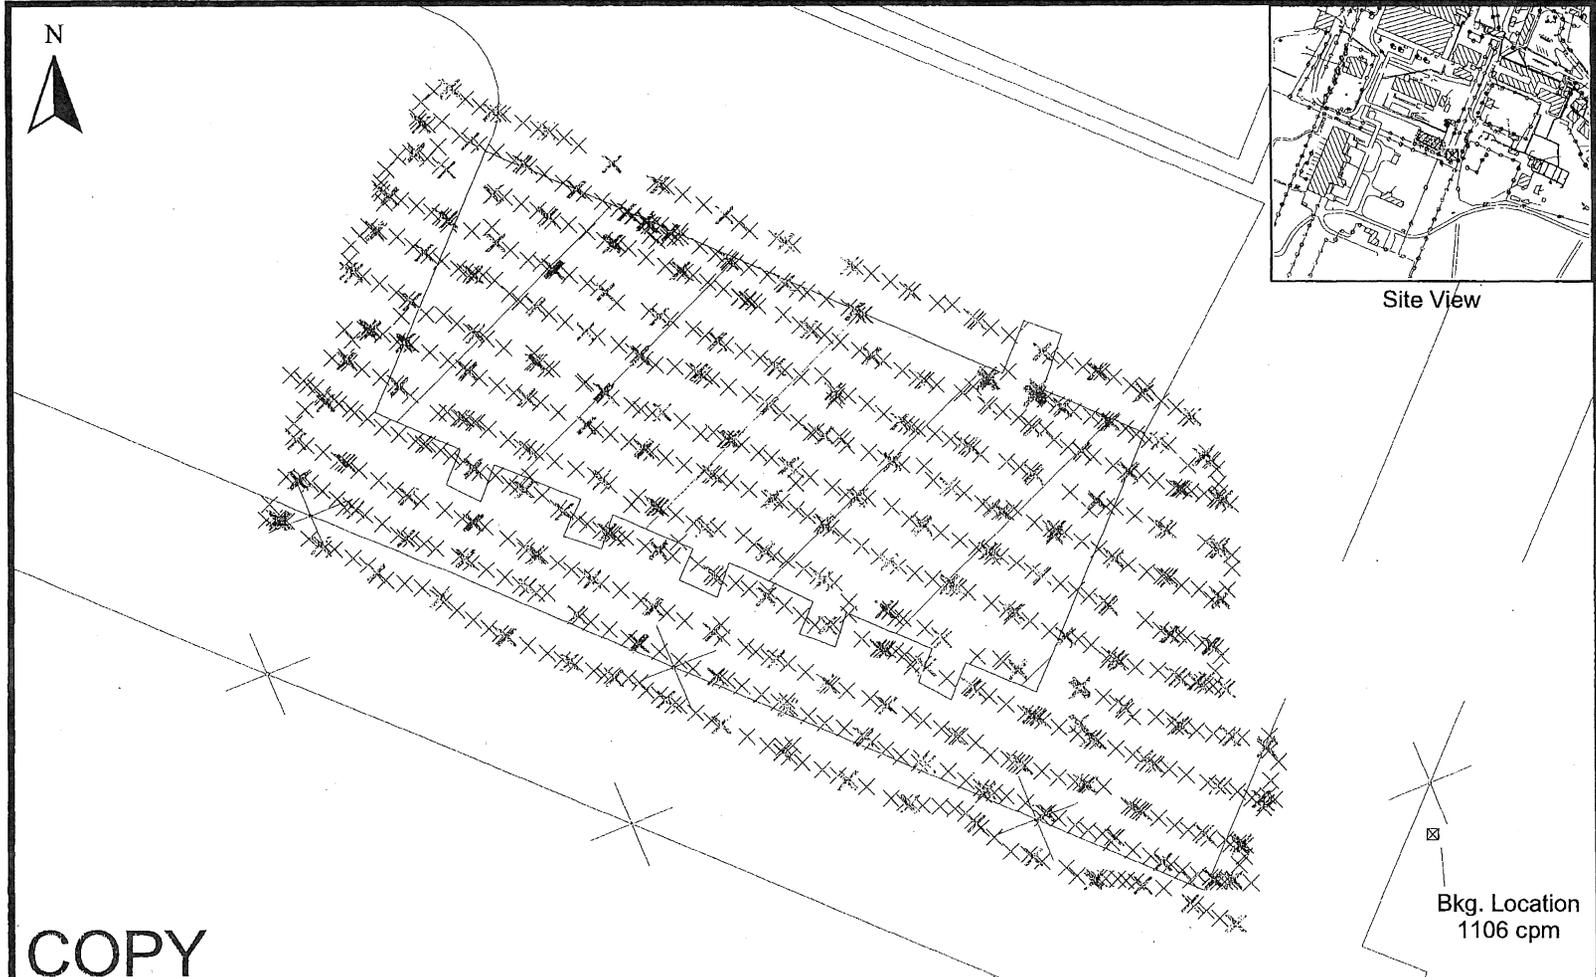
Legend	Summary Statistics
NETCPM	Coverage File: N308
	Number of Data Pnts: 3090
	Type of Survey: 'Gamma'
× < 2212	Max GCPM: 1707
● 2212 - 5000	Avg Bkg CPM: 1106
● 5000 - 10000	Survey Date: 11/03/2008
● 10000 - 25000	Area Surveyed: 2061 m2
● > 25000	Project File: N308
	Pdf File: ESRFRM080163C

100N Field Remediation
1330-N Waste Pad
GPERS Radiological Survey
Gamma Track Map

A post-demolition Global Positioning Environmental Radiological Survey (GPERS) was conducted on the 1330-N facility area as a final survey of this site in November 2008. A Beta and Gamma survey was performed. During the Beta radiation survey, 3090 data points were measured and no data point was greater than 2 times the average background of 411 counts per minute. During the Gamma radiation survey, 3090 data points were measured also and no data point was greater than 2 times the average background of 1106 counts per minute. A summary of the GPERS results are included in Table 2 and copies of the survey maps are in Attachment 3.

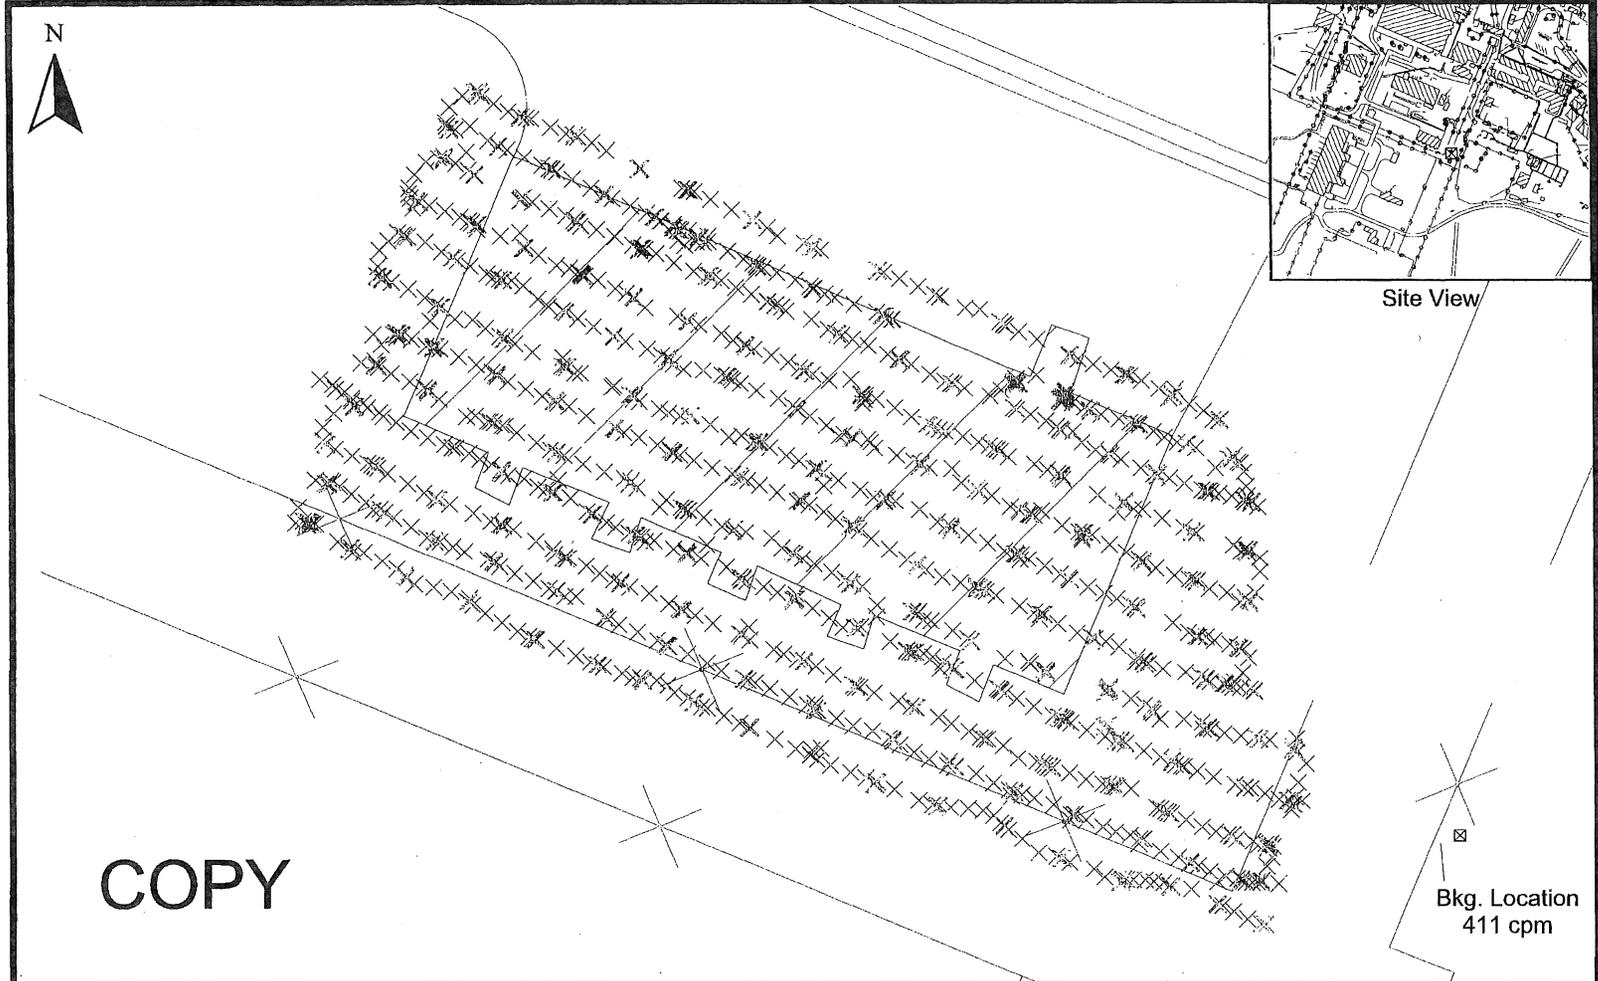
Coverage File: N308_
 Number of Data Pnts: 3090
 Type of Survey: 'Beta'
 Max GCPM: 388
 Avg Bkg CPM: 411
 Survey Date: 11/03/2008
 Area Surveyed: 2061 m2
 Project File: N308_
 Pdf File: ESRFRM080163_C

**100N Field Remediation
 1330-N Waste Pad
 GPERS Radiological Survey
 Beta Track Map**

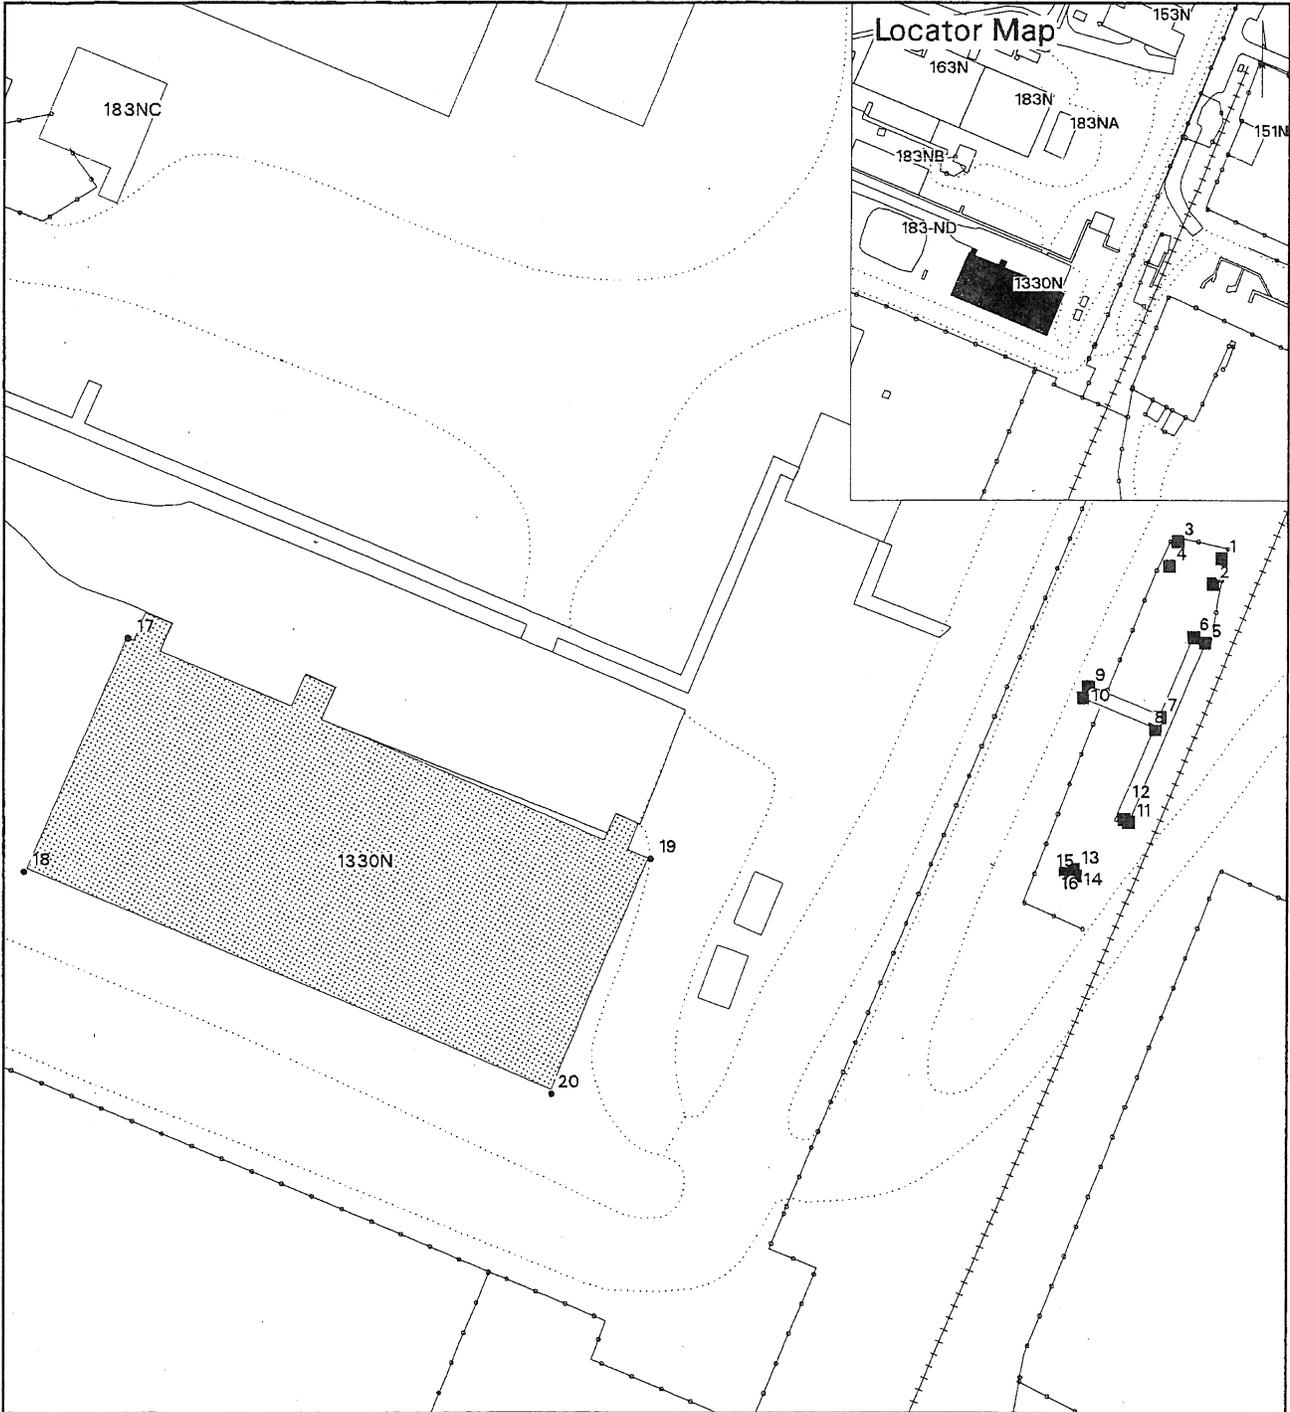
Pre- Demolition Survey of The 1330N Building

A pre-demolition GPS survey of the concrete pad corners was conducted February 2008. A post demolition GPS survey of the old building site was conducted November 2008. Both surveys are included in Attachment 4.

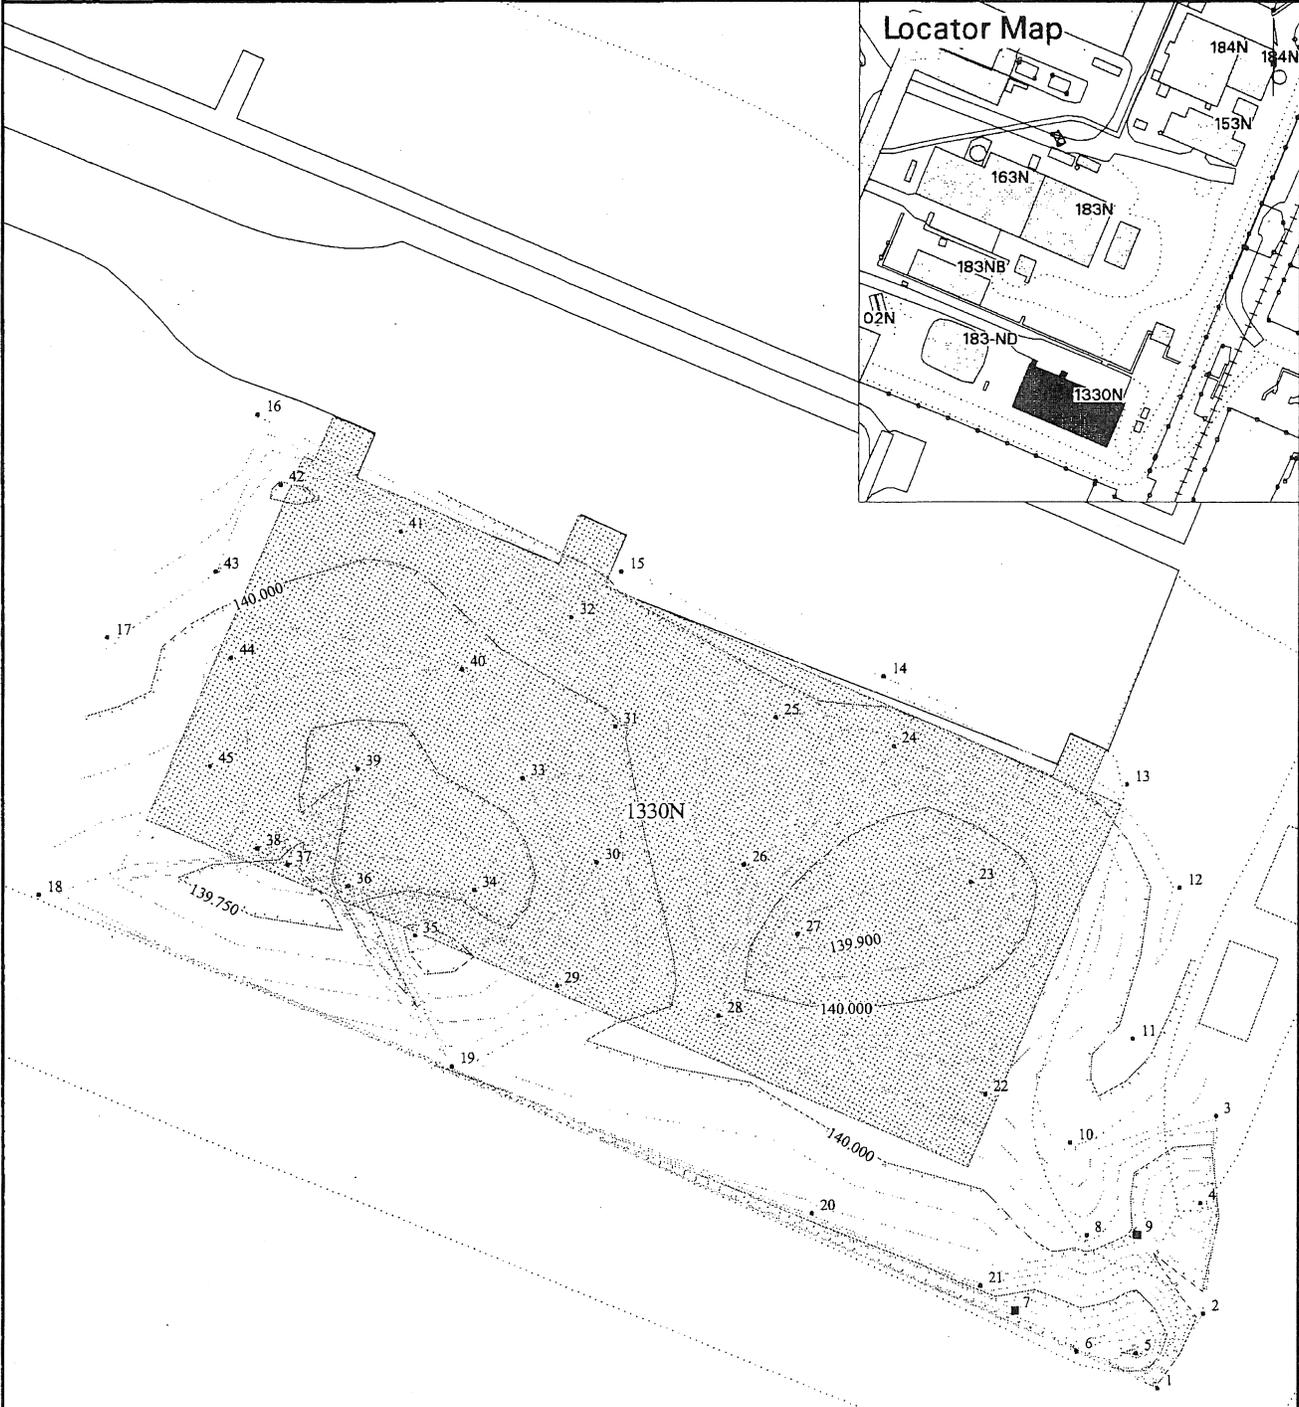
**Post Demolition Survey
for the 1330N Pad**

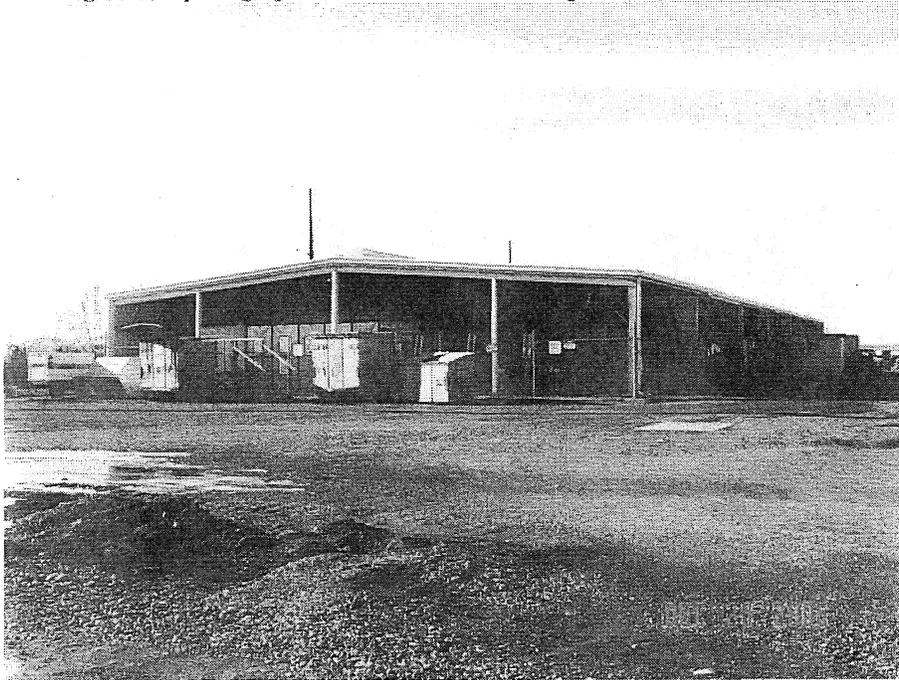
Figure 1. A photograph of the 1330-N Waste Storage Facility before demolition

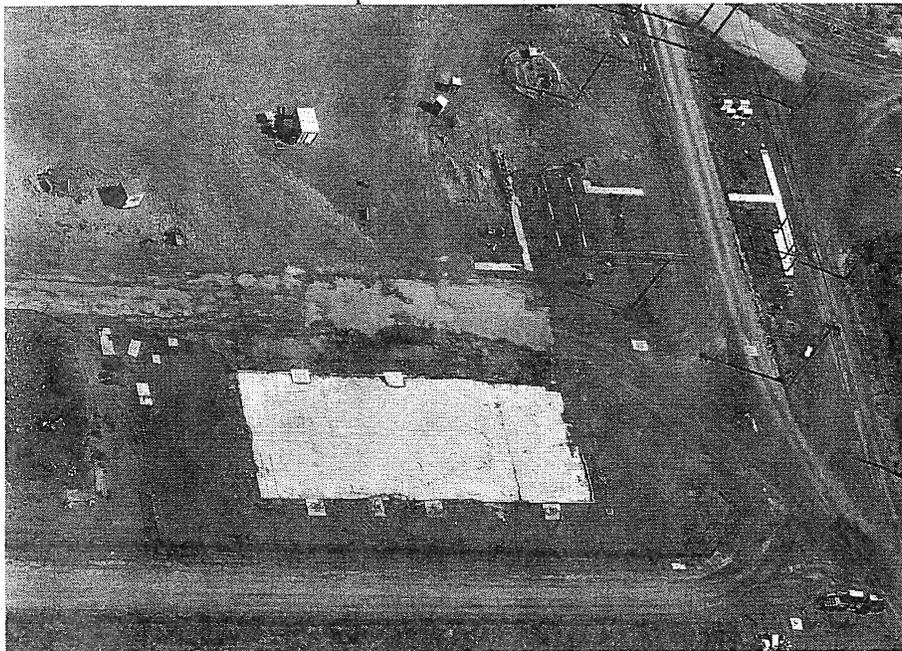
Figure 2. The aerial photograph shows the slab for the 1330-N Waste Storage Facility prior to slab removal.

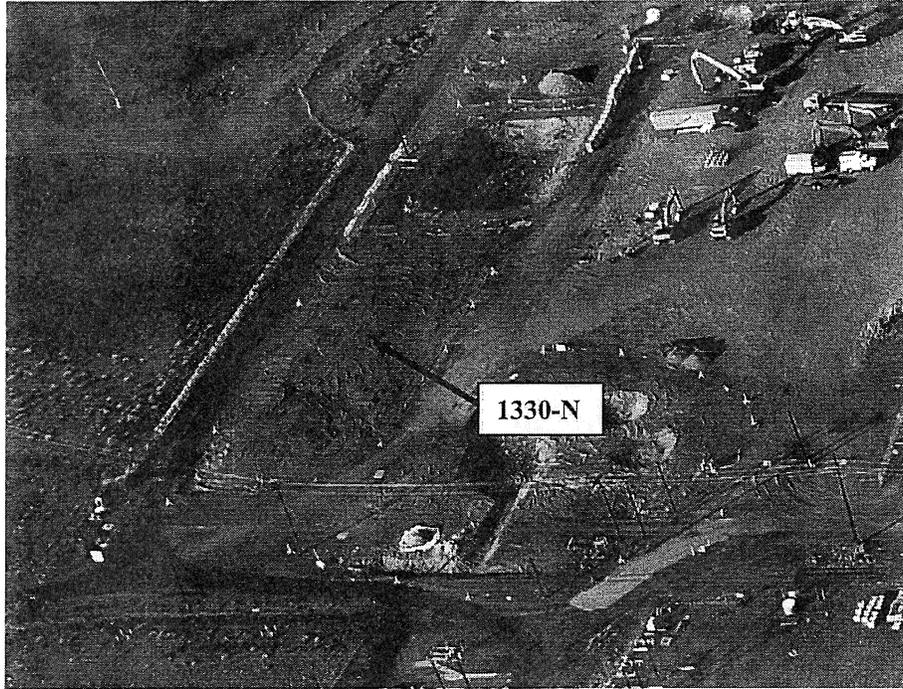
Figure 3. An aerial photograph of 1330-N Waste Storage Facility after demolition and slab removal.

The 1330-N Waste Storage Facility was demolished to the concrete pad in June 2008. After demolition was completed the building debris was stockpiled, sized reduced on the concrete pad, loaded out and disposed at the ERDF. Demolition and removal of all traces of the concrete pad was also completed in June 2008. A minimal amount of soil was removed along with the concrete pad. Backfill material from 100-N Borrow Pit was brought in to regrade the site.
