**TOWN OF COUPEVILLE  
SHORELINE MASTER PROGRAM  
GRANT NO. G0400107**

**SHORELINE MASTER PROGRAM – PHASE 1  
SHORELINE ANALYSIS REPORT  
TASK 4  
October 15, 2004**

**Report Prepared by  
Coastal Geologic Services, Inc.  
and  
Island Environmental and Technical Services**

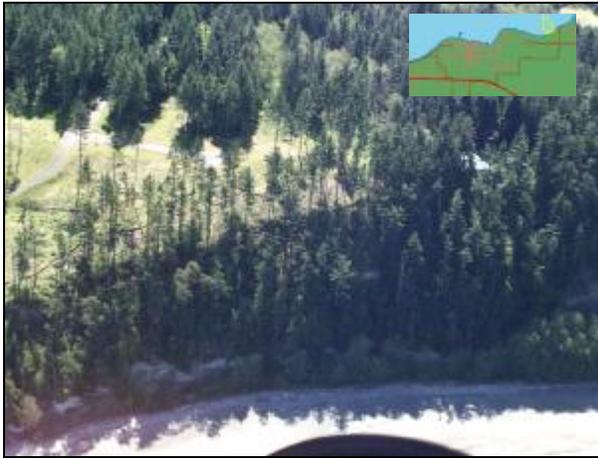
The forested uplands of Segment 1 consist primarily of northwest native conifers and shrubs including; Pacific madrone (*Arbutus menziesii*), Douglas fir (*Pseudotsuga menziesii*), western hemlock (*Tsuga heterophylla*) and several other species that can be found listed in Appendix 1. Approximately 90% of the segment offers an overhanging marine riparian area. Substantial clearing and thinning of upland vegetation has taken place landward of the bluff crest. A very thin buffer of conifers is all that remains at the bluff crest (Photo 1).

Photo 1. Segment 1. Vegetation clearing up to bluff crest

As previously mentioned, a (fairly) high degree of clearing of upland yards has occurred in Segment 1, in many cases up to or almost up to the bluff crest. This causes increases runoff directed towards these unstable bluffs as well as the loss of root strength in surficial soils. These factors are likely causing some increase in erosion and landsliding, as well as a medium and long-term reduction in the large woody debris (LWD) input to the nearshore. It is recommended to require preservation of bluff top vegetation buffers (with tree limbing and careful vegetation management allowed to enhance views) on the order of 25 – 40ft wide, and establishment of these buffers where they do not exist upon development applications. Stormwater management is also important in minimizing erosion, landsliding and water quality degradation in this segment.

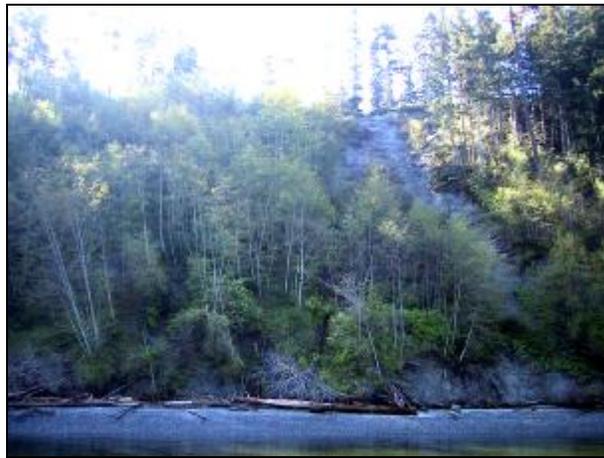
Steep, high, forested bluffs best characterize the upland areas of Segment 2. The geology of the segment is composed mainly of the Everson gravels with underlying undifferentiated Pleistocene deposits found in the eastern-most portion of the reach (Map 2; DOE 1979). The bluff is actively eroding, and was classified as unstable and erosive by several sources (DNR 2001, DOE 1979 and CGS *prep.*), however, Keuler's (1988) geomorphic mapping classified this shoreline segment as neutral. CGS observed a relatively large recent slide that extended the entire height of the bluff (Photo 2). The scarp was near the bluff crest and the slide (at beach) measured approximately 100 ft in width. Several large slumps were also noted from mid-bluff height. Toe erosion of colluvium and bluff material was evident at numerous locations throughout the reach. It is clear from field observations and previous research that this shoreline reach is actively contributing sediment to downdrift shorelines and the segment was recently therefore mapped as a feeder bluff (Map 3).

Photo 2. Segment 2. Landslide from bluff crest

Management of Segment 2 should be focused upon conserving the habitat value found within this shore reach. Similar to Segment 1, small patches of land clearing could potentially destabilize the steep erosive bluffs. In addition, removing the forested vegetation found on the bluffs as well as landward of the bluff crest will alter stormwater run off, destroy root strength in surface soils and lead to a long-term reduction in large woody debris supplied to the nearshore. Vegetation removal within much of the segment may also have adverse impacts to the two bald eagle nests located mid-segment. This clearing should be kept to a minimum to prevent further slope failures and conserve valuable bald eagle habitat.

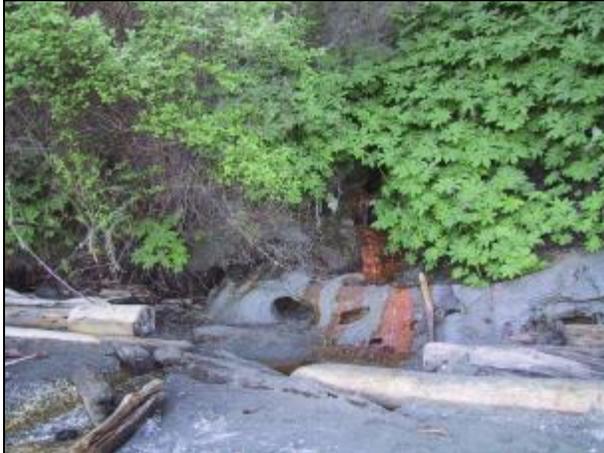
An iron-rich freshwater spring was observed flowing from significantly vegetated colluvium approximately 400 ft west of the boundary between Segment 1 and 2 (Photo 3). The spring was significant enough in size that its flow was audible from a considerable distance. The freshwater input also resulted in a band of *Enteromorpha sp.* (marine algae) extending beachface.

Photo 3. Segment 2. Iron rich spring flowing from bluff

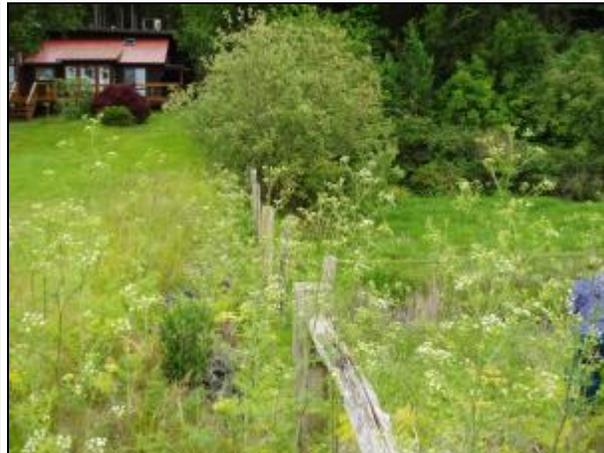
Approximately 1650 ft of this low elevation backshore area falls within a Coastal Flood Hazard area as mapped in the Coastal Zone Atlas (DOE 1979). It is very likely that the most low-lying backshore areas have been filled, possibly since this mapping was originally completed. However, during a storm surge in conjunction with a very high tide or a strong NE-wind, it is possible that properties located within the flood hazard area could be inundated with seawater.

Photo 4. Segment 3. Backshore wetland and elevation contrast between adjacent lots indicative of backshore filling

Natural processes in Segment 3 have been altered by vegetation clearing and filling of coastal wetlands for residential development. Residential dwellings are found throughout most of the reach at variable distances from the storm berm. Several dwellings are located within the Coastal Flood Hazard area mapped by the Department of Ecology (1979). There are small sections of shoreline that have not undergone considerable clearing and filling that still possesses coastal wetland characteristics.

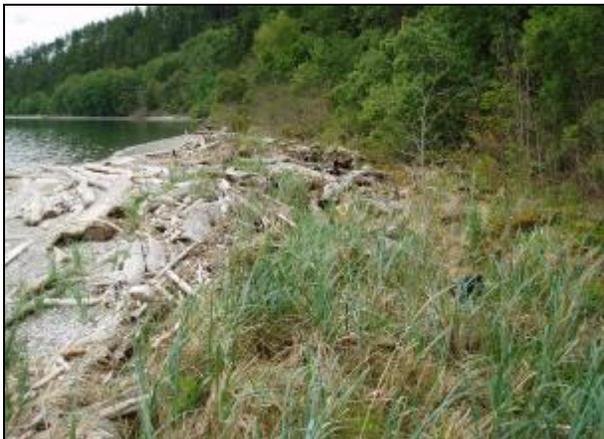
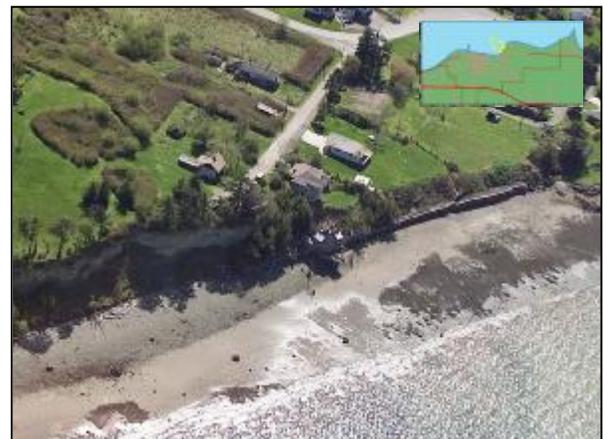
Based on familiarity with this type of spit/beach and examination of the historic T-sheet (T-2011 from 1888), it appears that a tidal wetland and/or lagoon existed in the backshore through most of the length of Segment 3. During field reconnaissance several parcels of land with contrasting backshore elevations were observed (Photo 4), implying that widespread filling likely occurred. One property with what appeared to be an unmodified backshore had a small pond surrounded by facultative and obligate wetland species (not inventoried) including; *Rumex sp.*, *Triglochin maritima*, and *Atriplex patula*. The pond was less than 15 ft in length and less than 6 ft in width. Another backshore depression was observed near the eastern end of Segment 3. This backshore area is nearly filled with considerably decayed driftlogs that appear to be acting as nurse logs for several upland species (Photo 5).

Photo 5. Segment 3. Backshore depression with LWD with colonizing upland vegetation

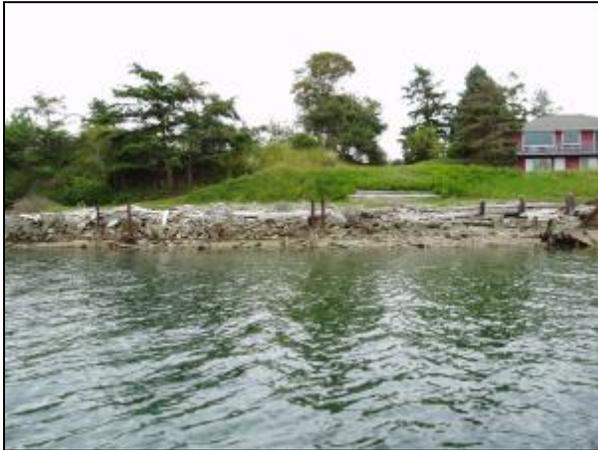
The upland areas of this segment are only lightly vegetated due to the close proximity of residential dwellings and abundant land clearing. No overhanging (northwest native) riparian vegetation is found in the reach (DNR 2001). Some non-native invasive species were observed growing in the uplands including Himalayan blackberry (*Rubus discolor*) and Scotch broom (*Cytisus scoparius*). A small patch of native conifers is found behind the bulkhead on the eastern portion of the segment. A narrow band of driftwood and beach wrack is found along the base of the eroding bluffs. Minimal beach wrack and/or vegetation are found at the base of the bulkhead.

Photo 6. Segment 5. Lack of beach sediment and backshore beneath bulkheaded shoreline

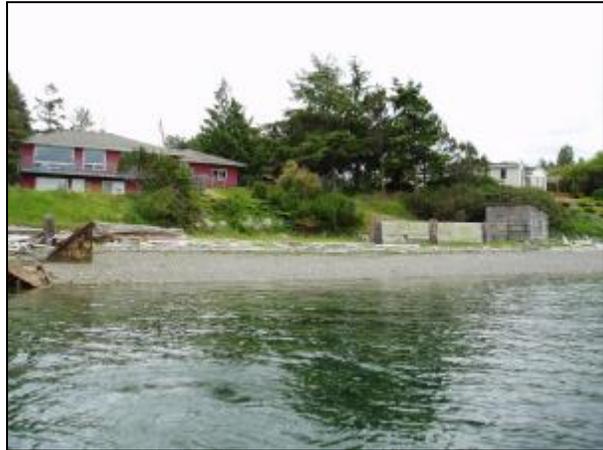
Photo 7. Segment 6. Relict steel structures in intertidal

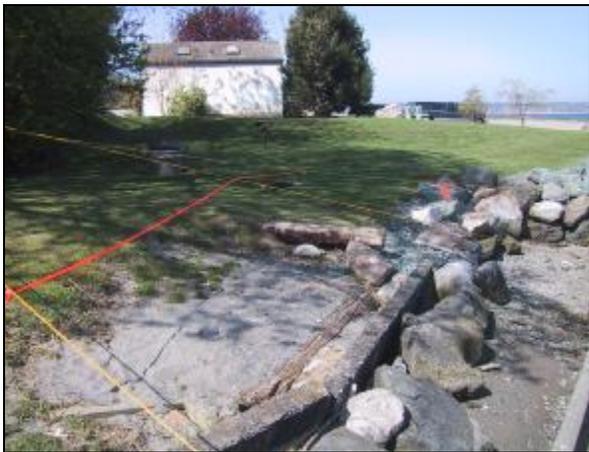
Net shore-drift travels west to east in this segment. Due to shoreline modifications, only one small pocket of beach is functioning naturally and able to accrete sediment (Map 4). This pocket exists due to the failure of a bulkhead, located approximately 550 ft east of the boat launch. The beach is now forming a natural storm berm, consisting primarily of large pebbles with sand, and beach wrack including driftlogs, is beginning to accumulate. There are numerous opportunities to further enhance and/or restore this reach of shoreline, outlined in the Recommendation section below.

Photo 8. Segment 6. Accretion adjacent to relict bulkhead (restoration opportunity)

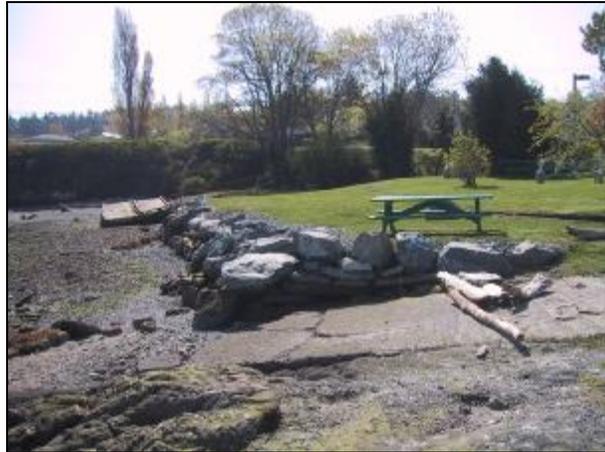
Photo 9. Segment 6. Failing bulkhead in Thomas Coupe Park

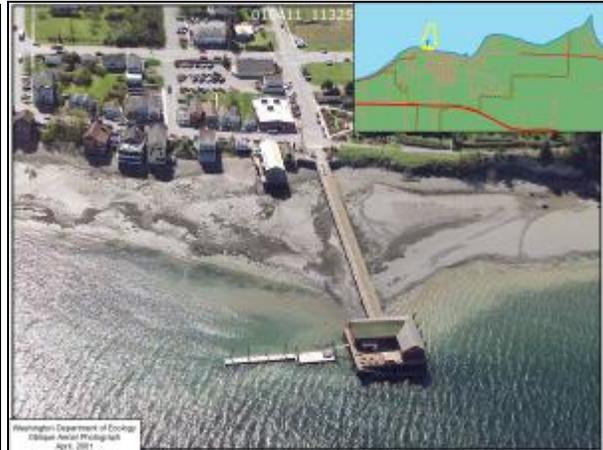
Photo 11. Segment 7. Flat wooden structure with small piles over intertidal

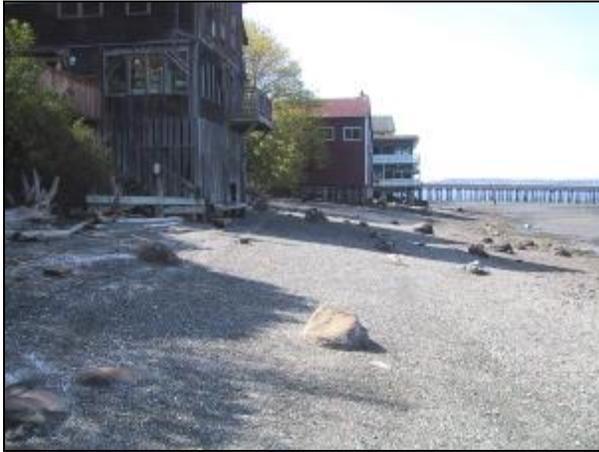
Photo 12. Segment 8. Coupeville Wharf; sedimentation and over-water structures

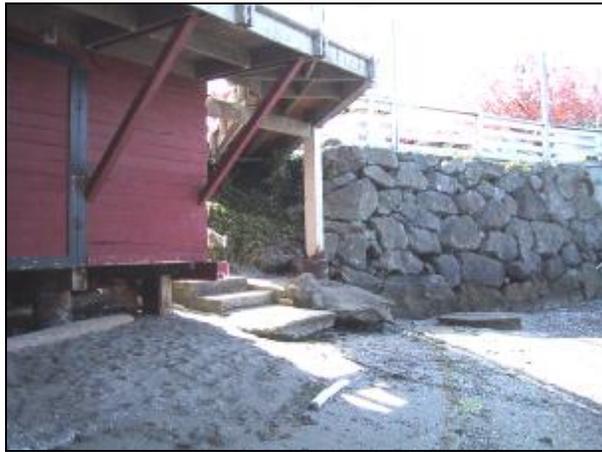
Photo 13. Segment 8. Fine gravel and sand beach and boulders scattered over upper beachface and wooden seawall at base of overwater structures

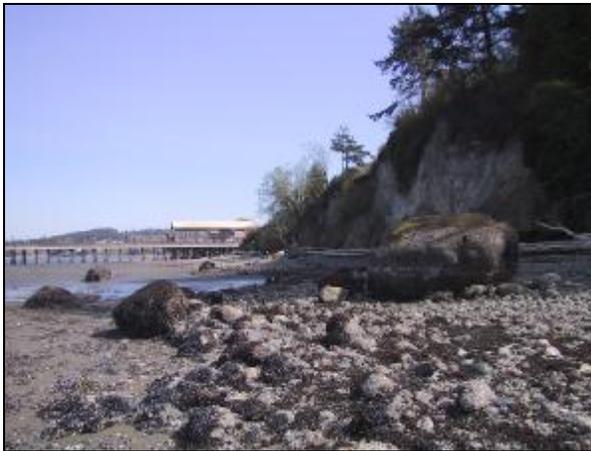
Photo 14. Segment 8. Beneath Coupeville Wharf; note erosion right of stairs, accretion of sand beneath building.

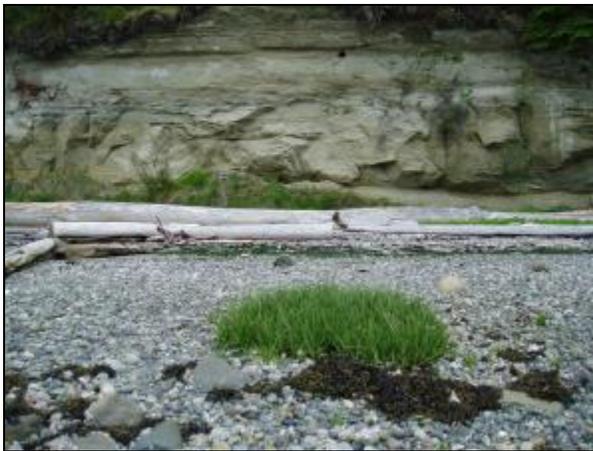
Photo 15. Segment 9. Boulders on lower high-tide beach and eroding bluffs
