Multi-Year Repair and Maintenance of the White River Barrier Structure Water Quality Certification Package

1. Project Name (A name for your project that you create. Examples: Smith's Dock or Seabrook Lane Development) [help]
Multi-Year Repair and Maintenance of the White River Barrier Structure

Coastal Zone Management Act Consistency Determination Multi-Year Repair and Maintenance of the White River Barrier Structure, 2015-2020 07 January 2016

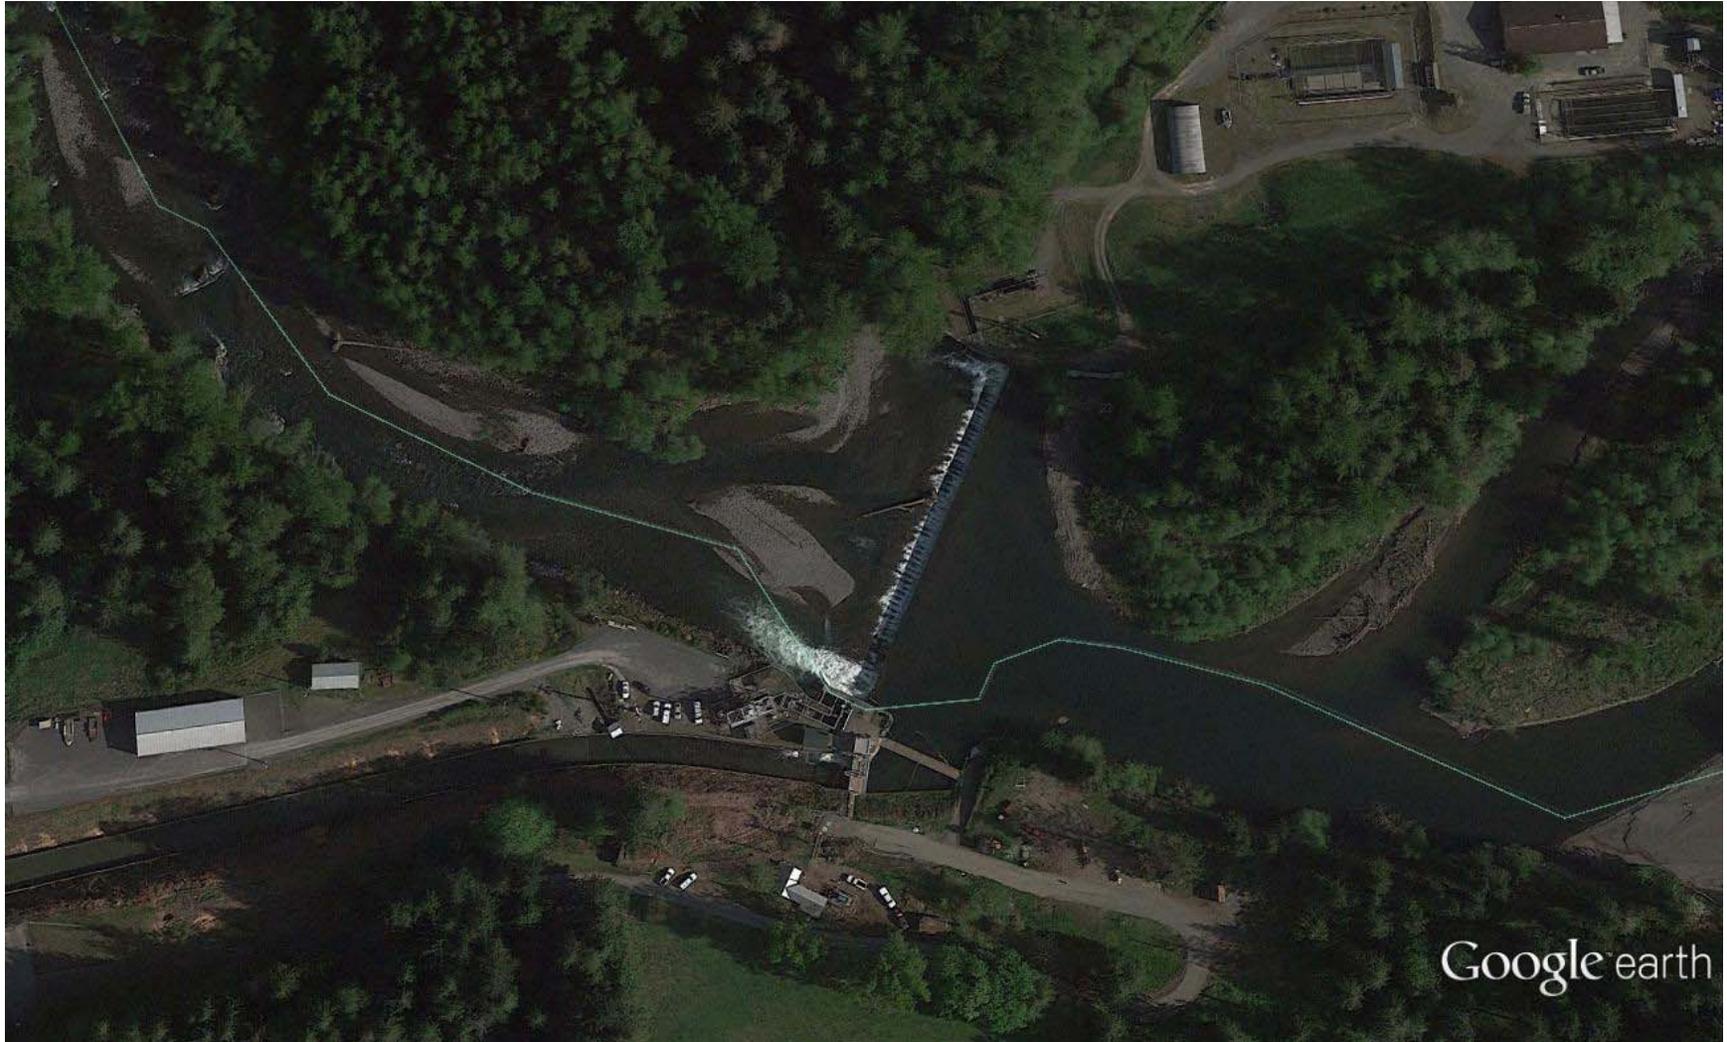
Figure 2. Photo of Barrier structure and adjacent facilities taken on April 19, 2015, at Buckley, Washington. The county line that divides King and Pierce counties runs down the center of the White River.

The Corps is proposing to repair and maintain the White River Barrier Structure (Figure 2), as needed, over a five year period. The proposed repairs remain the same as those approved by the Washington Department of Ecology (Ecology) since 2005, and consist of the following project elements: White River flow control, excavate a temporary diversion channel, construction of temporary earthen access roads, excavate and place exposed bedload and construct earthen cofferdams and plugs, removal of accumulated sediment and debris, barrier repair, and conduct unscheduled repairs.

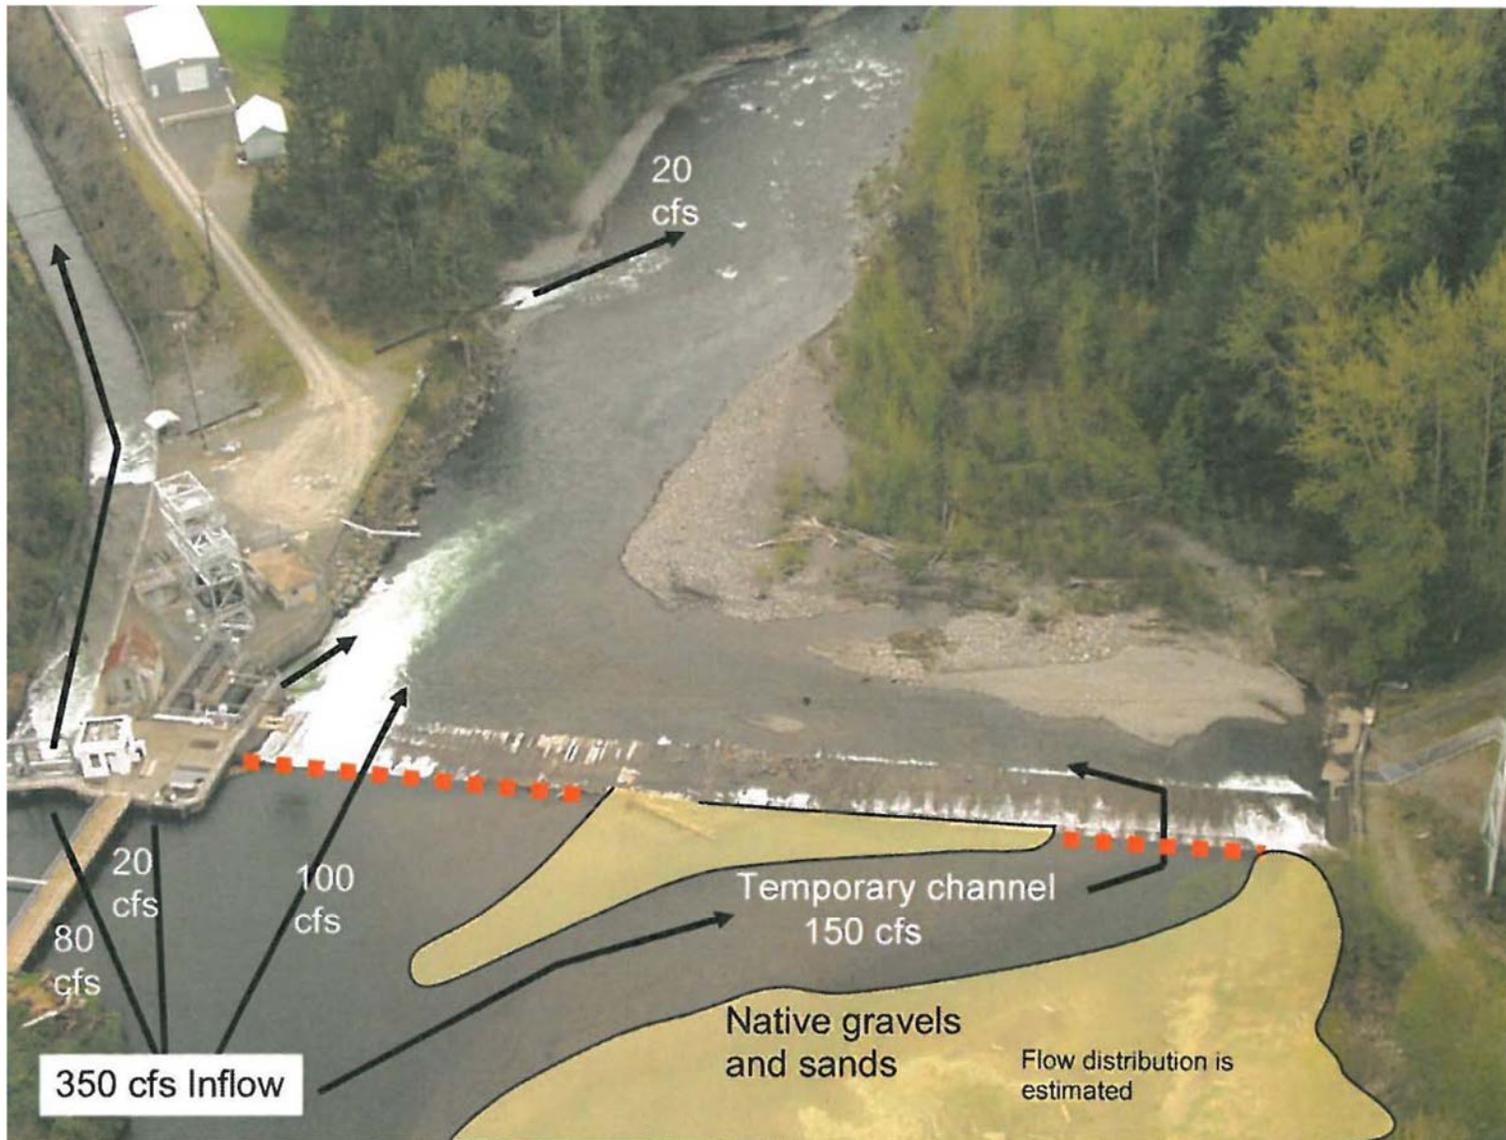
Figure 3. Diagram of work site and flow management.

Cascade would excavate a temporary low-flow diversion channel using a trackhoe or backhoe through the gravel bar, and then open it to the river flow to route water to the right bank. Routing water to the right bank would enable repairs to be conducted along the length of the barrier structure (Figure 3). Although the work would be below the ordinary high water mark (OHWM), the gravel bar would be in-the-dry due to managed flow rate by the Corps at MMD. We anticipate the temporary channel will be no more than 100 feet long, 40 feet wide and 4 feet deep; however, the actual size and alignment will be determined in the field by Cascade and Corps engineers and biologists, to take advantage of the natural topography and to avoid existing vegetation. Tracks will remain out of flowing water to the extent practicable, although some river crossings will be required.

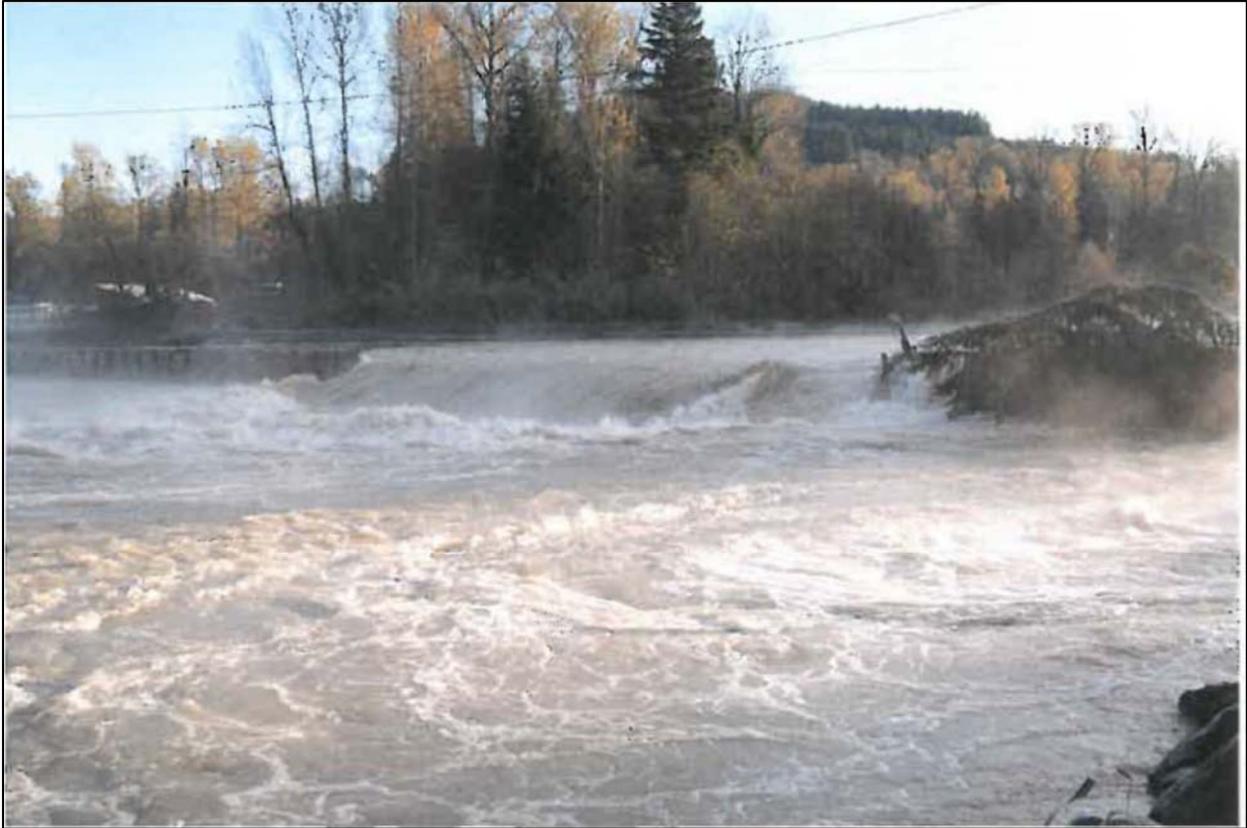
Figure 4. View from left bank looking upstream.

The amount of large woody material (LWM) accumulated along the left bank in the vicinity of the Corps fish trap intake is unusual and will require significant effort to remove (Figures 4 – 7). If possible, removal of the LWM will be completed in advance of the managing White River flow for the repair of the damaged barrier structure. The actual method of large woody debris removal would require use of a crane positioned on the left bank. The crane operator could lift the debris and reposition it more toward the center of the river, so that river flow would carry the LWM downstream. If this is not feasible, the crane operator could lift the material out of the river and place it in uplands on the left bank. The LWM would be transported to a location downstream of the barrier structure and placed in the river no later than March 31, 2016.

If the LWM is not able to be removed prior to the Corps management of the White River flow for the unscheduled barrier repairs, the LWM will be moved downstream using a track hoe (or similar equipment) prior to the barrier repairs.

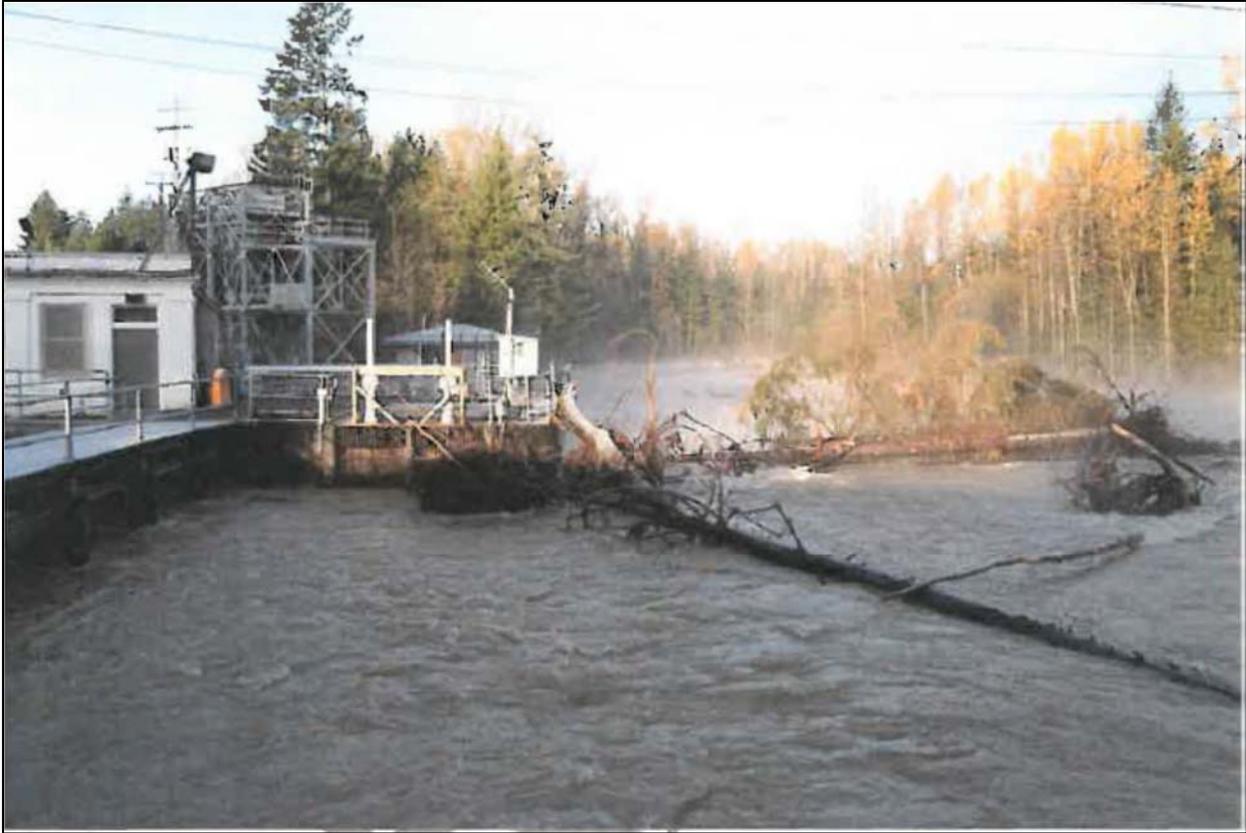
Figure 5. View from left bank looking downstream

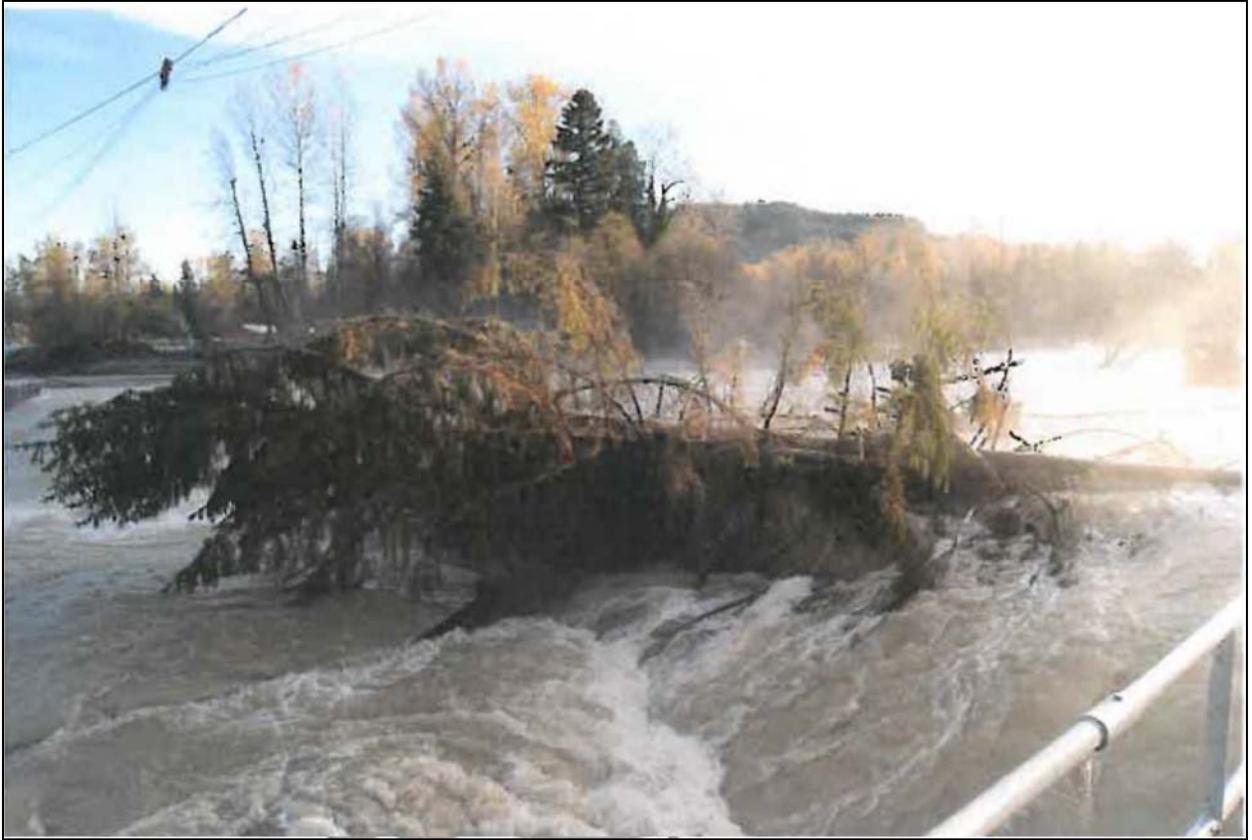
Figure 6. View from left bank looking across.

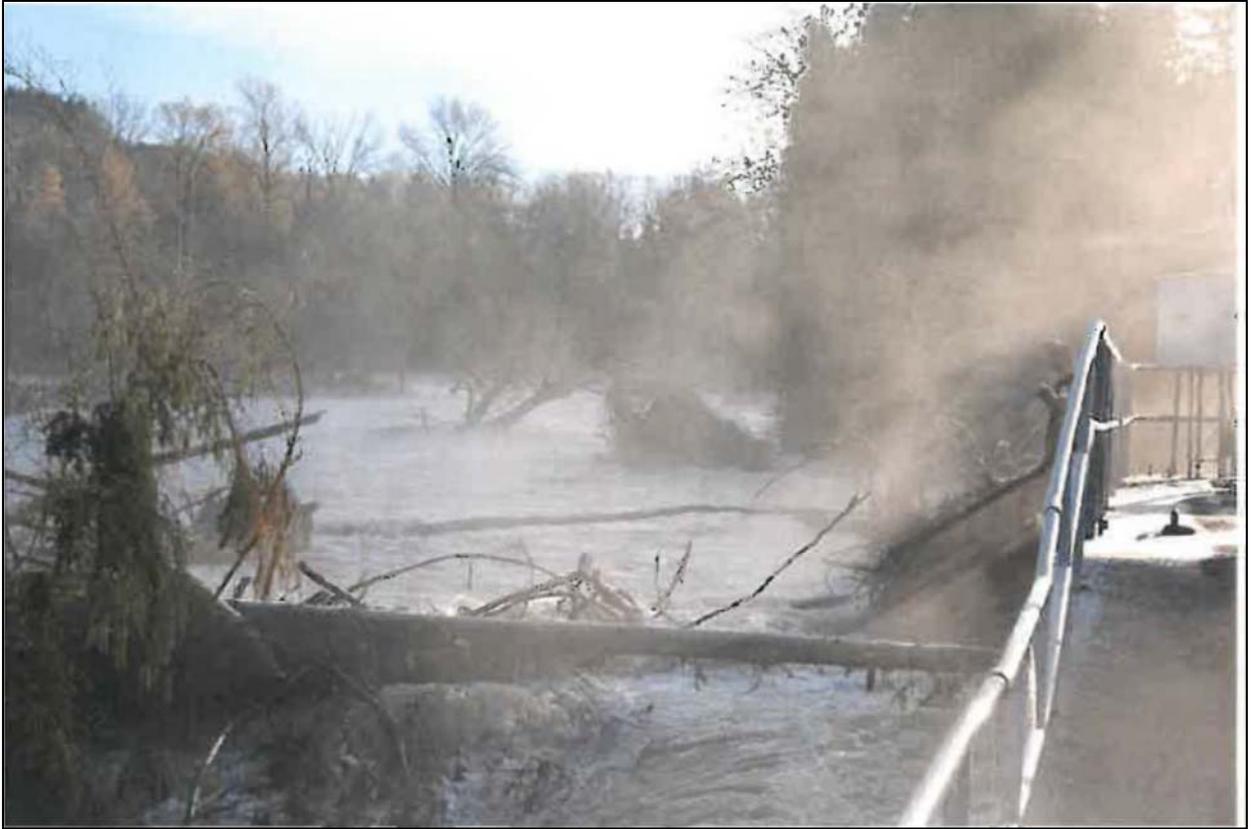
Figure 7. View from left bank looking upstream.

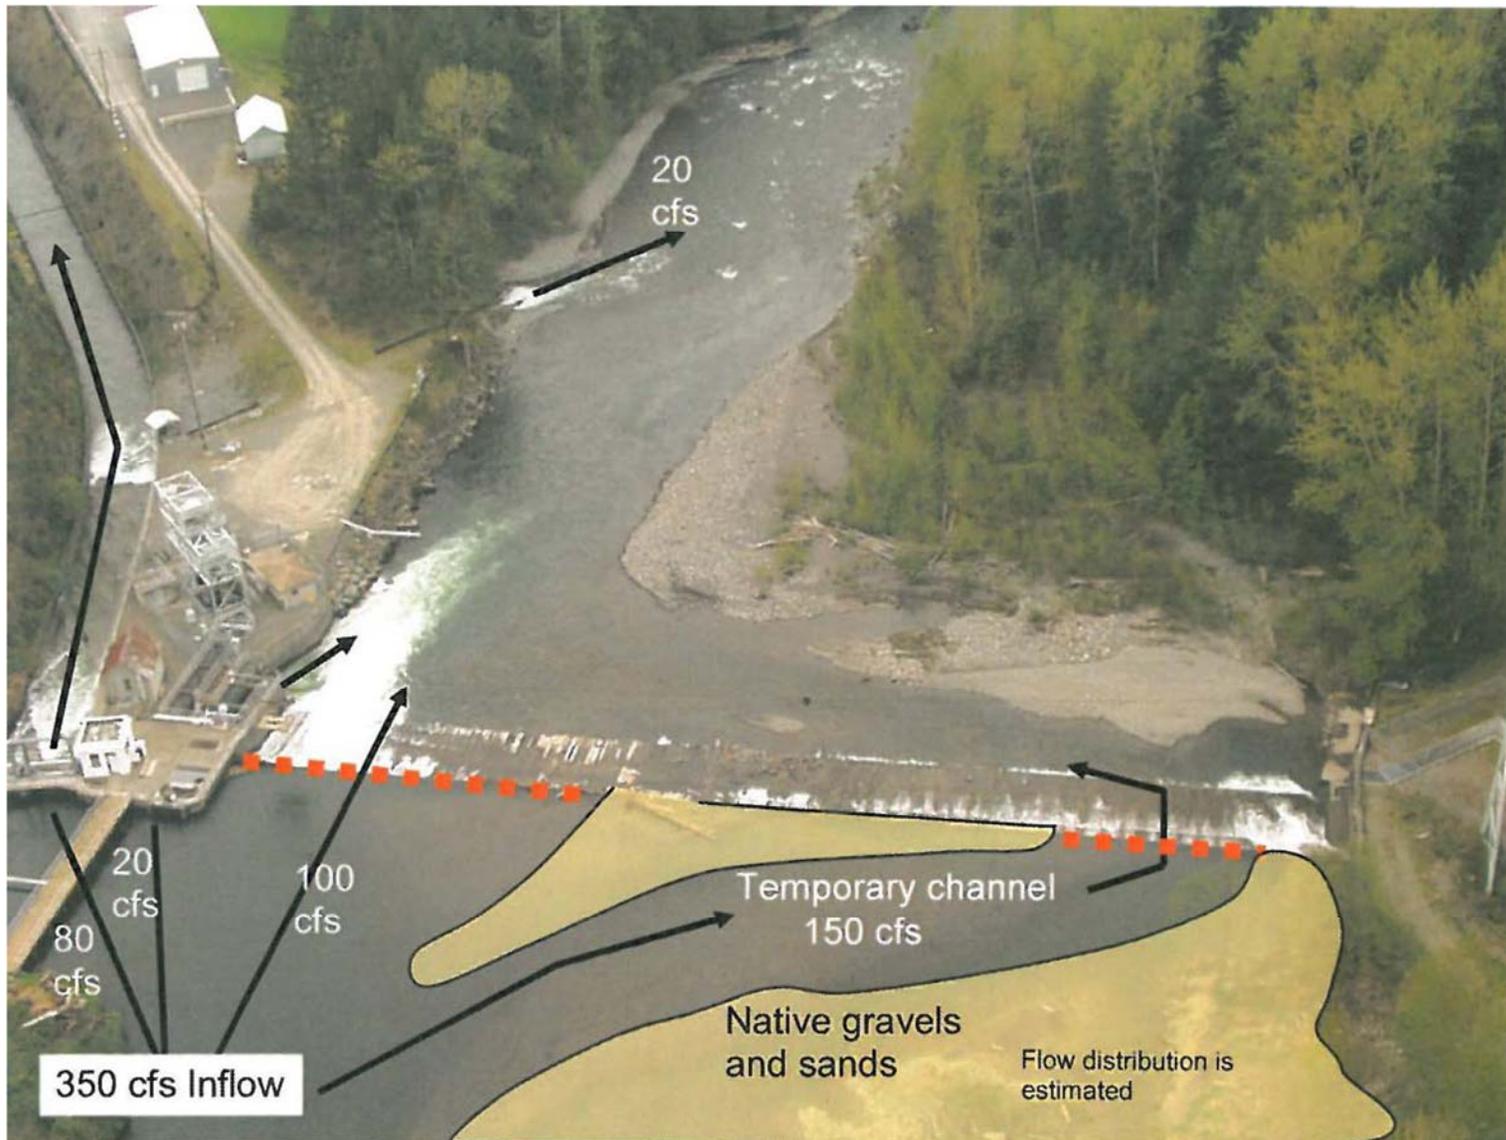
Figure 2. Depiction of proposed work.

Cascade would excavate a temporary low-flow diversion channel using a trackhoe or backhoe through the gravel bar, and then open it to the river flow to route water to the right bank. Routing water to the right bank would enable repairs to be conducted along the length of the barrier structure (Figure 2; Attachment 3). Although the work would be below the ordinary high water mark (OHWM), the gravel bar would be in-the-dry due to managed flow rate by the Corps at MMD. We anticipate the temporary channel will be no more than 100 feet long, 40 feet wide and 4 feet deep; however, the actual size and alignment will be determined in the field by Cascade and Corps engineers and biologists, to take advantage of the natural topography and to avoid existing vegetation. Tracks will remain out of flowing water to the extent practicable, although some river crossings will be required.

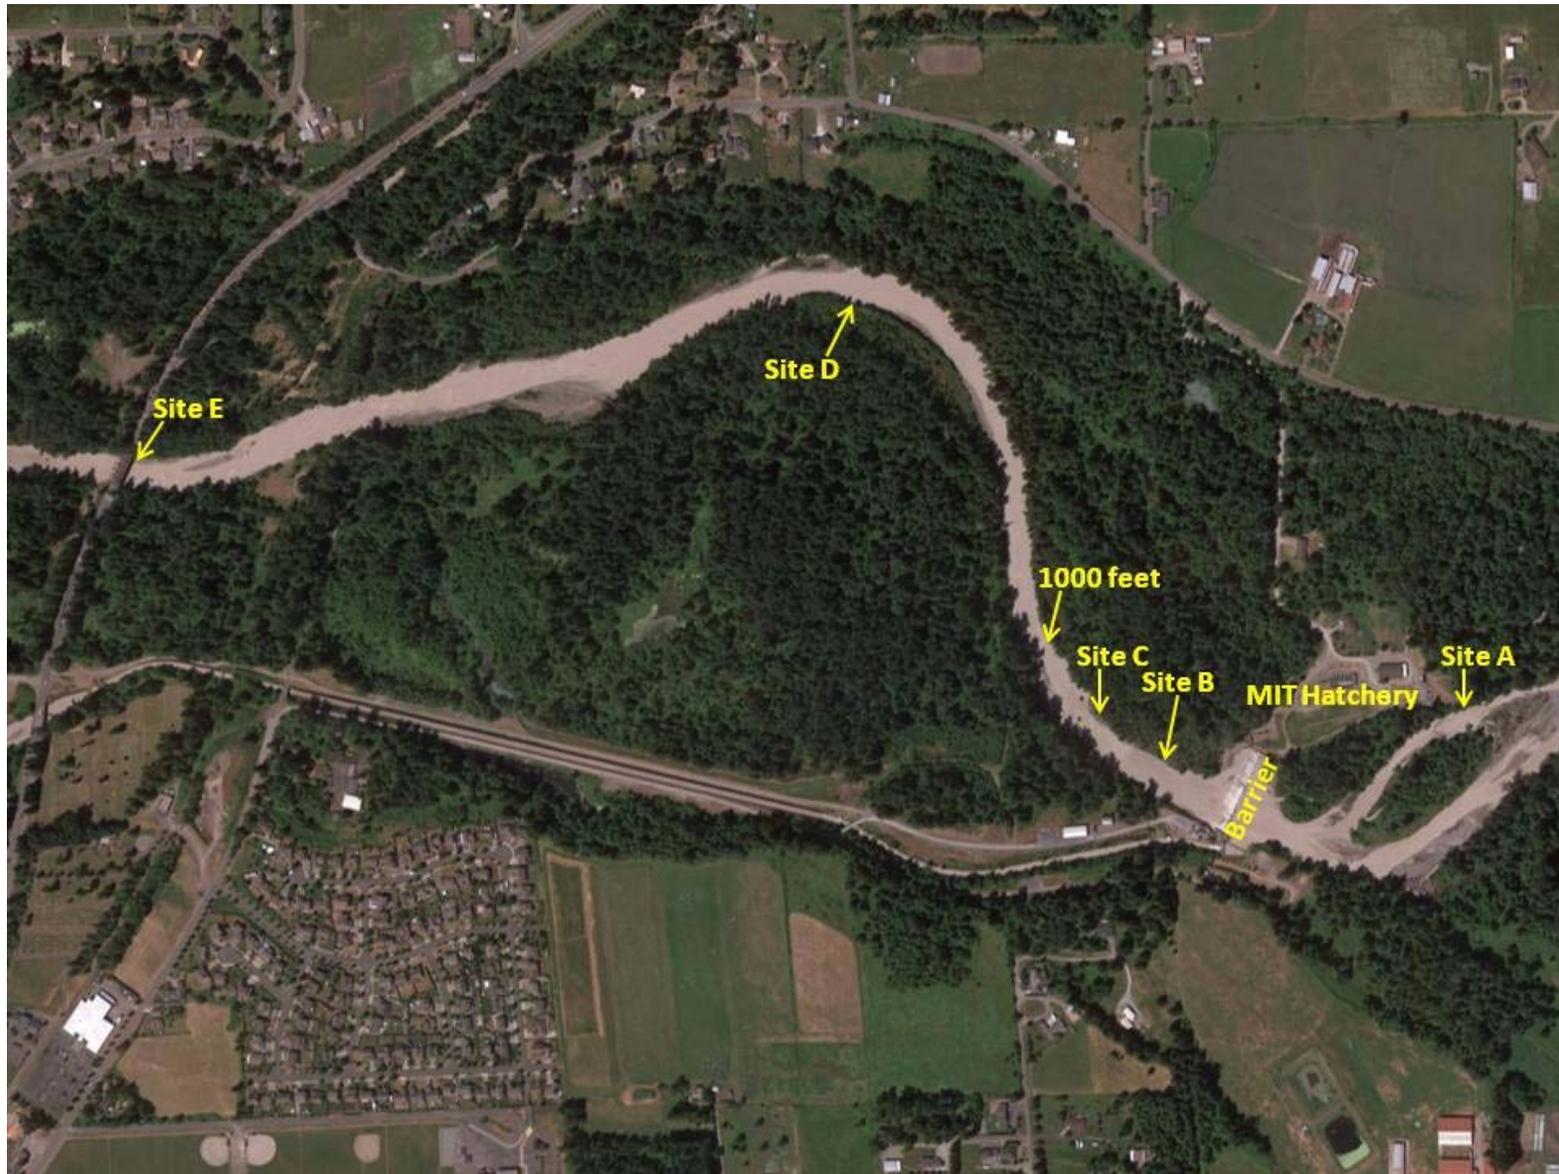
Figure 3. All monitoring sites above and below the barrier structure.
