CHAPTER 3. UPPER COUNTY

This chapter describes the conditions within the shoreline inventory area of upper Kittitas County (including the City of Cle Elum and Town of South Cle Elum). The upper Kittitas County shorelines include the upper Yakima River and its tributaries from the Yakima River headwaters to the Taneum Creek confluence (Figure 3-1). The 35 streams and 29 lakes and ponds within the upper county are described in terms of their physical characteristics, ecological conditions, and human environment/land use characteristics. Readers are encouraged to review Chapter 2 and the maps in Appendix A for additional context on the information presented here.

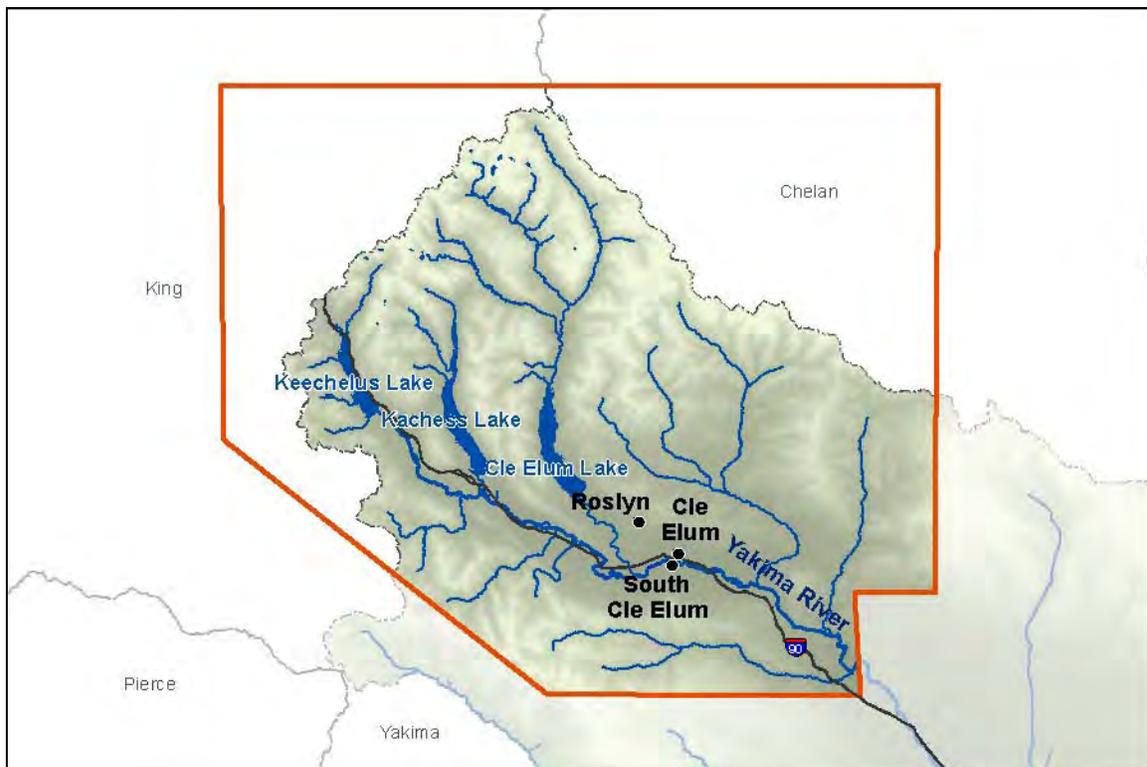
Figure 3-1. “Upper County” shorelines.

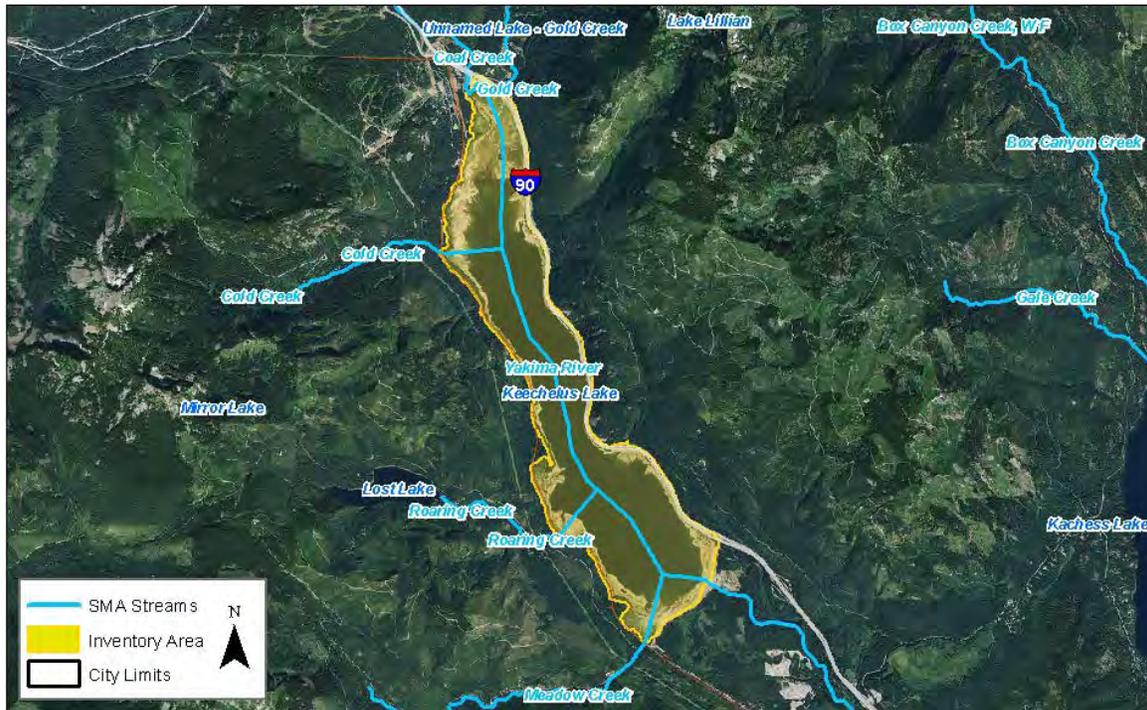
KEECHELUS LAKE

SHORELINE LENGTH:
49.5 Miles

WATERBODY AREA: 2,408.5 Acres
REACH INVENTORY AREA: 2,772.4 Acres

The lake is located in a valley, oriented northwest to southeast. The 128-foot-high dam, located at the south end of the lake, regulates pool elevations between 2,517 feet and 2,425 feet.

This reach is primarily open water (49%), unvegetated (19%), and other (10%). Limited developed land (7%), conifer-dominated forest (7%), shrubland (6%), riparian vegetation (1%), and harvested forest (1%) are also present.

Roughly one-third of the reach (32%) is located within the FEMA 100-year floodplain and a few landslide hazard areas (1%) are mapped along the eastern shoreline of the lake.
