FRENCH CABIN CREEK

PHYSICAL AND ECOLOGICAL FEATURES

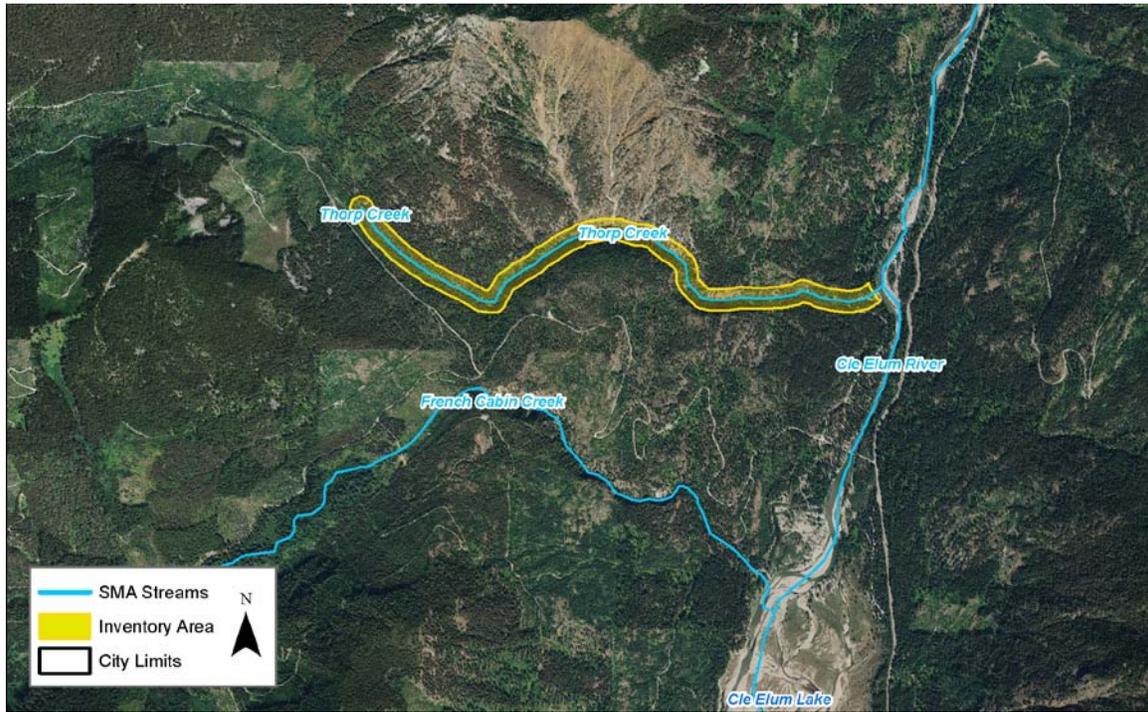
THORP CREEK

The reach flows west to east and is undeveloped..

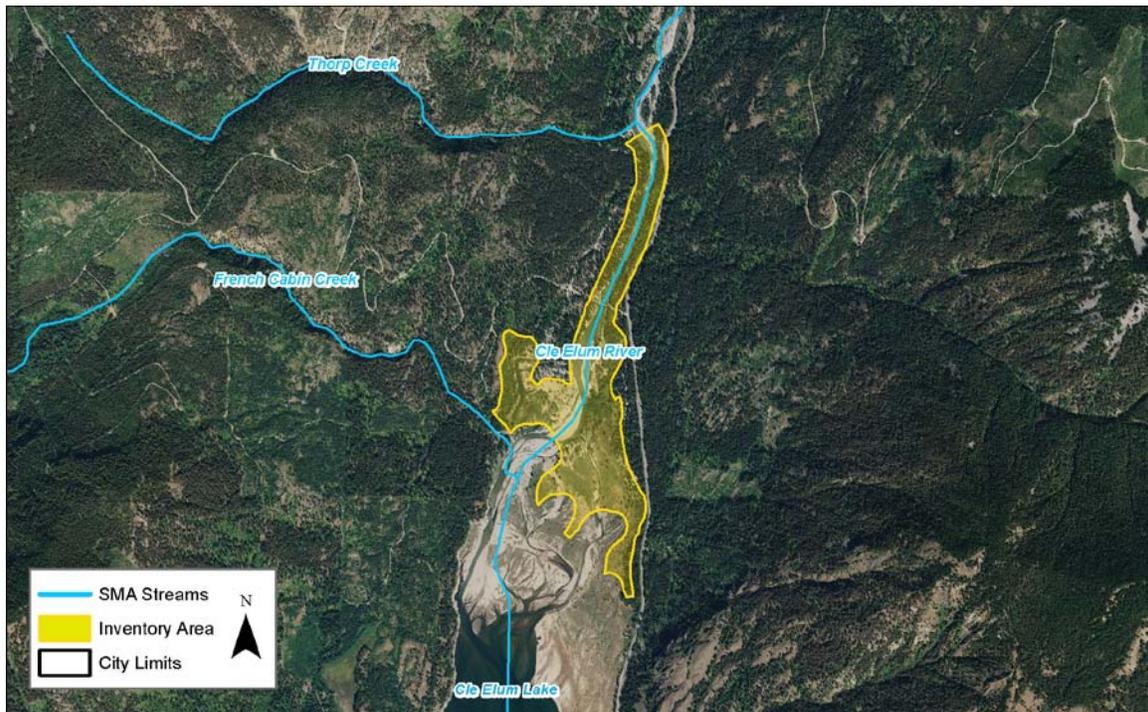
CLE ELUM RIVER-REACH 2

The reach is undeveloped. A Forest Service road located west of the stream and Salmon La Sac Road to the east flank the stream. A Forest Service bridge crosses the reach near its mouth. The southern portion of the reach becomes inundated when Cle Elum Lake is full.

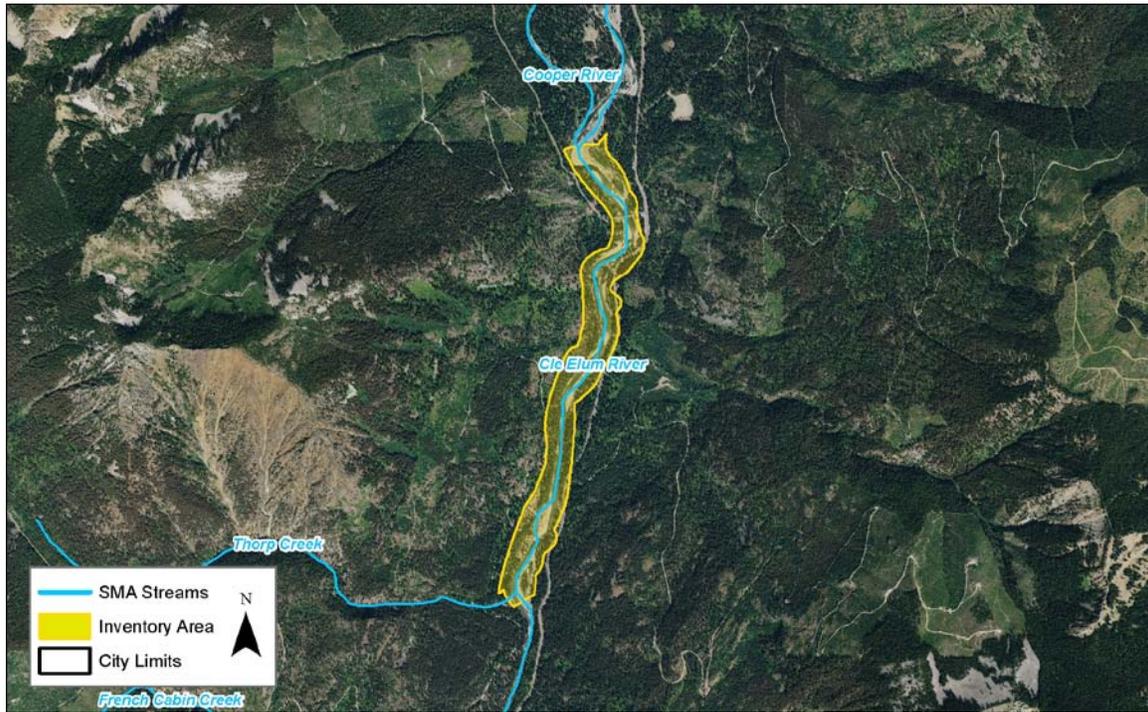
CLE ELUM RIVER-REACH 3

The reach flows north to south and is undeveloped.

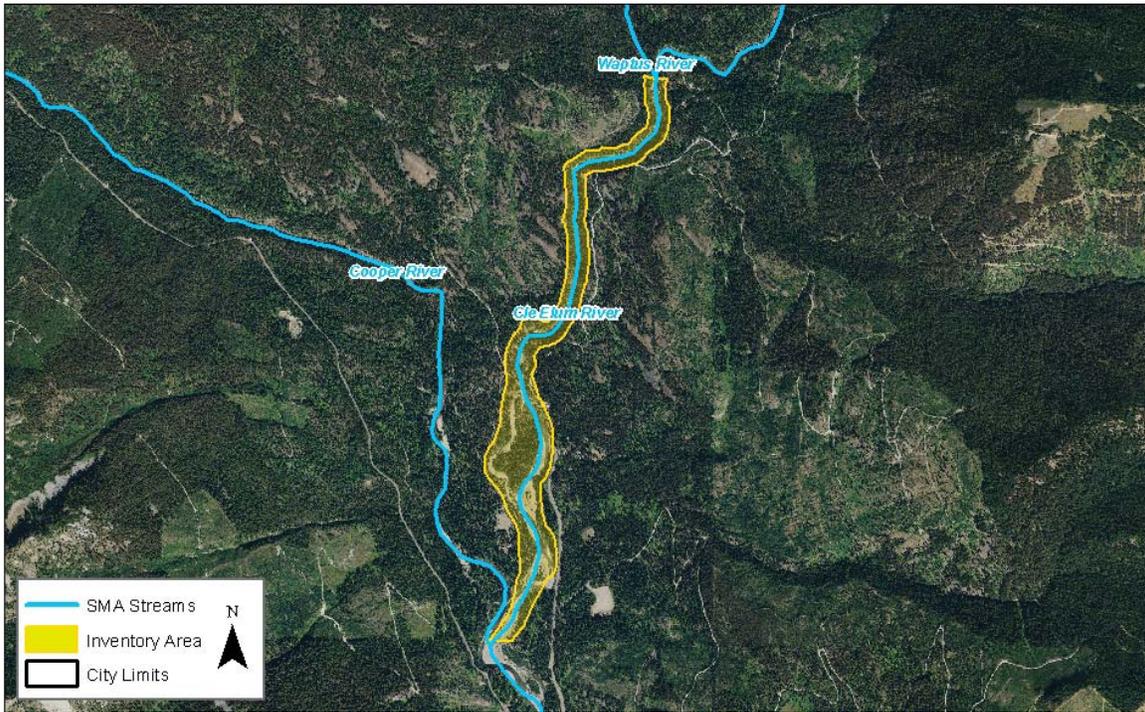
CLE ELUM RIVER-REACH 4

The upstream portion of the reach is confined to a single channel in a steep, narrow valley. Near the confluence with the Cooper River, the topography becomes less severe and the river splits into multiple channels with large gravel bars.

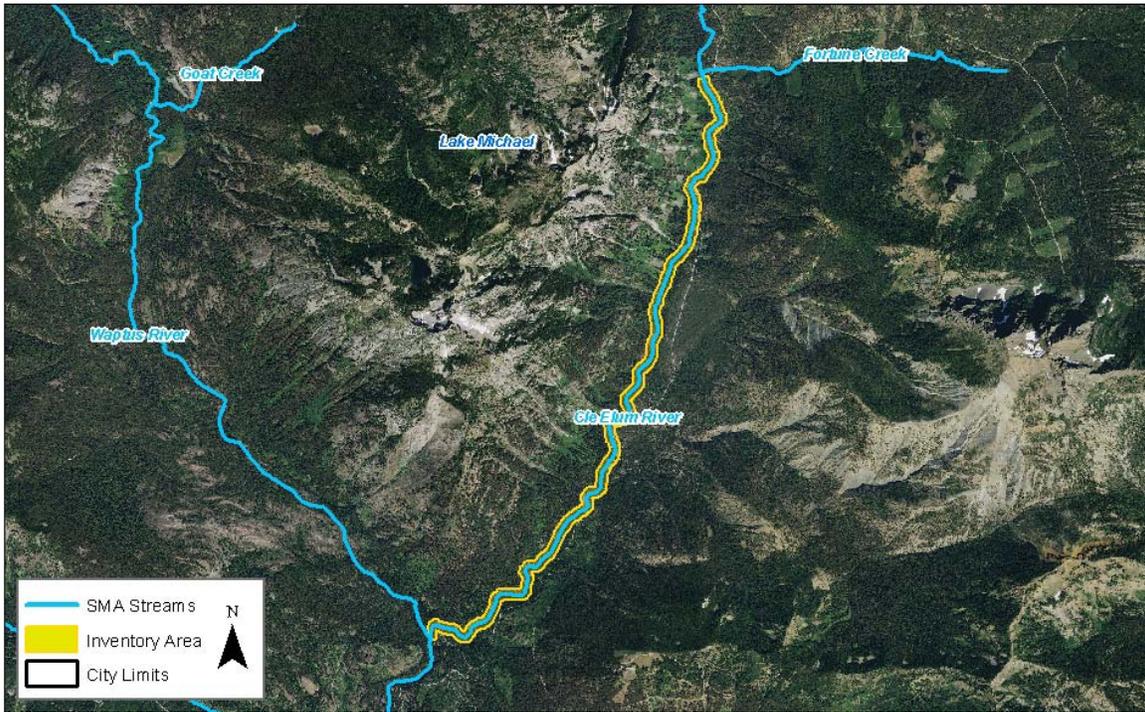
CLE ELUM RIVER-REACH 5

The reach is located within a narrow valley with moderate to steep topographic relief; the river is generally confined within a single channel with numerous gravel bars.

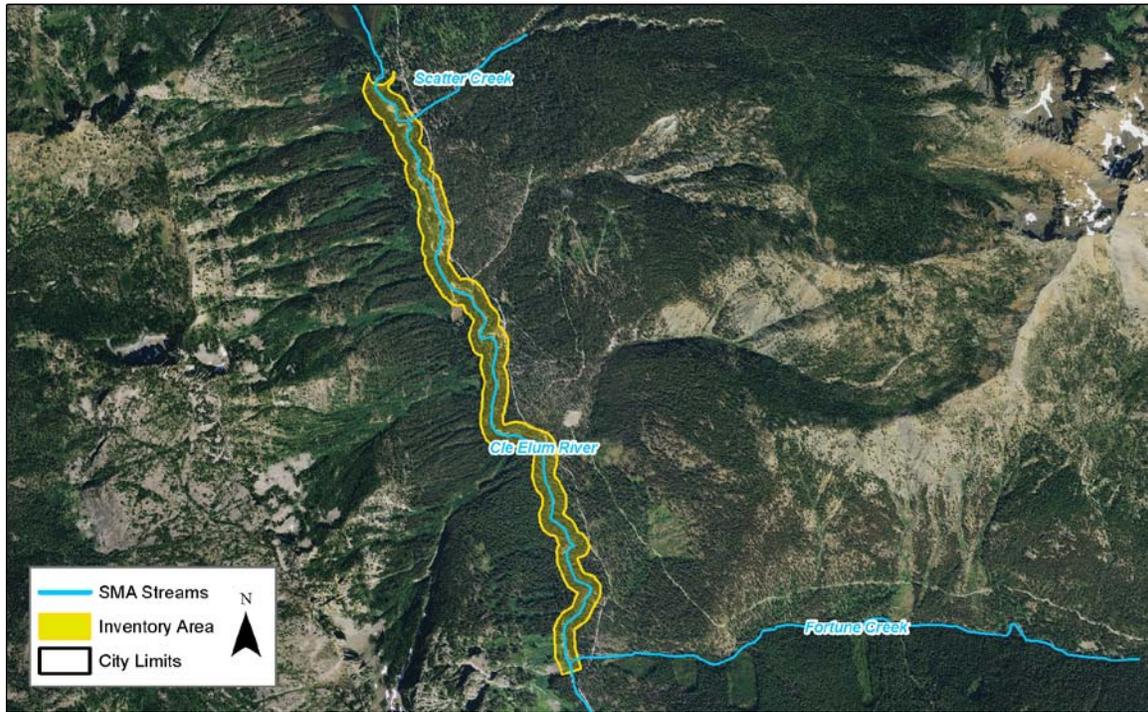
CLE ELUM RIVER-REACH 6

The reach roughly flows to the south in a flat valley bottom.

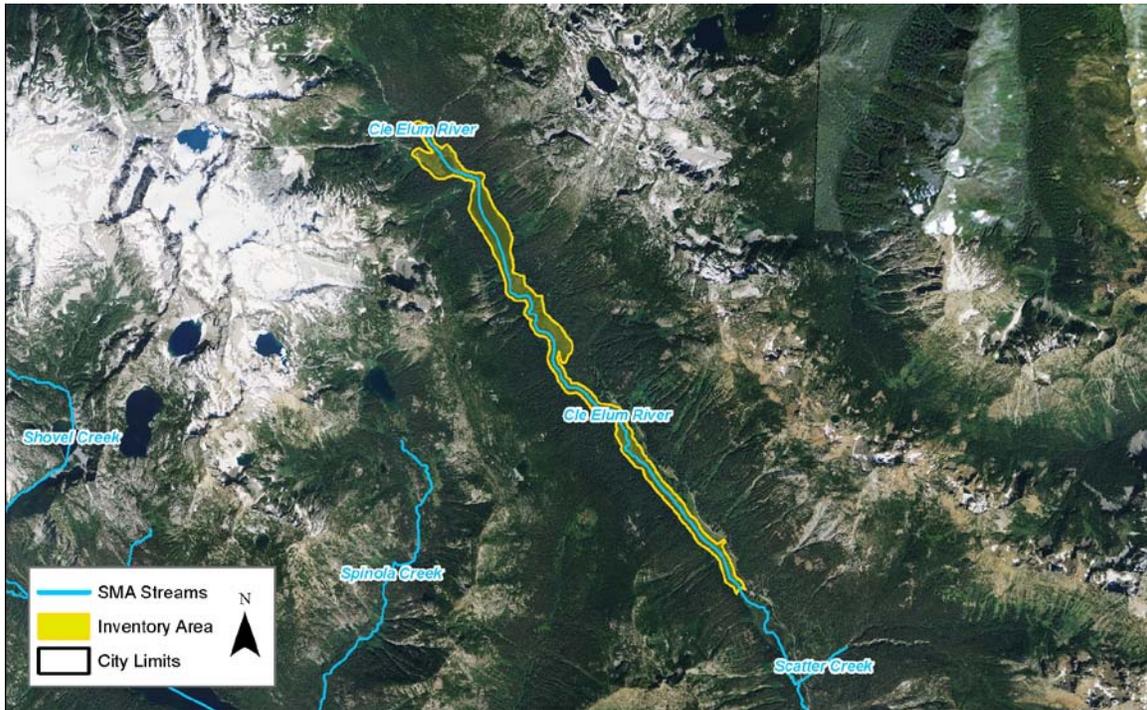
CLE ELUM RIVER-REACH 7

Approximately 41% of the reach is located within the FEMA 100-year floodplain and a small number of landslide hazard areas (6%) are mapped.
