CHAPTER 4. KITTITAS VALLEY

This chapter describes the conditions within the shoreline inventory area of the Kittitas Valley (including the City of Ellensburg). Kittitas Valley shorelines include the Yakima River and its tributaries between the Taneum Creek confluence and the Wilson Creek confluence (Figure 4-1). The 12 streams and 7 lakes and ponds within the Kittitas Valley are described in terms of their physical characteristics, ecological conditions, and human environment/land use characteristics. Readers are encouraged to review Chapter 2 and the maps in Appendix A for additional context on the information presented here.

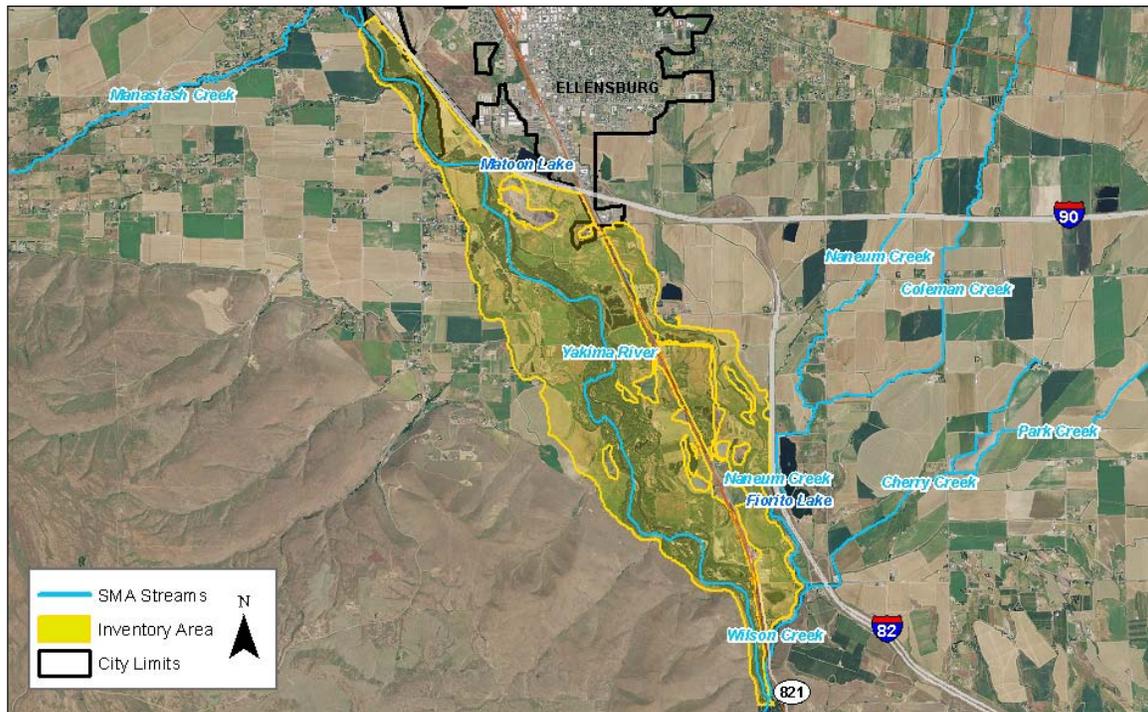
A significant area of the reach (98%) is located within the FEMA 100-year floodplain. No landslide hazard areas are mapped within the reach. The majority of the reach (92%) has potential for channel migration.

- The reach has a wide floodplain; there is significant development and undeveloped land that lies within flood-prone areas.
- Investigate opportunities for floodplain reconnection and setting-back hydromodifications
- New development should be set back an adequate distance from the shoreline to protect riparian functions and protect structures from flooding and channel migration hazards.
- Protect the remaining high-value, forested floodplain, shrub-steppe, and wildlife areas within the reach.
- Educate shoreline property owners about measures to protect and restore riparian areas.
- Support programs such as the Yakima/Klickitat Fisheries Project, Yakima River Side Channels Project, and Yakima Tributary Access and Habitat Program.
- Encourage use of agricultural best management practices to reduce erosion and transport of legacy pesticides.

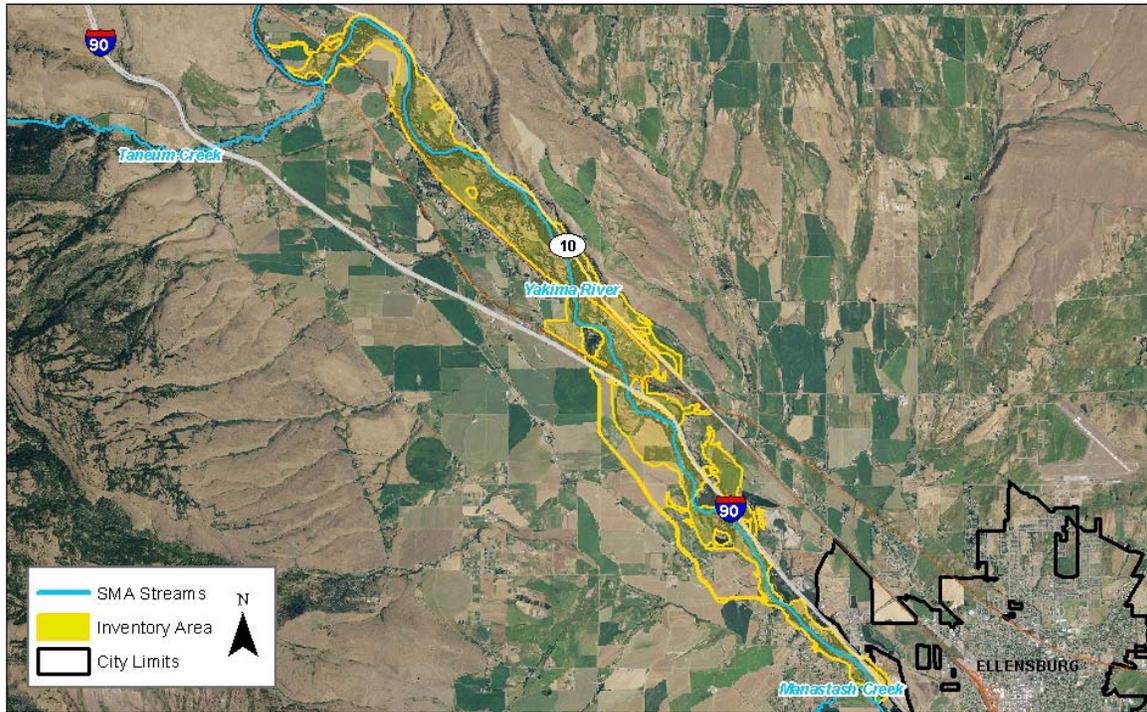
The majority of the reach (91%) is located within the FEMA 100-year floodplain. No landslide hazard areas are mapped within the reach. The majority of the reach (88%) has potential for channel migration.

- There is significant development and undeveloped land that lies within flood-prone areas
- New development should be set back an adequate distance from the shoreline to protect riparian functions and protect structures from flooding and channel migration hazards.
- Most of the floodplain areas within the reach have been historically altered; protect the remaining high-value, forested floodplain areas within the reach.
- Support programs such as the Yakima/Klickitat Fisheries Project, Yakima River Side Channels Project, and Yakima Tributary Access and Habitat Program.
- Educate shoreline property owners about measures to protect and restore riparian areas.
- Encourage use of agricultural best management practices to reduce erosion and transport of legacy pesticides.

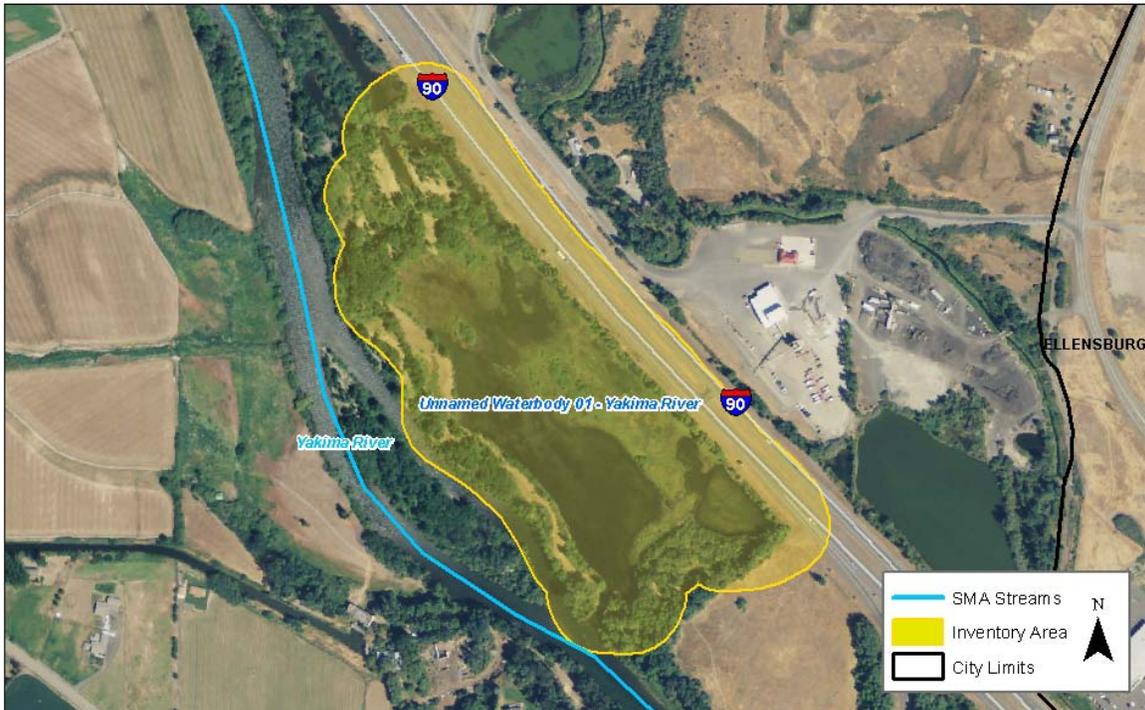
More than half of the reach area (58%) is located within the FEMA 100-year floodplain. No landslide hazard areas are mapped within the reach. The reach is within the channel migration zone of the Yakima River.

KEY MANAGEMENT ISSUES AND OPPORTUNITIES
<ul style="list-style-type: none"> • New development should be set back an adequate distance to protect riparian functions and protect structures from flooding hazards. • Protect the remaining forest cover and high-value wetland areas within the reach. • There is no public access to the waterbody. • Explore restoration of former gravel pits to create more natural floodplain and riverine habitat.

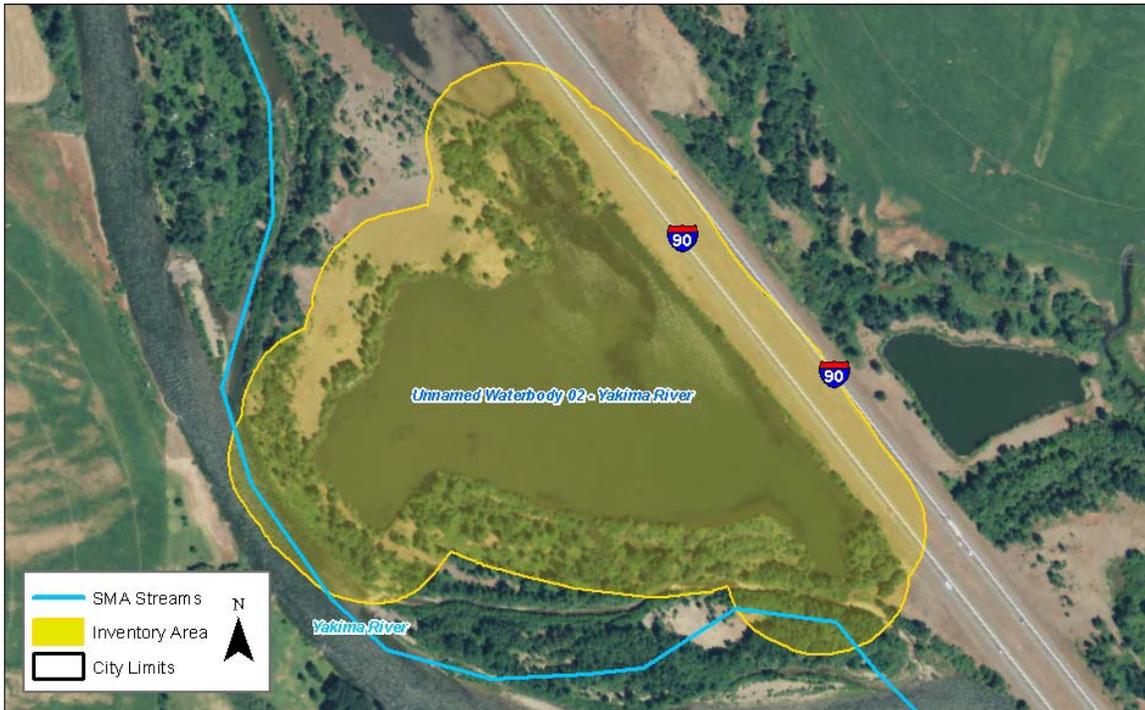
A significant portion of the reach (81%) is located within the FEMA 100-year floodplain. No landslide hazard areas are mapped within the reach. The reach is within the channel migration zone of the Yakima River.

KEY MANAGEMENT ISSUES AND OPPORTUNITIES
<ul style="list-style-type: none"> • New development should be set back an adequate distance to protect riparian functions and protect structures from flood hazards. • Protect the remaining forest cover and high-value wetland areas within the reach. • There is no public access to the waterbody. • Explore restoration of former gravel pits to create more natural floodplain and riverine habitat.

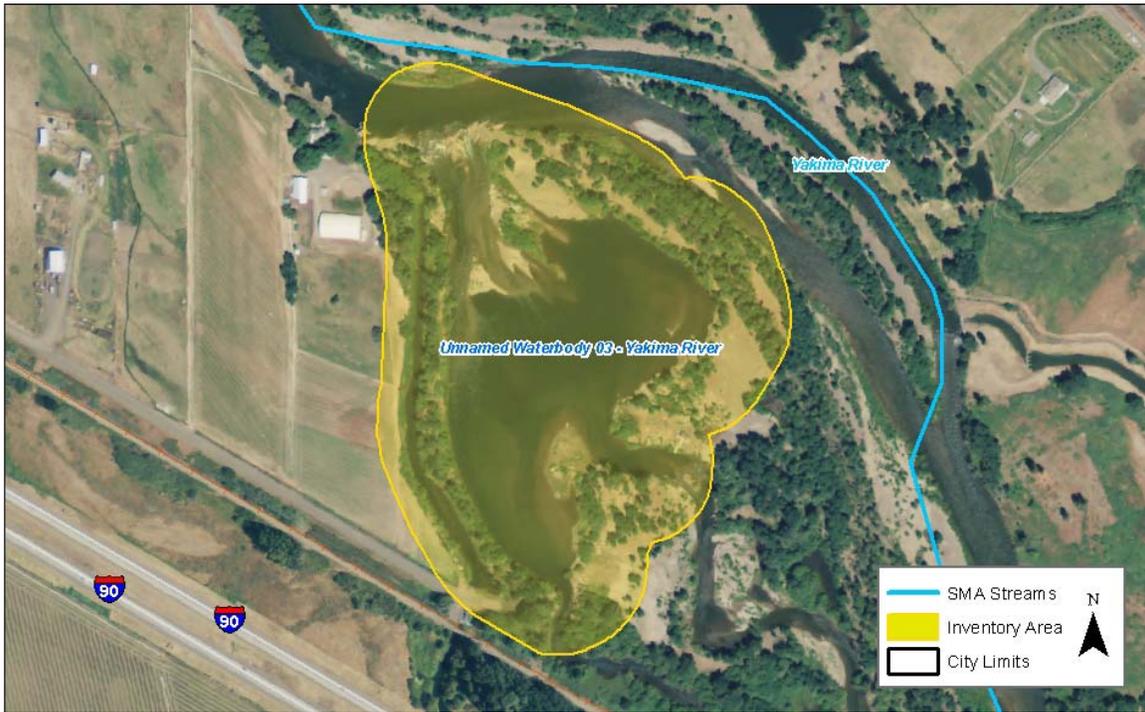
The entire reach area (100%) is located within the FEMA 100-year floodplain. No landslide hazard areas are mapped within the reach. The reach is within the channel migration zone of the Yakima River.

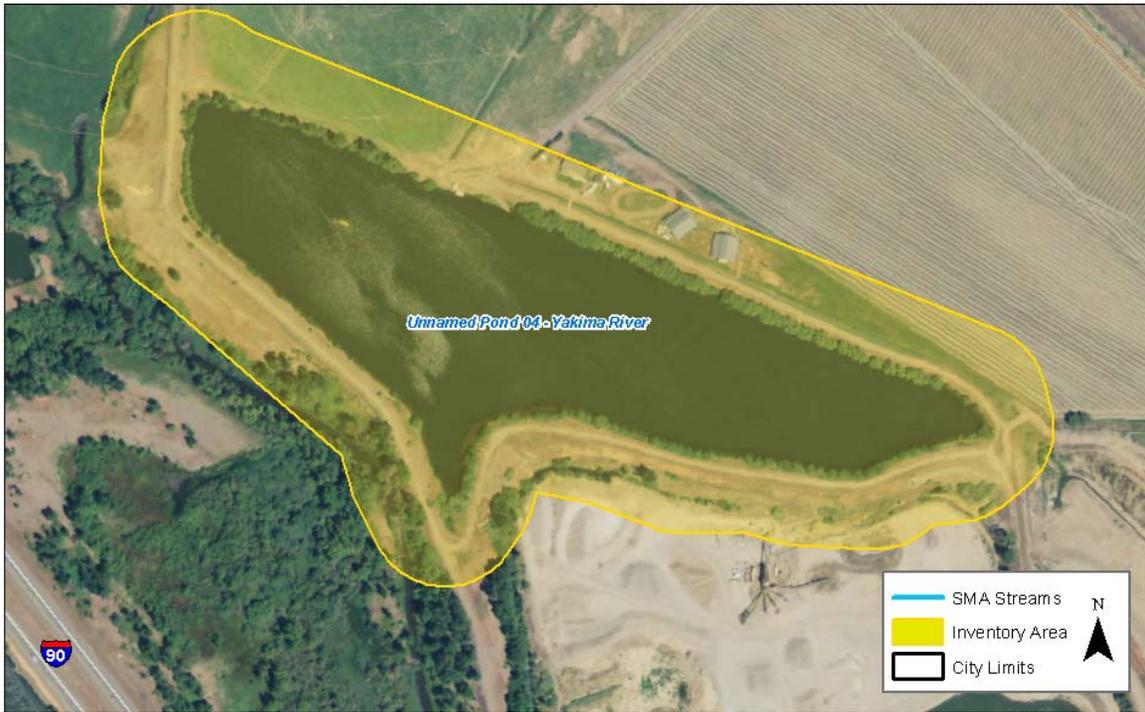
A limited area of the reach (27%) is located within the FEMA 100-year floodplain. No landslide hazard areas are mapped within the reach.

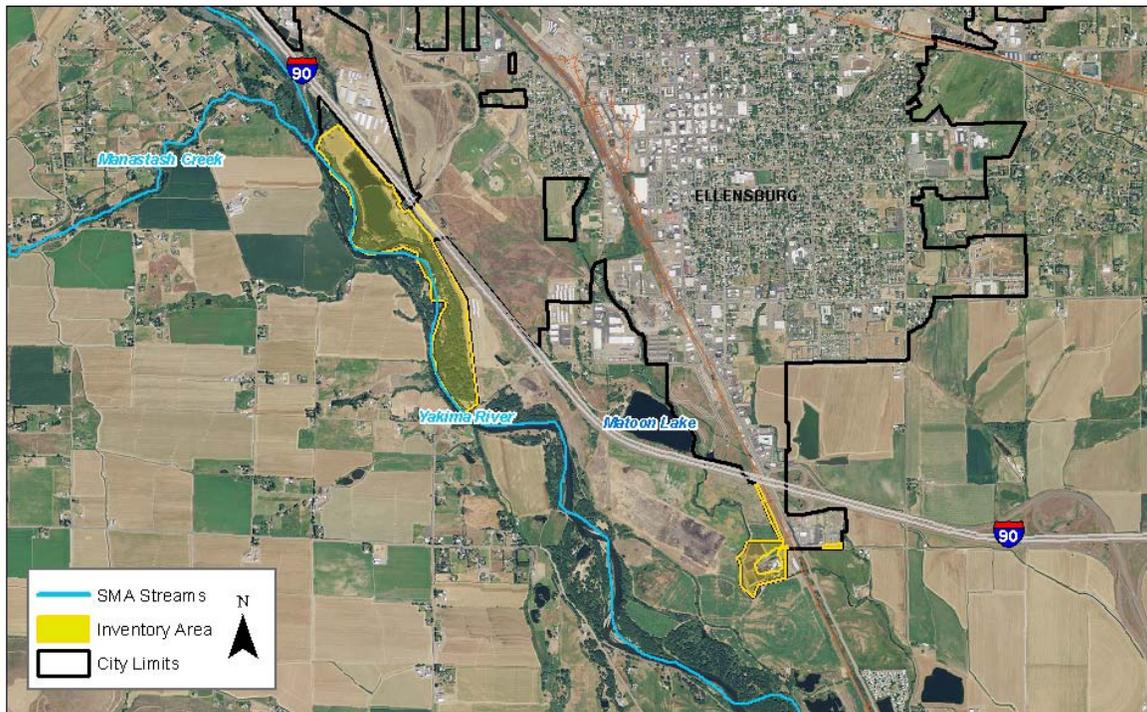
The entire reach (100%) is located within the FEMA 100-year floodplain. No landslide hazard areas are mapped within the reach. The entire reach has potential for channel migration.

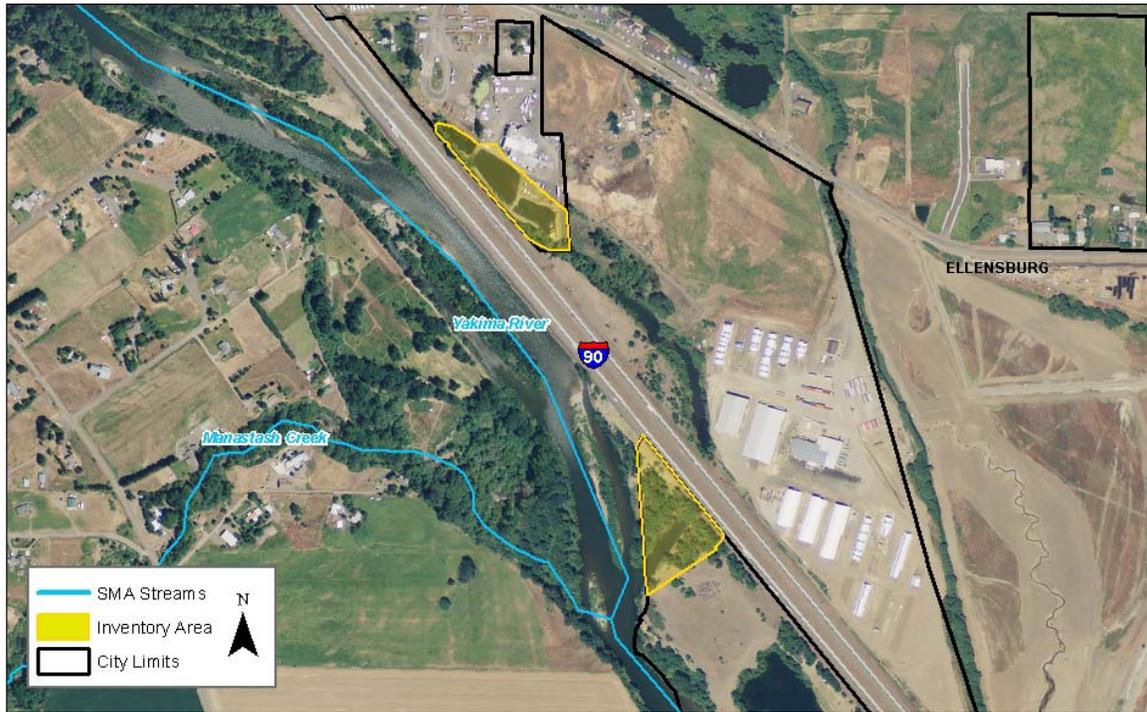
A significant area of the reach (86%) is located within the FEMA 100-year floodplain. No landslide hazard areas are mapped within the reach. The southern portion of the reach has potential for channel migration.

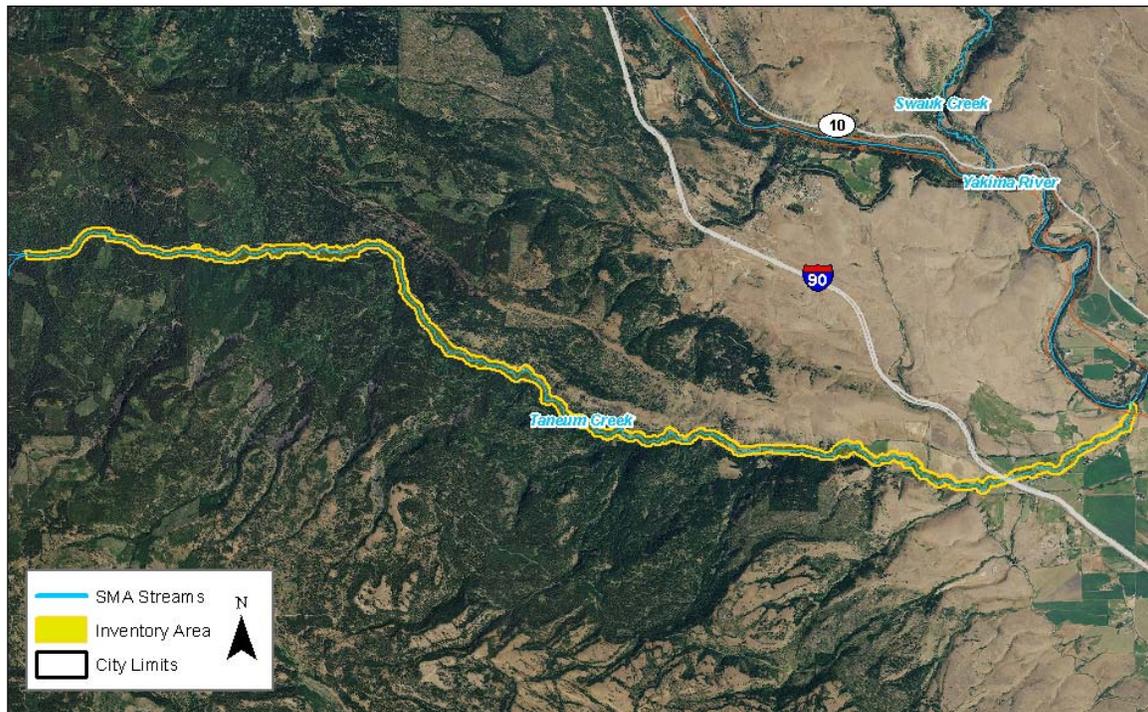
Less than half of the reach area (42%) is located within the FEMA 100-year floodplain. No landslide hazard areas are mapped within the reach. Almost the entire reach (97%) has potential for channel migration.

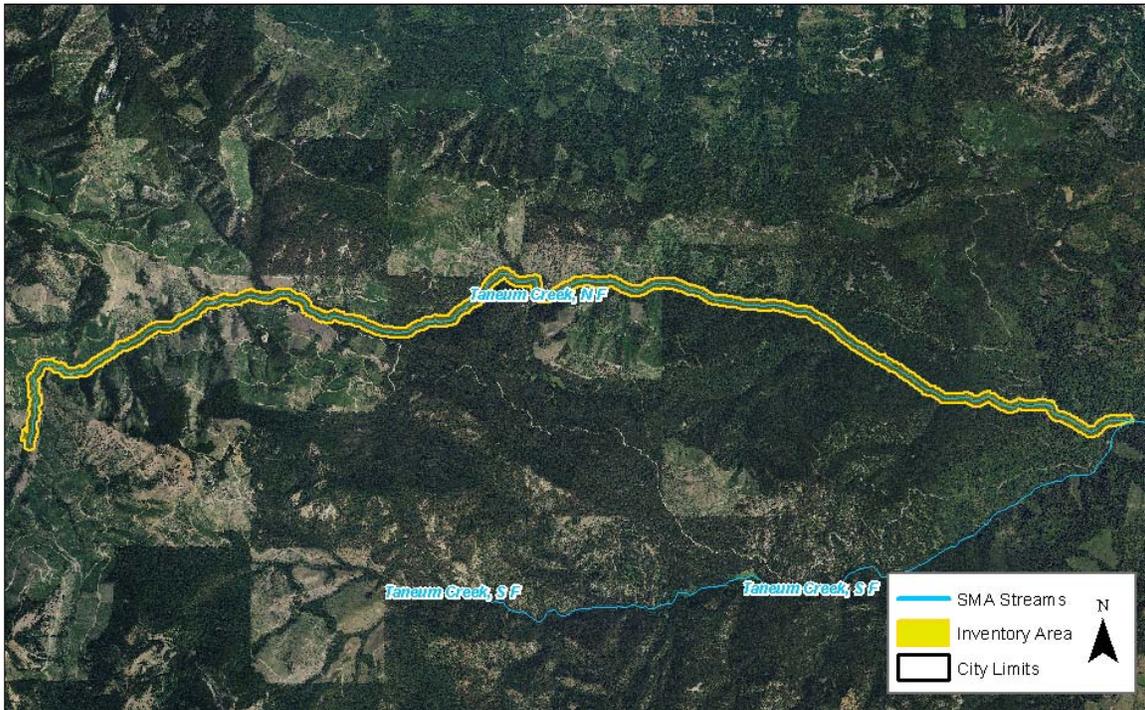
The reach is not located within the FEMA 100-year floodplain. Limited amount of landslide hazard areas (4%) are mapped within the reach.

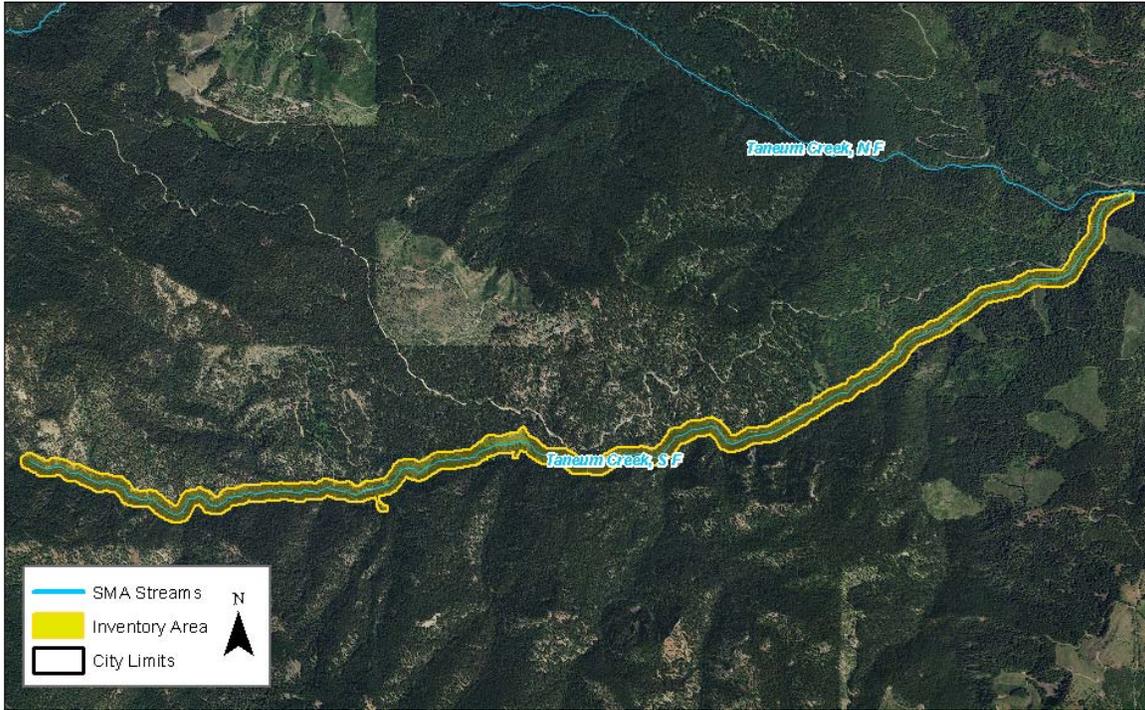
The reach is not located within the FEMA 100-year floodplain. Limited amount of landslide hazard areas (4%) are mapped within the reach.

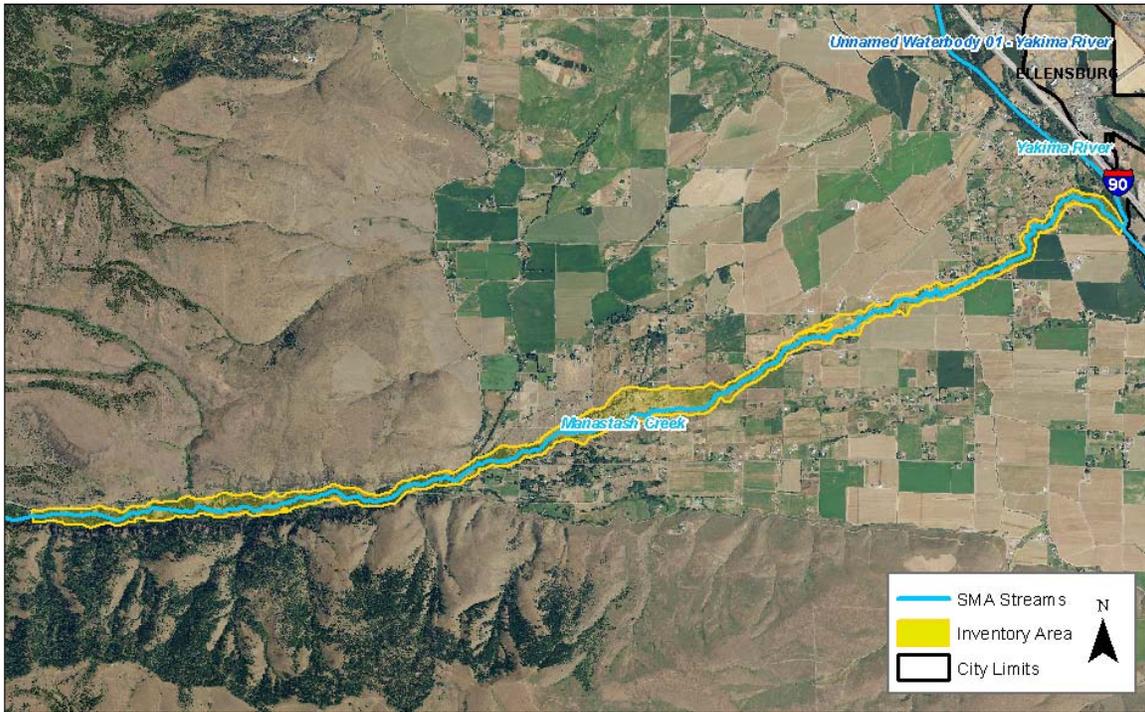
The majority of the reach area (70%) is located within the FEMA 100-year floodplain. No landslide hazard areas are mapped within the reach. The entire reach has potential for channel migration.

- Flooding and alluvial fan hazards are prevalent within this reach; limit development within the floodplain and implement bioengineered measures, where practical, to avoid and minimize flood damage to existing structures.

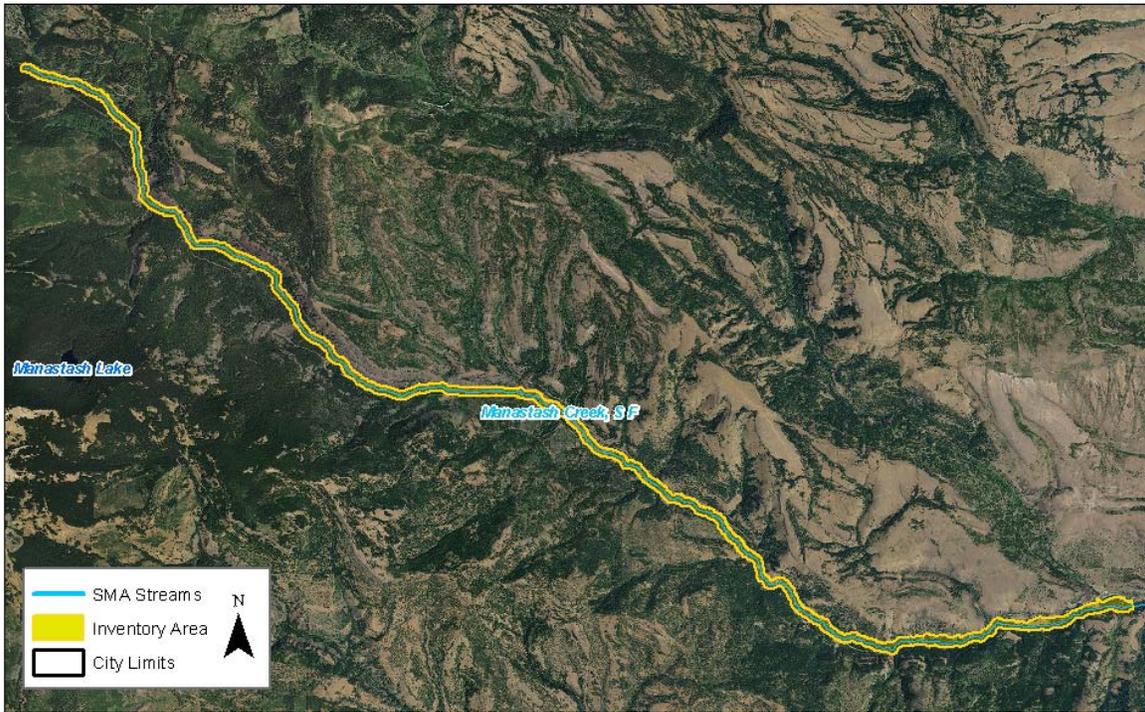
A limited reach area (22%) is located within the FEMA 100-year floodplain. No landslide hazard areas are mapped within the reach. The majority of the reach (79%) has potential for channel migration.

- Flooding and alluvial fan hazards are prevalent within this reach; limit development within the floodplain and implement bioengineered measures, where practical, to avoid and minimize flood damage to existing structures.
- Resource lands within the reach have the potential to be converted to more intensive uses (e.g., from forest/range lands to residential subdivisions). New development should be set back an adequate distance to protect stream functions and protect structures from flooding and channel migration.
- Protect the remaining high-quality forested areas, shrub-steppe habitat, and wildlife habitat.
- Educate shoreline property owners about measures to protect and restore riparian areas.
- Decommission and revegetate any unused roads along the shoreline.

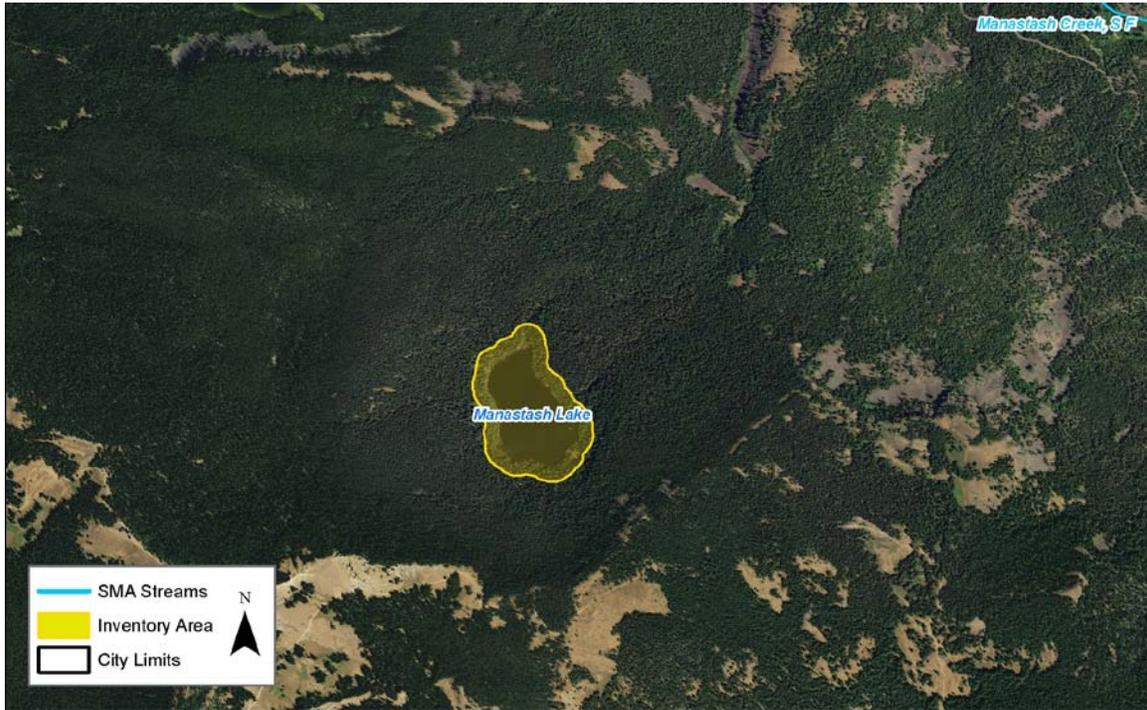
The reach is not located within the FEMA 100-year floodplain and no landslide hazard areas are mapped.

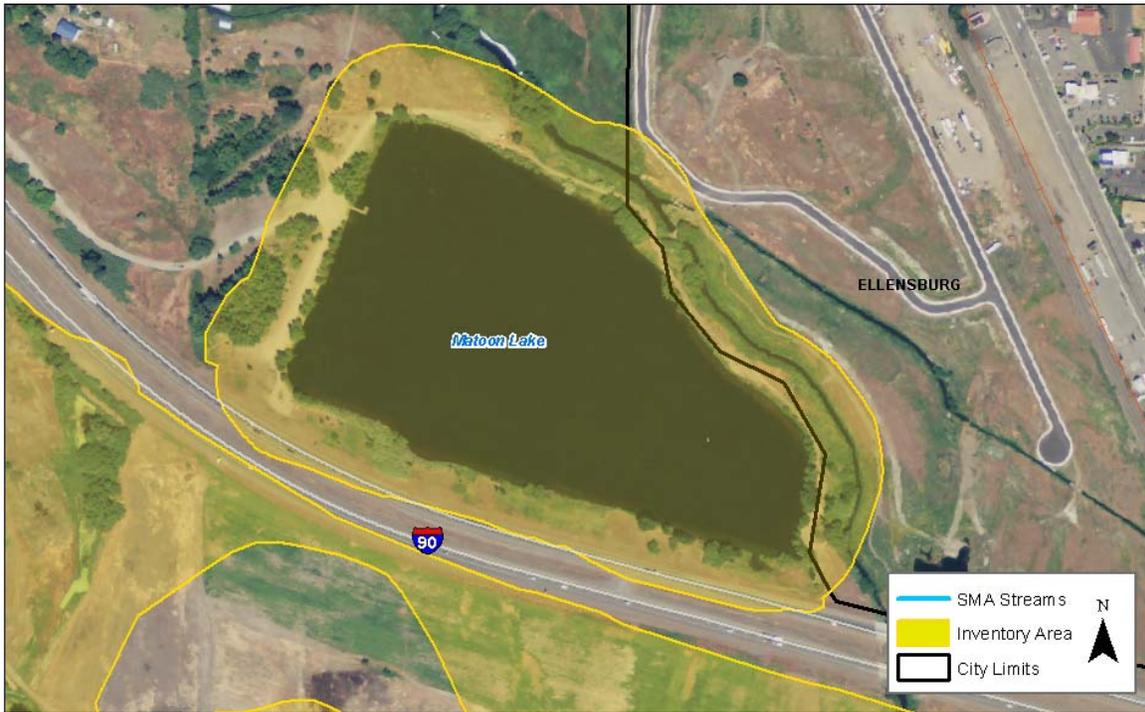
Almost half of reach (46%) is located within the FEMA 100-year floodplain. No landslide hazard areas are mapped within the reach.

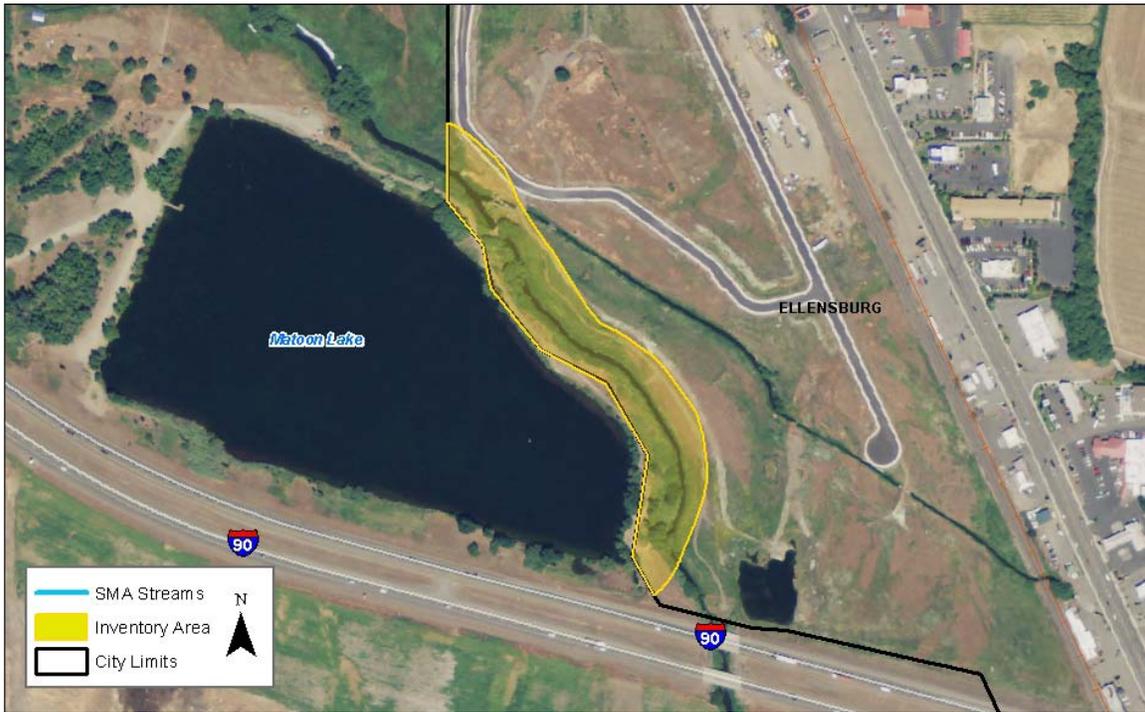
A significant area of the reach (84%) is located within the FEMA 100-year floodplain. No landslide hazard areas are mapped within the reach.

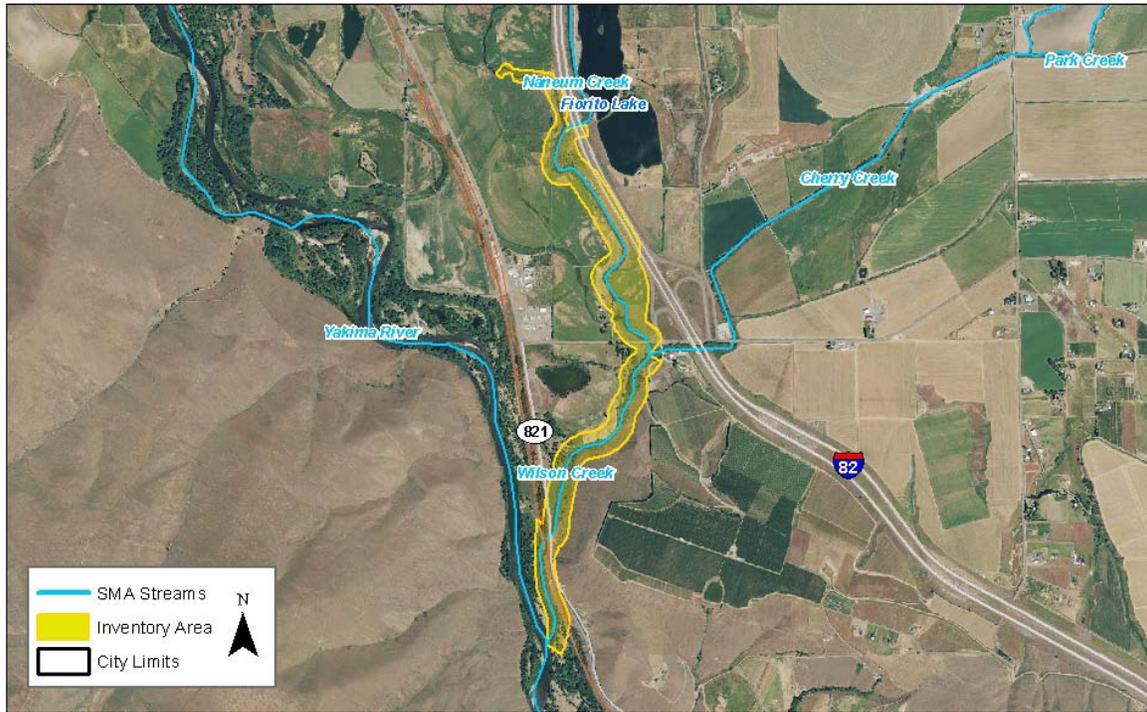
Over half of the reach area (64%) is located within the FEMA 100-year floodplain. No landslide hazard areas are mapped within the reach. The lower portion of the reach (54%) is within the channel migration zone of the Yakima River.

KEY MANAGEMENT ISSUES AND OPPORTUNITIES
<ul style="list-style-type: none"> • New development should be set back an adequate distance from the shoreline to protect riparian functions and protect structures from flooding and channel migration hazards. • The stream channel and adjacent riparian areas have been highly altered by adjacent development, (including I-82) and agricultural activities (including irrigation uses). • Educate shoreline property owners about measures to protect and restore riparian areas. • Encourage use of agricultural best management practices to reduce erosion and transport of legacy pesticides. • Study the feasibility of stormwater treatment retrofits to improve runoff water quality from urban areas.

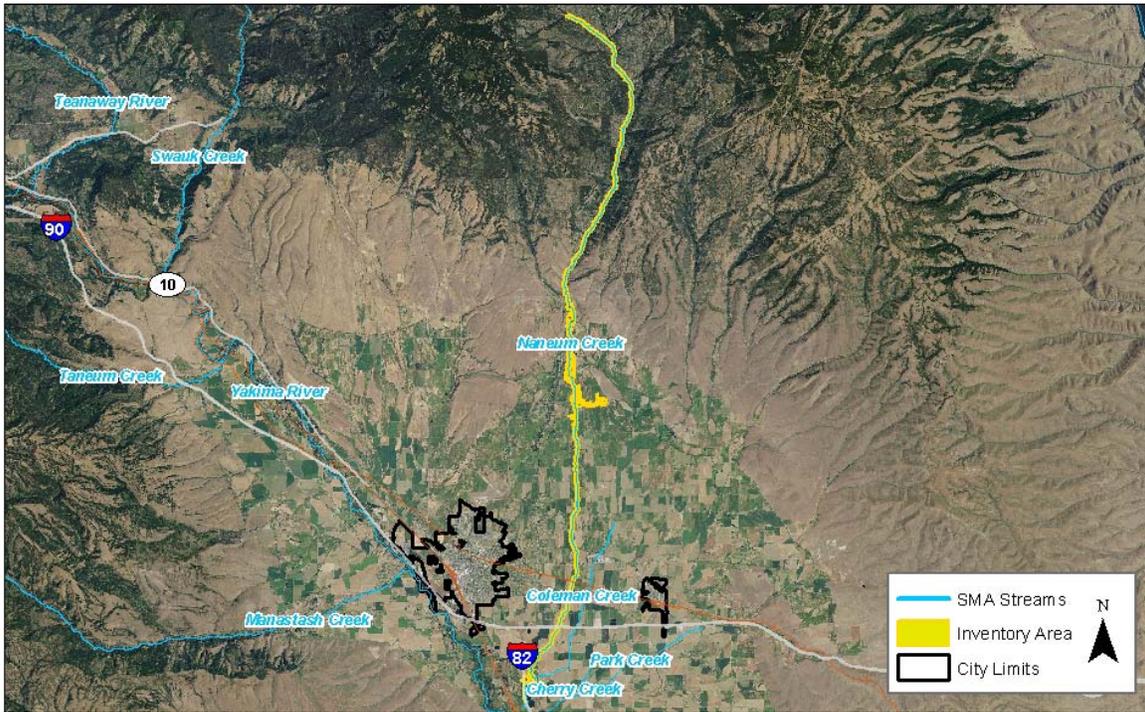
A limited area of the reach (28%) is located within the FEMA 100-year floodplain. No landslide hazard areas are mapped within the reach. The majority of the downstream half of the reach has potential for channel migration.

KEY MANAGEMENT ISSUES AND OPPORTUNITIES
<ul style="list-style-type: none"> • New development should be set back an adequate distance from the shoreline to protect riparian functions and protect structures from flooding and channel migration hazards. • The downstream portions of the stream channel and adjacent riparian areas have been highly altered by adjacent development and agricultural activities (including irrigation uses). • Encourage irrigation districts and private irrigators to work with the Yakima Tributary Access & Habitat Program to install fish screen on irrigation diversion, correct fish passage barriers and separate canals and creek to prevent entrainment of fish. • Control structures associated with irrigation canal intersections may entrain fish within the canals. • Decommission roads, where possible, to reduce sedimentation in the stream. • Educate shoreline property owners about measures to protect and restore riparian areas. • Protect intact habitat in the upper reaches. • The reach contains a rare plant species, mapped by the Washington Natural Heritage Program. • Encourage use of agricultural best management practices to reduce erosion and transport of legacy pesticides.

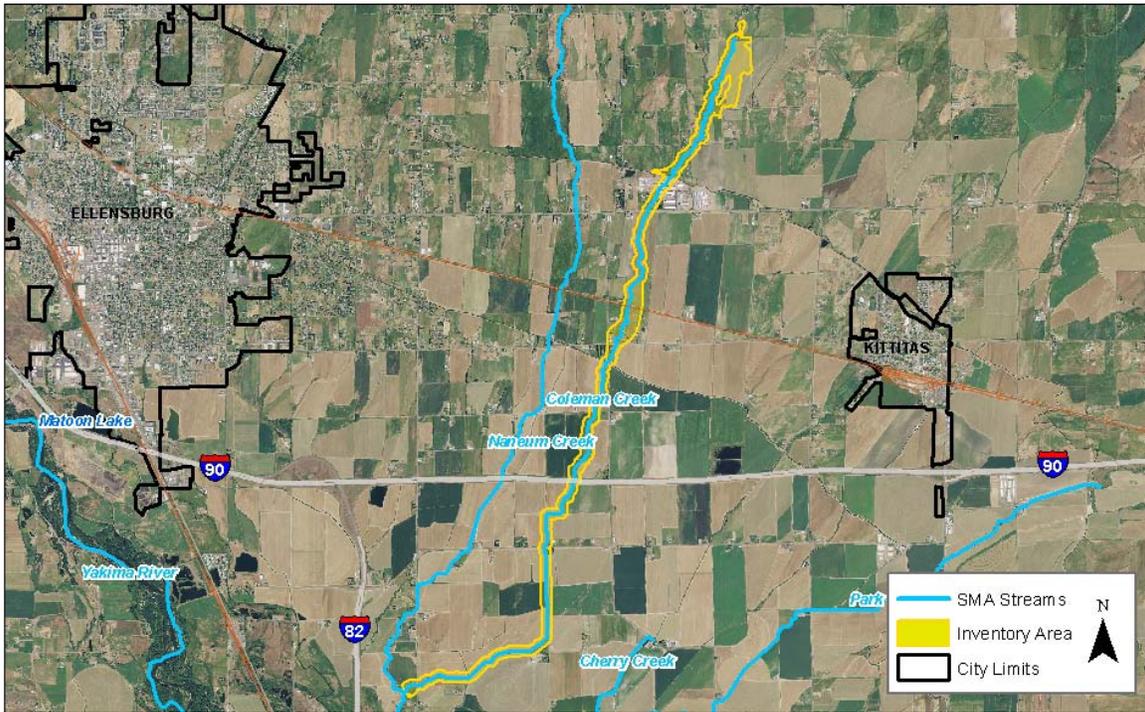
Approximately 44 percent of the reach area is located within the FEMA 100-year floodplain. No landslide hazard areas are mapped within the reach. The majority of the reach has potential for channel migration.

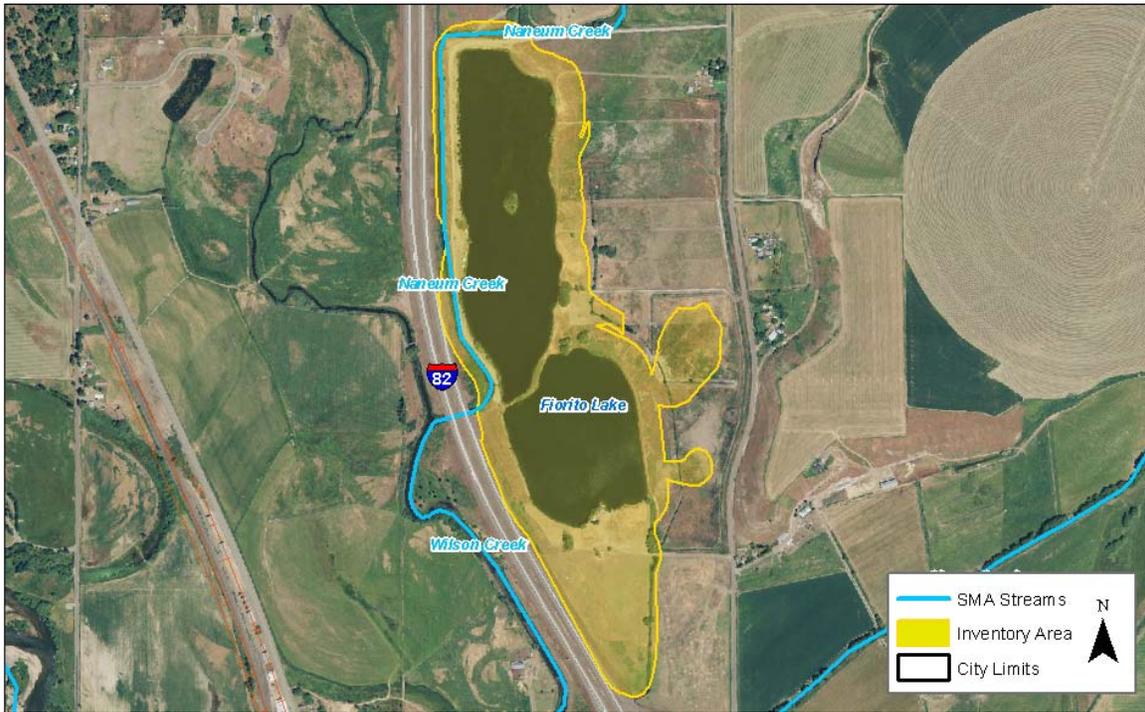
A large extent of the reach (70%) is located within the FEMA 100-year floodplain. No landslide hazard areas are mapped within the reach.

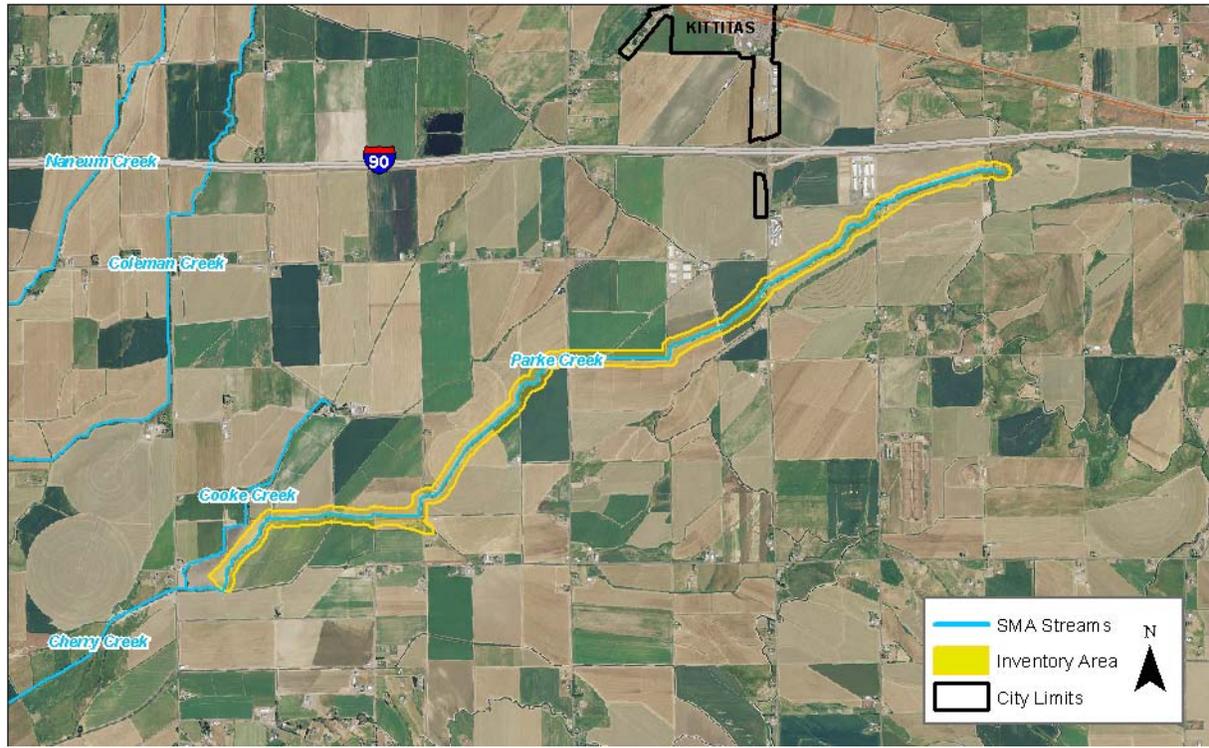
About 59 percent of the reach is located within the FEMA 100-year floodplain. No landslide hazard areas are mapped within the reach.

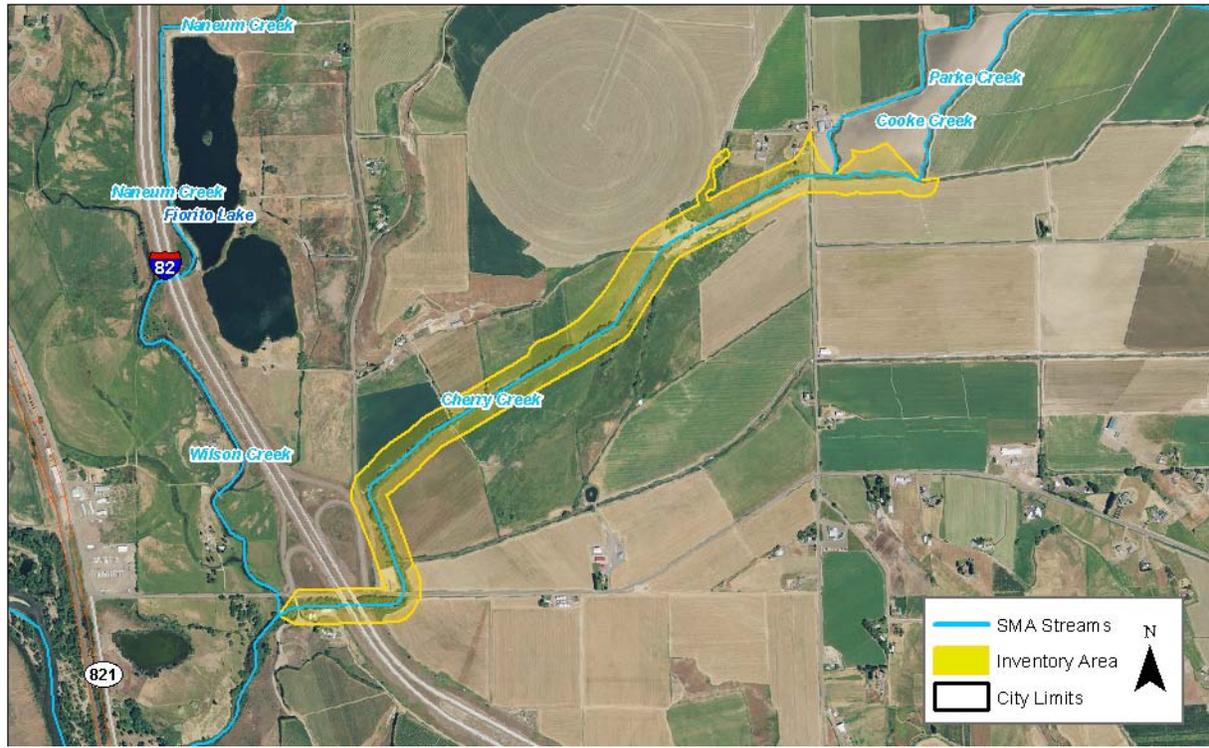
Over half of the reach (59%) is located within the FEMA 100-year floodplain. No landslide hazard areas are mapped within the reach.

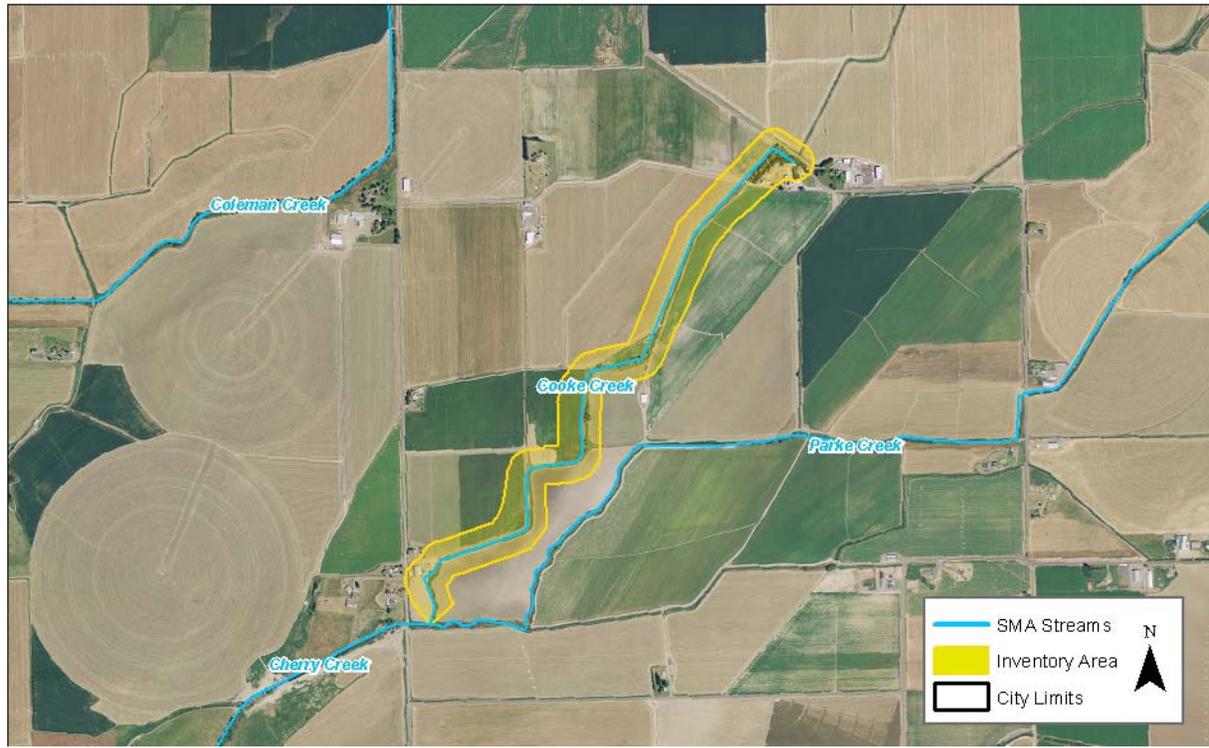
Over half of the reach (56%) is located within the FEMA 100-year floodplain. No landslide hazard areas are mapped within the reach.
