## CHAPTER 5. YAKIMA CANYON AND LITTLE NACHES RIVER

This chapter describes the conditions within the shoreline inventory areas of the portions of the Yakima Canyon (Figure 5-1) and Little Naches River (Figure 5-2) that lie within Kittitas County. These stream reaches are described in terms of their physical characteristics, ecological conditions, and human environment/land use characteristics. Readers are encouraged to review Chapter 2 and the maps in Appendix A for additional context on the information presented here.

## 5.1 Yakima Canyon

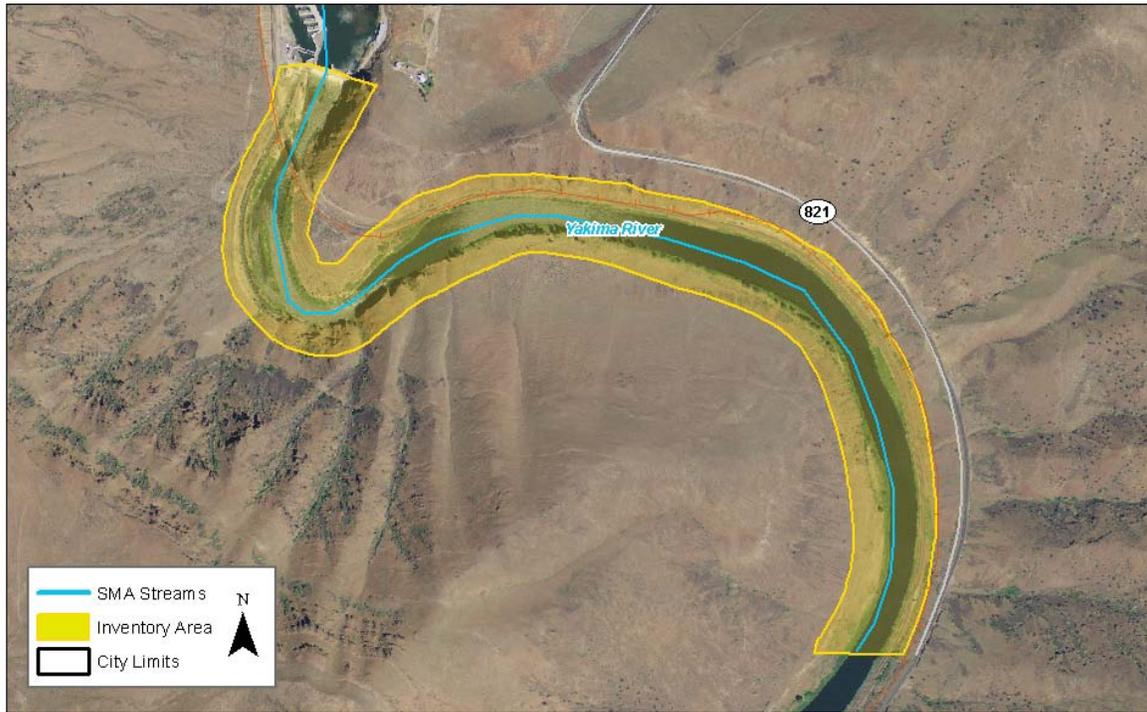
## YAKIMA RIVER-REACH 1

The reach flows as a single channel through a canyon with moderate topographic relief. The upstream portion of the reach is confined by the Roza Dam, bordered by an irrigation canal and is crossed by a railroad. Downstream, the railroad and Canyon Road parallel the channel.

About half the reach area (49%) is located within the FEMA 100-year floodplain. No landslide hazard areas are mapped within the reach, although landslides have occurred on steep slopes bordering the canyon.

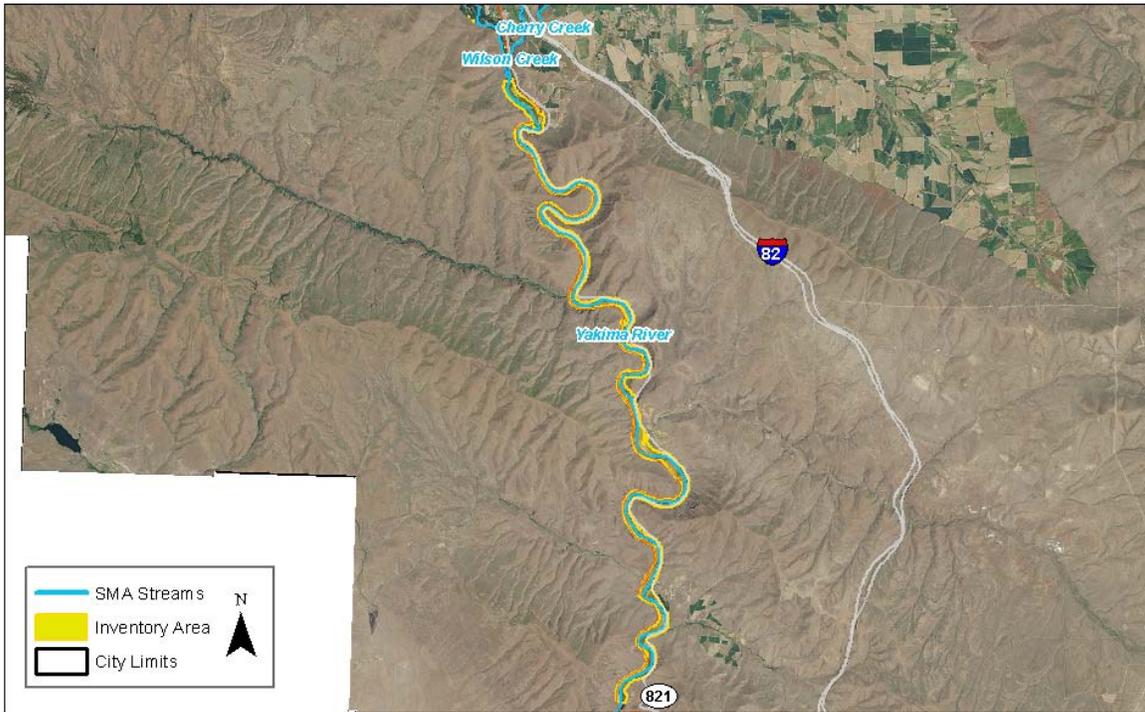
## YAKIMA RIVER-REACH 2

The reach primarily flows as a single channel through a confined canyon with moderate topographic relief, generally flowing north to south. Low floodplain terraces have limited distribution within the reach.

A large extent of the reach area (60%) is located within the FEMA 100-year floodplain. No landslide hazard areas are mapped within the reach, although steep slopes bordering the river may occasionally slide. Approximately one-third of the reach (38%) has potential for channel migration.

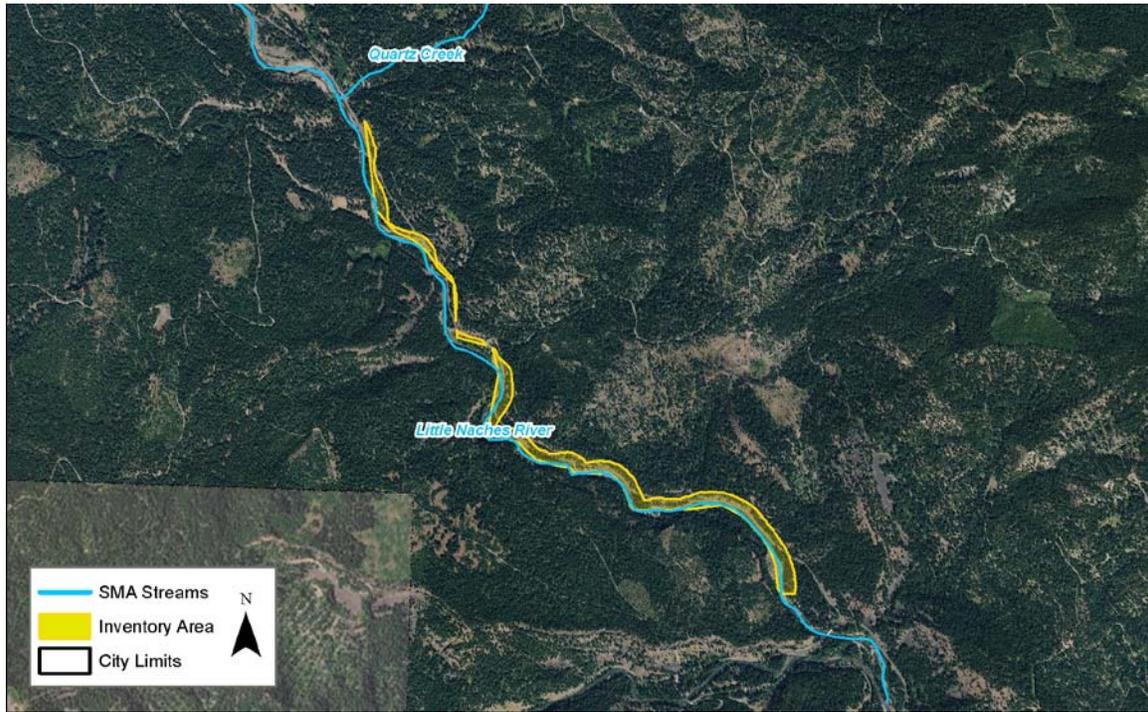
## LITTLE NACHES RIVER-REACH 1

The reach flows to the southeast and is largely undeveloped.

The reach is not located within the FEMA 100-year floodplain and no landslide hazard areas are mapped. The majority of the reach (77%) has potential for channel migration.
