APPENDIX A
KETTLE RIVER REACH
CHARACTERIZATION TABLES AND
REACH MAPS

Kettle River – Reach 1	Ferry County
Reach Description	
Kettle River from Canada-United States boundary to T39N R32E S2 near the mouth of Tonata Creek	
Shoreline Jurisdiction	
759 acres

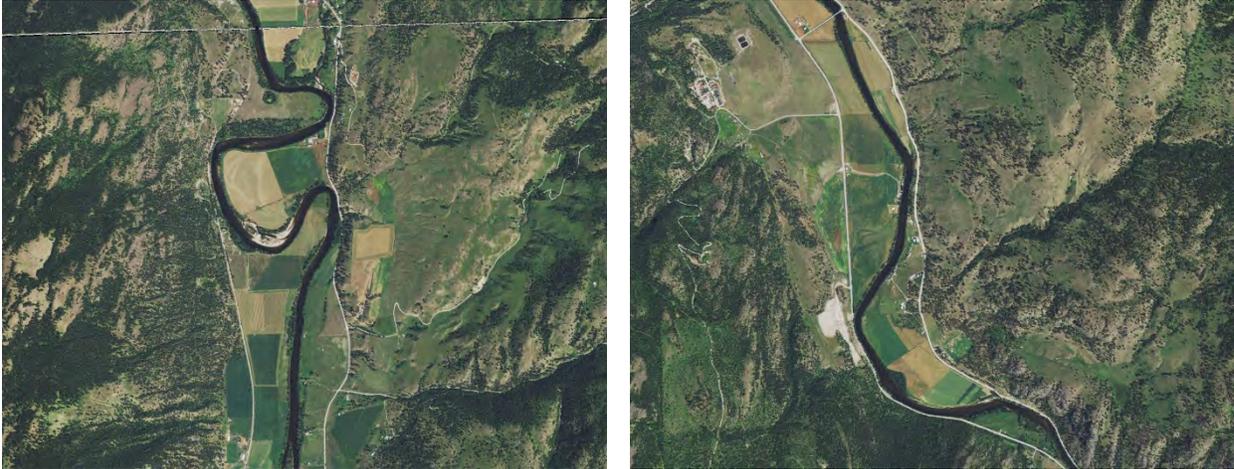
Source: U.S. Department of Agriculture (USDA) National Agriculture Imagery Program (NAIP) 2013	
Subreaches (SRs); see Map 1:	
Not applicable	
Characteristics	
Ownership	
Reach 1 is mostly private with a very small amount (less than 5%) of public ownership.	
Land Use/Current Shoreline Management Program	
Land Use Designation:	
<ul style="list-style-type: none"> • Current land uses are private ownership and public lands • Rural 	
Current Shoreline Management Program Environment Designation:	
<ul style="list-style-type: none"> • Rural and Natural 	
Existing Land Cover/Development	
Existing land cover includes forest, shrubland, and agricultural lands, and riparian vegetation. Development includes a small number of residential structures.

Kettle River – Reach 1	Ferry County
Geomorphic Character	
<p>Description – Throughout Reach 1, the Kettle River flows within a wide, low-gradient valley with a valley bottom that consists mostly of alluvium and some local areas of continental glacial drift. Bedrock outcrops of the Sanpoil Volcanics and Klondike Mountain Formations define the valley margins. In the lower portion of the reach, the river is sinuous and consists of large river meanders. The valley width narrows upstream with valley boundary and hill slopes consisting of bedrock.</p> <p>Hardened Banks – Approximately 600 feet of artificial hardened banks exist along the shoreline and are associated with the Toroda Bridge Customs Road.</p> <p>Channel Migration Zone – The channel migration zone (CMZ) throughout the lower segments of this reach is wide. Kroupa Road, Customs Road, and Kettle River Road limit channel migration potential. In addition, the CMZ narrows upstream as the valley becomes more confined within bedrock valley boundaries.</p>

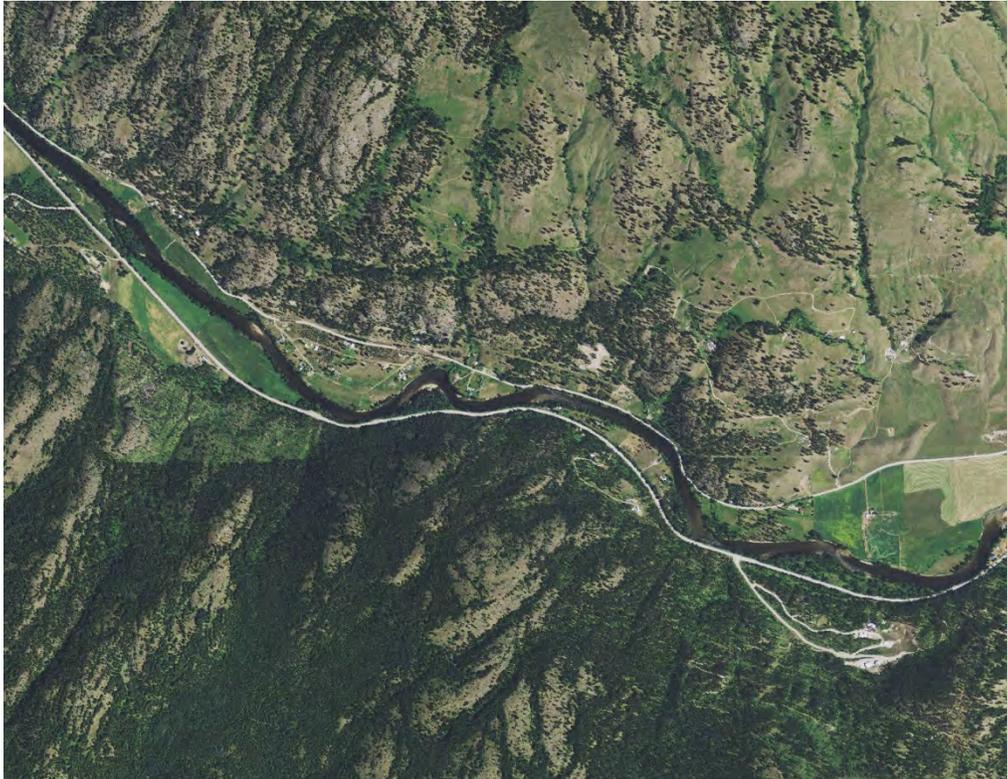
Source: USDA NAIP 2013	
Subreaches (SRs); see Map 2:	
<ul style="list-style-type: none"> • SR 2a – Begins at T39N R32E S2 near the mouth of Tonata Creek and extends east to the edge of residential developments • SR 2b – Extends 1.6 miles to the east to the edge of residential developments • SR 2c – Extends 2.4 miles to the east to the southwest (SW) ¼ of T39N_R33E_S10 near Hummingbird Road • SR 2d – Extends 1.7 miles to the east to the edge of the Curlew community 	
Characteristics	
Ownership	
Reach 2 is mostly private with a small amount (less than 10%) of public ownership.

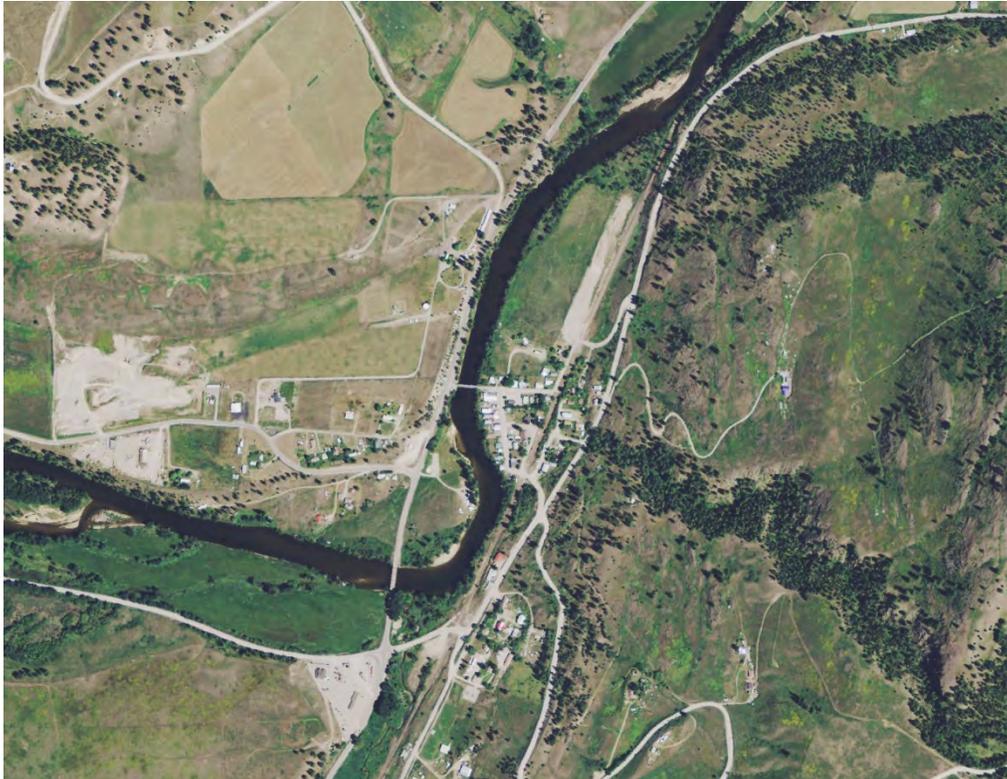
Source: USDA NAIP 2013	
Subreaches (SRs); see Map 2:	Not applicable
Characteristics	
Ownership	Reach 3 is about 20% public (Ferry County) and 80% private.
Land Use/Current Shoreline Management Program	Land Use Designation: <ul style="list-style-type: none"> • Current land uses are private ownership and public lands • Rural and Rural Service Area

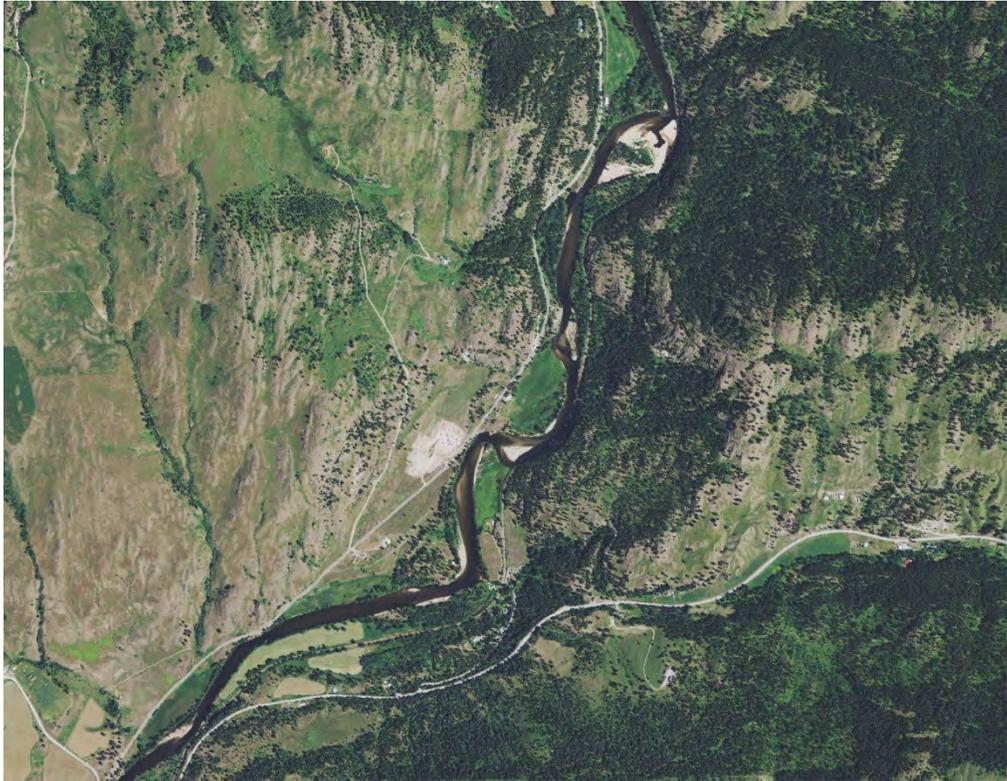
Source: USDA NAIP 2013	
Subreaches (SRs); see Map 4:	Not applicable
Characteristics	
Ownership	Reach 4 is about 20% public (U.S. Bureau of Land Management, tribal, and Ferry County) and 80% private.
Land Use/Current Shoreline Management Program	Land Use Designation: <ul style="list-style-type: none"> • Current land uses are private ownership, public lands, and Indian allotment trust lands • Rural

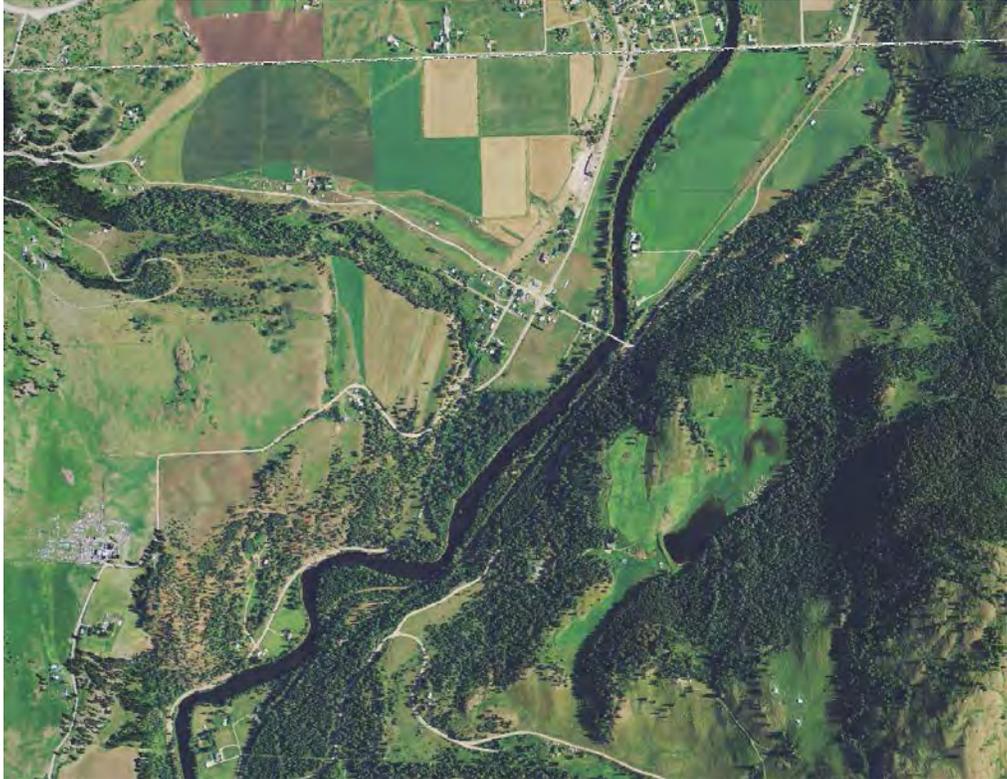
Source: USDA NAIP 2013	
Subreaches (SRs); see Map 4:	
<ul style="list-style-type: none"> • SR 5a – Begins at the Lone Ranch Creek Road Bridge and extends north to the edge of Danville • SR 5b – Extends 0.9 mile to the north to the Canada-United States border 	
Characteristics	
Ownership	
Reach 5 is mostly private with a very small amount (less than 5%) of public ownership.	
Land Use/Current Shoreline Management Program	
Land Use Designation:	
<ul style="list-style-type: none"> • Current land uses are private ownership, public lands, and Indian allotment trust lands • Rural and Rural Service Area

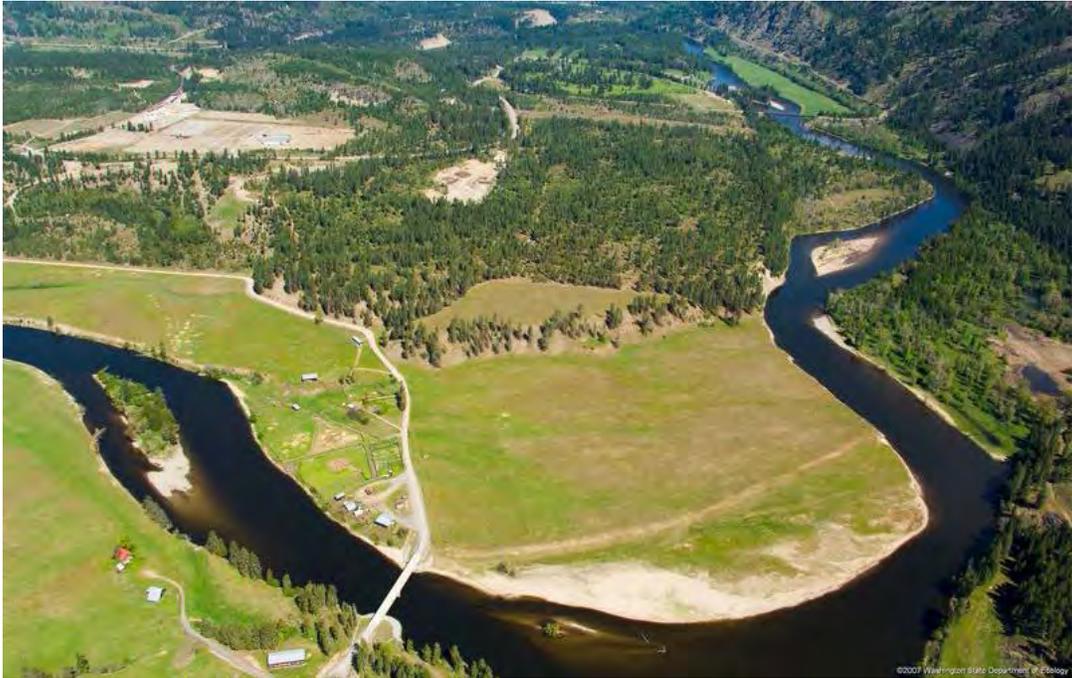
<p>Source: https://fortress.wa.gov/ecy/coastalatlantlas/UICoastalAtlas/Tools/ShorePhotos.aspx</p>	
Subreaches (SRs); see Map 5:	
Not applicable	
Characteristics	
Ownership	
Reach 6 is mostly private with a small amount (less than 10%) of public ownership.	
Land Use/Current Shoreline Management Program	
Land Use Designation:	
<ul style="list-style-type: none"> • Current land uses are private ownership and public lands • Rural 	
Current Shoreline Management Program Environment Designation:	
<ul style="list-style-type: none"> • Rural

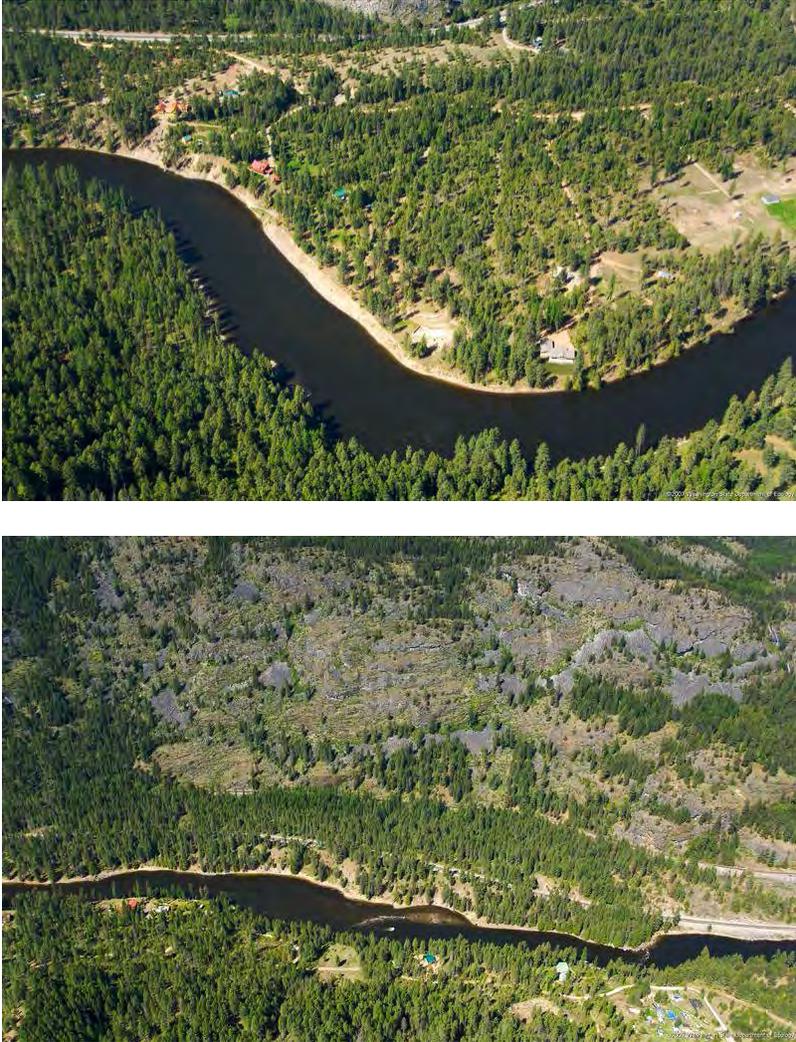
Source: https://fortress.wa.gov/ecy/coastalatlantools/UICoastalAtlas/Tools/ShorePhotos.aspx	
Subreaches (SRs); see Map 5:	Not applicable
Characteristics	
Ownership	Reach 7 is about 40% public (U.S. Forest Service [USFS]) and 60% private.

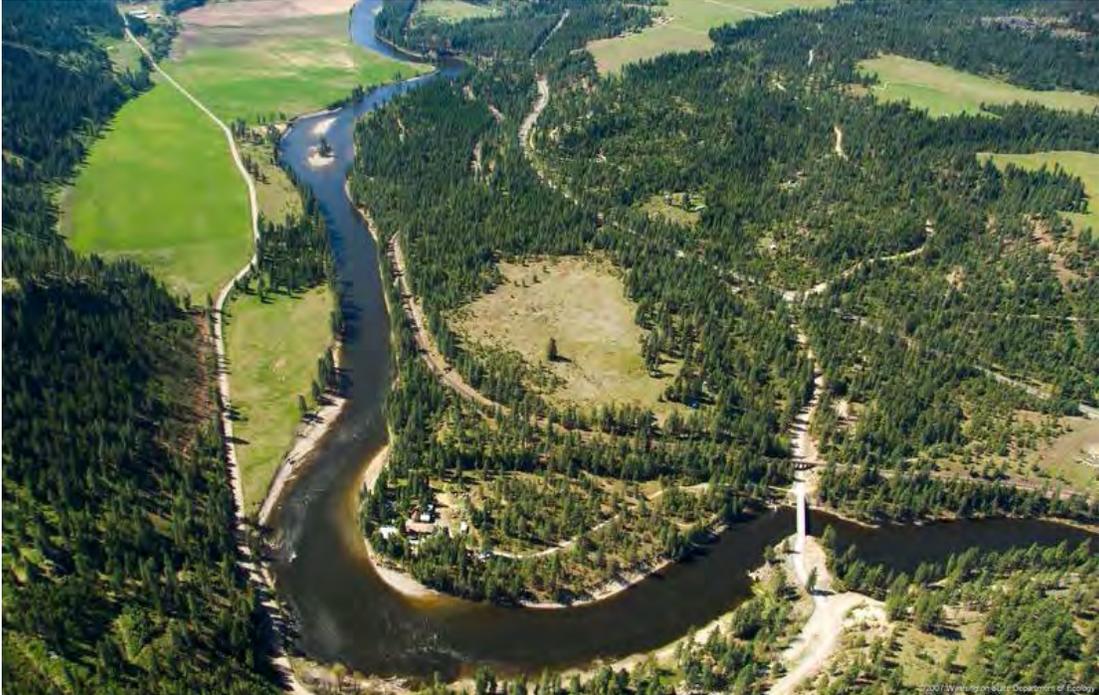
Source: https://fortress.wa.gov/ecy/coastalatlantlas/UICoastalAtlas/Tools/ShorePhotos.aspx	
Subreaches (SRs); see Map 6:	
<ul style="list-style-type: none"> • SR 8a – Begins at Rock Cut Road Bridge and extends south to the NW ¼ of T39N_R36E_S14 at the beginning of grazing fields • SR 8b – Extends 1.3 miles to the south to the edge of the community of Orient 	
Characteristics	
Ownership	
Reach 8 is entirely private.	
Land Use/Current Shoreline Management Program	
Land Use Designation:	
<ul style="list-style-type: none"> • Current land use is private ownership • Rural

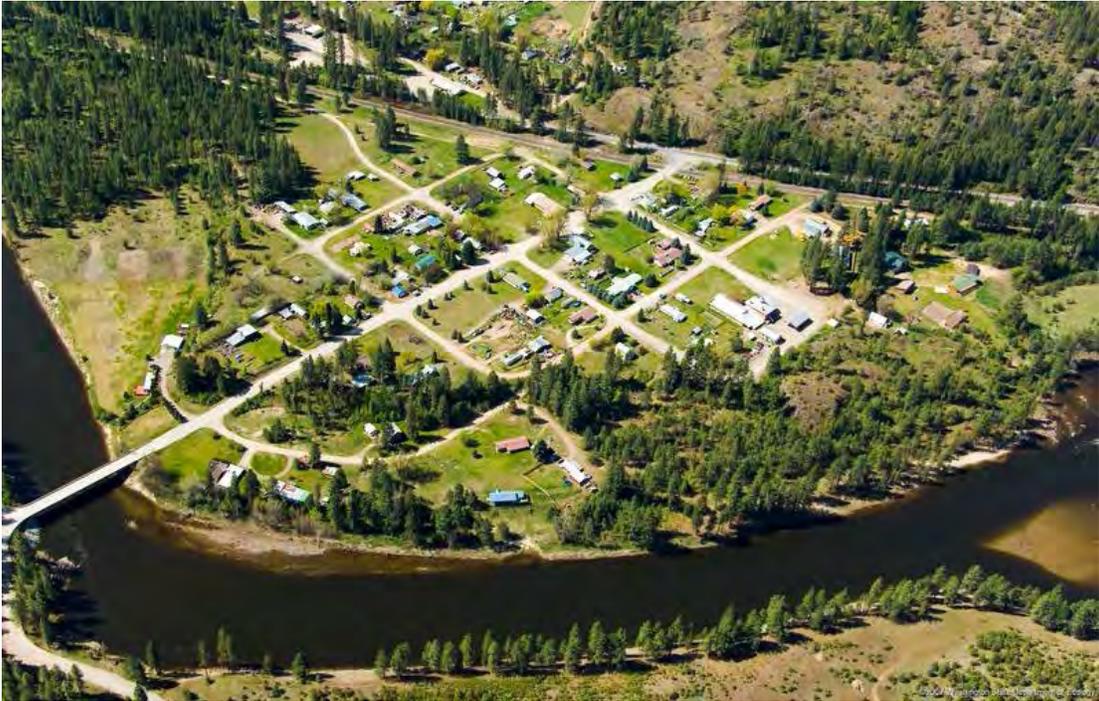
<p>Source: https://fortress.wa.gov/ecy/coastalatlantools/UICoastalAtlas/Tools/ShorePhotos.aspx</p>	
Subreaches (SRs); see Map 6:	Not applicable
Characteristics	
Ownership	Reach 9 is entirely private.
Land Use/Current Shoreline Management Program	<p>Land Use Designation:</p> <ul style="list-style-type: none"> • Current land use is private ownership • Rural and Rural Service Area <p>Current Shoreline Management Program Environment Designation:</p> <ul style="list-style-type: none"> • Conservancy

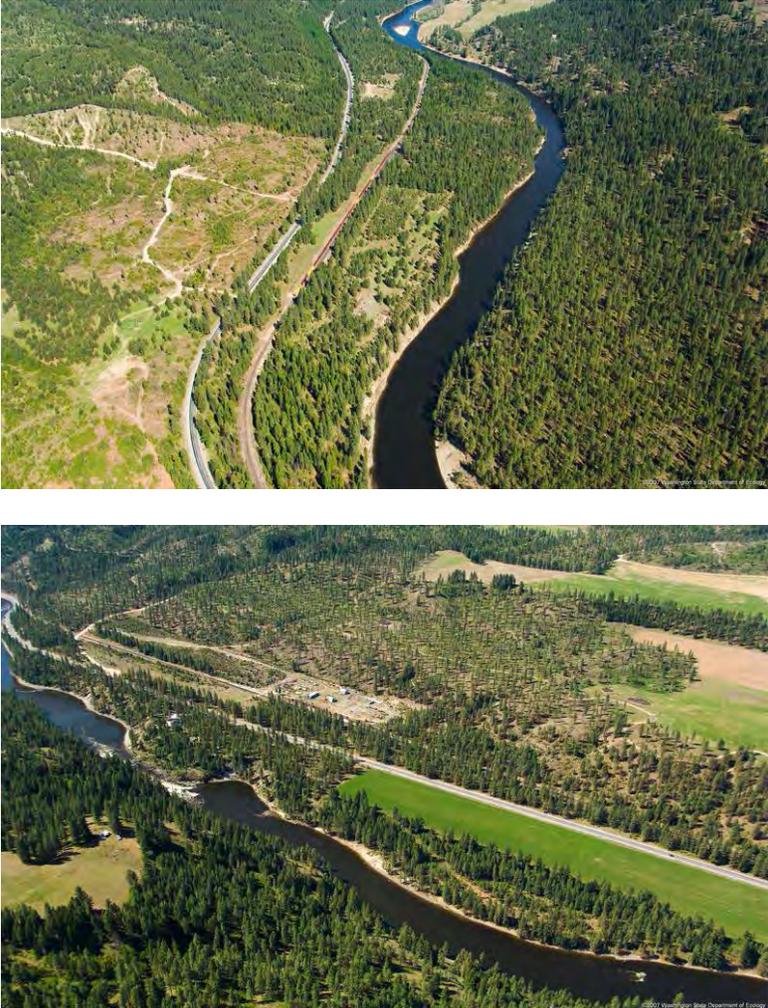
Source: https://fortress.wa.gov/ecy/coastalatlantlas/UICoastalAtlas/Tools/ShorePhotos.aspx		
Subreaches (SRs); see Map 8:		
<ul style="list-style-type: none">• SR 10a – Begins at the edge of the community of Orient and extends south to the edge of agricultural fields• SR 10b – Extends 5.5 miles to the SE ¼ of T38N_R37E_S18

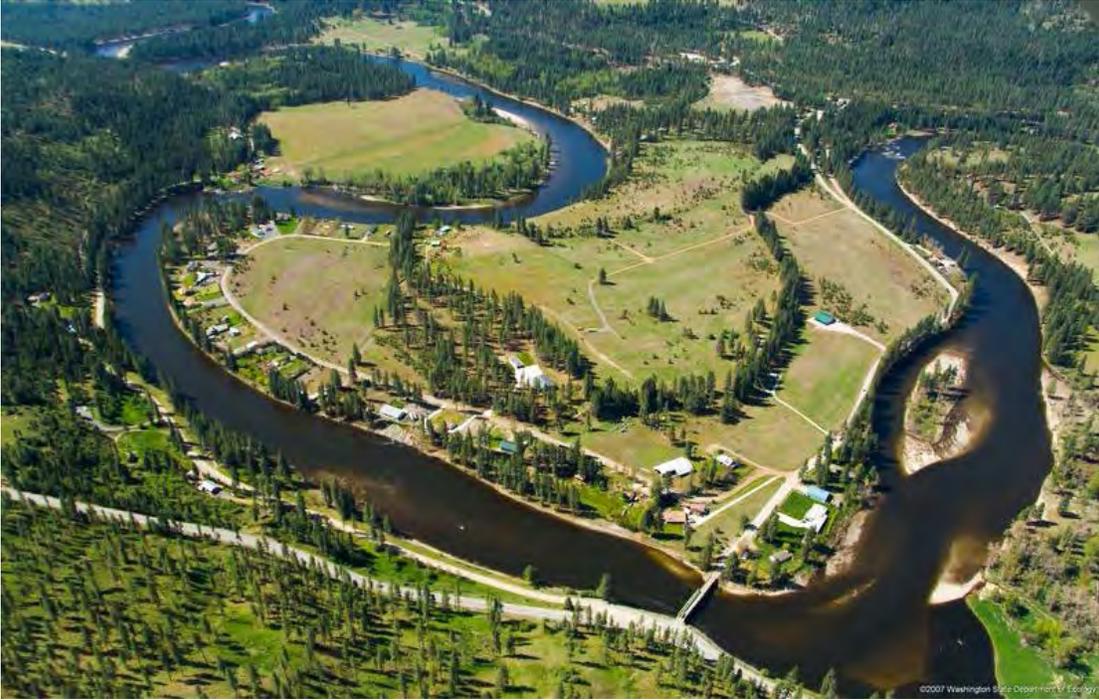
Source: https://fortress.wa.gov/ecy/coastalatlus/UICoastalAtlas/Tools/ShorePhotos.aspx	
Subreaches (SRs); see Map 8:	
Not applicable	
Characteristics	
Ownership	
Reach 11 is about 15% public (U.S. Bureau of Reclamation and Ferry County) and 85% private.	
Land Use/Current Shoreline Management Program	
Land Use Designation:	
<ul style="list-style-type: none"> • Current land uses are private ownership and public lands • Rural 	
Current Shoreline Management Program Environment Designation:	
<ul style="list-style-type: none"> • Rural and Conservancy

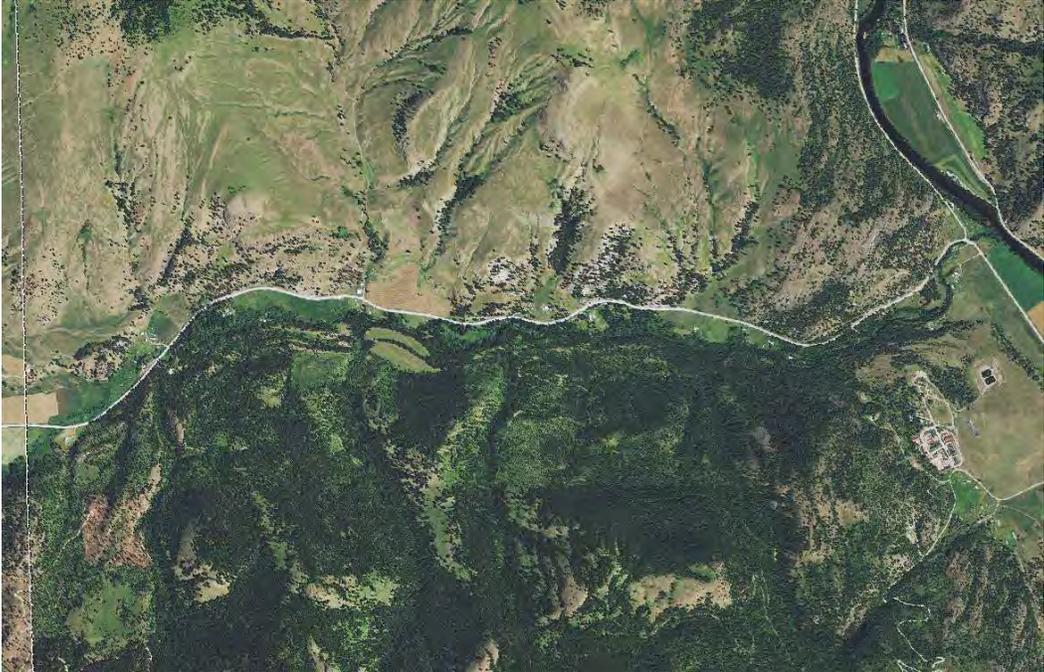
Source: USDA NAIP 2013	
Subreaches (SRs); see Map 1:	
<ul style="list-style-type: none"> • SR 1a – Begins at Okanogan-Ferry County line and extends east to Toroda Creek Road channel crossing • SR 1b – Extends 3.2 miles to the east to the NW ¼ of T40N_R32E_S27 at the edge of the forested area • SR 1c – Extends 0.5 mile to the east to the confluence with the Kettle River 	
Characteristics	
Ownership	
Reach 1 is mostly private with a very small amount (less than 5%) of public ownership.

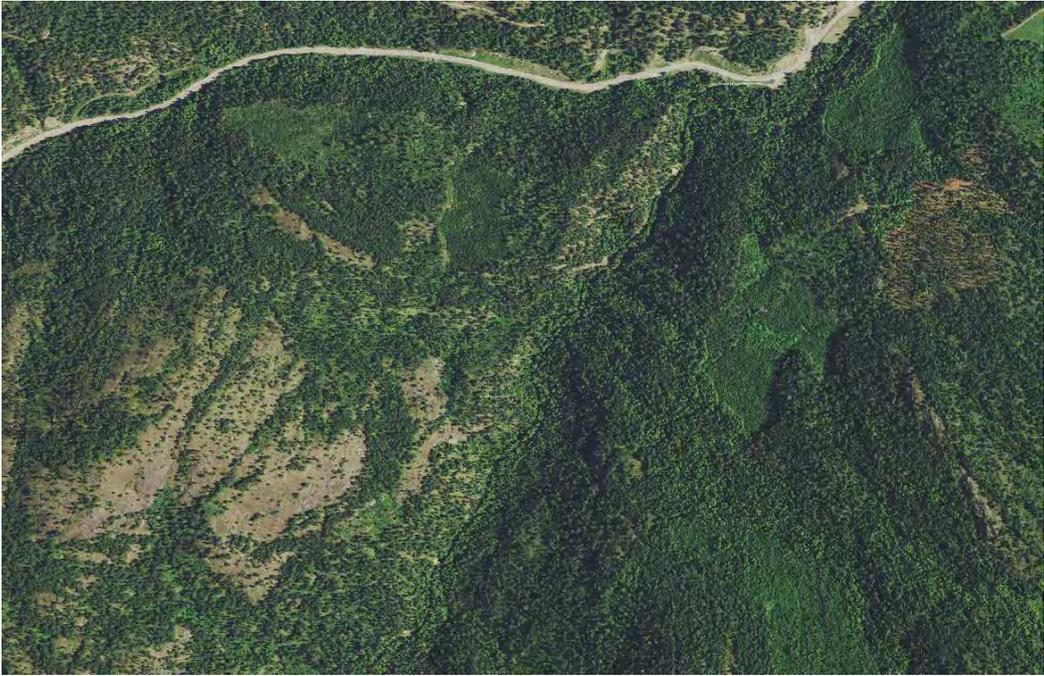
Source: USDA NAIP 2013	
Subreaches (SRs); see Map 7:	
Not applicable	
Characteristics	
Ownership	
Reach 1 is entirely managed by USFS.	
Land Use/Current Shoreline Management Program	
Land Use Designation:	
<ul style="list-style-type: none"> • Current land use is public lands • Rural 	
Current Shoreline Management Program Environment Designation:	
<ul style="list-style-type: none"> • Rural

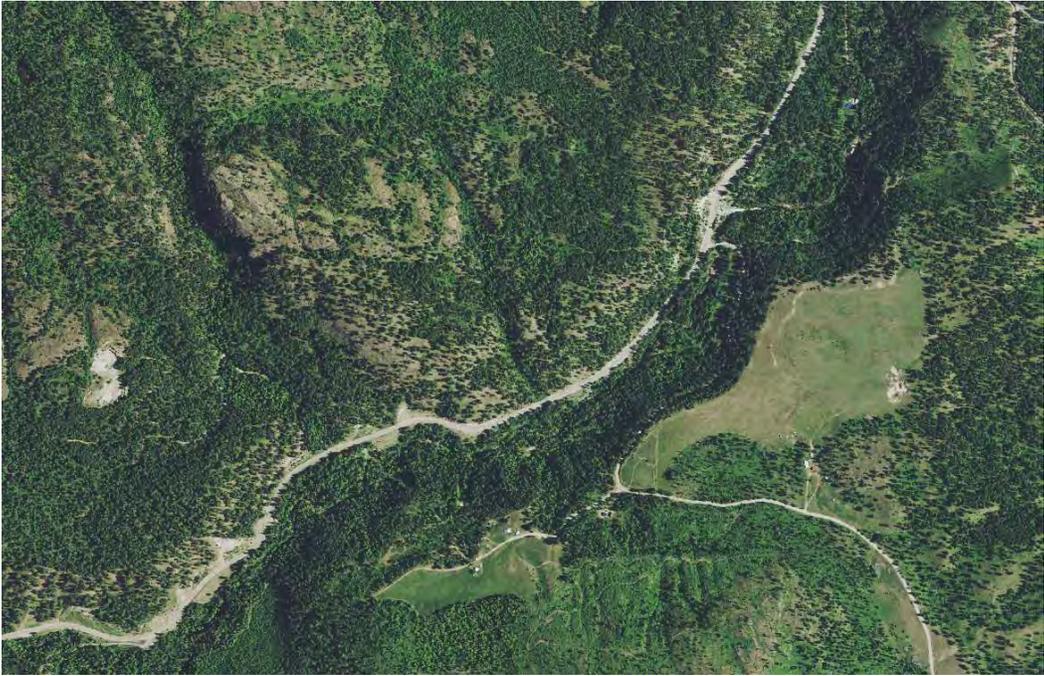
Source: USDA NAIP 2013	
Subreaches (SRs); see Map 7:	
Not applicable	
Characteristics	
Ownership	
Reach 1 is 50% public (USFS) and 50% private.	
Land Use/Current Shoreline Management Program	
Land Use Designation:	
<ul style="list-style-type: none"> • Current land uses are private ownership and public lands • Rural 	
Current Shoreline Management Program Environment Designation:	
<ul style="list-style-type: none"> • Rural

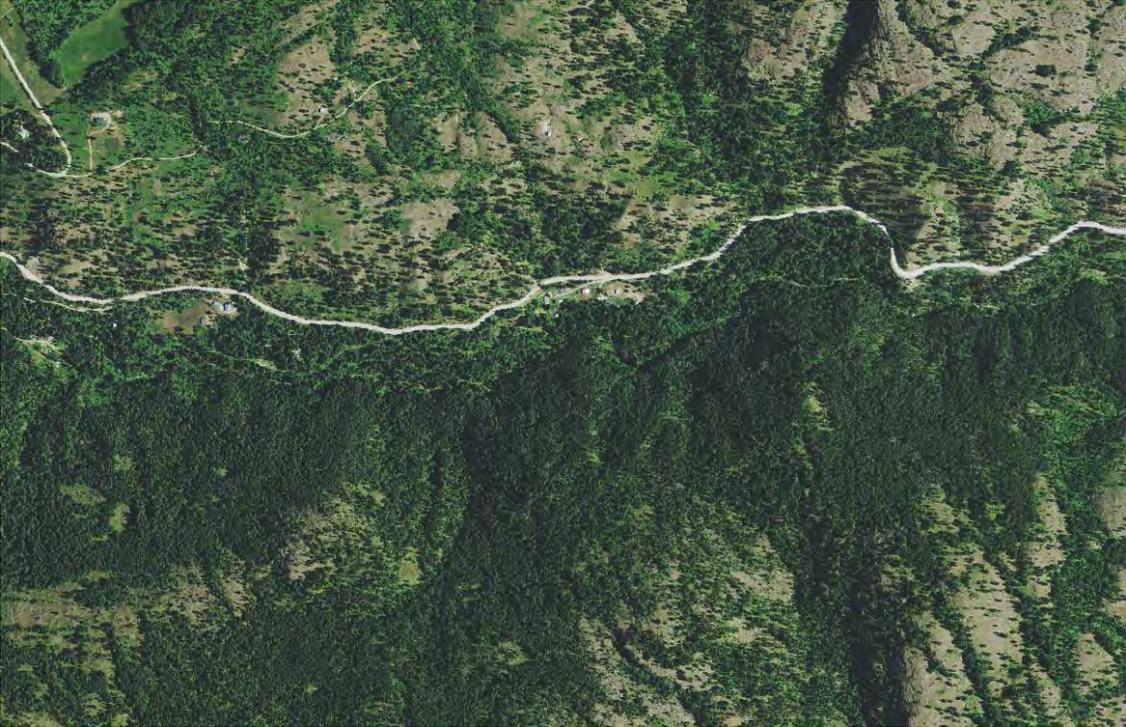
Source: USDA NAIP 2013	
Subreaches (SRs); see Map 9:	
Not applicable	
Characteristics	
Ownership	
Reach 1 is about 15% public (USFS, U.S. Department of the Interior, and Washington Department of Natural Resources) and 85% private.	
Land Use/Current Shoreline Management Program	
Land Use Designation:	
<ul style="list-style-type: none"> • Current land uses are private ownership and public lands • Rural
