APPENDIX A
FRANKLIN COUNTY REACH
CHARACTERIZATION TABLES AND
REACH MAPS

Columbia River – Reach 1	Franklin County
Reach Description: Columbia River from Grant County boundary to downstream of Savage Island	
Shoreline Jurisdiction: 1,735 acres

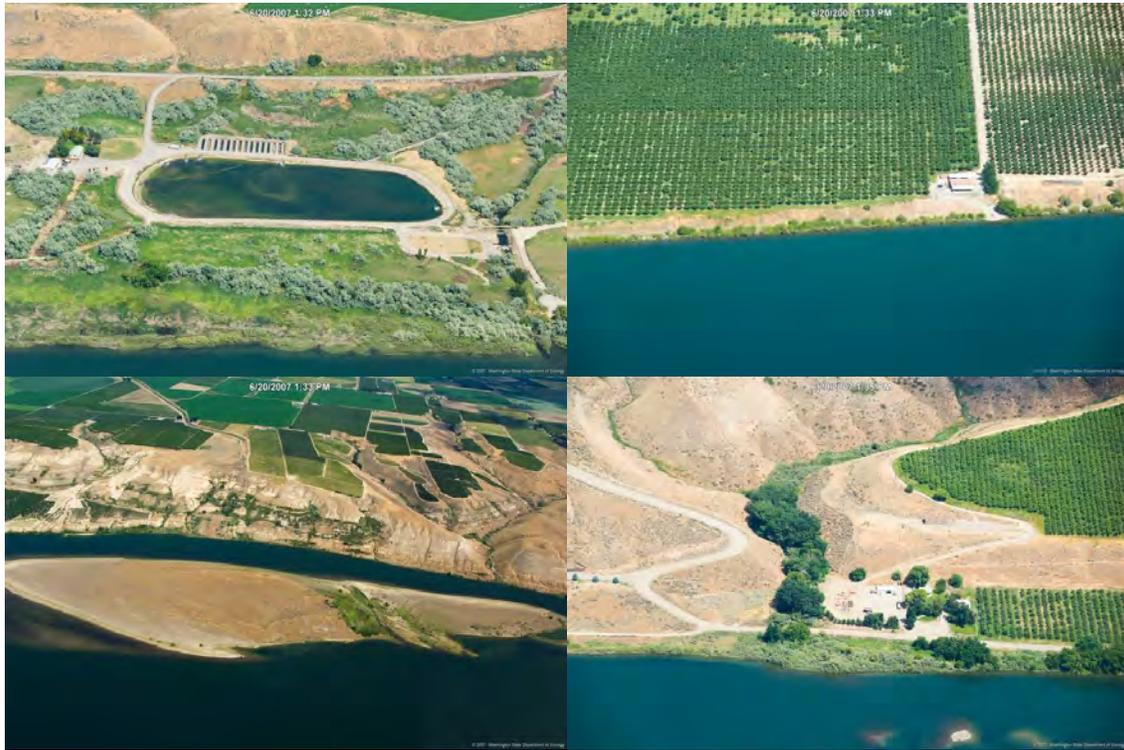
Columbia River – Reach 2 Franklin County

Reach Description: Columbia River from the downstream end of Savage Island to Baxter Canyon

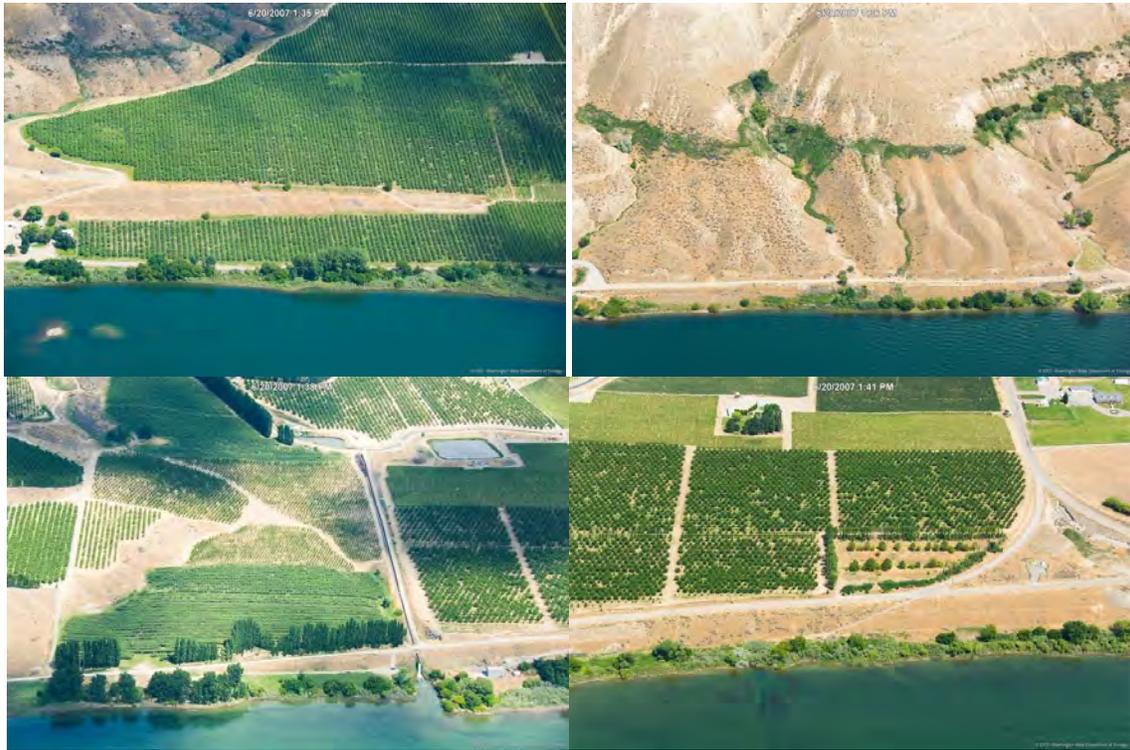
Columbia River – Reach 3 Franklin County

Reach Description: Columbia River from Baxter Canyon to Sagemoor Road

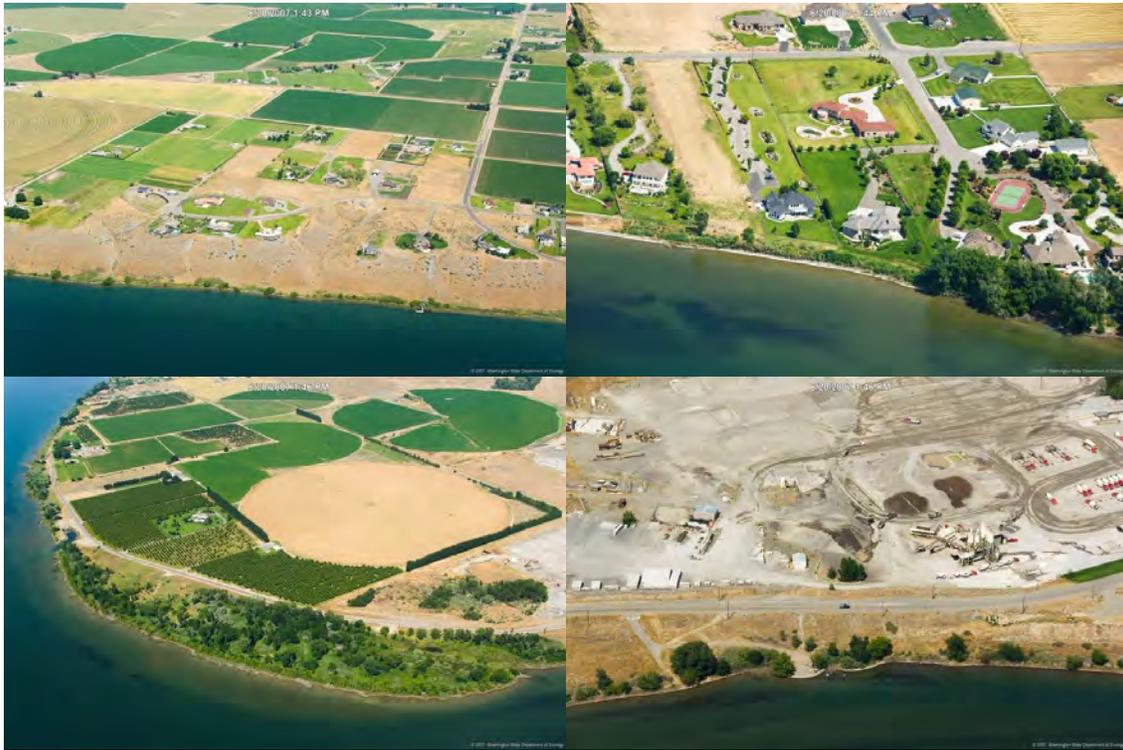
Columbia River – Reach 4 Franklin County

Reach Description: Columbia River from Sagemoor Road to Interstate 182 Bridge

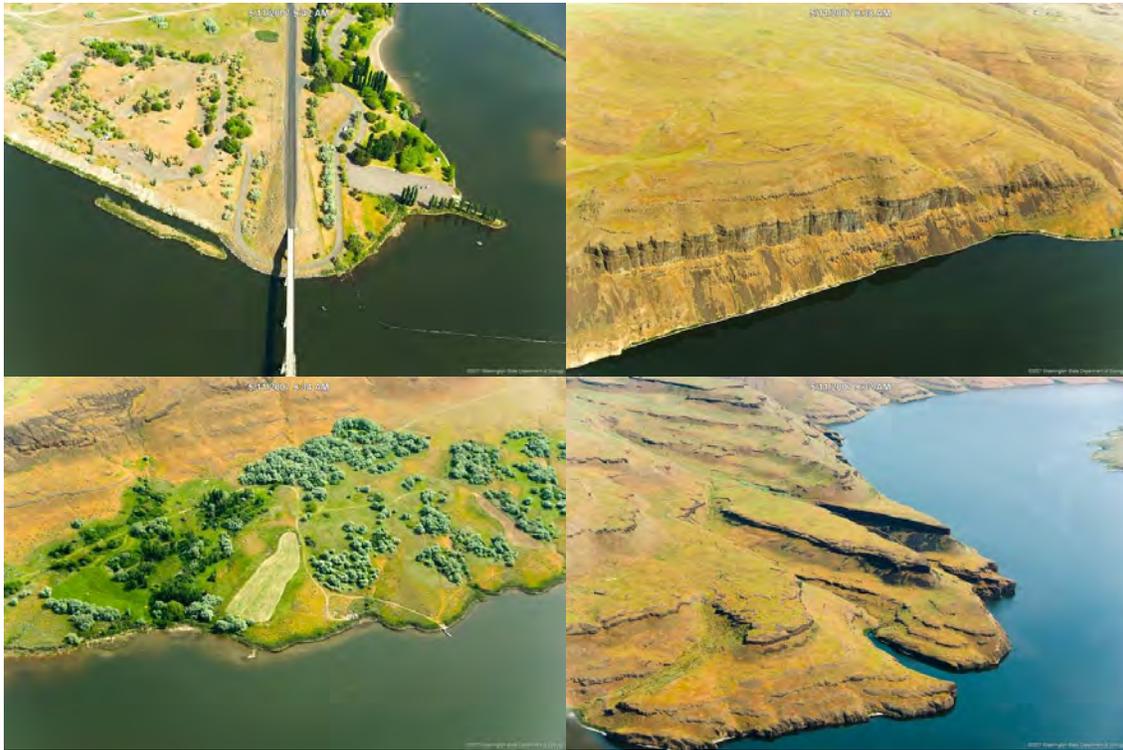
Snake River – Reach 1 Franklin County

Reach Description: Snake River from the Confluence with Palouse River to Lower Monumental Dam
