Snake River – Reach 2 Franklin County**Reach Description:** Snake River from Lower Monumental Dam to McCoy Canyon**Shoreline Jurisdiction:** 2,591 acres

Map 10
Snake River Subreaches 1f-2a
Franklin County Shoreline Master Program
Franklin County, WA

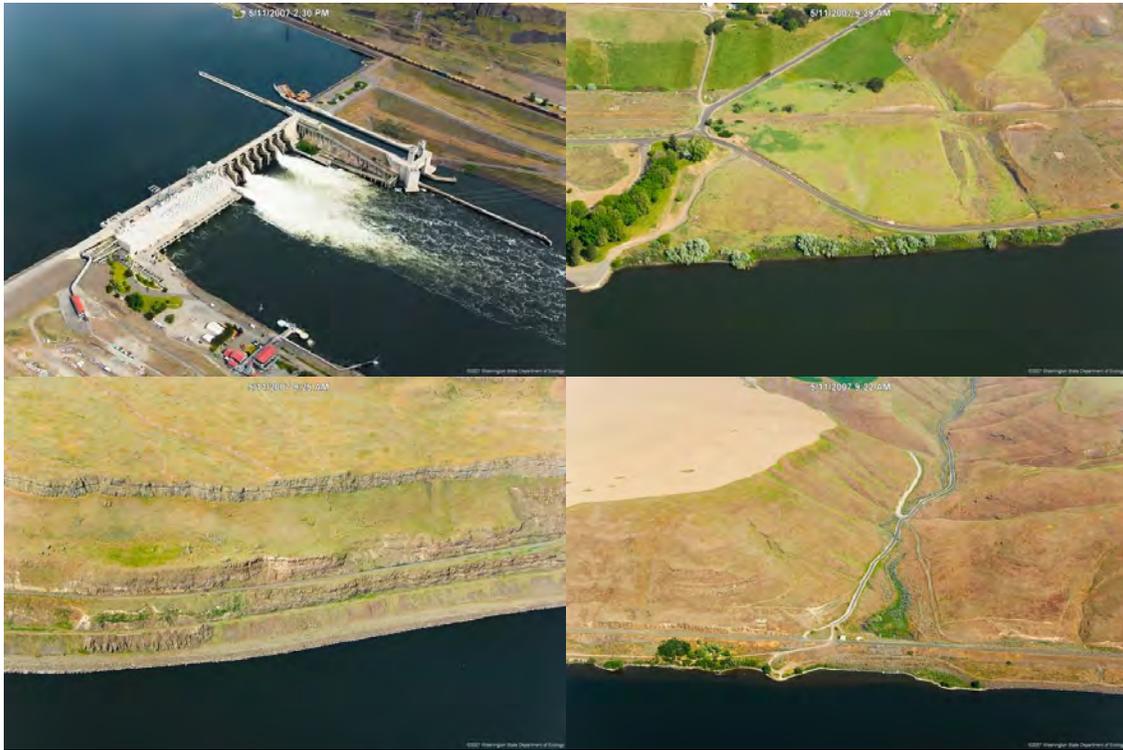
Source: <https://fortress.wa.gov/ecy/coastalatlus/UICoastalAtlas/Tools/ShorePhotos.aspx>**Subreaches (SRs); see Figures 10, 11, and 12:**

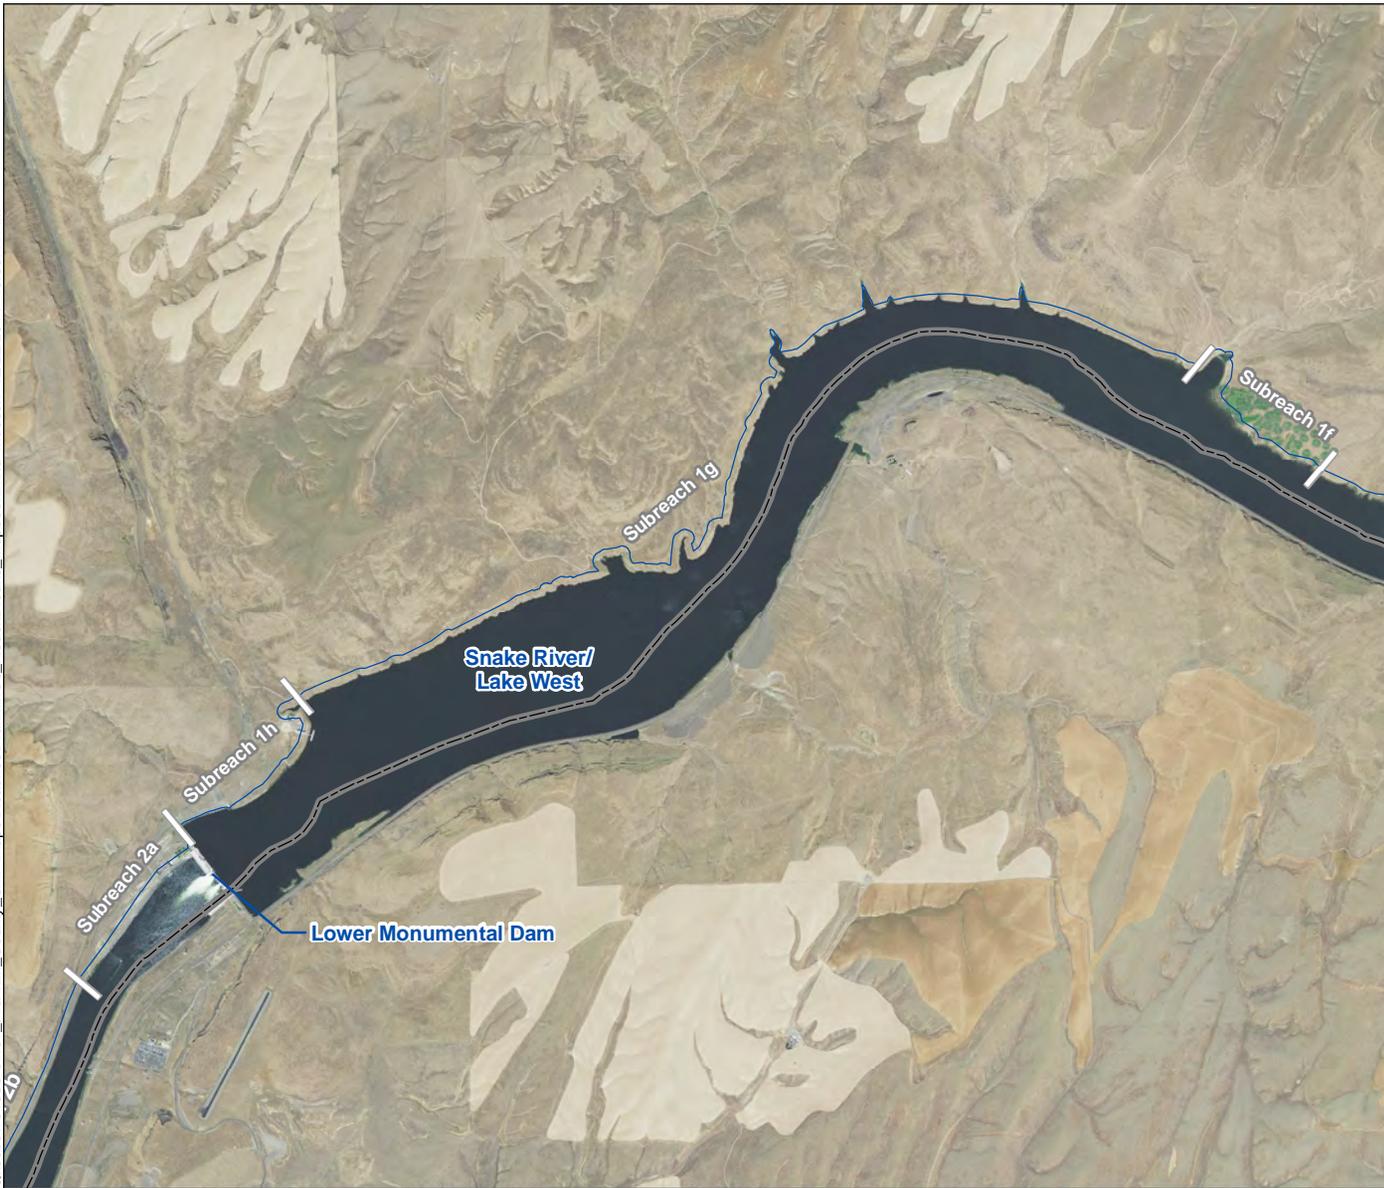
SR 2a: Begins at the downstream of the Lower Monumental Dam extending 0.8 miles to the southwest

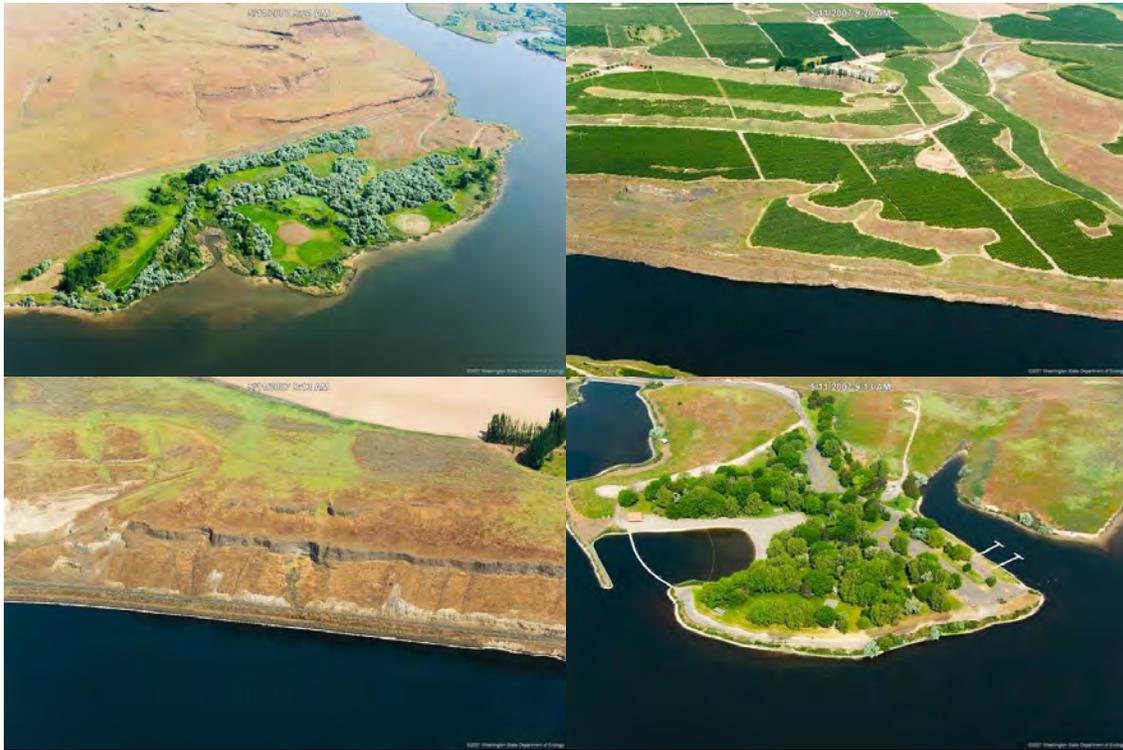
Source: <https://fortress.wa.gov/ecy/coastalatl/UICoastalAtlas/Tools/ShorePhotos.aspx>**Subreaches (SRs); see Figures 13 and 14:**

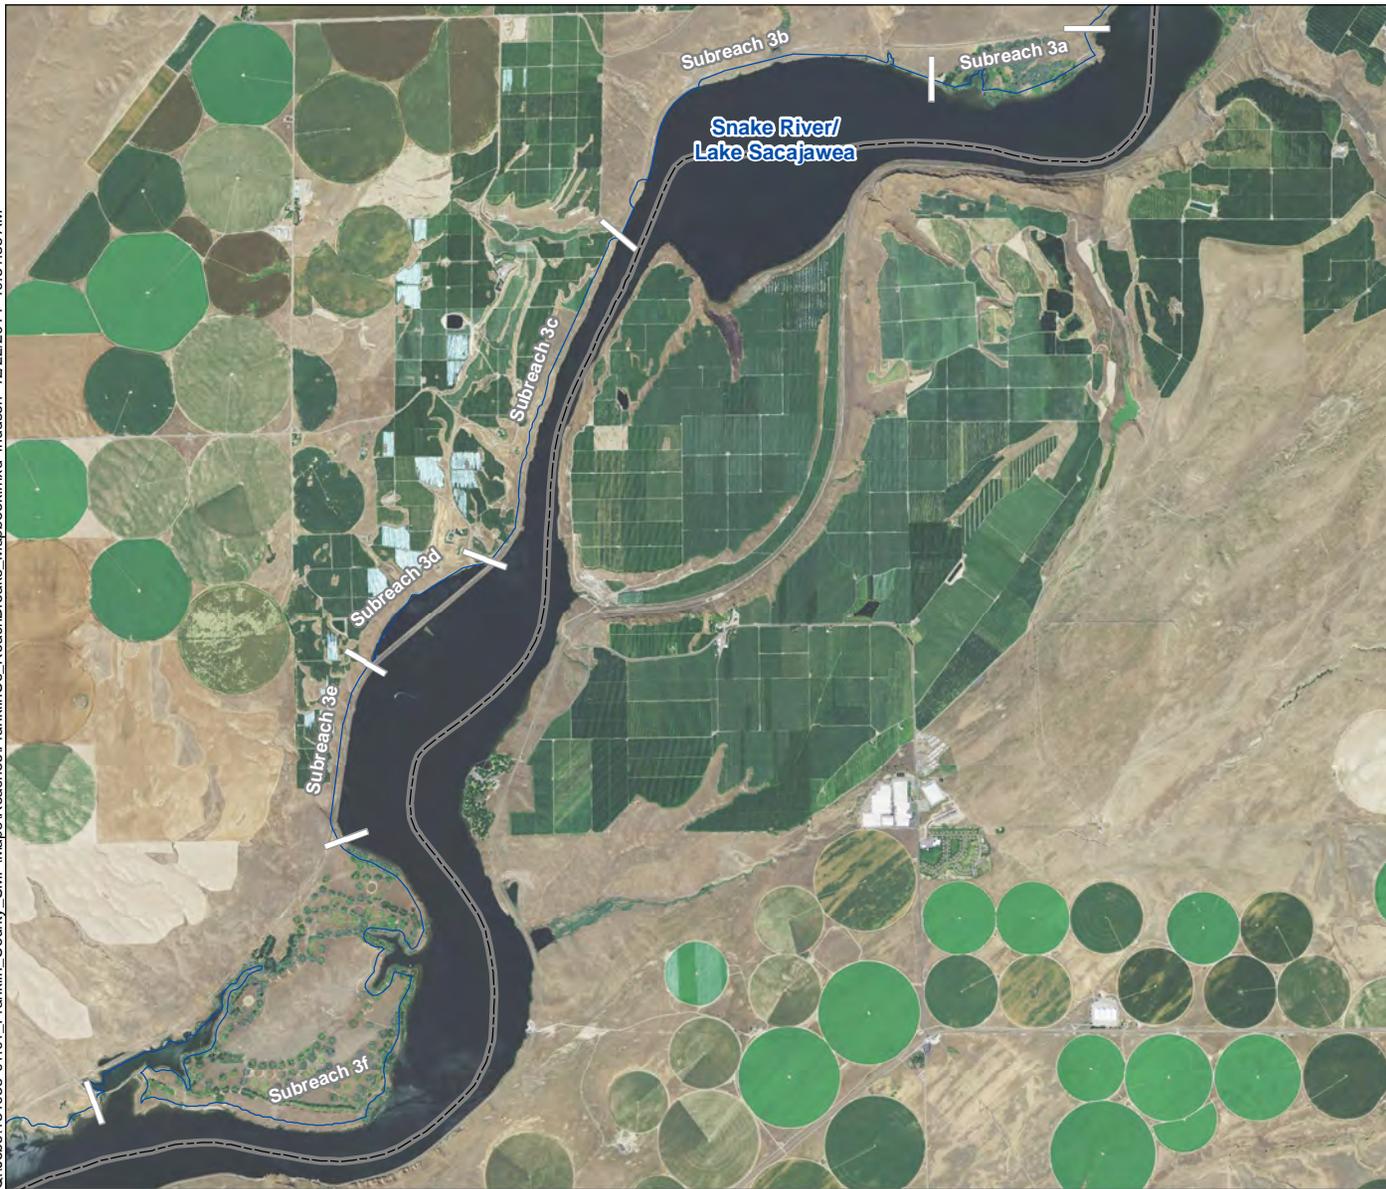
Map 13
Snake River Subreaches 3a-3f
Franklin County Shoreline Master Program
Franklin County, WA

SR 3a: Begins at McCoy Canyon extending 1 mile to the west

SR 3b: Extends 2 miles to the west ending at the edge of agricultural developments

SR 3c: Extends 1.7 miles to the south to the edge of Emma Lake

SR 3d: Extends 0.9 miles to the southwest ending at the downstream of Emma Lake

SR 3e: Extends 0.9 miles to the south to the edge of Big Flat Recreation Area

SR 3f: Extend 4 miles to the southwest ending at the downstream of Big Flat Recreation Area

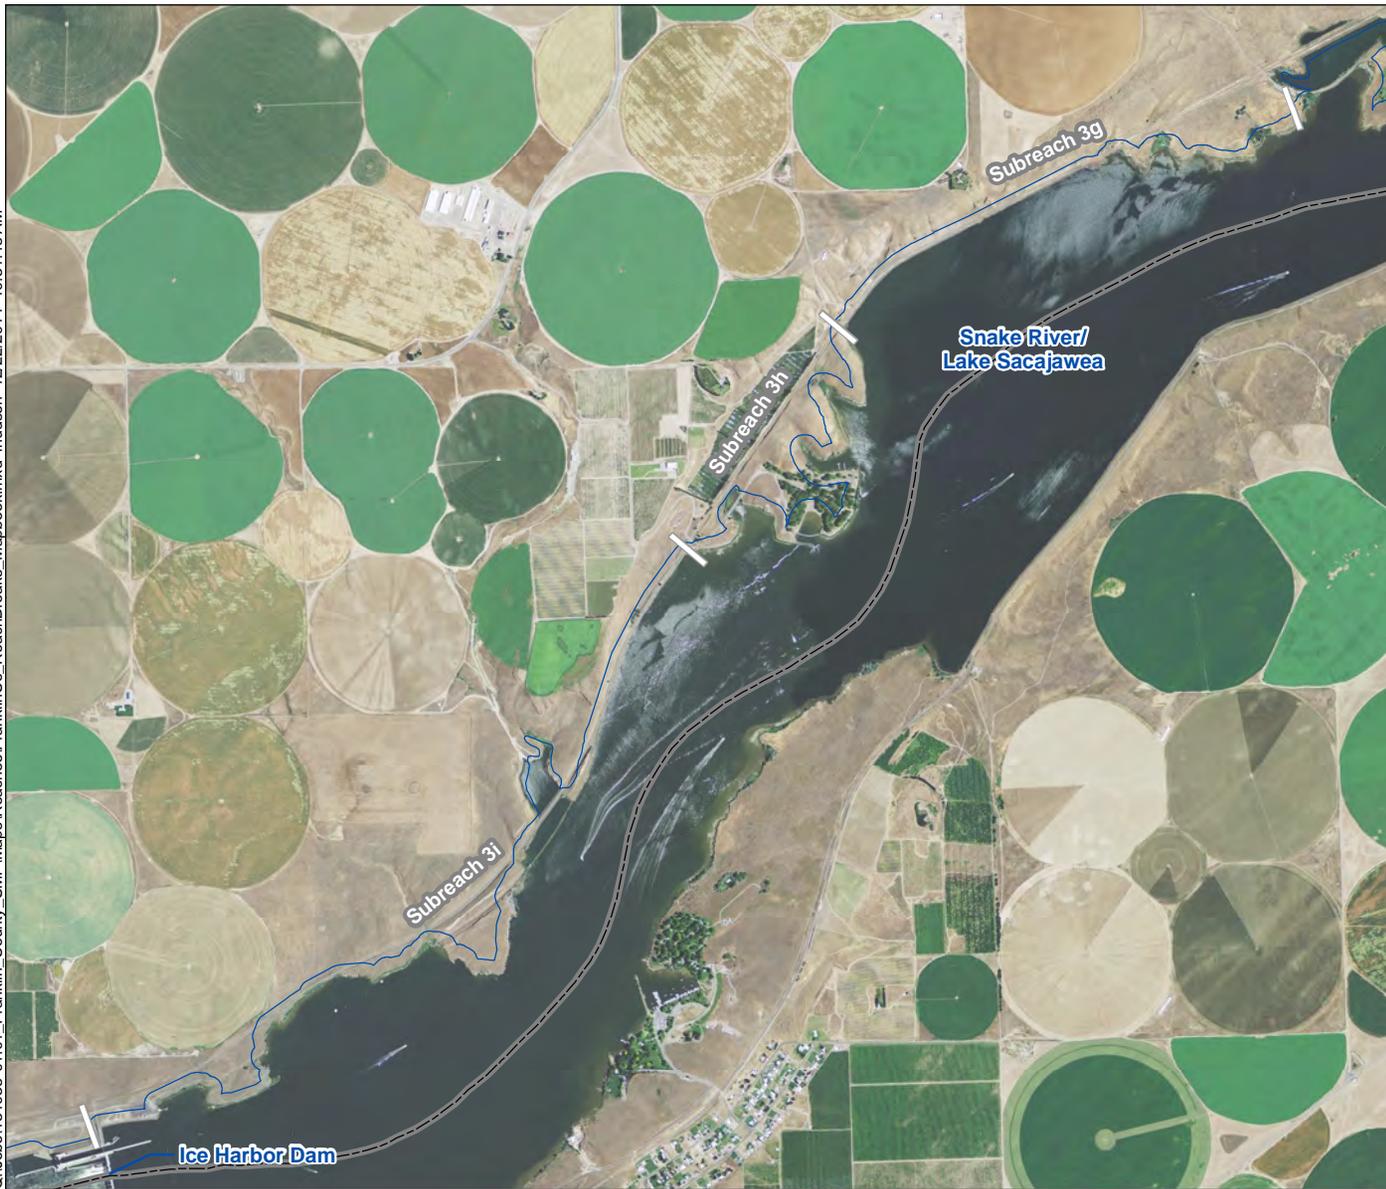
Map 14
Snake River Subreaches 3g-3i
Franklin County Shoreline Master Program
Franklin County, WA

SR 3g: Extends 1.5 miles to the southwest

SR 3h: Extends 1 mile to the southwest ending at the end of Levey Landing Park

SR 3i: Extends 2.7 miles to the south west ending at the Ice Harbor Dam

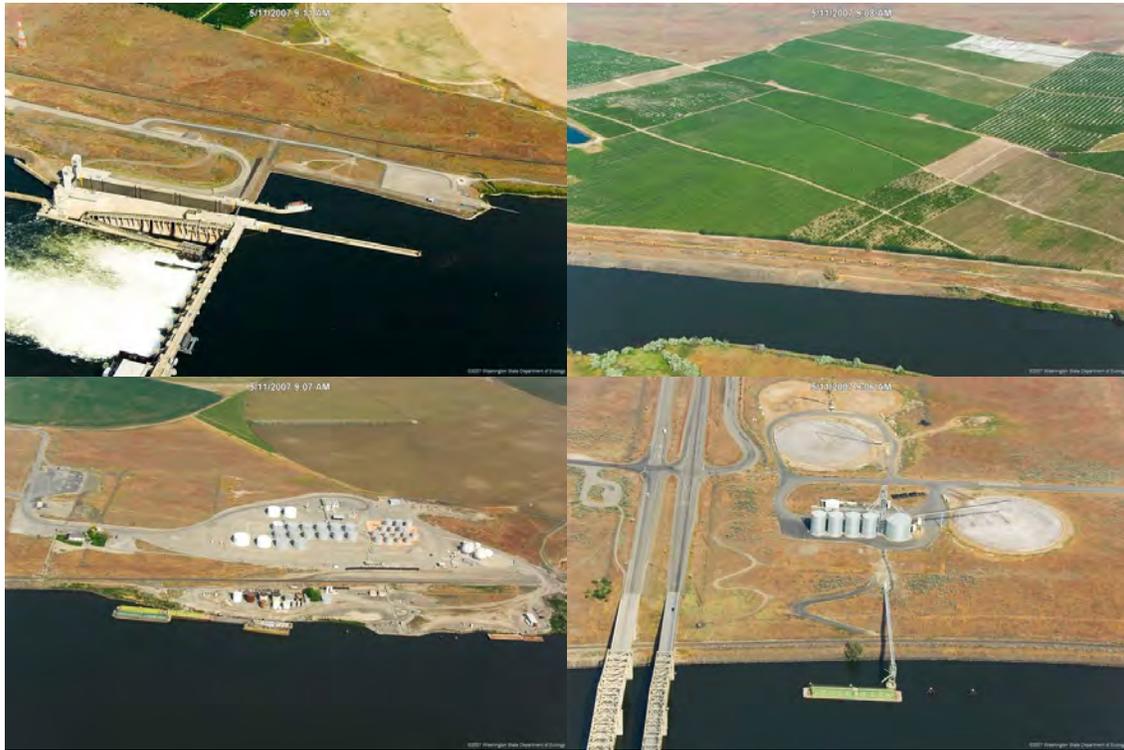
Source: <https://fortress.wa.gov/ecy/coastalatlas/UICoastalAtlas/Tools/ShorePhotos.aspx>

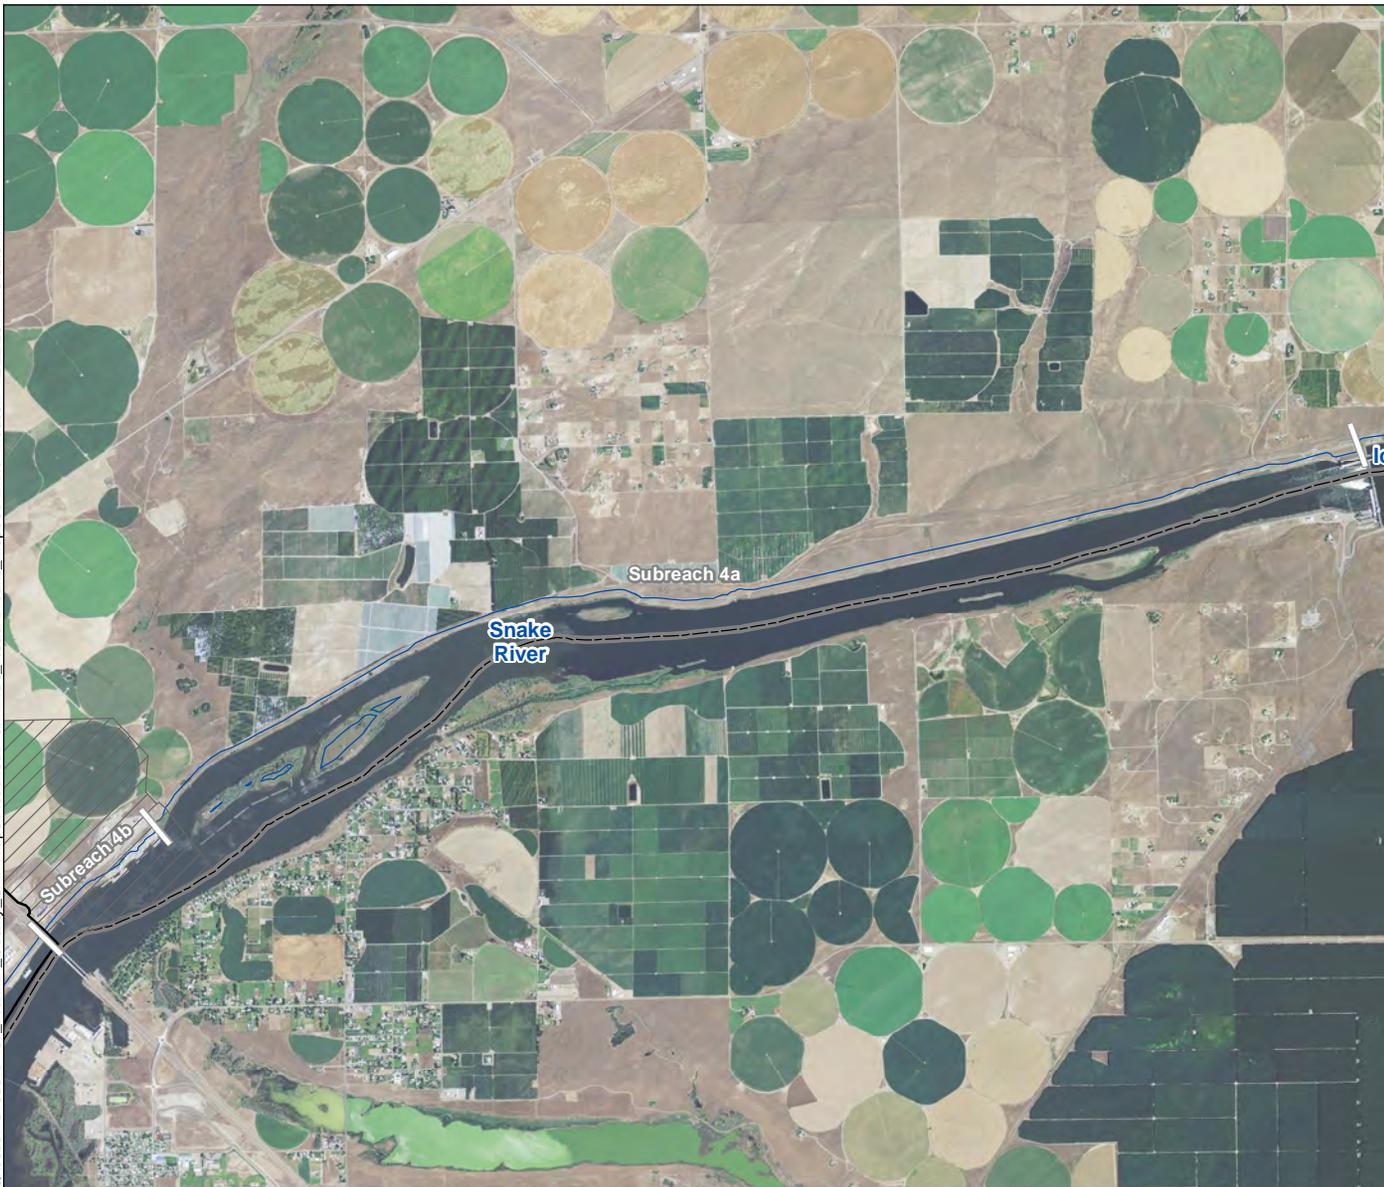
Map 15
Snake River Subreaches 4a-4b
Franklin County Shoreline Master Program
Franklin County, WA

SR 4b: Extends 0.8 mile to the southwest ending at US 12 Bridge

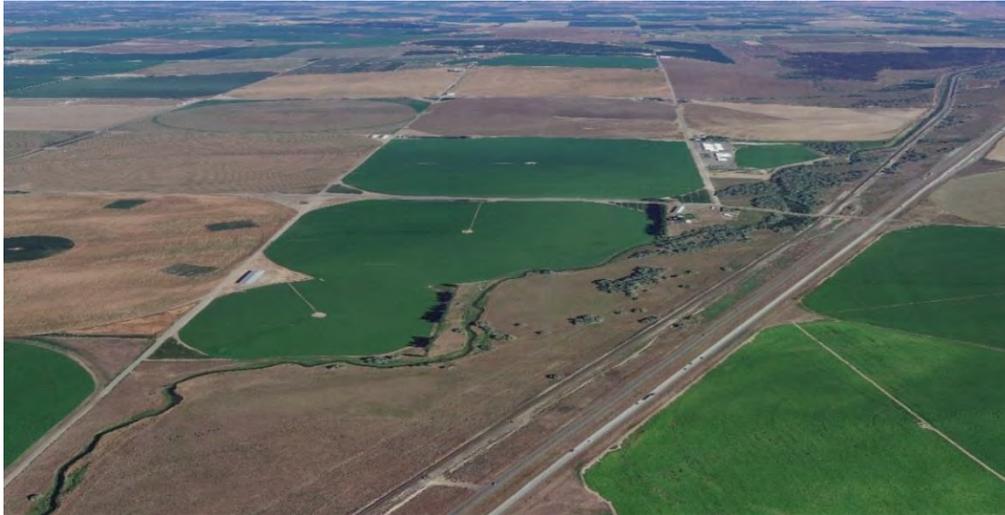
Source: Google Maps (<https://www.google.com/maps>)

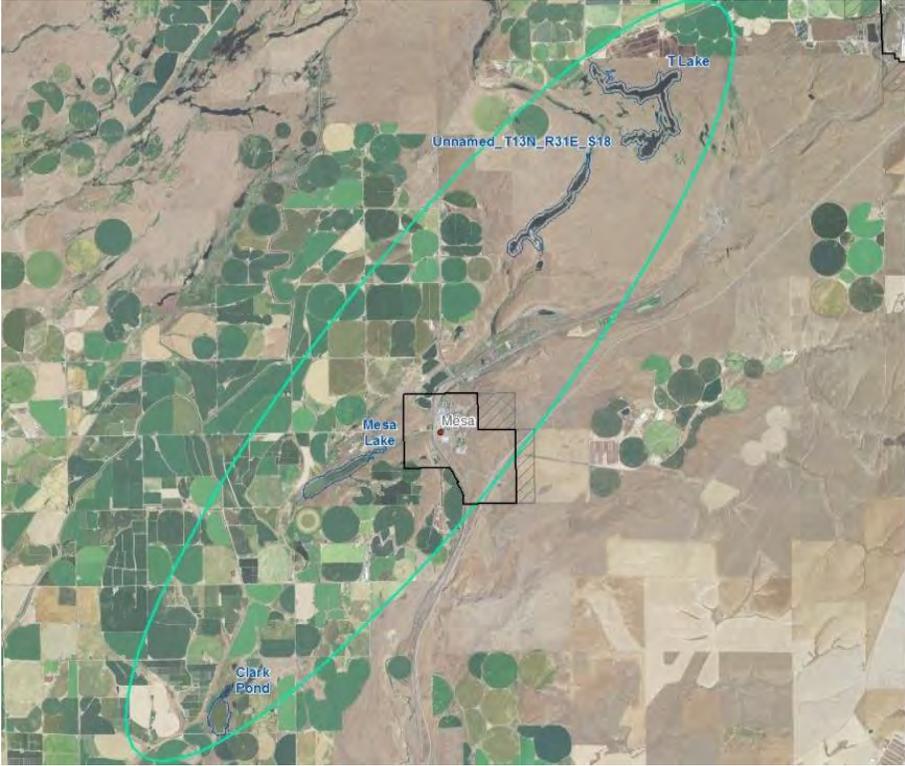
Source: U.S. Department of Agriculture, <i>National Agriculture Imagery Program (NAIP): 2013 data</i>	
Subreaches (SRs); see Figure 16:	
Not Applicable.	
CHARACTERISTICS	
Ownership: Mesa Lake's ownership is separated between federal and state. A portion of Unnamed Lake (T13N R31E S18) and Clark pond is federally owned. Mesa Lake has an ownership separated between federal and state. T-Lake is privately owned.

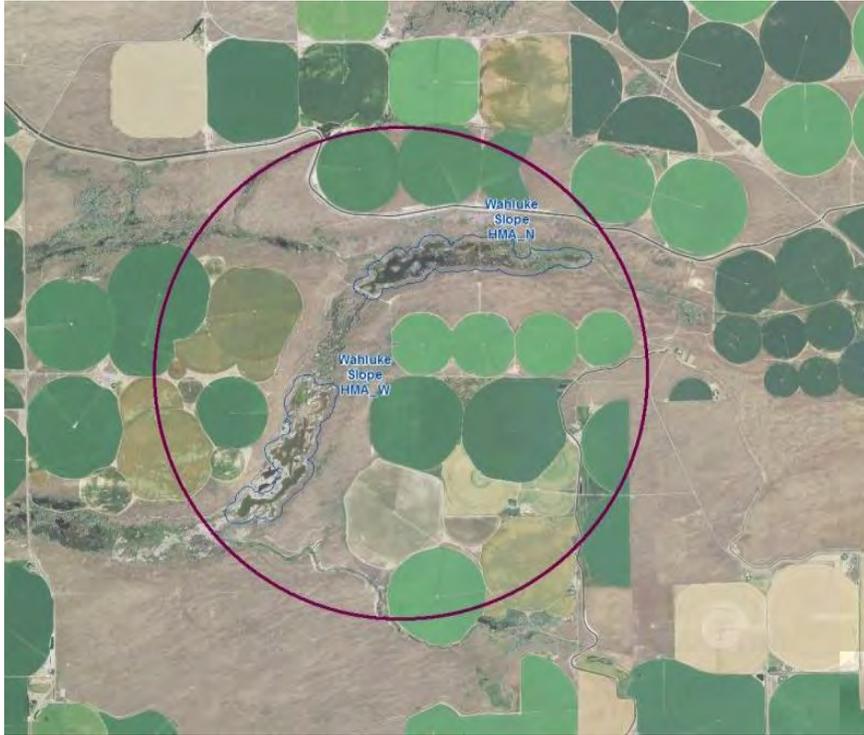
<p>Source: U.S. Department of Agriculture, <i>National Agriculture Imagery Program (NAIP): 2013 data</i></p>	
Subreaches (SRs); see Figure 19:	
Not Applicable.	
CHARACTERISTICS	
Ownership: Wahluke Slope HMA_W and Wahluke Slope HMA_N are federally owned.	
Land Use/Current SMP:	
Land Use Designation:	
<ul style="list-style-type: none"> • Current land use is Agricultural • Zoning - Agricultural Production 20 	
Current SMP Environment Designation:	
<ul style="list-style-type: none"> • Rural
